Assessment of damages on a RC building after a big fire

Mehmet Ada, Barış Sevim*, Nabi Yüzer and Yusuf Ayvaz

Abstract. This paper presents a case study about the damages on the structural elements of a cast in place reinforced concrete (RC) building after a big fire which was able to be controlled after six hours. The fire broke off at the 2nd basement floor of the building, which has five basements, one ground, and two normal floors. As a result of intensely stocked ignitable materials, it spread out to the all of the upstairs. In visual inspection, most of the typical fire damages were observed (such as spalling, net-like cracks, crumbled plasters, bared or visible reinforcement). Also, failures of the 2nd basement columns were encountered. It has been concluded that the severity failures of the columns at the 2nd basement caused utterly deformation of the building, which is responsible for the massive damages on the beam-column connections. All of the observed damages were categorized related to the types and presented separated regarding the floors. Besides to the visual inspection, the numerical analysis was run to verify the observed damaged on the building for columns, bea

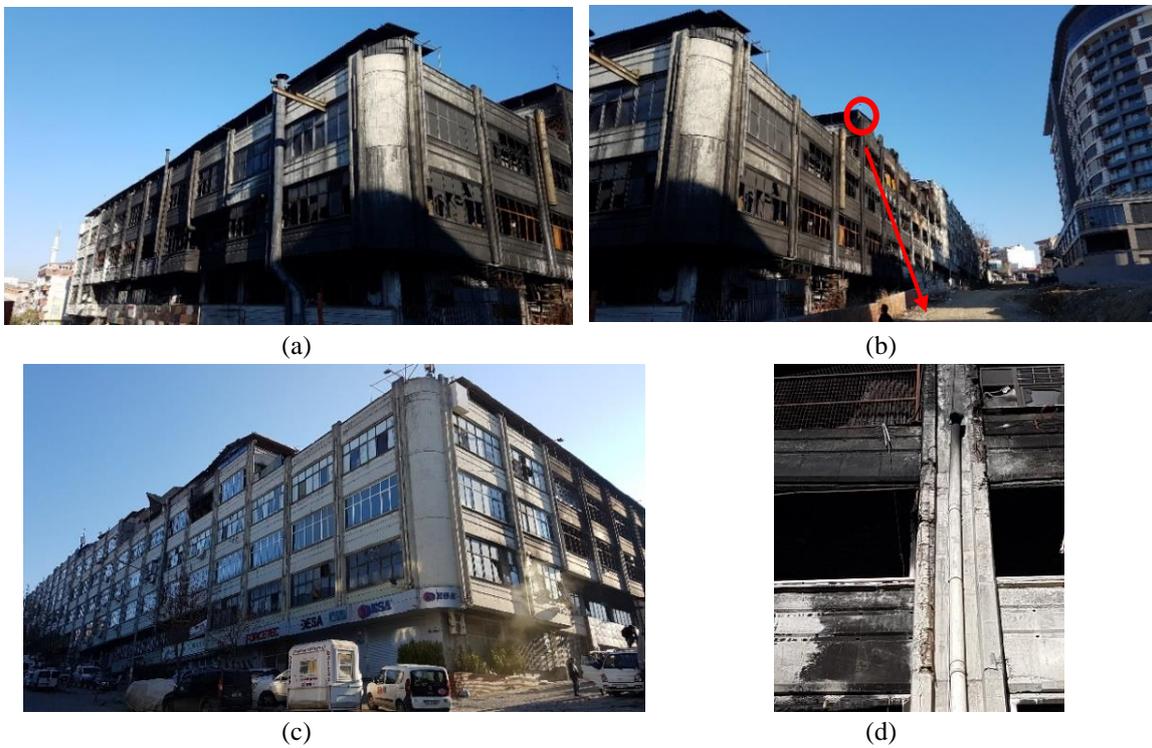
Fig. 7 External view of the building after the fire

All structural elements (columns, connections, beams, slabs of the RC building) were investigated visually after the fire to assess the damage level of the building. The damages were categorized according to the element types, floors and the level of damage. Although the most elements of Block 5 was damaged, only some part of Block 4 was damaged. The fired regions could be observed from the external view of the building (Figs. 7(a)-(c)). The spalling of the exterior elements were observed (Fig. 7(d)).

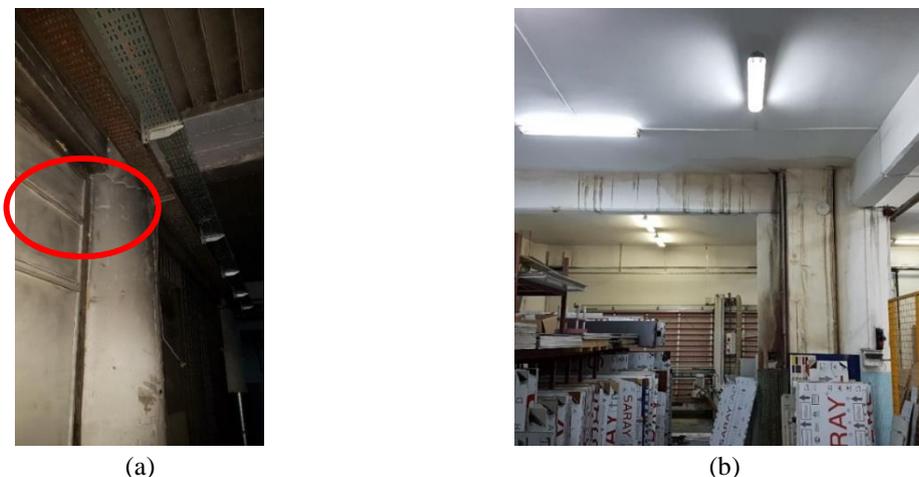
Fig. 8 Beam-column connection cracks (a) and the local leakage of the cooling water on 3rd basement (b)

In view of the damages on the structural elements, the 2nd basement where the fire was broke out was the most damaged floor. Other floors were damaged depending on the spreading of fire due to the ignitability of the wares which existed. As expected, the storeys below this floor were not damaged. It should be stated that a few of the beam-column connection regions very slightly cracked (Fig. 8(a)) and especially at the connections regions the leakage trace of the cooling water could be observed at some regions (Fig. 8(b)) at the 3rd basement.

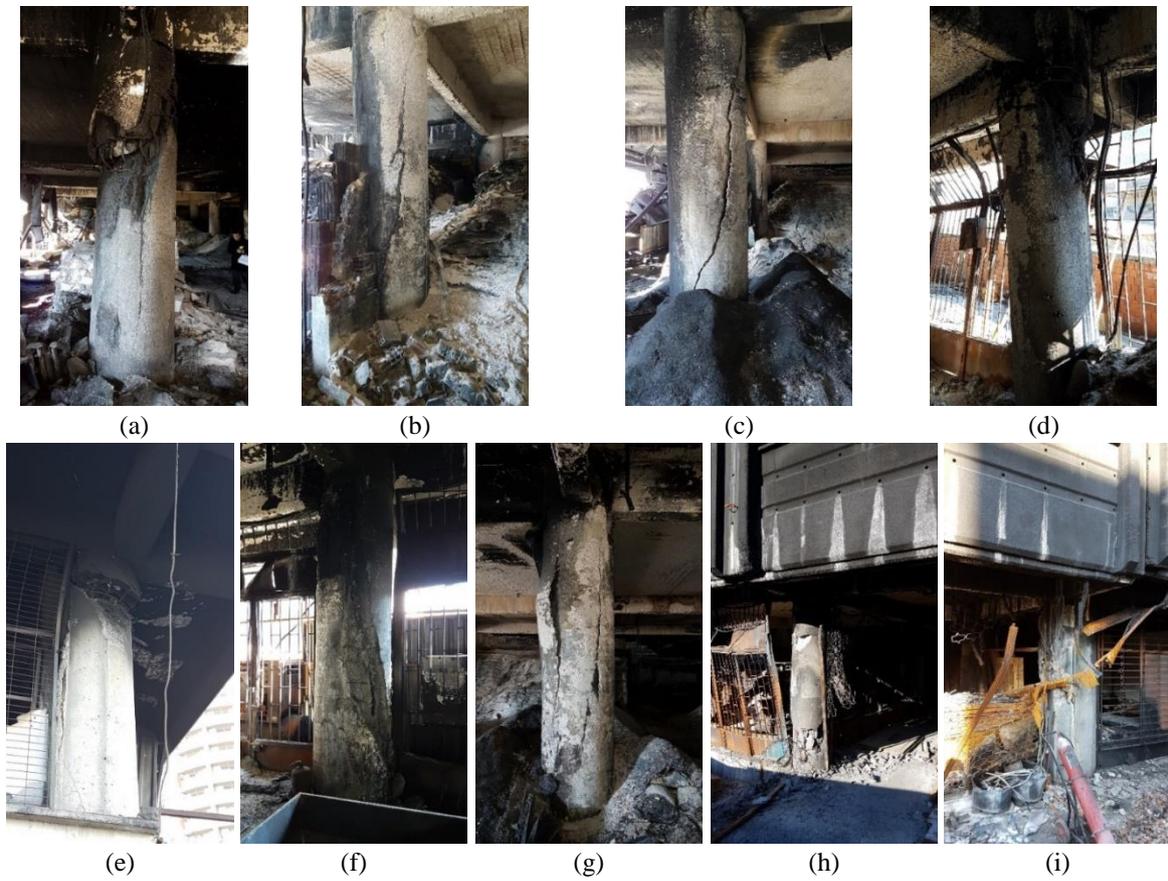
Fig. 9 Failures of the several columns at the 2nd basement

higher than expectations. For 2nd basement, some of the loss was damaged partially with inclined cracks (Figs. 9(b), (c), (g) and (i)). However, on the multiple columns lost their bearing capacities completely. It is noteworthy to state that the columns damaged heavily in the 2nd basement are

between the 30-34 and H-K axes. As a result of complete crush on the columns, the longitudinal reinforcements were buckled, and bond strength was lost between reinforcements and concrete, stirrups were crushed and deformed (Figs. 9(a), (d), (e), (f), and (h)).

- The columns are one of the most critical elements of a structure. Therefore they should be coated with fire protection material. In this study, it was observed that the failure of the multiple columns on the 2nd basement caused an overall structural deformation.

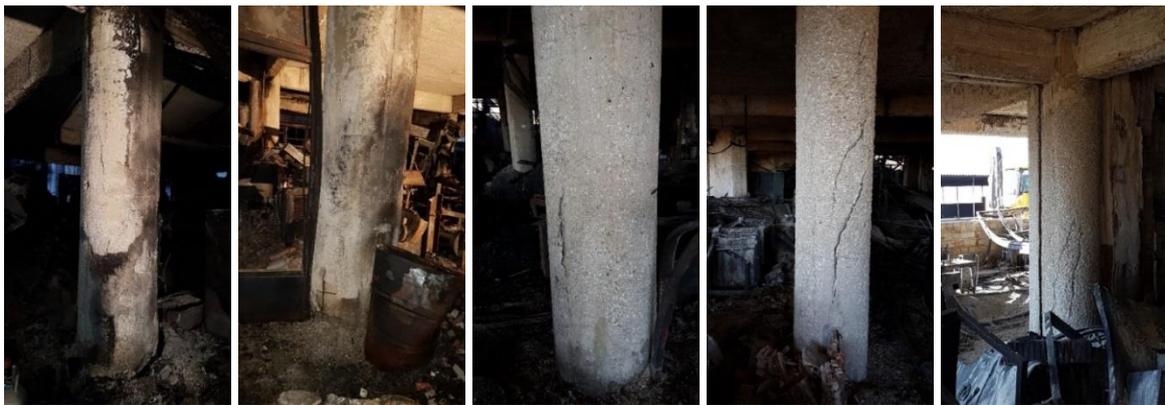
Fig. 10 Cracks of several columns and spalling on the 1st basement and 1st floor

In other storeys, only partially deep cracks and spalling were observed. Moreover, the longitudinal and stirrups were bared but not damaged or lost contact with the core concrete (Fig. 10). In consequence of crush of the multiple columns in 2nd basement, the whole structure was deformed, and a relative movement was occurred between Block 5 to Block 4. This phenomenon could be seen on the expansion joint between Block 4 and 5 (Figs. 11 and 12). Informatively, there was not any relative displacement on the expansion joint between Block 3 and Block 4.

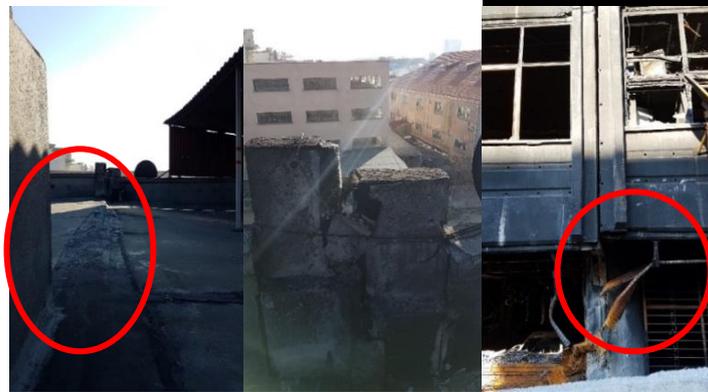
Fig. 11 The displacement of Block 5 relative to Block 4 from the roof of the building

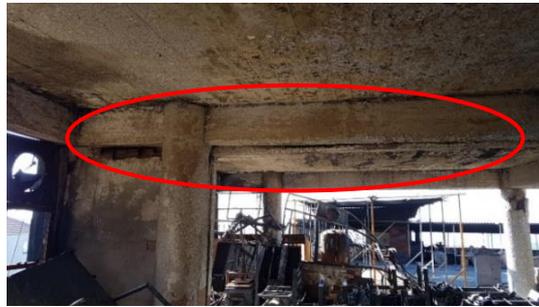
Fig. 12 The displacement of Block 5 relative to Block 4 from inside of the building (shot on 1st floor)

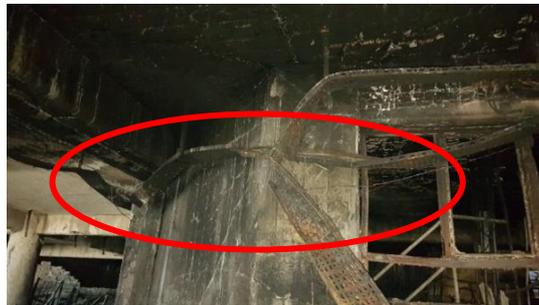
Fig. 13 Shear wall beam cracks on 2nd basement

The connection of the shear wall with the beam an obvious horizontal crack was determined (Figs. 13 and 16). For column beam connections single or multiple horizontal cracks were observed (Figs. 14-16). Simultaneously the elevated temperature and the relative movement of the building some of the column beam connections were cracked and local spalling were observed (see Fig. 16).

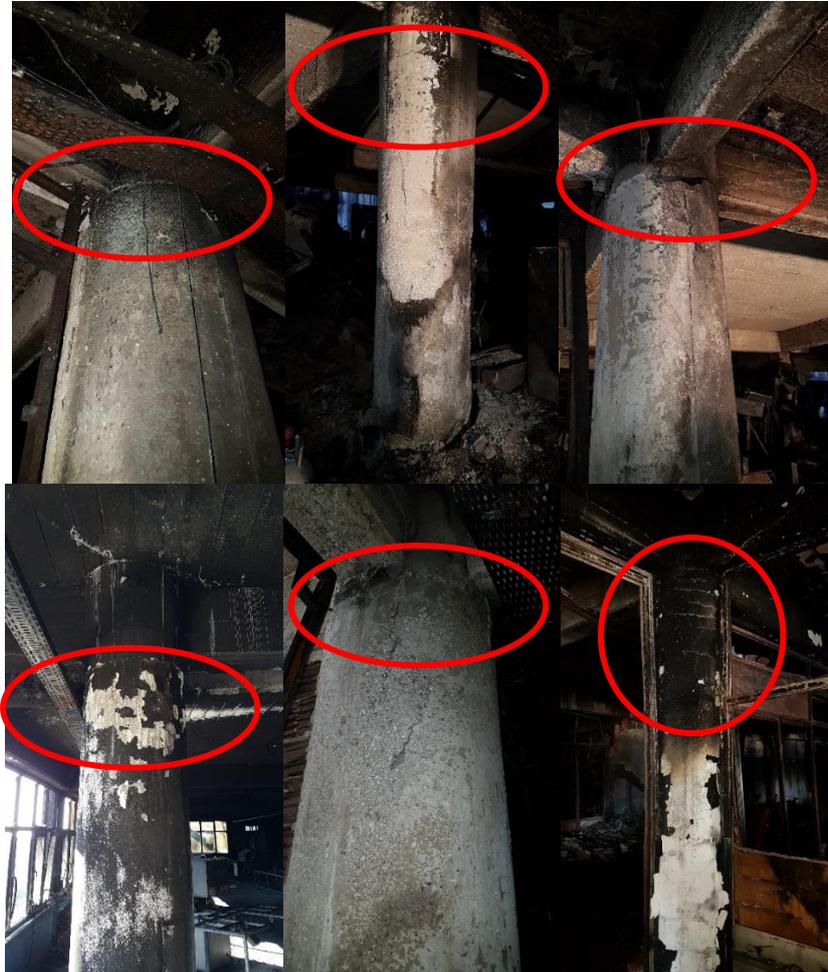
Fig. 14 Connection cracks on the 1st basement and ground floor

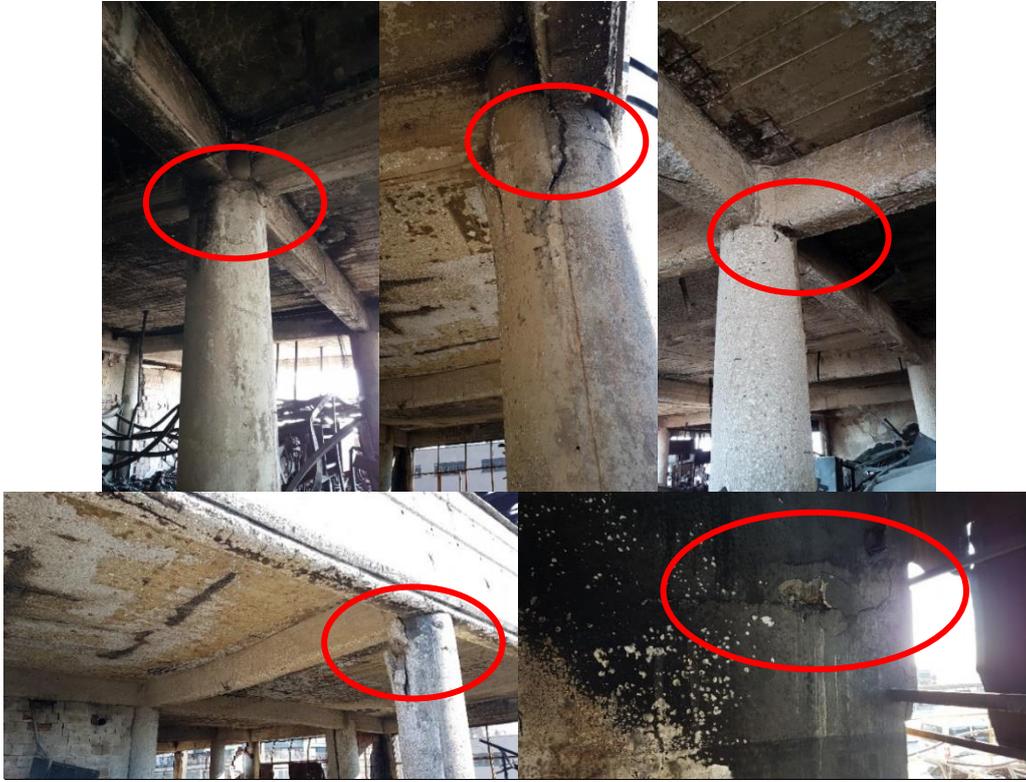
Fig. 15 Connection cracks on the 1st and 2nd floors

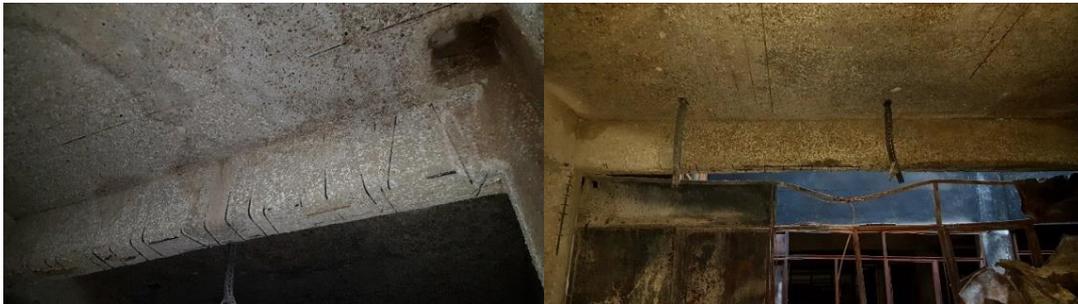
Fig. 16 Spalling of beams and visible reinforcements on the ground floor

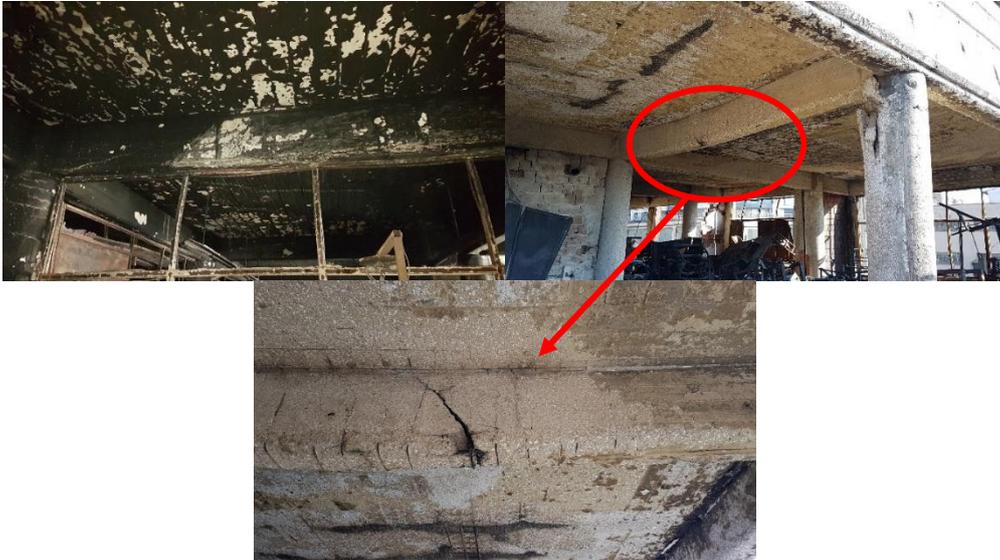
The bending capacity of a beam primarily varies by the strength and the elasticity modulus of the materials, size & shape of the beam, and reinforcement characteristics. It was observed that cross-section area of the some of the beams was decreased as a result of spalling of concrete cover. Longitudinal and stirrup were bared and direct flame effected to these reinforcements on some beams (Fig. 16). Moreover, on several beams are vertically deformed and cracked with the loss of the cross-section and the material strength reduction (Fig. 17).

Fig. 17 Deformed beams at Ground and 1st floors

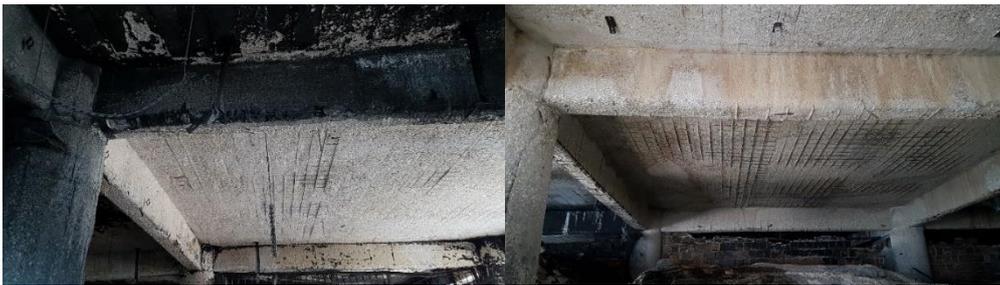
Fig. 18 Spalling of slabs and visible reinforcements at the 2nd basement

In some part of the building, especially on the 2nd basement, slabs are damaged with net-like cracks, cracks at the bottom surface, loss in bond strength between reinforcement and concrete, bared or visible reinforcements (Figs. 18-20). The physical characteristics of the fire and bared reinforcement, some of the slabs were deformed slightly. For damaged floors, it was hard to determine slab deformations and cracks on the slabs because of the burnt stock ruins. Luckily, on the upper surface of the top floor, multiple deep cracks were observed with varying slopes of the cracked slabs (Fig. 20).

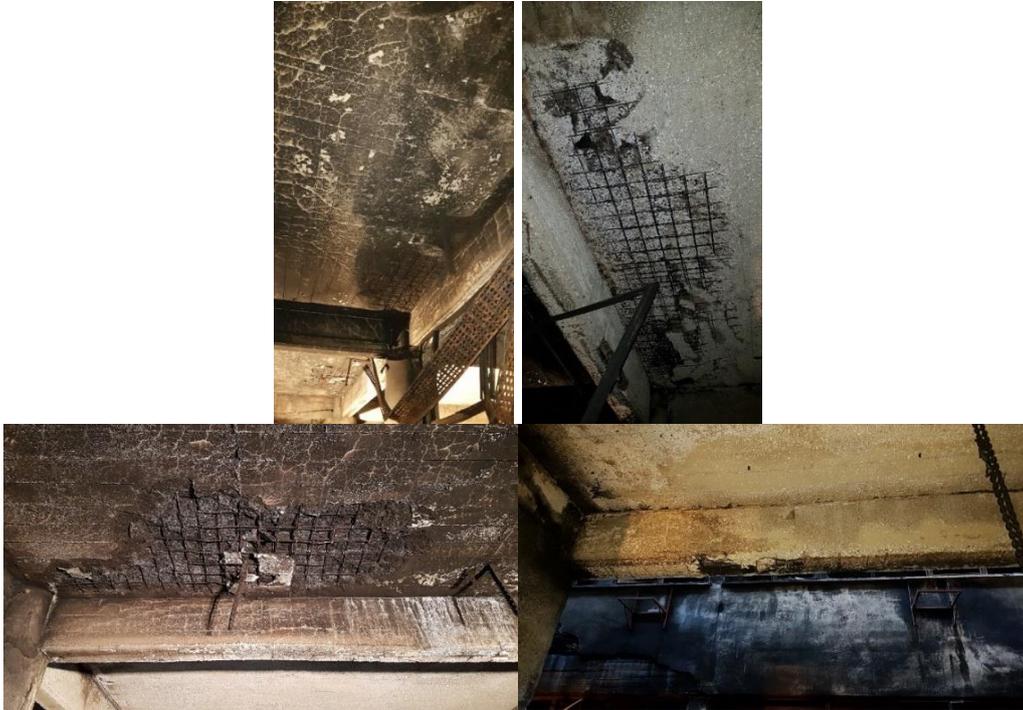
Fig. 19 Net-like cracks, spalling and bared reinforcements at 1st basement slabs

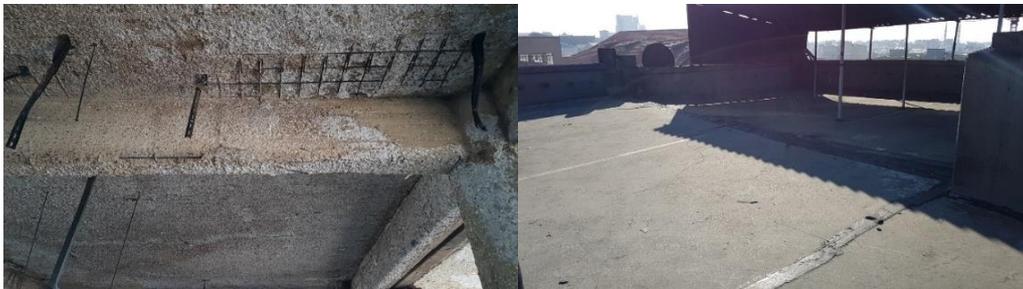
Fig. 20 Spalling and bared reinforcement at 1st floor and deep cracks on 2nd floor slabs

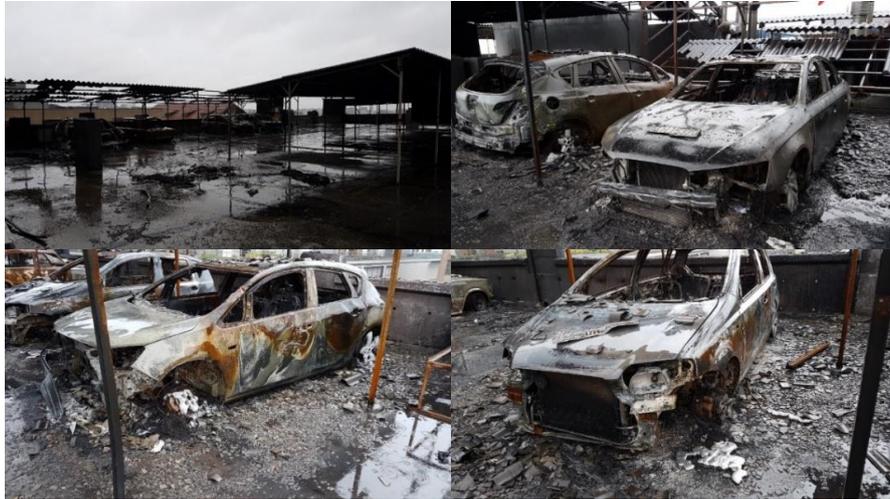
(open air area) and the melting heat of the alloy the temperature is about 650°C (Ashby 2006). This can be interpreted that the temperature inside the building was higher than 650°C. Regarding the strength loss of the concrete and the reinforcement with the elevated temperatures in EN 1992-1-2 (CEN 2004), the strength of the structural materials of the building was decreased critically (see Figs. 3-4).

Fig. 21 Burnt vehicles that some of the aluminum wheels trims melted in the parking area on the roof

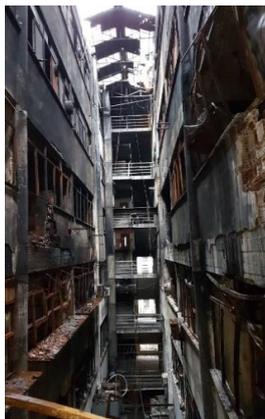
Fig. 22 The view of the stairway case with lighting clearance

sides of the clearance (see Fig. 5) was closed with windows, but with the fire, all of the windows were splintered, and the clearance behaved as a vertical shaft (Fig. 22). Thus, the fire could easily transmit to the upstairs, was not able to keep down and took longer than it should be.

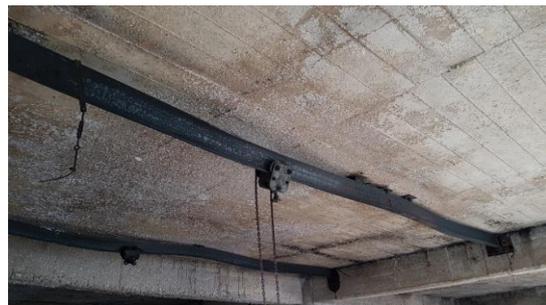
Fig. 23 A deformed steel roof rail at 1st floor

Besides, the severity of the elevated temperatures of the fire may be observed from the deformed a steel roof rail that is on the 1st floor (Fig. 23). If the melting point of the steel is considered, the temperature during the fire can be estimated.
