# Seismic assessment of historical masonry structures: The case of Amasya Taşhan

**Keywords:** Amasya Taşhan; strengthening; structural safety assessment; masonry

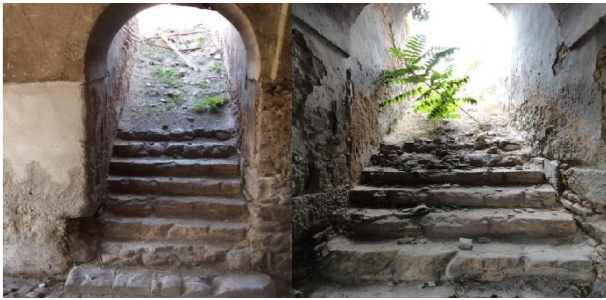
Fig. 3 Weather-related material deteriorations occurred on stairs

It is clear from Fig. 3 that stone steps and risers of the stairs were partially broken or totally disappeared in time. Also, the stone columns of Amasya Taşhan were damaged or collapsed. Before strengthening, current state of some of the stone columns was given in Fig. 4 (Pergel 2013).

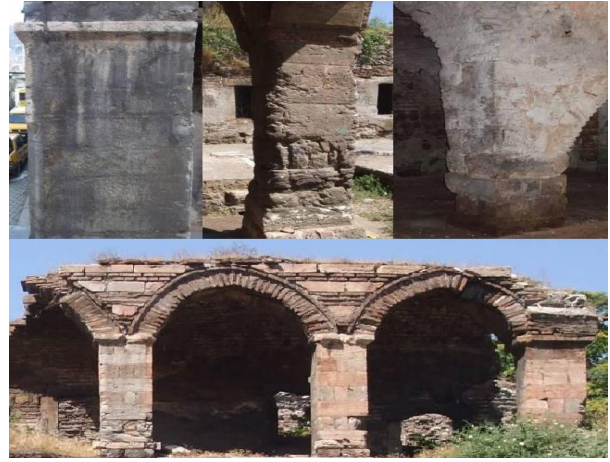
Fig. 4 Current state of stone columns before strengthening

- All the damaged stone columns should be removed. In the rebuild process of these columns, all stones should be clamped to each other. All the stone columns of porches should be attached together with the wood beams and steel tie bars at the specified heights.
- The entrance stone vault was cracked along its length.

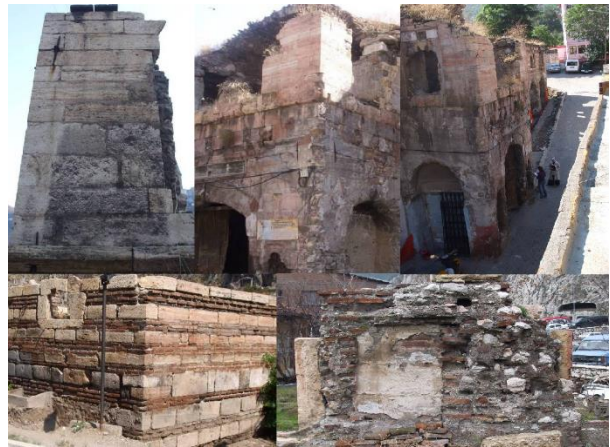
Fig. 5 Cracked, damaged or collapsed main load carrying masonry stone walls

As can be seen from Fig. 5 that different types of materials, i.e., quarry stone, brick or cut stone were used in the construction of masonry walls. In time, these masonry walls were damaged or collapsed due to corrosive effects of nature, debonding of mortar between the stones or bricks,

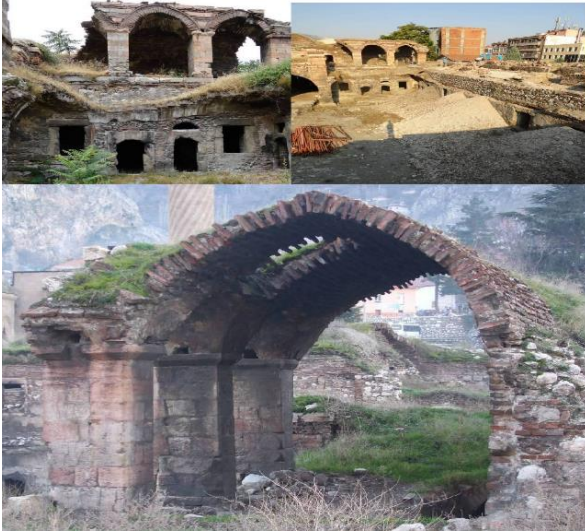
Fig. 6 Damaged or collapsed stone vaults

strength lose in the constituting materials, decaying of wood used as the bonding material between stones and bricks etc. Also, the stone vaults (Fig. 6) (Pergel 2013) were damaged or collapsed due to the unfavorable effects of time. Different from other structural elements, wood or wrought iron tie bars were used to keep the stone vaults together without splitting into pieces.

As can be seen from Fig. 6 that damages occurred on vaults mainly caused by tension stress concentrations on intersection regions. Also, tie bars were used on vaults to transfer and distribute tension stress safely to the other load carrying structural elements. In Fig. 7 (Pergel 2013), the space occurred after damage of tie bars was shown.

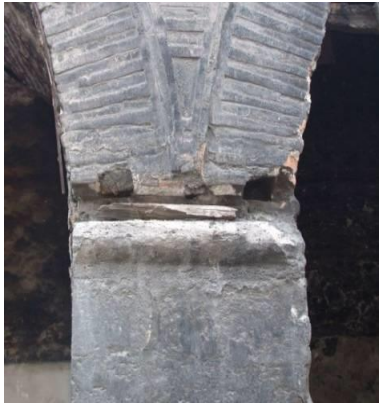
Fig. 7 Space of tie bars after damage

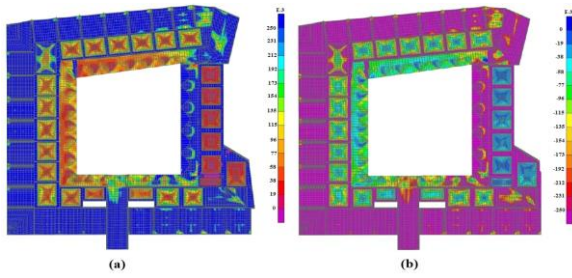
Fig. 9(a) Maximum and (b) minimum shear stresses occurred on porches and stone vaults

From Figs. 9-14, it can be clearly interpreted that the shape of the historical masonry structure, Amasya Taşhan, is not in the regular geometrical form. As can be seen from the FEM model, the earthquake behavior of the whole structure in North-South direction. The masonry stone porches found in the northern part of the structure are the most affected regions of the structure due to the reason that the weight of the porches are carried by the two stone columns sensitive to shear and tension stresses. Also, the region of the intersection of masonry stone porches with the stone columns are the vital and the most negatively affected regions of the structure. This phenomena explains the reason of the collapse of the structure in these intersection regions in time. Moreover, consistent with the dynamic analyses results of the FEM model of the structure, except the side masonry walls found in south region of the structure, the side walls of the structure are heavily damaged.

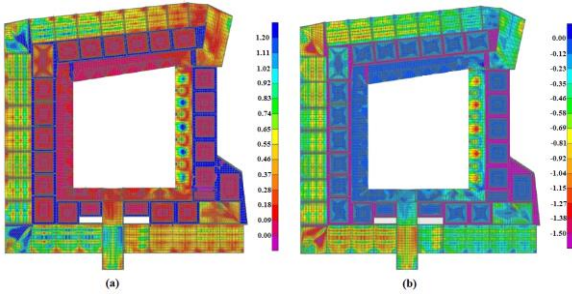
Fig. 10(a) Maximum and (b) minimum shear stresses occurred on store stone vaults

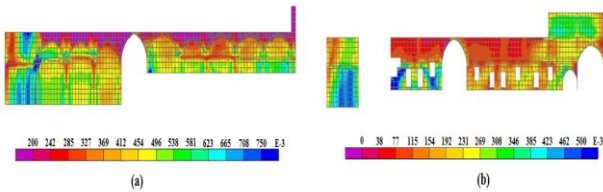
Fig. 11(a) Outer and (b) inner shear stresses occurred on west side of masonry stone walls

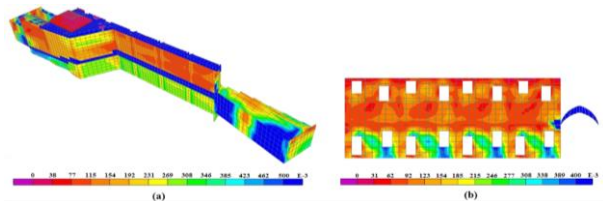
Fig. 12(a) Outer and (b) inner shear stresses occurred on south side of masonry stone walls

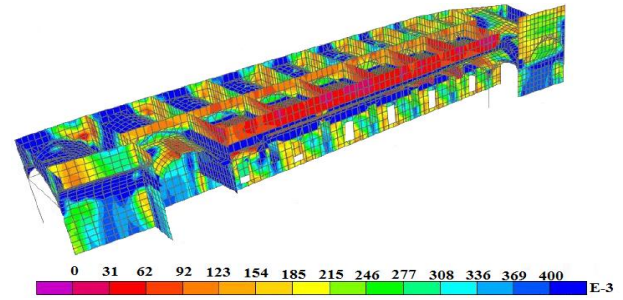
Fig. 14 Inner shear stresses occurred on east side of masonry stone walls

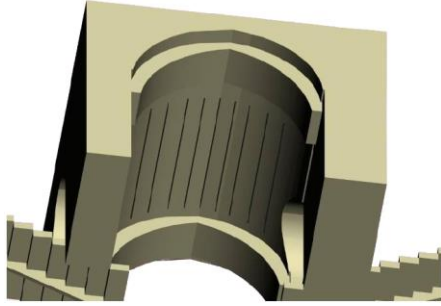
Fig. 15 Details of crack sewage with the carbon rods

Therefore, this crack should be filled with the injection and should be sewed with the carbon rods in 40 cm. spacing (Fig. 15) (Pergel 2013).

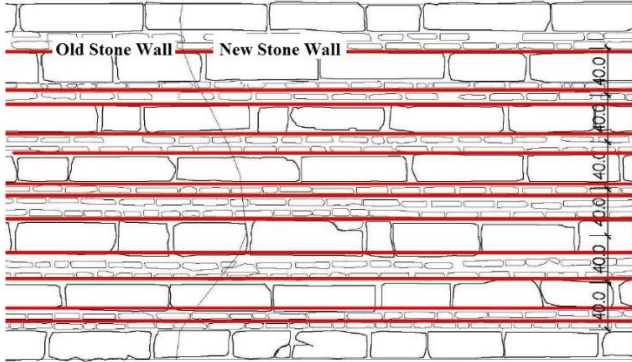
Fig. 16 Details of integration of walls with the flat steel

- The integration of old stone walls with the new ones should be made mechanically. In order to integrate the walls to each other mechanically, the flat steel should be placed to the wall joints in 40 cm. spacing (Fig. 16) (Pergel 2013).

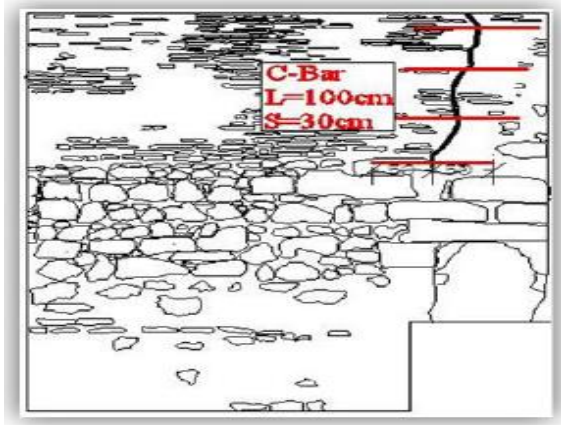
Fig. 17 Details of repair of cracks on stone walls smaller than 10 mm

- The cracks on masonry stone walls which are smaller than 10 mm. were first filled with the injection of pozzolan-hydraulic lime and then sewed with 1,00 meter carbon rods in 40 cm. spacing (Fig. 17) (Pergel 2013).

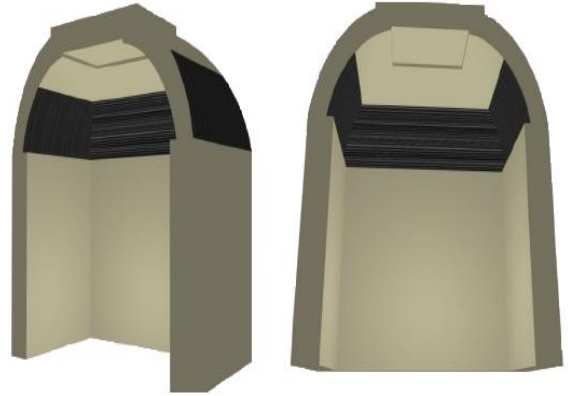
Fig. 18 Details of repair of 300 g/m<sup>2</sup> FRP from inside and outside of stone vaults

- The side walls of stone vaults should be covered with the 300 g/m<sup>2</sup> fibrous polymer fabric (FRP) from inside and outside as indicated in Fig. 18 (Pergel 2013).

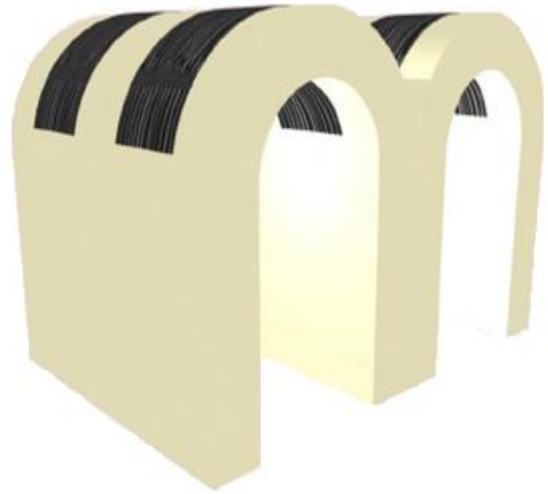
Fig. 19 Details of strengthening of 300 g/m<sup>2</sup> FRP from inside and outside of stone vaults

- In the ground floor of the structure, the stone vaults should be covered with the 300 g/m<sup>2</sup> FRP from inside and

outside. The spacing and length of these FRP's should be 75 cm. and 1,00 meters, respectively (Fig. 19) (Pergel 2013).

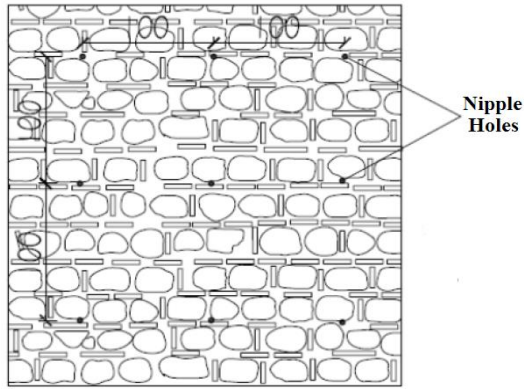
Fig. 22 Details of nipple holes on inner and outer masonry stone walls

- The nipple holes with the spacing of 1,00 meters in vertical and horizontal directions should be drilled on inner and outer faces of masonry stone walls. After drilling, these holes should be filled with the injection of pozzolan-hydraulic lime. By this method, the masonry stone walls behave as a single member. The details of nipple holes were given in Fig. 22 (Pergel 2013). Also, in this method, the carbon plates were placed inside the walls of stores where there occurs shear stress accumulation.

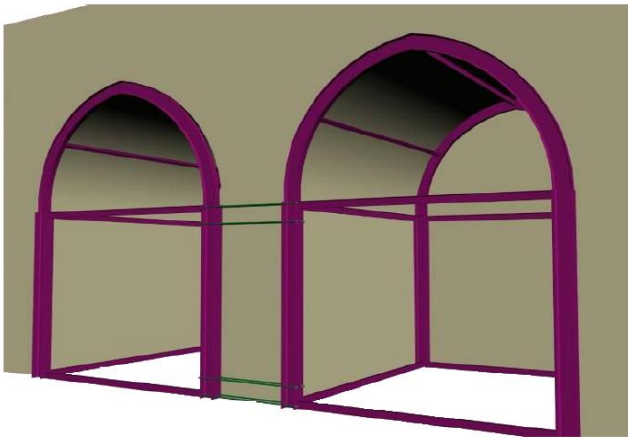
Fig. 23 Details of steel ties applied on masonry stone walls and vaults

- In order to prevent the displacement of masonry side walls, steel ties should be anchored to the masonry stone walls and stone vaults (Fig. 23) (Pergel 2013).

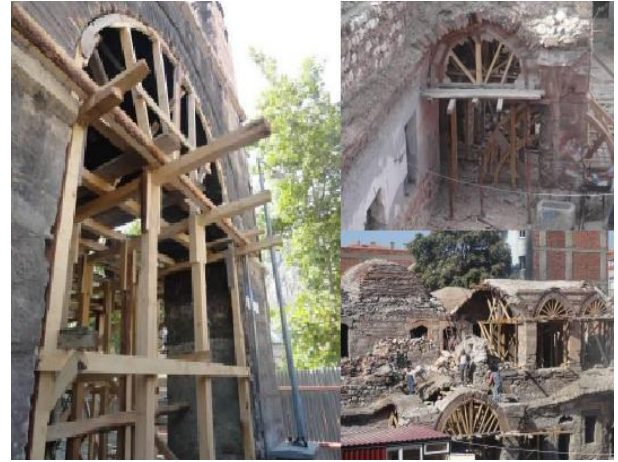
Fig. 24 Suspension of stone vaults and porches with wood formings

In order to apply the strengthening and repair suggestions to the structure, firstly, all the stone vaults and porches that have the potential of collapse were suspended with the wood forms. These were given in Fig. 24 (Pergel 2013).

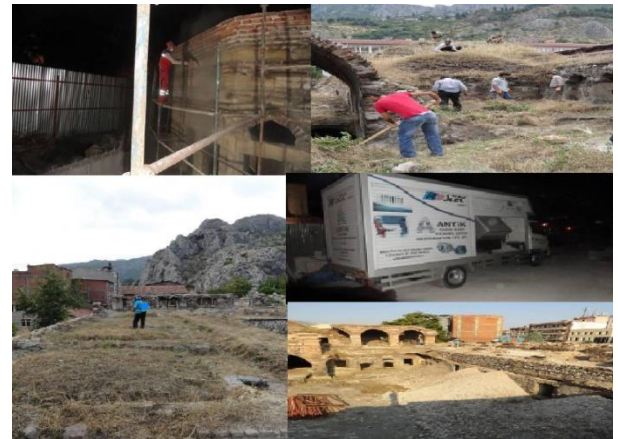
Fig. 25 Cleaning and removal process of unsuitable and damaged materials

Also, outer masonry stone walls of the structure were cleaned with the pressurized granular material. This process was given in Fig. 25 (Pergel 2013). Then, the cracks on masonry stone walls, vaults and porches were repaired (Fig. 26) (Pergel 2013) as indicated in repair suggestions of the structure.

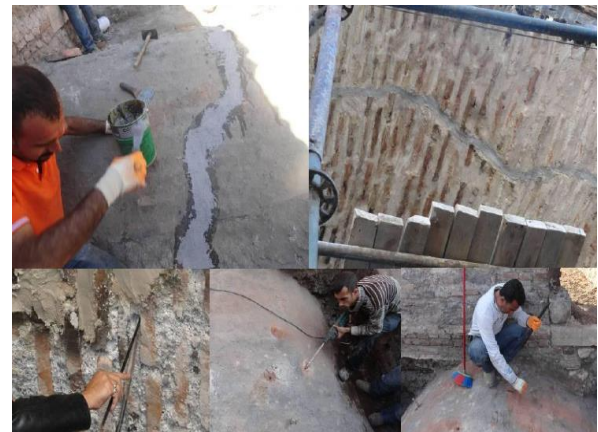
Fig. 26 Repairing of cracks on stone masonry elements

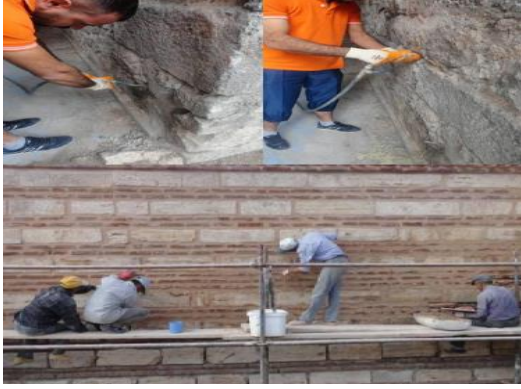
Fig. 27 Filling of nipple holes with the injection of pozzolan-hydraulic lime

The nipple holes with the spacing of 1,00 meters in vertical and horizontal directions were drilled on inner and outer faces of masonry stone walls. After drilling, these holes were filled with the injection of pozzolan-hydraulic lime as given in Fig. 27 (Pergel 2013).

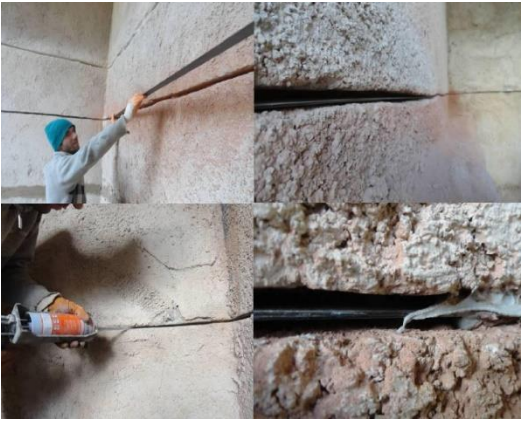
Fig. 28 Application of flat steel in the joints of masonry stone walls

The integration of old masonry elements with the new ones i.e., stone walls, vaults or porches were made mechanically by using flat steel (Figs. 28-29) (Pergel 2013).

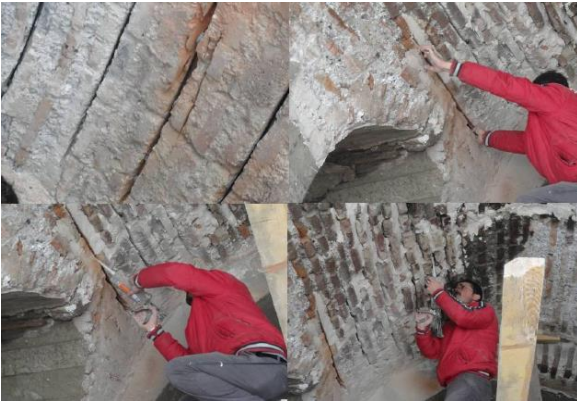
Fig. 29 Application of flat steel in the joints of masonry stone vaults and porches

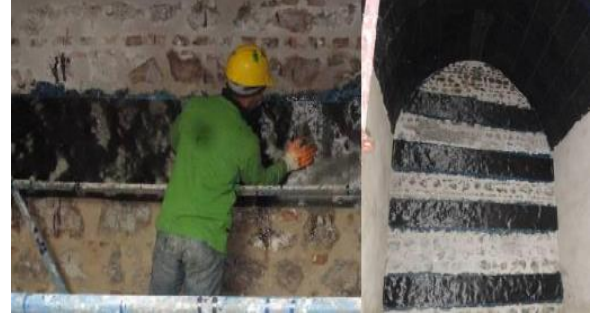
Fig. 30 Covering of masonry walls of the structure with 300 g/m<sup>2</sup> FRP

The masonry walls of the structure, side walls and arches of stone vaults were covered with the 300 g/m<sup>2</sup> FRP

from inside and outside as indicated in Figs. 30-31 (Pergel 2013).

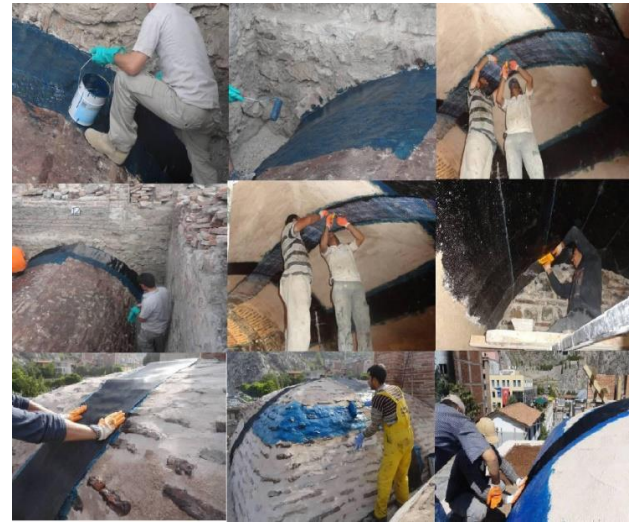
Fig. 31 Covering of masonry vaults of the structure with 300 g/m<sup>2</sup> FRP

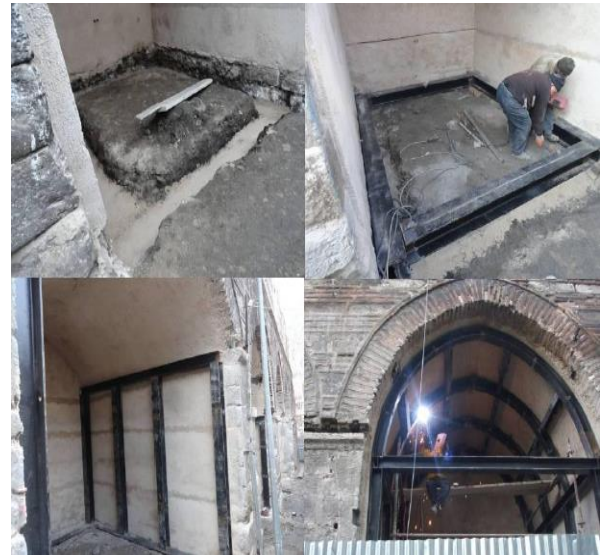
Fig. 32 Anchoring of steel ties to the masonry stone walls and stone vaults

walls, steel ties were anchored to the masonry stone walls and stone vaults (Fig. 32) (Pergel 2013).
