Engineering implications of the RC building damages after 2011 Van Earthquakes

Hayri Baytan Ozmen^{1a}, Mehmet Inel^{*2}, and Bayram Tanik Cayci^{2b}

Abstract. Two destructive earthquakes occurred on October 23 and November 9, 2011 in Van province of Turkey. The damage in residential units shows significant deviation from the expectation of decreasing damage with increasing distance to epicenter. The most damaged settlement Ercis has the same distance to the epicenter with Muradiye, where no damage occurred while relatively less damage observed in Van having half distance. These three cities seem to have resembling soil conditions. If the damages are evaluated: joint failures and insufficient lap splice lengths are observed to be the main causes of the total collapses in RC buildings. Additionally, low concrete strength, reinforcement detailing mistakes, soft story, heavy overhang, pounding and short columns are among other damage reasons. Examples of damages due to non-structural elements are also given. Remarkable points about seismic damages are: collapsed buildings with shear-walls, heavily damaged buildings despite adequate concrete strength due to detailing mistakes, undama

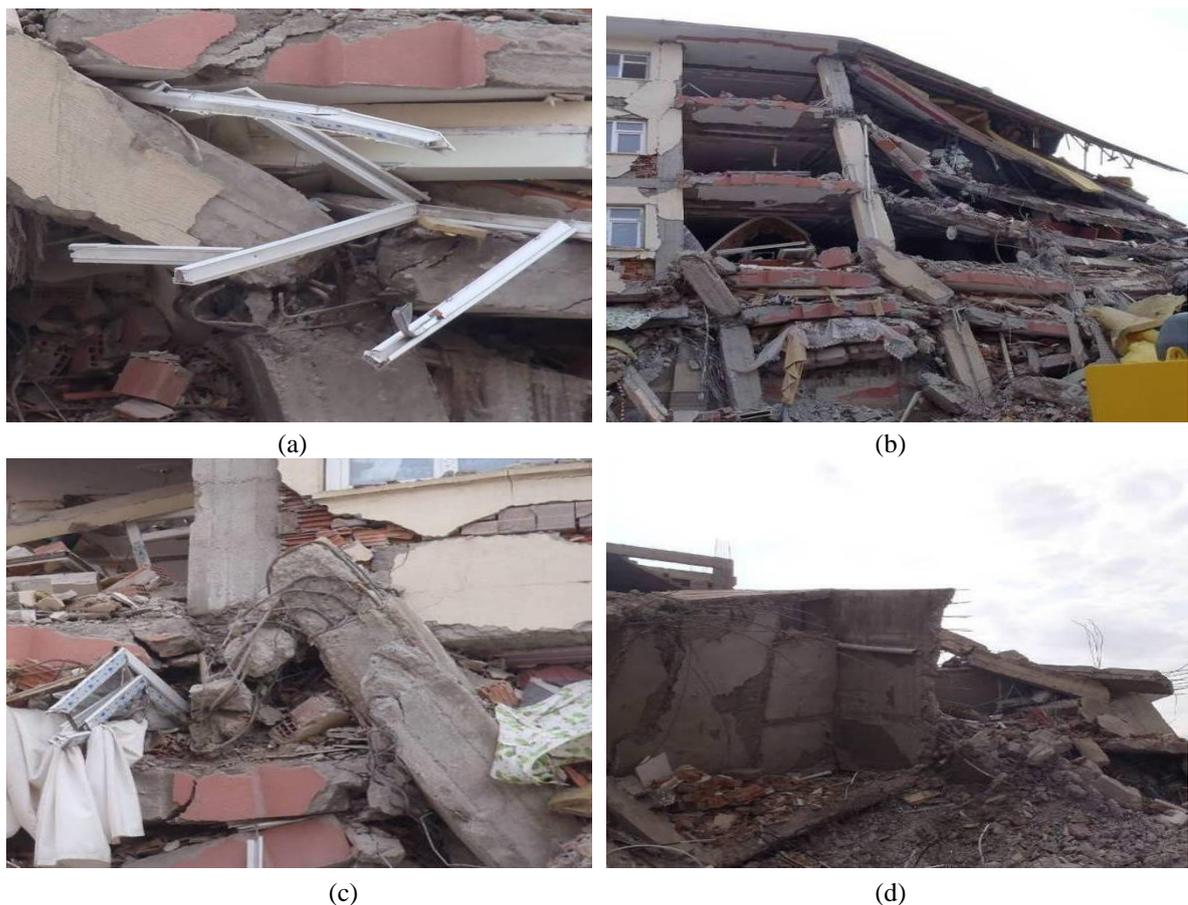
Failures in the joint regions are one of the most frequently observed types of damages. These types of damages are considered as one of the main reasons causing collapses in the structures. Structures with damaged joint regions become unstable quickly and collapse without significant resistance to the earthquake forces. According to design principles, joint regions are the points which should not be damaged. In a properly designed building, beams are the location of initial damages consuming significant amount of energy by ductile behavior. Unfortunately, in Turkey, joint regions are one of the parts where mistakes related to lateral reinforcement detailing are often made (Celebi *et al.* 2012). In the region, common application faults are discontinuity of lateral column reinforcements in the column-beam joint regions, insufficient lap splice length of the longitudinal reinforcements and improper termination of the longitudinal reinforcements in the beams at the joints (Erdik *et al.* 2012) (see Fig. 8(a)).

The investigation conducted in the region showed that in the buildings with heavily damaged joint regions, the columns and beams separated from the system without resisting the forces imposed by the earthquake. This rapid destabilization of buildings ended up sudden collapse of the structure (see Fig. 8(b)).

Debonding in many longitudinal reinforcements of the structural elements was observed as a result of the insufficient lap splice length (see Fig.8(c), (d) and Fig. 9(a)). In Fig. 8(d), the damage

on the shear wall clearly demonstrates the poor quality of the detailing. In cases, where shear walls are damaged in this manner, it is difficult to consider that the building could survive from an earthquake (Celebi *et al.* 2012).

As stated above, improper detailing of the joint regions may cause serious problems (see Fig. 8 (b), 9(b)). It should be noted that the cost of the proper reinforcement detailing is not much compared to the overall construction cost. For that reason, it is assumed that, these defects are not results of economic considerations but instead lack of proper engineering service.

Fig. 8 (a) Joint damage, (b) totally collapsed building with heavily damaged joints, (c) joint damage and (d) disintegrated shear wall with debonded longitudinal reinforcement

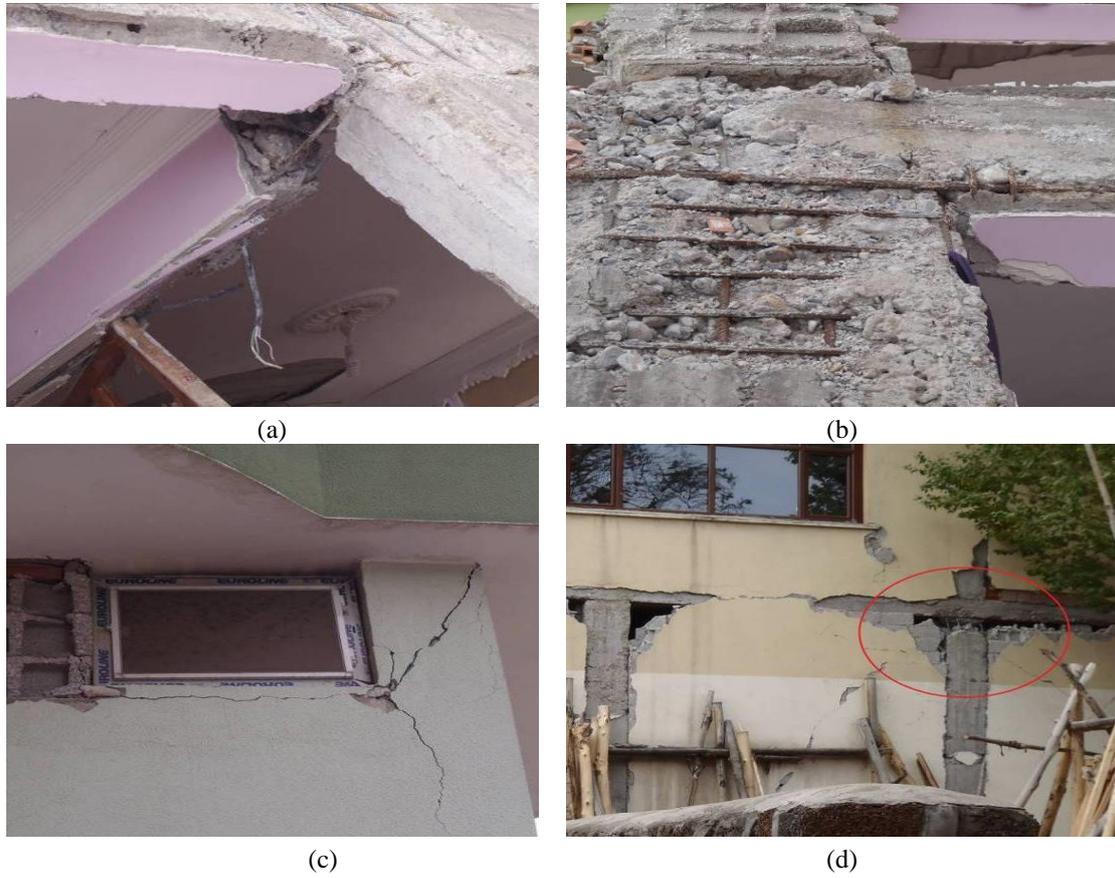
Short column formation, formed by ribbon window, was observed in many buildings (see Fig. 9(c)). In fact, short column damage does not form only due to ribbon windows, which decreases the clear length. In some cases, short column behavior can be seen as a result of the infill wall behavior. Deformation of the RC system under seismic effects may end up partial collapses of the infill walls. Similar to ribbon window, partial collapse of infill wall occurring at the edges of the column decreases the overall length of the column and may result in severe short column damages (see Fig. 9(d)). Such types of damages were also encountered in the other earthquakes in Turkey (Inel *et al.* 2013).

Fig. 9 (a) debonding of beam longitudinal reinforcement due to insufficient lap splice length, (b) deficient joint construction, (c) column damaged due to ribbon window and (d) short column damage due to disintegration of infill wall

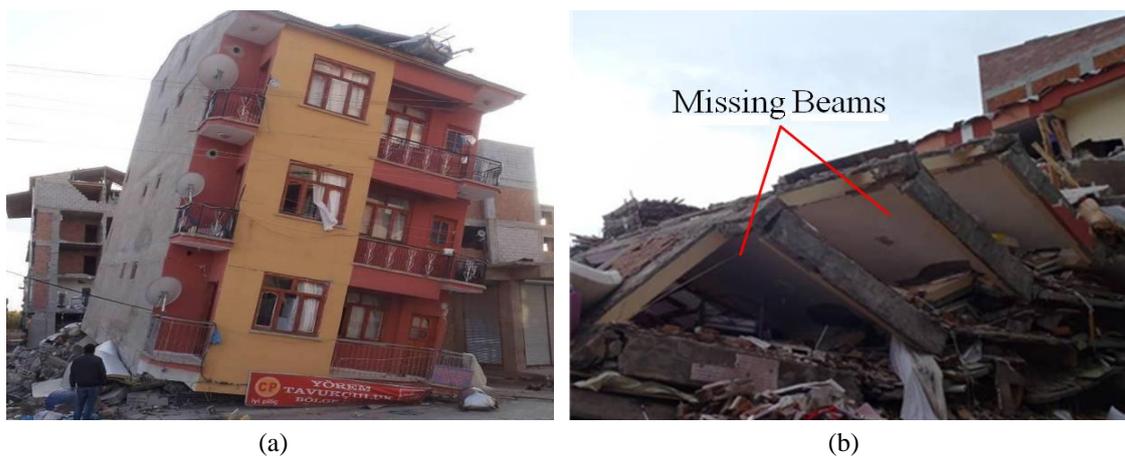
Fig. 10 (a) Building with collapsed ground floor due to soft story and (b) pan cake collapse toward the weak axis of RC building having overhang without beams connecting columns

Heavy overhangs, at which columns are not connected with beams, decrease the column rigidities in the direction of the missing beams. Thereby the overall resistance of the building against earthquake decreases. Considering that the ductility of the many buildings constructed in Turkey is much lower than the required values, increasing displacement demands due to decreased rigidity cause heavy damages or even total collapses (Inel *et al.* 2008a).

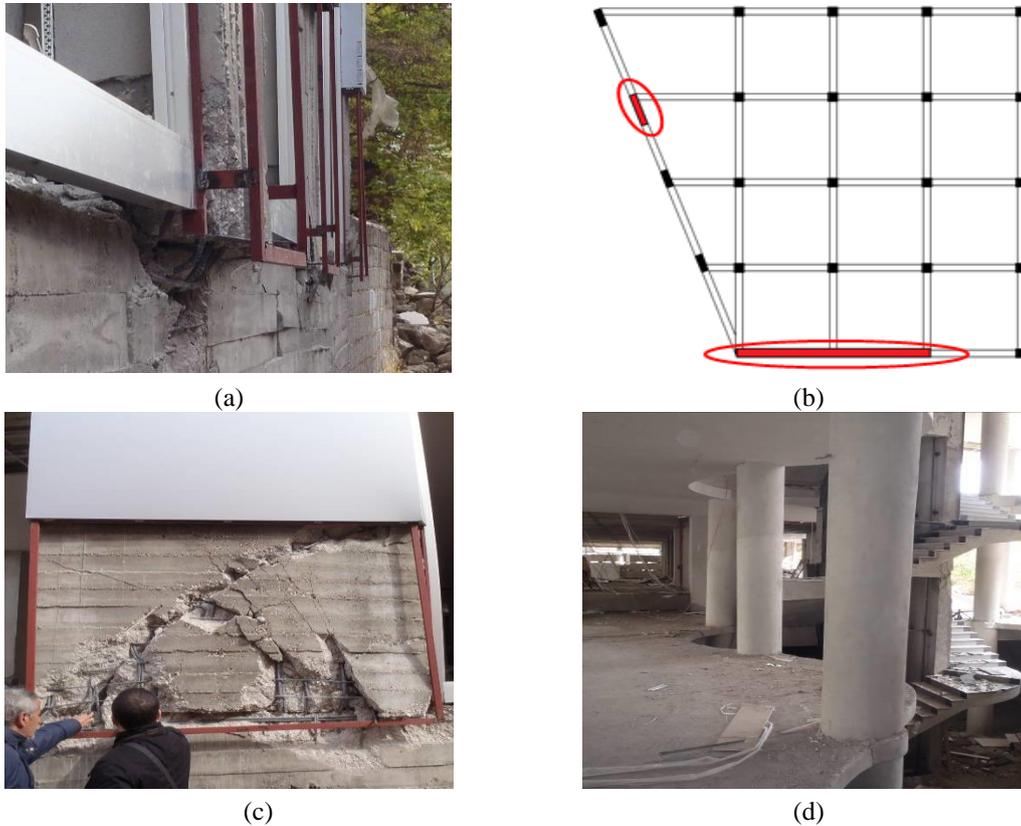
Fig. 11 (a) RC columns damaged and displaced out of the building due to unsymmetrical shear walls, b) building plan with unsymmetrical shear walls, (c) RC shear wall with heavy shear damage due to deficient changes of the design project and (d) undamaged circular columns after earthquake

An important design deficiency is the placement of the shear walls asymmetrically in plan view. This result in additional torsional moments and heavy damages may occur in the building, especially in the places where shear walls do not exist. In Fig. 11(a), displaced columns can be seen which occurred as a result of the asymmetrical placement of the shear walls. In Fig. 11(b), the plan view of the building in question is given. Asymmetrical placement of the shear walls can be seen, clearly.

In the same building, heavy shear damage occurred in an improperly designed shear wall element (see Fig. 11(c)). In fact, in the design drawings of the structure, it was shown that this shear wall was designed as a column. The dimensions of the RC member were increased and additional longitudinal reinforcement was utilized in the construction stage. The wall became insufficient against shear force effects, as it did not contain sufficient amount of lateral reinforcement. Since the amount of the longitudinal reinforcement increased unconsciously, shear forces increased as a result of the increased bending moment capacity. Such improper changes in the construction stage, may affect the seismic performance of the structure significantly. The concrete quality in this building is believed to be sufficient as the building is recently constructed and ready-mixed concrete is used.

In this building, damage in columns with circular cross-section was not observed (see Fig. 11(d)). As the stirrup was subjected to axial tension in the columns with spiral lateral reinforcement, hooks are not vital for the proper confinement. This may be taken as an example of the higher seismic performance of columns with circular lateral reinforcement.

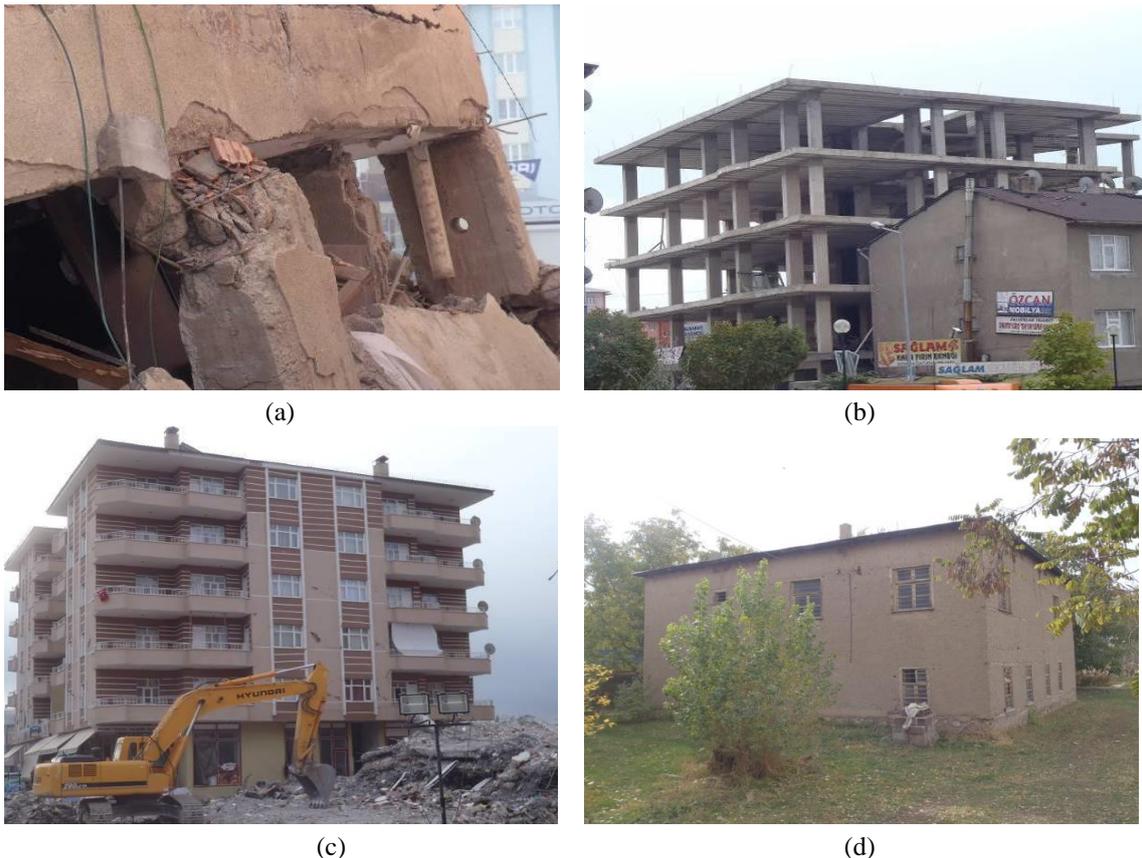
Fig. 12 (a)an example of strong beam-weak column; (b) a view of common flat slab beam system in the region; (c) slightly damaged RC building after earthquake; (d) an undamaged adobe building after earthquake

One of the main reasons of the heavy damages observed in the region is ignoring the fundamental design parameters. In Fig. 12(a) a heavily damaged column which had insufficient lateral reinforcement is seen. Apparently, the column was constructed without considering the strong column-weak beam principle. The cases of the broken concrete pieces give a clue for the quality of the materials used.

Many buildings with hollow-tile floor slab were detected during the investigation in the region (see Fig. 12(b)). Hollow-tile floor slab is frequently used for architectural purpose of having a flat ceiling. When the negative effects of hollow-tile floor slab on seismic performance of the buildings are considered, this can be thought as one of the reasons for heavy damages.

It should be remembered that properly designed and constructed structural unit of any kind could have sufficiently high performance under seismic effects. In Fig. 12(c), a RC building without significant damage, but surrounded by many collapsed buildings, is seen. In Fig. 12(d), an adobe building in the region without any sign of seismic damage after the earthquake is given.

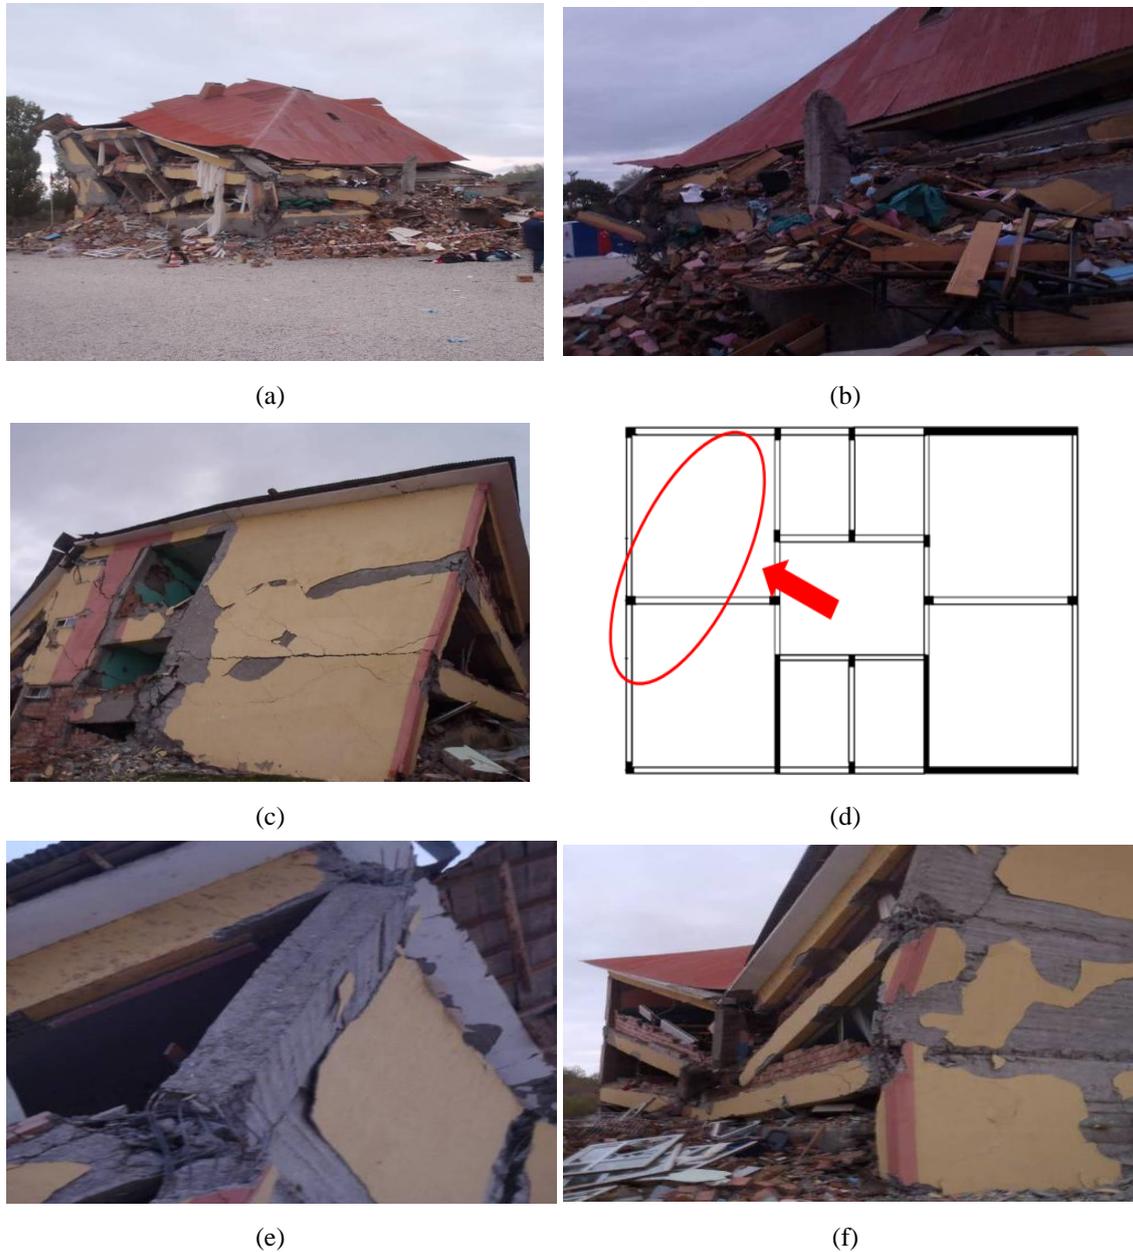
In Van Earthquakes, one important point is the high amount of damages occurred in shear wall-frame systems. Many of the RC shear walls did not behave properly under seismic effects. The most striking example was RC Gedikbulak Primary School (Gedikbulak P.S.) building (Fig 13(a), (b), (c)). The structure has the same template design with many of the buildings examined and strengthened by the authors within the scope of the 10370 type school projects in Denizli and Kutahya (Inel *et al.* 2008b). With its symmetrical structure, few number of stories and presence of shear walls with high amount (more than 0.8% and 1.14% of floor area in two principal directions), the building was expected to survive with no or limited damage after such an earthquake (see Fig. 13 (d)). It may be expected that there are more than one reason for the collapse of such a RC building.

The examination of the Gedikbulak P.S. demonstrated that RC shear walls were separated at the base and storey levels (see Fig. 13(c)). It is highly probable that insufficient lap splice lengths of the longitudinal reinforcement were the main reason for this separation. It can be suggested that total collapse of the building occurred due to the members of the RC system which did not behave monolithically. The building was collapsed towards the region where shear walls did not exist (see Fig. 13(b) and (d)). As the load-bearing system did not behave monolithically, shear walls did not contribute the strength and rigidity of the building at the required level.

In Fig.13 (e) and (f), damaged RC shear walls can be seen. As can be revealed from the figure,

Fig. 13 (a) Collapsed Gedikbulak Primary school, (b) totally collapsed portion of the building without shear walls, (c) shear wall decomposed at story and foundation levels, (d) building floor plan and collapse direction and (e-f) shear walls with heavy joint damage and decomposition at story levels

any damage was not observed on the shear walls indicating resistance to the seismic forces. The shear wall bended in the collapse direction as it was pulled by the floor during the failure of the building (see Fig. 13(c)). The lower side of the shear wall moved independently from the base, as there was no sufficient interlocking of longitudinal reinforcements to the foundation. It is probable

that the concrete strength of the building was much lower than what it should be. High axial load ratio in the columns, insufficient confinement and lap splice lengths are the main reasons of the inductile and non-monolithic behavior. It is highly probable that the collapse initiated from the region with columns experiencing high level of axial loads, where the shear walls are not present (see Fig. 13(d)).

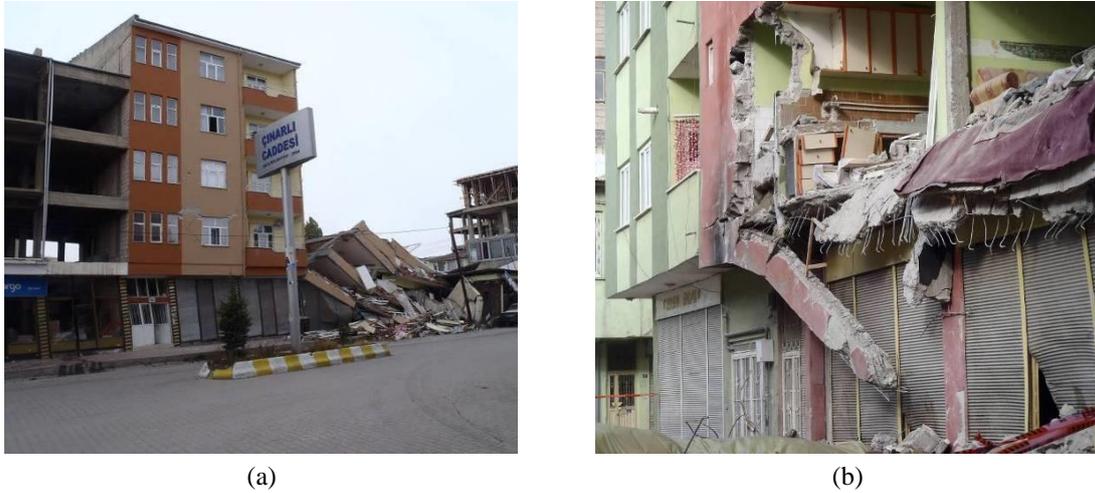
Fig. 14 (a) neighboring damage due to collide of the series of the buildings; (b) damaged beam element and walls due to the collapse of neighboring building)

One of the most frequently observed deficiency in the structural design and construction is insufficient distance between adjacent buildings. As the adjacent buildings did not behave in identical way, the pounding was also observed after Van Earthquakes. Apart from pounding, the collapsed buildings may collide to the neighborhood ones yielding severe damages, see Fig. 14(a)

and (b). One of the attached buildings given in Fig. 14(a) collapsed and collided the two other buildings, causing permanently shifted vertical axes.

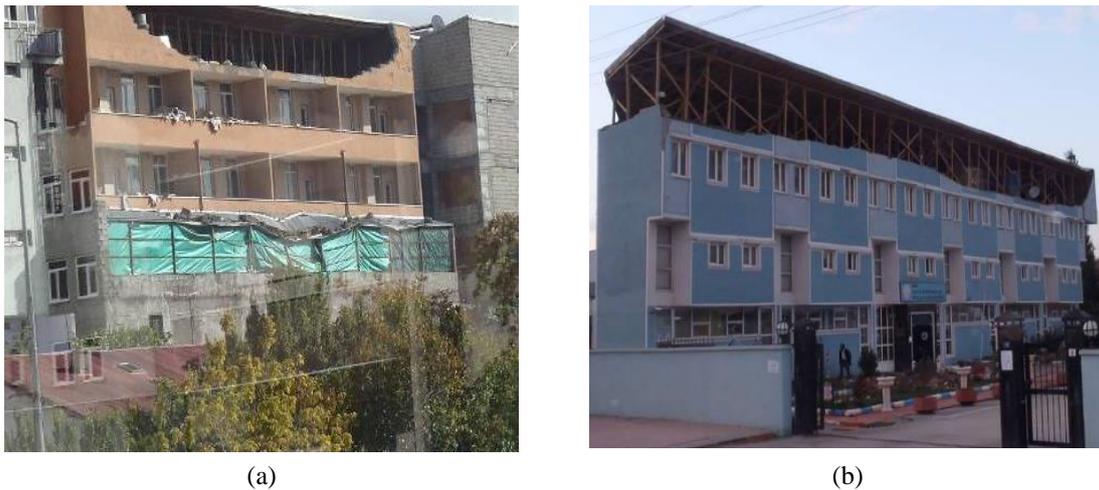
Fig. 15 Out of plane collapse of unframed gable walls

Non-structural damages were among important reasons of the casualties and economic losses (Boduroglu, 2011). Especially, improperly manufactured gable walls introduce significant damage. Due to the heavy snow in the region, the slope of the roof is increased by constructing one of the walls much higher than the other. However, construction is not performed properly in these walls. During the earthquakes, this ended up destruction of many walls which was not surrounded with a RC frame as forced by earthquake code (TEC-2007) (see Fig. 15).

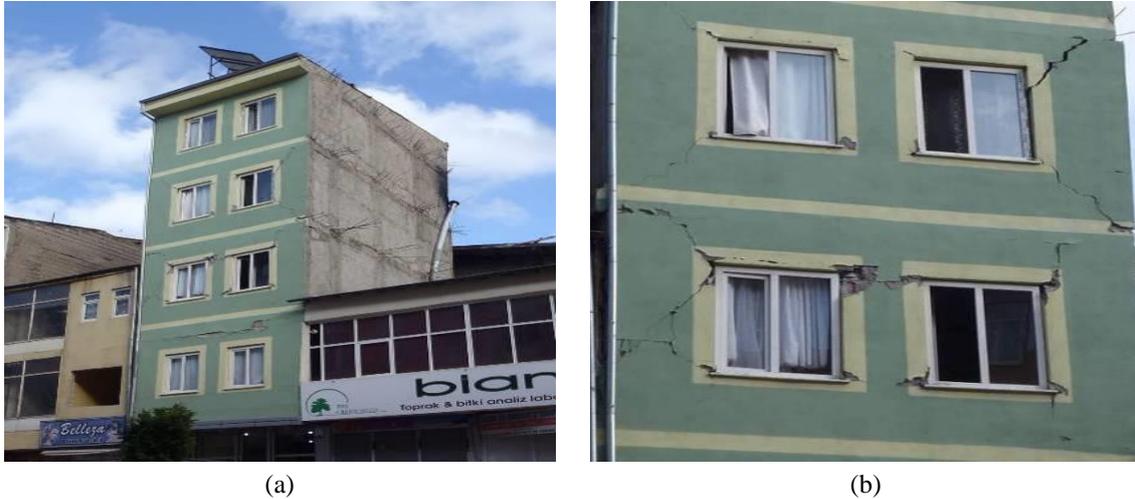
Fig. 16 Infill wall damage at overhang portion

The wall damages in overhang regions increase as a result of two problems: walls are not

enclosed by columns at the end of overhangs and significant movement occurs in the cantilever like overhang portion due to vertical acceleration of the earthquake. In fact, overhangs are improper architectural applications for seismic actions, as they also cause problems in connecting columns by beam elements. Encouraging people to construct such overhangs by current architectural codes is a significant problem in elimination of such earthquake damages. In Fig. 16, it can be seen that the walls of the overhang were damaged so heavily that they can fall off from the building.

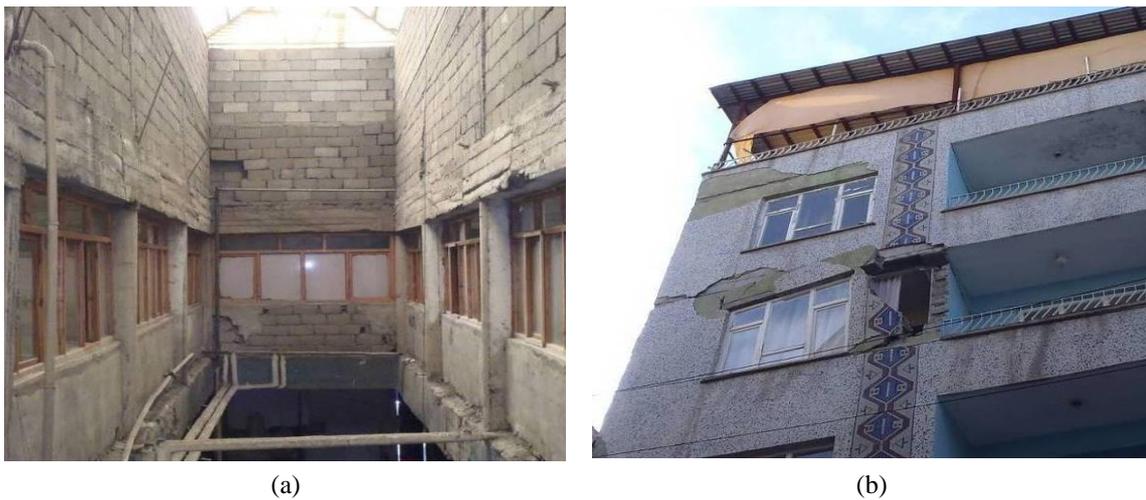
Fig. 17 (a) Partially collapsed wall constructed without mortar and (b) near collapse infill wall

Improper construction of the gable walls are frequently observed in the region. In Fig. 17(a), a gable wall constructed in a mall without using mortar is shown. During the earthquake, some parts of this wall fell off. In Fig.17 (b), an exterior infill wall, which was almost collapsed, can be seen.

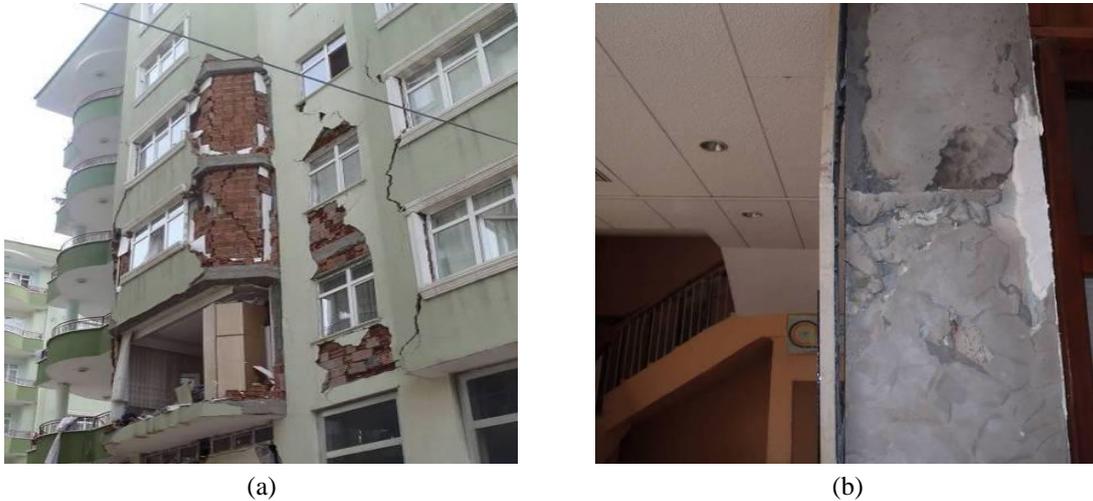
Fig. 18 (a) building with partially collapsed infill walls due to deficient insulation applications and (b) heavy cladding partially separated from the wall

As a result of the cold climate of the Van region, isolation is frequently applied to the buildings while unconsciously made applications could be dangerous. In Fig. 18(a), a typical example to this is given. Although such walls were constructed as a double-layer wall with isolation material in between, the connection of interior and exterior wall layers are commonly insufficient. For this reason, in many buildings parts of exterior wall, which were loosely attached, were partially collapsed. In such a case, the wall pieces falling off from a height could be very dangerous for people and property as experienced in 2011 Simav Earthquake (Inel *et al.* 2013, Tama 2012).

Additionally, as a result of the movement of the building during an earthquake, different types of coatings on the interior walls could also fall off. For example, heavy marble coatings can be dangerous if they are utilized up to the ceiling and/or in primary schools where pupils present. Fig.18 (b) gives an example where the coating separated from an interior wall and close to falling off. It should be noted that in the same building, coatings fell off in many places.

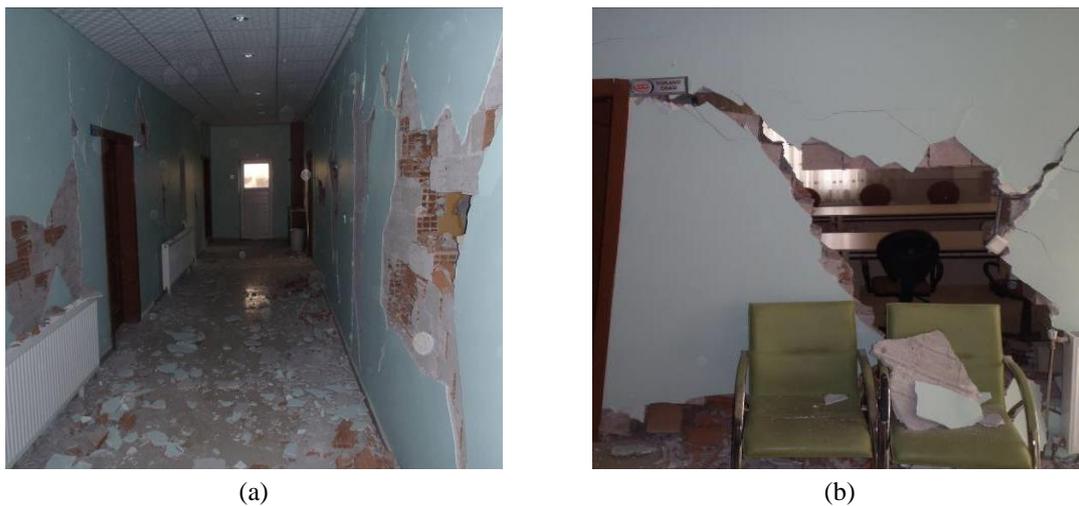
Fig. 19 Building with undamaged structural system but damaged architectural elements

After the earthquake, it was also observed that there were buildings with slightly damaged or un-damaged load-bearing system while their infill walls were heavily damaged. In Fig. 19, an example to this case is given. The building was constructed in accordance to the 2007 Earthquake Code (TEC-2007) and serious level of damage was not observed in load-bearing elements by visual inspection. However, the walls of the building were heavily damaged during the earthquakes as the structural system was flexible. While such structures with insufficient rigidity, do not pose a risk as a load-bearing system since they are ductile, they cause heavy infill wall and other property damages. This is problematic for the following reasons; firstly heavily damaged/collapsed infill walls may cause injuries and even casualties, and secondly, depending on the properties of the building, repairing architectural damages may have a significant cost even if there is no damage in load-bearing system. In this building, a well-preserved load-bearing system and a high-cost architectural damage coexist. While it can be stated that the target performance for load-bearing system was reached, it is highly questionable if the structure attained the required seismic performance when the overall cost of the repairing is considered.

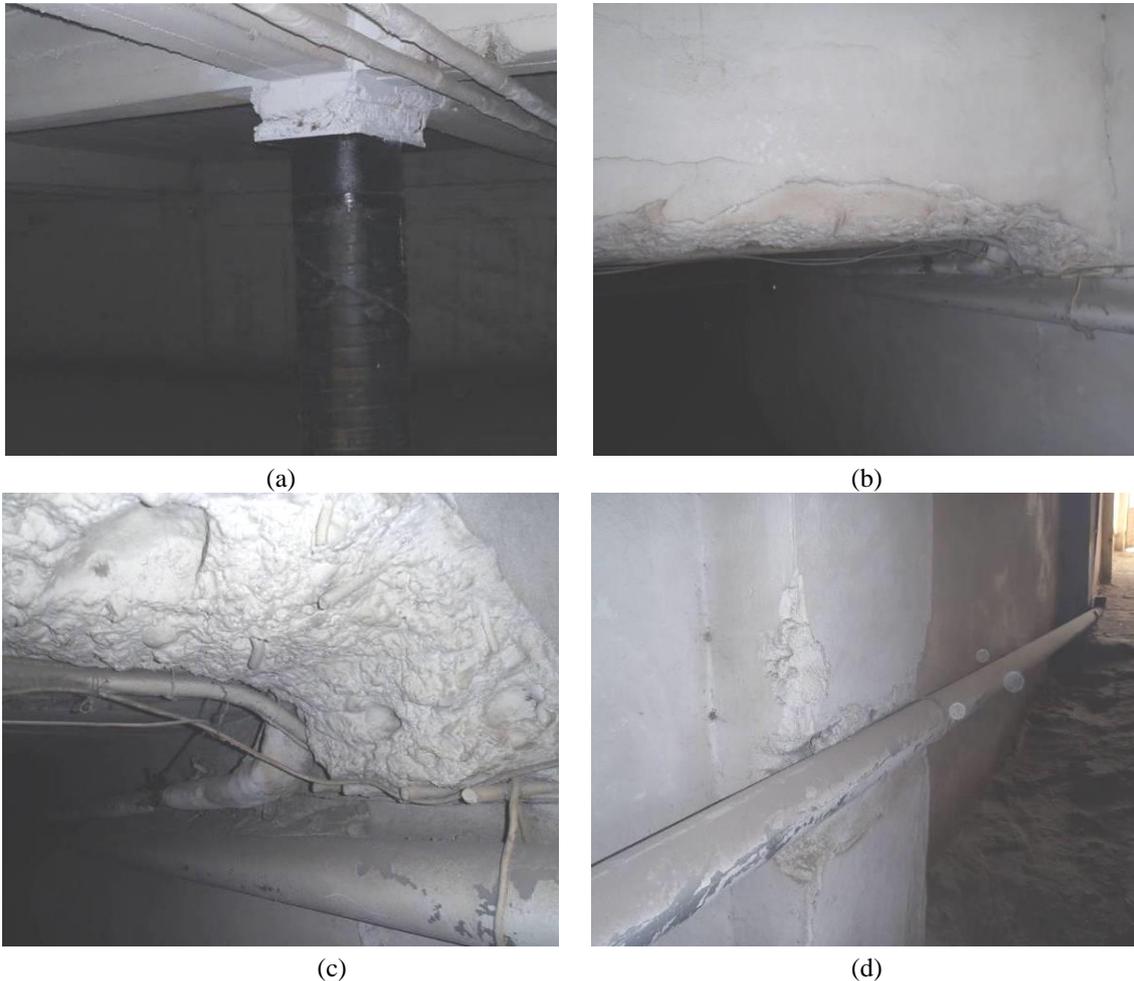
In the region, there are structures with unconsciously made changes performed in the load bearing system. These changes, generally applied to increase the architectural functionality of the structures, may cause significant problems under seismic effects. There is a common sense in the community that the load-bearing systems do not lose their capacities whatever change is made on them. Thus, it is not a rare practice to cut the column and longitudinal rebar and to break the beams, if thought necessary for architectural purposes (see Fig. 20). However, there is not any direct sentence in the criminal code to punish these actions and there is no tradition to punish them by indirect sentences. Commonly, punishment is applied when it is too late, e.g., in case of an event with casualties. In order to prevent those types of damages, it is important to make necessary arrangements and corrections in the code.

Fig. 20 (a) vertical element placed after the destruction of column, (b) partially destroyed beam for easy passage of the cars, (c) cut reinforcement and (d) partially destroyed column for placement of the pipe
