## Seismic response of buildings during the May 19, 2011 Simav, Turkey earthquake

Burak Yön<sup>1</sup>, Erkut Sayın<sup>1\*</sup> and Teoman S. Köksal<sup>2</sup>

**Keywords:** Simav earthquake; reinforced concrete buildings; masonry buildings; ground motions

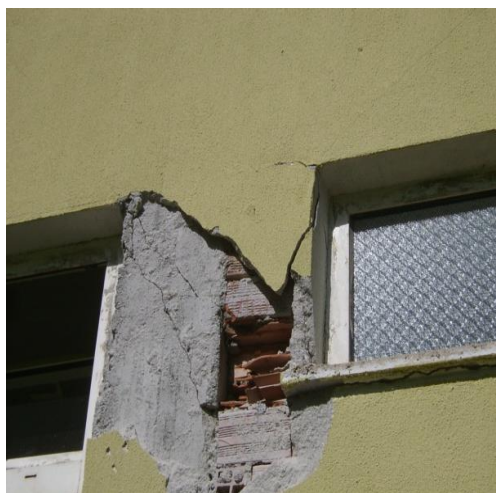
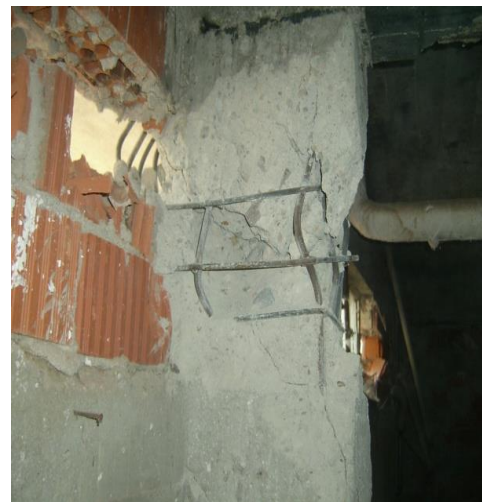
Fig. 5 Short column damages

Short columns are constructed to provide openings in infill walls between columns of structures. When the length of column decreases by various reasons the column to be more rigid than the others and subjects to more earthquake loads. In Simav earthquake, many columns damaged seriously since this reason. However, improper and inadequate stirrups increased damage level. Fig. 5 shows short column damages in various buildings.

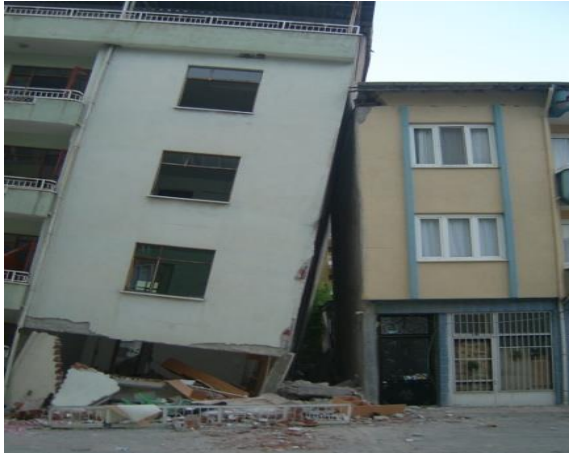
(a)

Soft-storey mechanism has been the most common mode of failure which causing to the partial or total collapse at the ground floor level in mid-rise R/C buildings. However, in Turkey many mid-rise R/C buildings have soft storeys. In these buildings, ground floors have glass partitioning windows instead of infill walls due to these storeys are used as stores and commercial areas. However, the infill walls are constructed above the soft storeys for separating rooms for the residential usage. While a building designed or constructed, contribution of the infill walls to lateral rigidity generally are ignored by designers. But these walls increase the rigidity of the structure and limit the storey drift. When infill walls are not constructed at the ground floor level, lateral strength and stiffness have to be provided by the frames alone. Also, the storey height of this floor is approximately 40-50% more than the upper storeys. Thus, during an earthquake effective shear forces and moments occur on the end of columns at the ground floor. In Simav earthquake, this wrong application caused damages at buildings. Fig. 6(a) shows the collapsed building due to the soft-storey mechanism.

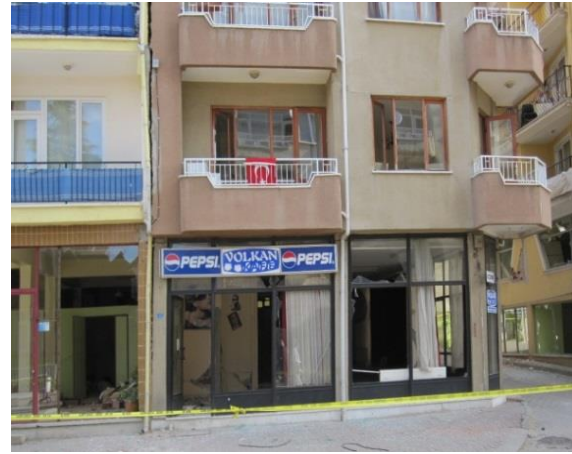
(b)

Another example of soft story mechanism is illustrated in Fig. 6(b). Also, this building was constructed with inadequate gap sizes. Thus, hammering effect occurred together with soft story mechanism. Therefore this building suffered seriously from these wrong applications.

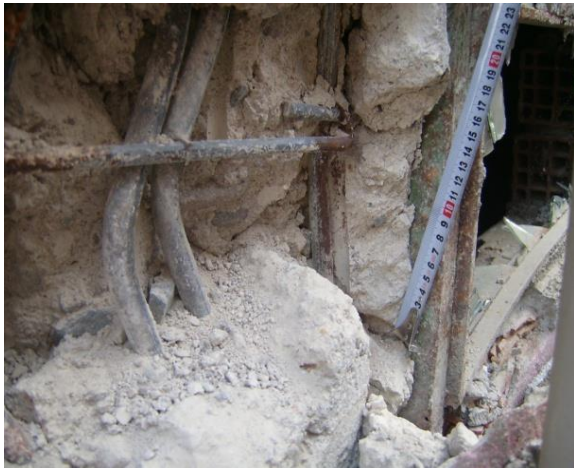
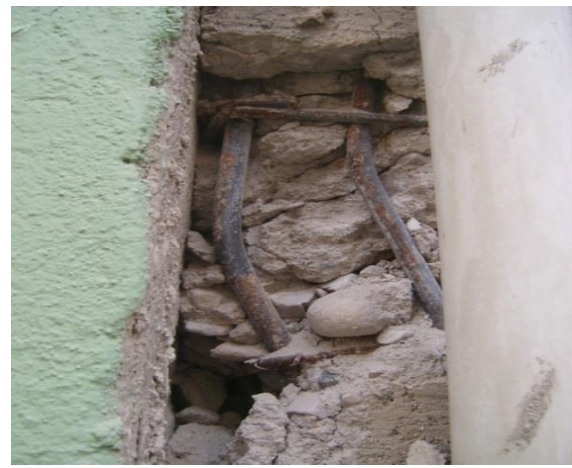
Fig. 7 Concrete quality of various buildings

Concrete quality is very important for structural performance. In Turkey, using of ready mix concrete did not common until last twenty years. Handmade concrete was generally used for construction of buildings. Due to using of hand made concrete and lack of using vibrator for compaction, homogeny mixing had not been obtained and expected strength not provided. In this earthquake, it was seen that, one of the main reasons of damages was poor concrete quality and workmanship. Although TEC requires that minimum characteristic compressive strength of concrete should be 20 MPa at least for buildings, our field observation showed that concrete quality of investigated buildings was considerably under this value. Fig. 7 shows concrete quality of various buildings in the earthquake area.

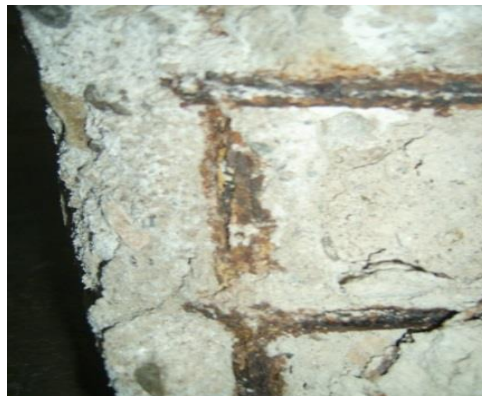
Fig. 8 Corrosion in a column of a building

Also, it was seen that, concrete cover was very thin for preventing reinforcement to corrosion. Thus, tension strength of reinforcement decreased and lost bond strength between concrete due to decreasing in area of the reinforcing bars. Corrosion in a column of a building is shown in Fig. 8.

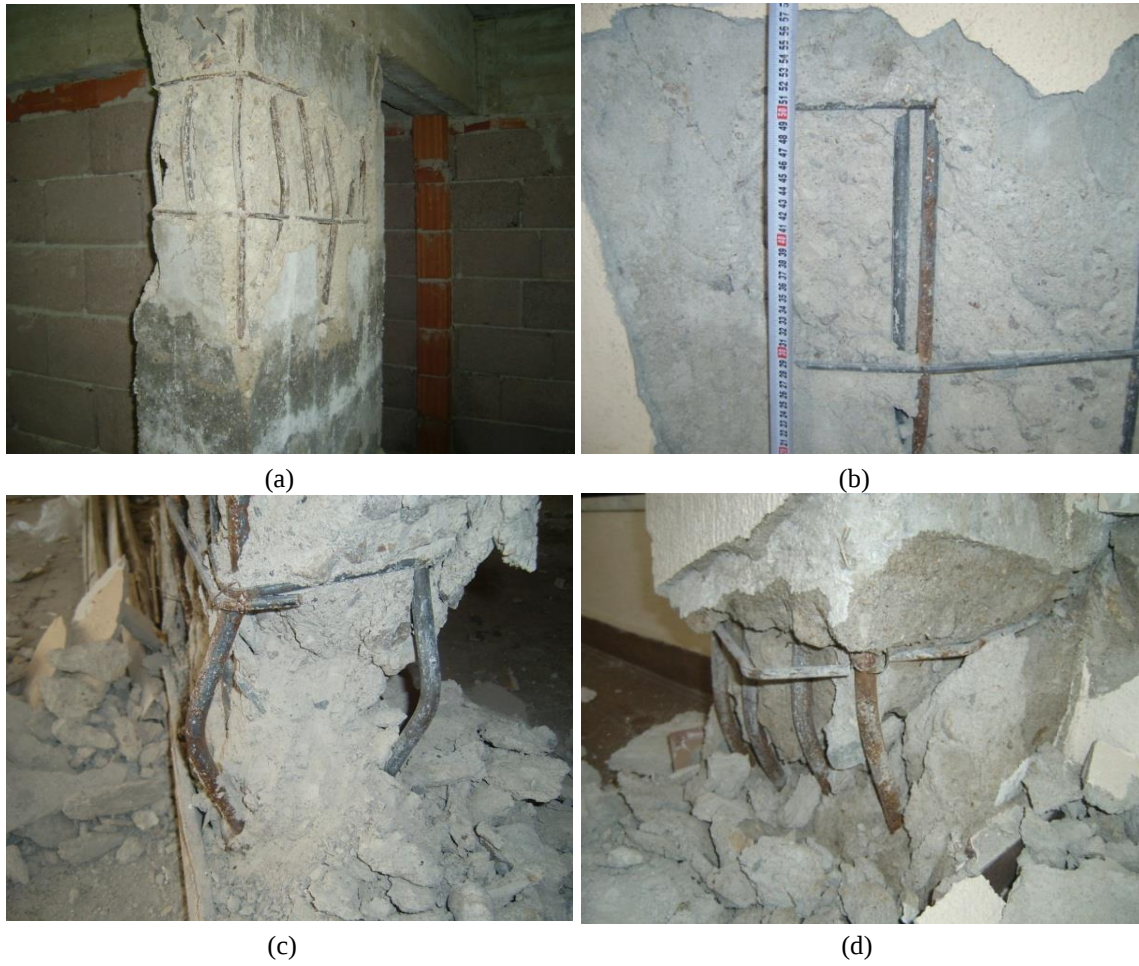
In Simav, structural elements of old buildings which constructed before the current seismic code had insufficient detailing. Especially columns of the buildings had inadequate stirrups and longitudinal bars in the plastic hinge region. Therefore, shear strength and axial load carrying capacity of these structural elements had been diminished, considerably. Wide spacing of the between stirrups caused buckling of longitudinal rebar and spalling off concrete cover during an even low moderate earthquake. According to TEC, hoops of stirrups and cross ties must be bended  $135^\circ$ . But, at columns of damaged buildings in the earthquake area, stirrups were generally smooth reinforcing bars and bended  $90^\circ$ . Also, it was seen that, spacing of stirrups in the columns were approximately 25-30 cm. But TEC requires that, the maximum tie spacing should not be exceed 10 cm in plastic hinge region for columns of reinforced concrete buildings in all seismic zones. Fig. 9 shows columns of damaged buildings due to inadequate transverse reinforcement.

Fig. 9 Damages at columns due to inadequate transverse reinforcement

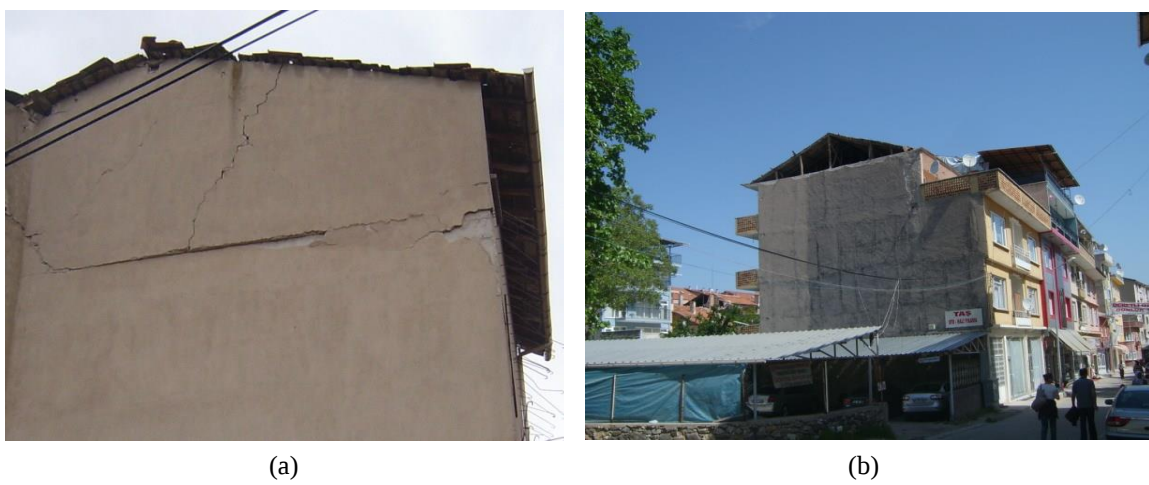
This failure mode is observed commonly in earthquakes due to poor connection and workmanship. In Simav earthquake, lack of lateral supporting walls and tie beams, poor wall to floor and wall to wall connections caused out of plane failures or partial collapse of the gable walls. Although, the TEC requires vertical and horizontal tie beams for masonry gable walls that exceed 2 m, it was seen that gable walls of observed buildings were not constructed properly as regards the available building code. Fig. 10 shows common gable wall failures observed in the earthquake area.

Fig. 10 Gable wall damages

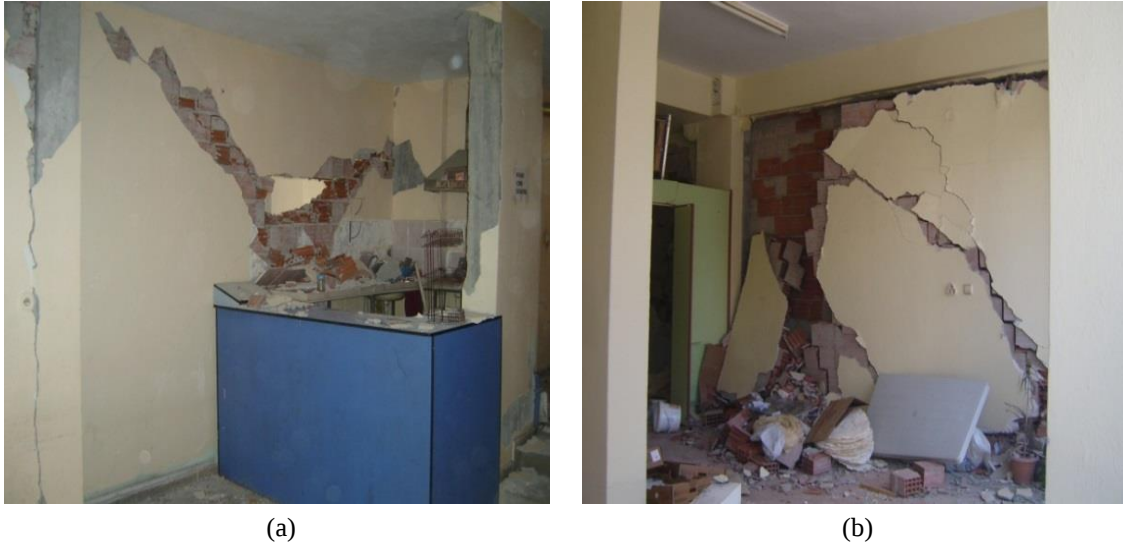
In R/C buildings, infill walls generally consist of unreinforced brick masonry using cement mortar in Turkey. Infill walls contribute to structural performance of buildings by increasing rigidity and limit storey displacement. But, unreinforced brick masonry walls have lower deformation capacities than the R/C structural members. For this reason, during an earthquake diagonal cracks at infill walls occur due to large deformations. Fig. 11(a) shows diagonal cracks in plane wall in Simav earthquake. Sometimes, infill walls are constructed two layers due to heat and sound isolation. But, it was seen that this type of masonry infill walls failed out of-plane mechanism due to the weak connections between the interior and the exterior layers (Fig. 11(b)).

Fig. 11 Damages in infill walls

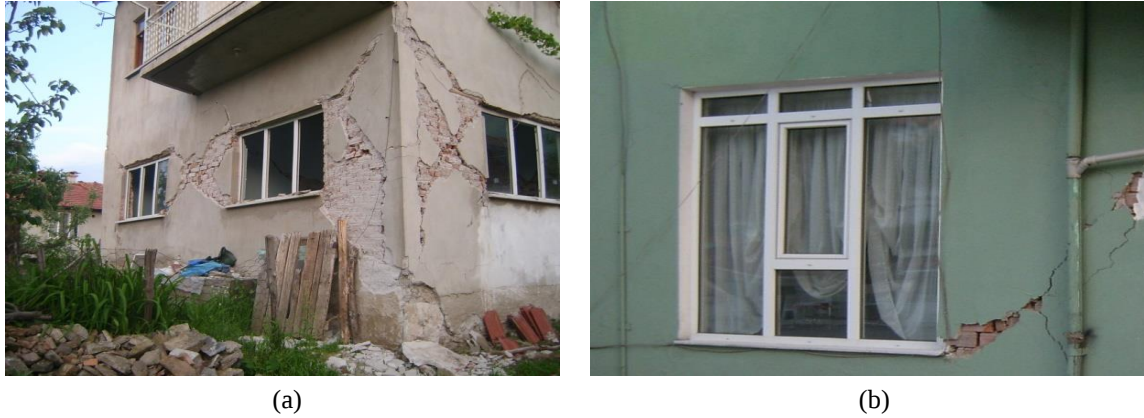
These buildings in the earthquake region were generally unreinforced and most of them did not have sufficient and proper tie beams. Tie beams are used for increasing the lateral strength of walls. Absence of these beams causes not orderly distributing of the lateral forces. Thus, diagonal cracks occur near openings with effect of shear forces. Fig. 12 shows diagonal cracks in various brick masonry buildings in which diagonal cracks start from the corner of windows. To prevent this kind of failures TEC requires that, reinforced concrete vertical tie beams should be constructed in full storey height on the corners of buildings, along the vertical intersections of the load-bearing walls and on both sides of the door and window openings. In addition to this, reinforced concrete horizontal tie beams should be constructed with the reinforced concrete slabs and width of these beams should be equal to the width of wall, and their height should not be less than 20 cm.

Fig. 12 Damages at brick masonry buildings

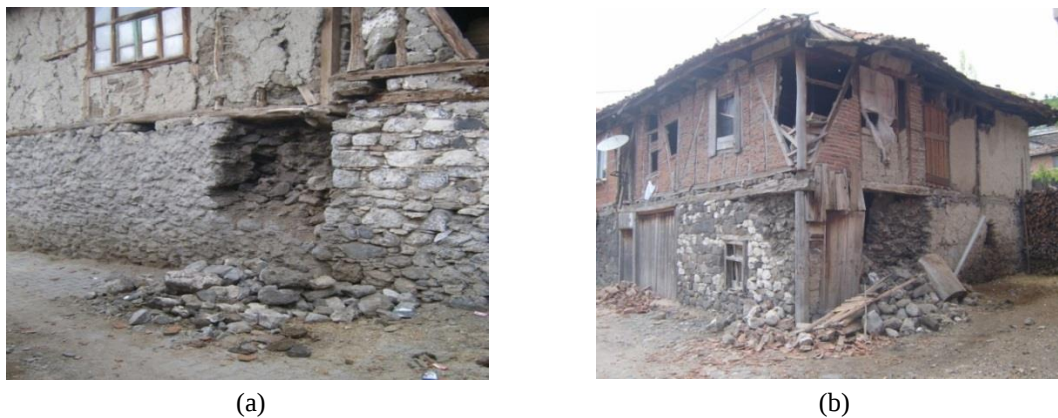
The code requires that lime mortar which supported with cement (cement/lime/sand volumetric ratio = 1/2/9) or cement mortar (cement/sand volumetric ratio = 1/4) should be used in load-bearing walls. However, due to economical reasons clay mortar which has low binding performance had been used instead of cement mortar among the stones as binder. Ground walls of the buildings had been constructed as multilayer. This situation caused behaving independently of the outer and inner of the walls.

Second floor of these buildings were constructed with hımsı style. In such construction type, vertical timber elements which connect to each other with horizontal and cross timbers are used to provide rigidity of the buildings. In these buildings the first floor that constructed by rubble stones without tie beams were damaged, but the second floor that built hımsı style were not damaged relatively first floor.

Fig. 13 Damages at buildings having stone and hımsı material

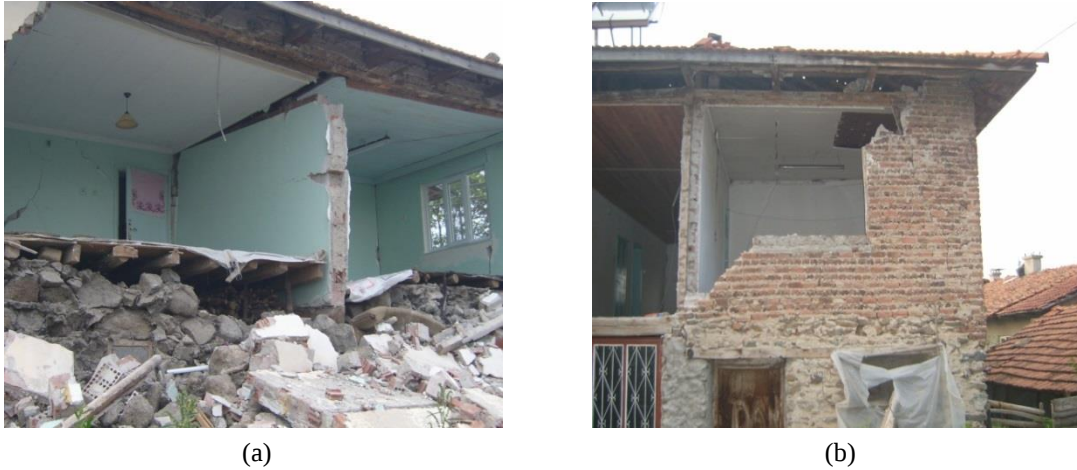
The other masonry building in earthquake area had been constructed with stone and brick. Out-of-plane mechanism occurred in this kind of buildings due to lack of tie beams and poor connections between walls. Each wall of the buildings behaved independently out-of-plane direction during the earthquake. In Fig. 14, total and partial collapses are seen due to out-of-plane failure at various buildings.

Fig. 14 Damages at buildings having stone and brick material
