Lessons learned from recent destructive Van, Turkey earthquakes

Keywords: 2011 Van earthquakes; ground motion characteristics; reinforced concrete buildings; earthquake damages

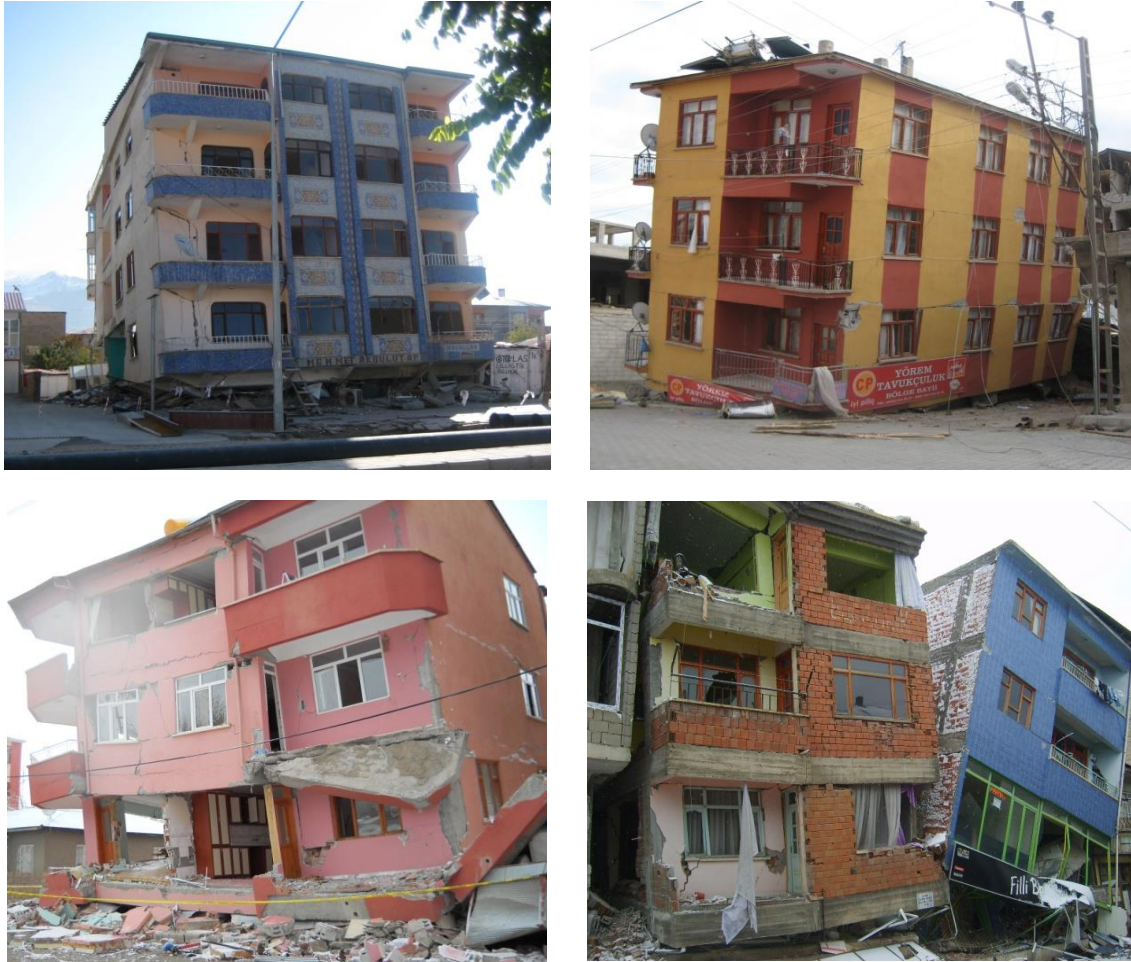
In some R/C buildings, especially at the ground floor, walls may not be continuous along to height of building for architectural, functional and commercial reasons. While ground floor generally encloses with glass window instead of brick infill walls, partition walls are constructed above from this storey for separating rooms for the residential usage. If partition walls are not constructed at the ground floor, more heavy and stiff upper floors forced large inelastic displacement at ground floor level. Also in these buildings, the storey height of the ground floor which has not separating walls is approximately 40-50 % more than the upper stories. This situation causes brittle failures at end of the columns. In mid-rise reinforced concrete buildings, the most common failure mode is soft-storey mechanism, particularly at the first storey, in Turkey. Fig. 11 shows total and partial collapses which arisen from soft storey mechanism at various reinforced concrete buildings. In these buildings, soft-storey mechanism occurred at the ground floor due to no special attention is paid to the code requirements. These wrong applications caused brittle collapse at columns in which no plastic hinges developed at the end of columns. In order to prevent this kind of failures, amount of structural walls which limit lateral displacement and/or cross section of columns should be increased.

Fig. 11 Soft storey mechanism at various reinforced concrete buildings

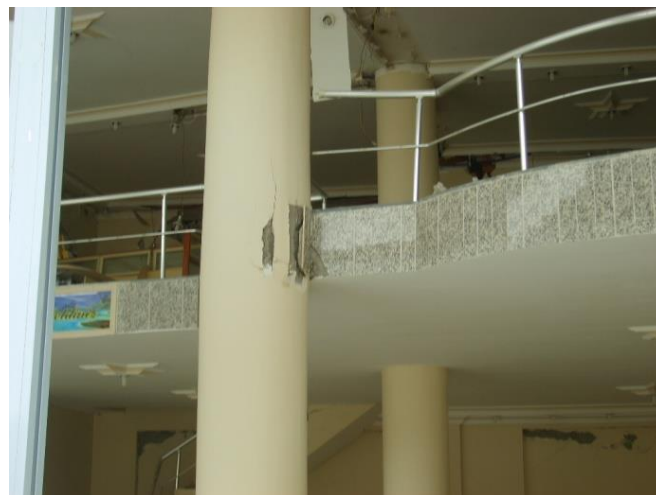
Also, some soft storey buildings includes mezzanine. These mezzanines, depending on earthquake motion, cause damages at columns especially if there is no inadequate gap between column and mezzanine. Such a damage type is seen in Fig. 12.

Fig. 12 Damage at a column due to mezzanine

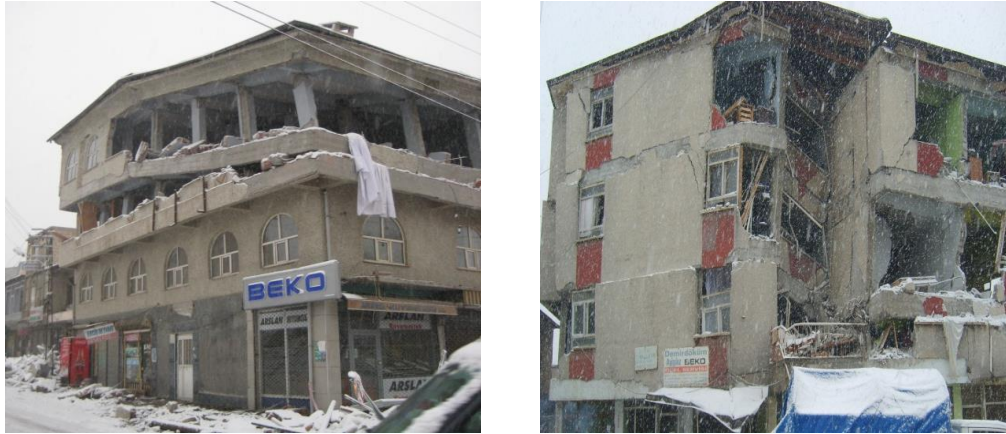
Failures can be concentrated at any story as called weak storey in which the lateral strength changes suddenly between adjacent stories due to lack of or remove of partition walls or decreasing of cross section of columns. Thus, during an earthquake partial and total collapses occur in these storeys. To prevent this kind of collapse and failures TSC requires that, in R/C buildings, the case where in each of the orthogonal earthquake directions, the ratio of the effective shear area of any storey to the effective shear area of the storey immediately above, should not be less than 0.80. But it was seen that these requires had not been considered in some buildings. Fig. 13 shows the effect of weak-storey at various R/C buildings.

Fig. 13 Weak storey mechanism at various R/C buildings

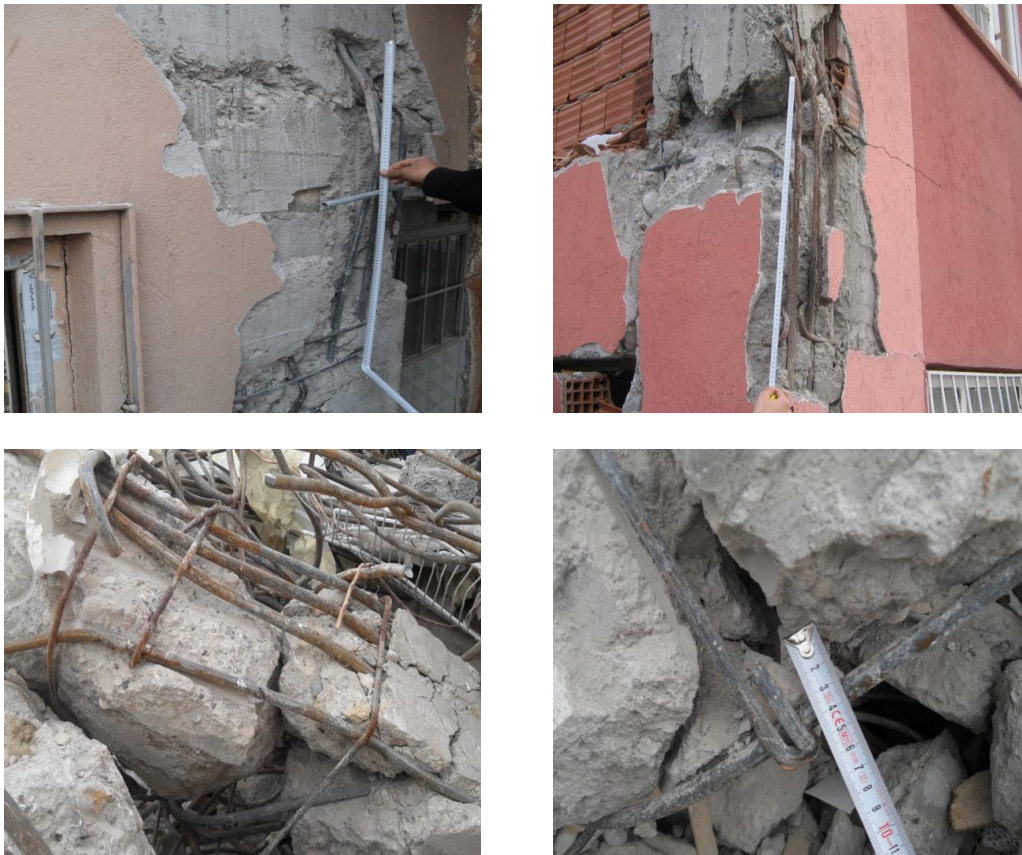
Fig. 14 Inadequate transverse reinforcement, improper hooks and smooth bars

Consequently, special attention should be paid to construction and design of beam-column joints and columns. Seismic design requires increasing of ductility of structures for performance-based design approach. But it had not been paid necessary attention to this approach when old R/C buildings constructed in Turkey. In these earthquakes, our observations showed that, especially columns of buildings had insufficient transverse reinforcement in the plastic hinge region. Therefore, structural elements which have such details shown low performance against to dynamic loads and lost their shear and axial load carrying capacity. It was seen that, spacing ties in the columns were approximately 20-40 cm. The wide spacing of the between transverse reinforcement caused buckling of longitudinal rebar, spalling off concrete cover and shear failures. But, according to TSC the maximum tie spacing should not be exceed 10 cm in plastic hinge region for columns of R/C buildings in all seismic zones. Also, special seismic cross ties and hooks should be bended 135° in all seismic zones. But, transverse and longitudinal bars of columns and beams at damaged buildings were smooth and hooks of ties had been bended 90° . In the observed buildings, it was seen that, necessary care was not given to designing of longitudinal reinforcement bars and sufficient amount of transverse bars were not used in the columns and beams. Fig. 14 shows damaged structural elements of buildings due to inadequate transverse reinforcement, improper hooks and smooth bars.

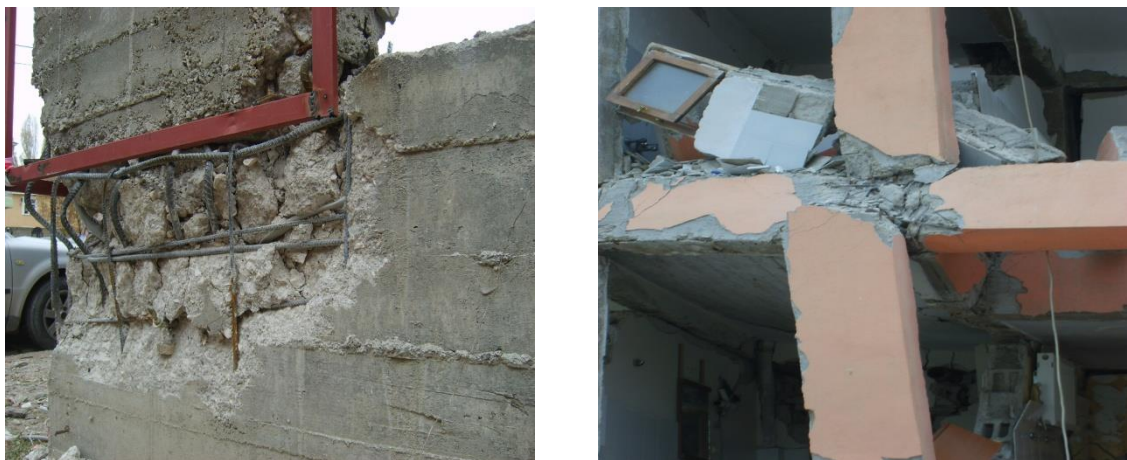
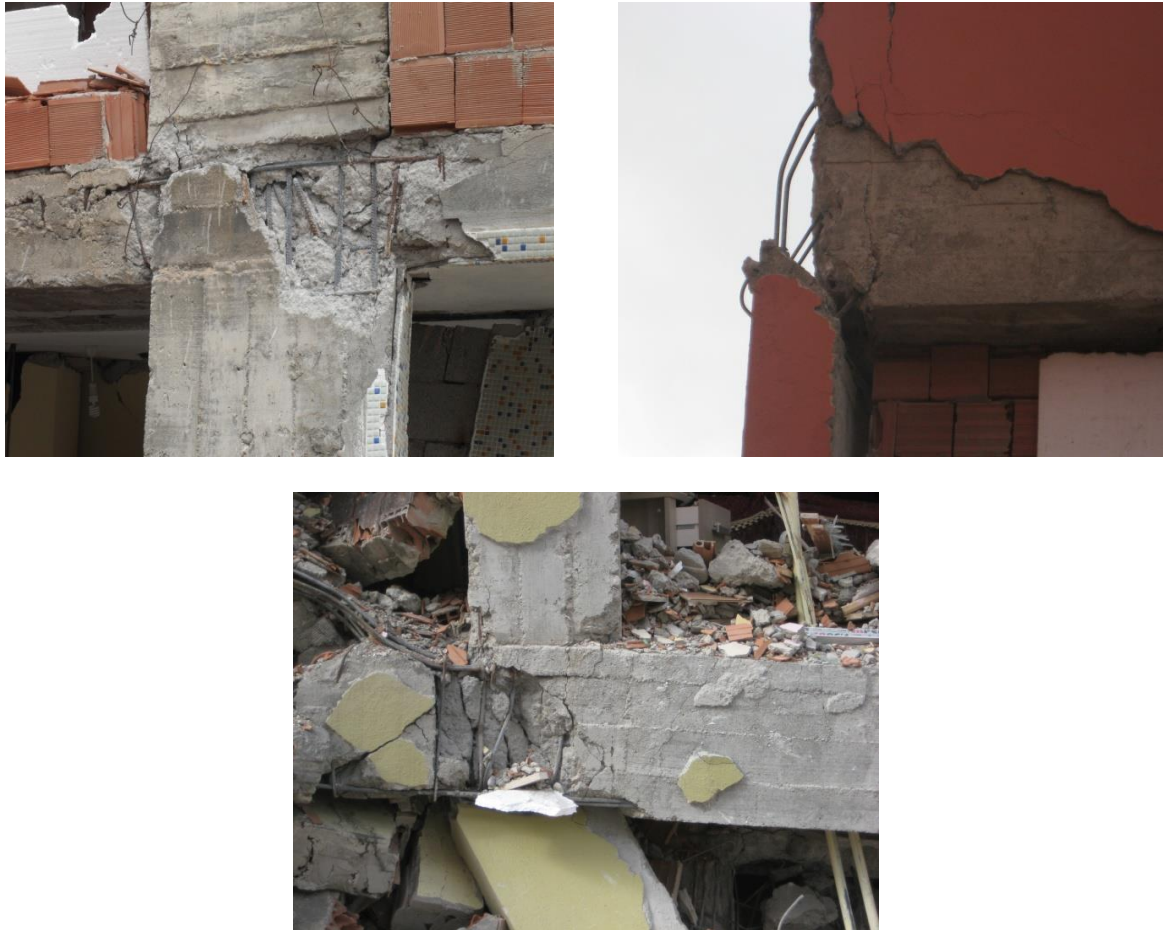
The structural performance of buildings completely changes due to improper design of beam-column joints during an earthquake. The joints must be remained in elastic region and there are not to be serious failures after an earthquake. These joints are very important distribution of force and moment. Shear and bond mechanisms are common failure of these joints. In Van earthquakes many R/C buildings heavily damaged or collapsed since failures of these joints. It was seen that poor detailing at joints of beam-column and poor quality of materials with low workmanship were the main reasons of these failures. Also lack of transverse and seismic cross ties, and inadequate anchorage bars of beam and column in reinforced concrete elements lead to joint failure. Fig. 15 shows various beam-column joints failures. In this figure, it is seen that beam-column joint have insufficient confinement and shear reinforcement at the joint.

Fig. 15 Joint failures at various reinforced concrete buildings

To prevent failure of the joints, sufficient confinement and shear reinforcement must be used and paid special care designing of these joints.

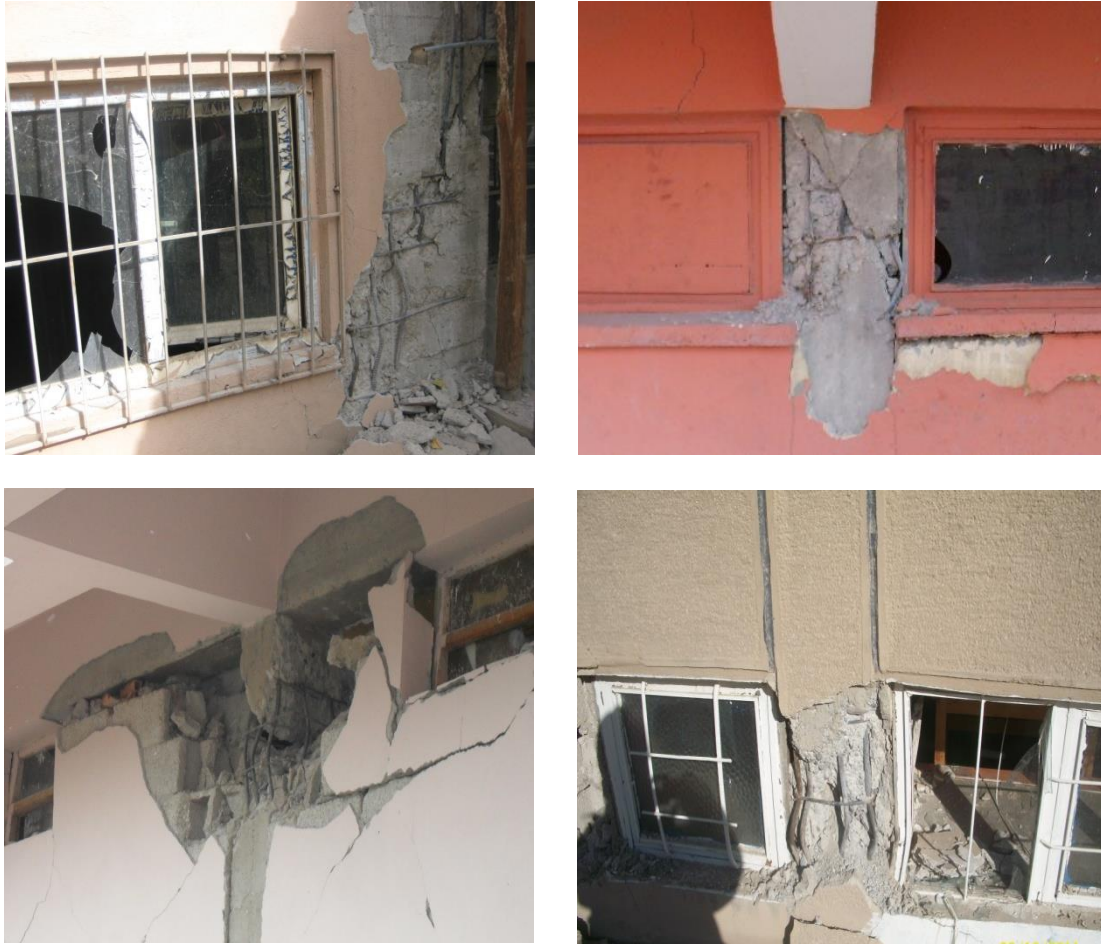
Due to structural adjustments and/or to continuous openings at the top of infill walls between columns, short columns may be developed. Lateral forces which occurred by an earthquake are received by columns and shear walls. Length of column is an important factor at dissipation of these loads. When the length of column decreases, the column becomes stiffer and brittle than the other columns and this column attracts more shear forces. Thus, shear failure which is a critical type of concrete column damage occurs at these columns. However, TSC requires certain requirements for confinement of longitudinal reinforcement for short columns. According to the code, transverse reinforcement requirements, used in column confinement zones (wide spacing should not exceed 10 cm), should be applied at these columns. It was seen that any requirement which determined in TSC was not applied and thus, many R/C buildings damaged due to the short column effect during the earthquakes. Fig. 16 shows short column failures at various buildings.

Fig.16 Short column damages at various buildings

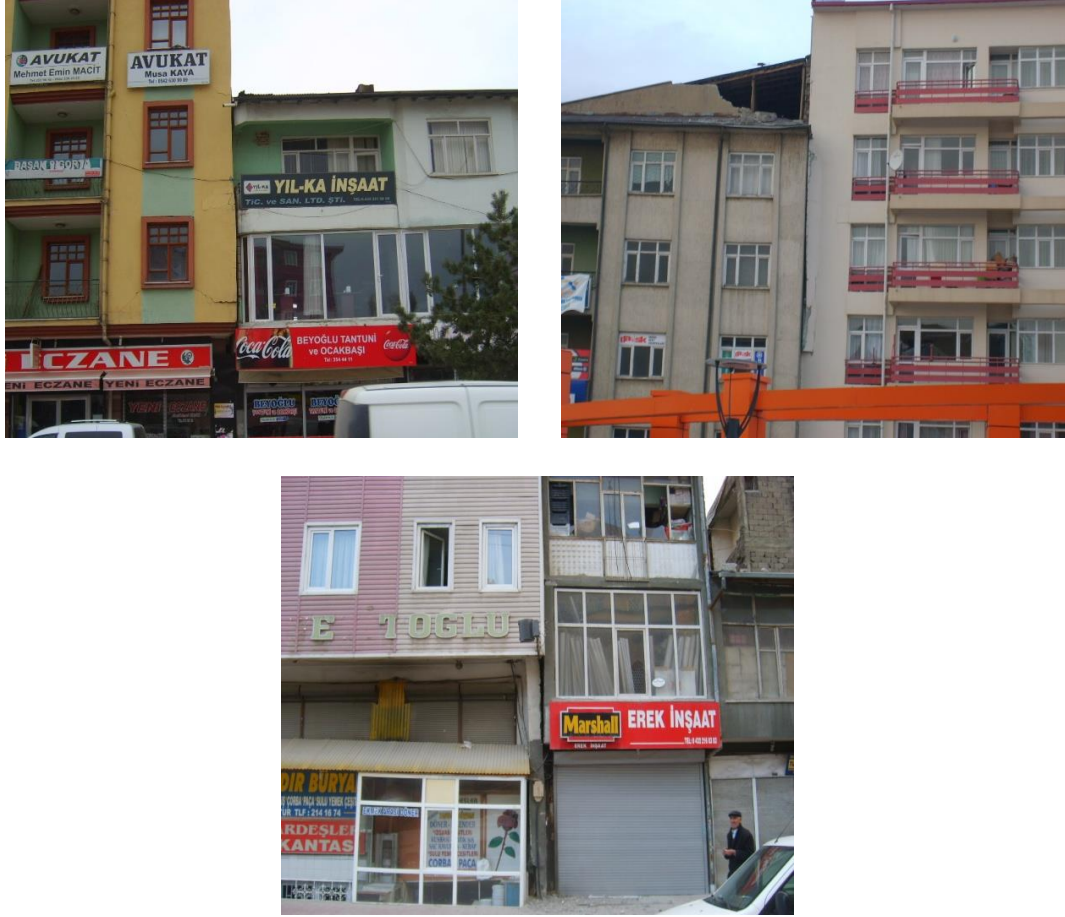
Buildings are generally constructed adjacent in city centre in Turkey because of the lack of building lots. In this layout plan, two faces of two buildings are contact to each other. Consequently, the buildings which have not adequate gaps pound to each other during the earthquake. If the floors of the buildings are not at the same level, hitting of the buildings becomes more dangerous because floor of the building hit the other building's column. To prevent this damage, TSC requires gap between the adjacent buildings. According to the code, minimum size of gaps should be 30 mm up to 6 m height and from thereon a minimum 10 mm should be added for each 3 m height increment. Unless a more unfavourable value is obtained in accordance with requirement defined in previous statement, sizes of gaps should not be less than the sum of the absolute values of average storey displacements multiplied by the coefficient α . If adjacent buildings' floor levels at all stories are same then $\alpha=R/4$ else then $\alpha=R/2$. In these equations, factor of the structural behaviour is shown by R. Damaged buildings due to inadequate gap are given in Fig. 17.

Fig. 17 Inadequate gap between adjacent buildings and damages

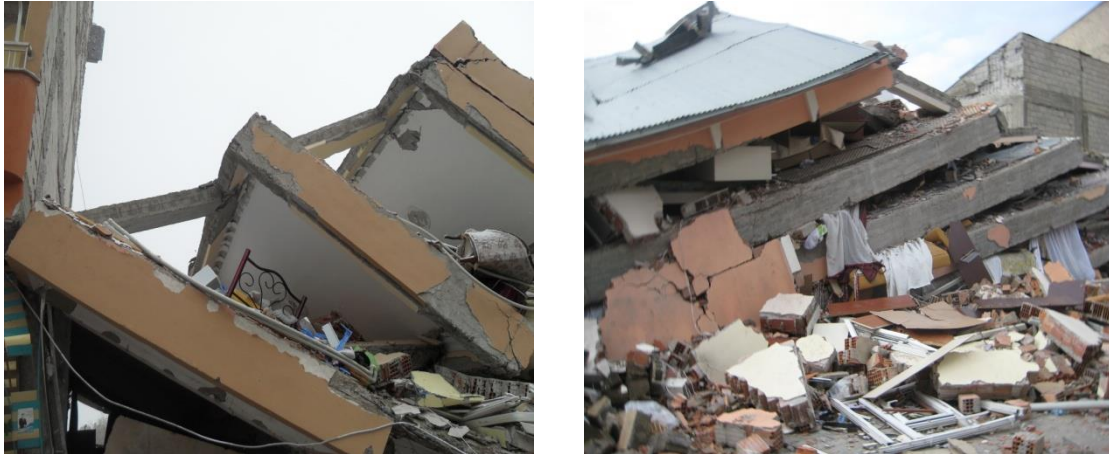
In Turkey especially many old R/C buildings were constructed with strong beam and weak column before the development of current seismic codes. In these buildings, deep and rigid beams were used with flexible columns. Therefore, these beams resist more moments, occurred by dynamic loads, than weak columns. In such a design during an earthquake while deep and rigid beams show elastic behaviour, shear failure or compression crushing cause plastic hinges at flexible columns. Design of strong beam-weak column was the main reason of the partial and total collapse during the Van earthquakes. Fig. 18 shows collapsed buildings in one direction where column's depths are considerably small according to depth of beams. To prevent this kind of damages or collapses which arisen from strong beam-weak column, TSC requires that sum of ultimate moment of columns framing into a beam-column joint should be at least 20% more than the sum of ultimate moment of beams framing into the same joint. Thus, plastic hinges occur ends of the beam and brittle failure prevents. But this situation had not been seen at observed buildings which collapsed totally. Also, it was determined that, these buildings had not shear wall, thus all of lateral forces had been provided weak columns.

Fig. 18 Total collapses at various buildings due to strong beam-weak column

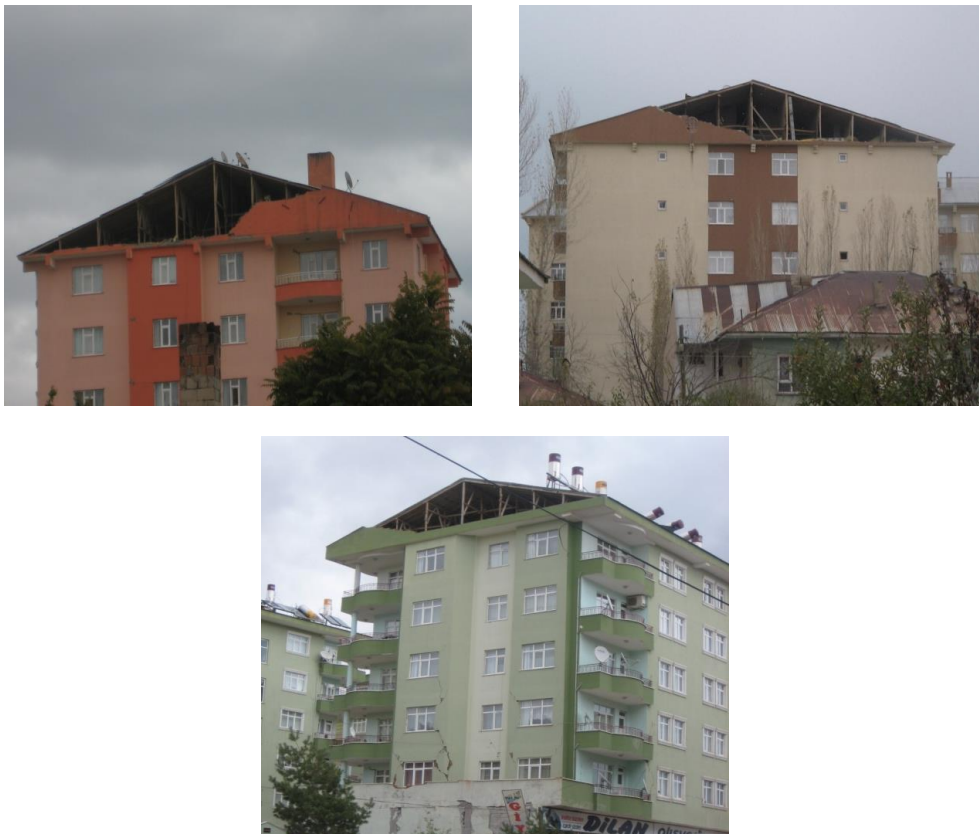
Fig. 19 Out-of-plane failures of gable walls at various buildings

The most common failure mode at gable walls is out-of-plane collapse in the earthquakes.

Although failures of gable walls are not structural damages, these damages may be cause loss of lives and properties. Stability problems and large unsupported wall lengths cause damages at these walls. It was determined that poor wall to wall and wall to floor connections, and absence of lateral supporting walls were main reasons of these damages. To prevent these kinds of damages, TSC requires that if height of masonry gable walls exceeds 2 m reinforced concrete vertical and inclined tie beams should be used. Gable walls of investigated buildings were not built according to the current seismic codes. In these walls had not got any vertical or inclined reinforced concrete tie beams. Out-of-plane failures of gable walls of various reinforced concrete buildings in the region are illustrated in Fig. 19.

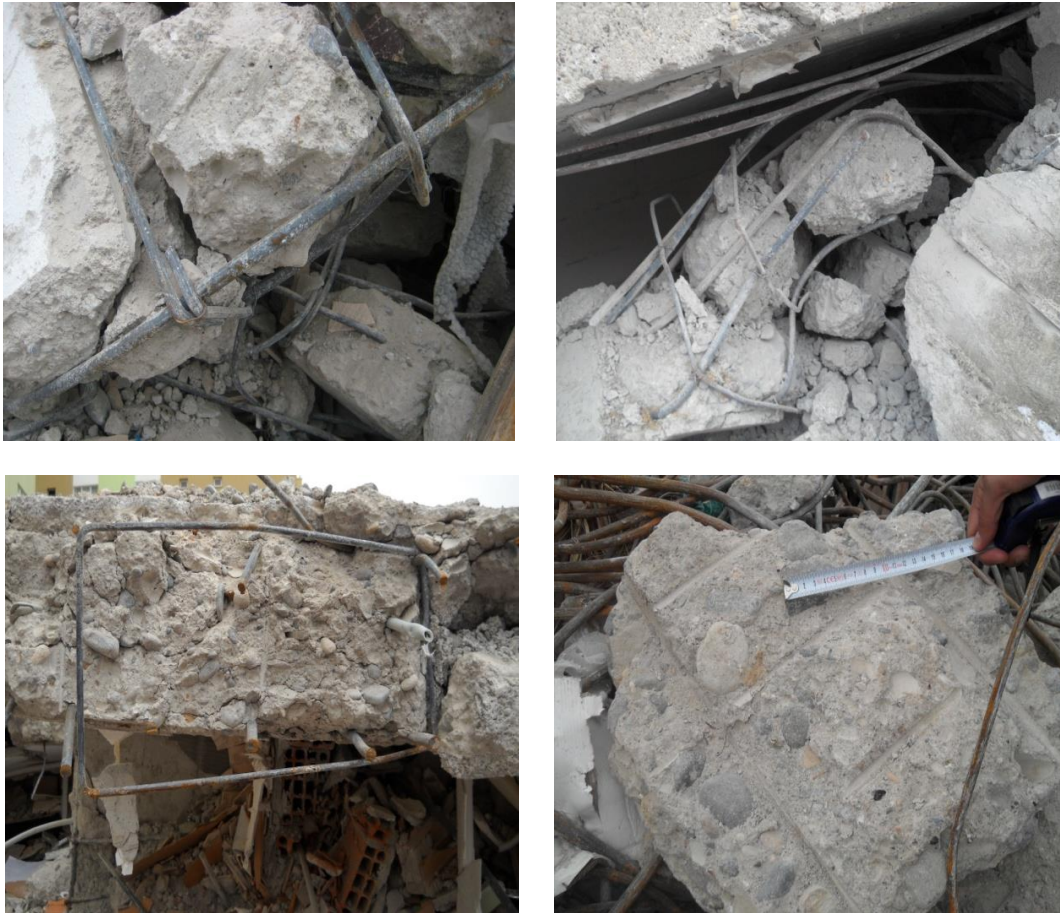
Our field observation showed that the other main reasons of damages were low concrete strength and workmanship. Concrete quality is an important factor for building performance against to earthquake. In Turkey, using of ready mix concrete became common after 1999 Kocaeli earthquake. Before this earthquake handmade concrete was generally used without using

Fig. 20 Poor quality concrete at various buildings

vibrator. Due to this wrong application, homogeneity mixing was not obtained and expected compressive strength was not provided. The TSC requires that compressive strength of concrete should be minimum 20 Mpa in all buildings to be constructed in all seismic zones. But it was seen that, strength of concrete was very low at observed buildings. Fig. 20 shows poor quality of concrete in various buildings that existed earthquake area.

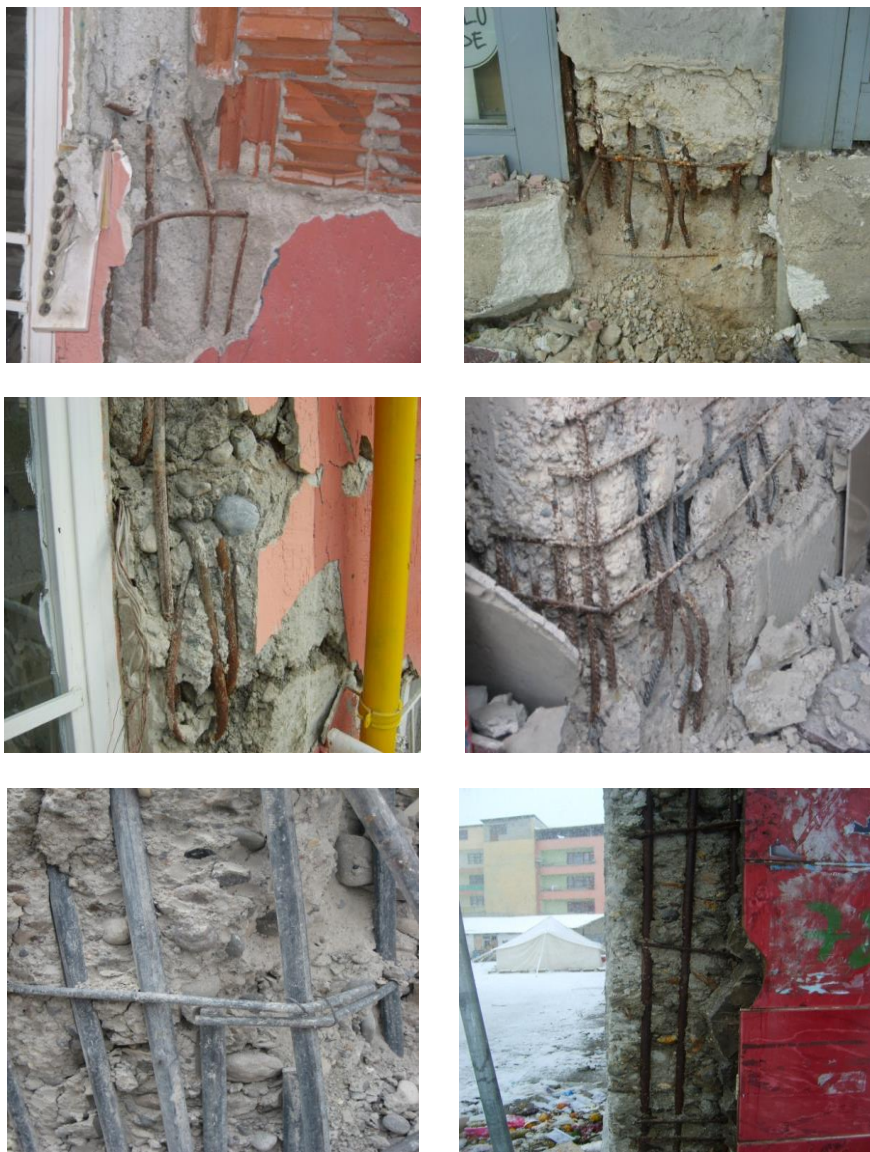
Using of aggregates which have improper granulometry, corrosion which decreases reinforcement bar area and using of smooth steel reinforcement effected strength of concrete. Also it was seen that at many buildings concrete cover was very thin for preventing reinforcement to corrosion. Fig. 21 illustrates these mistakes at columns of different buildings.

Fig. 21 Corrosion, smooth reinforcement and improper granulometry at columns of different buildings

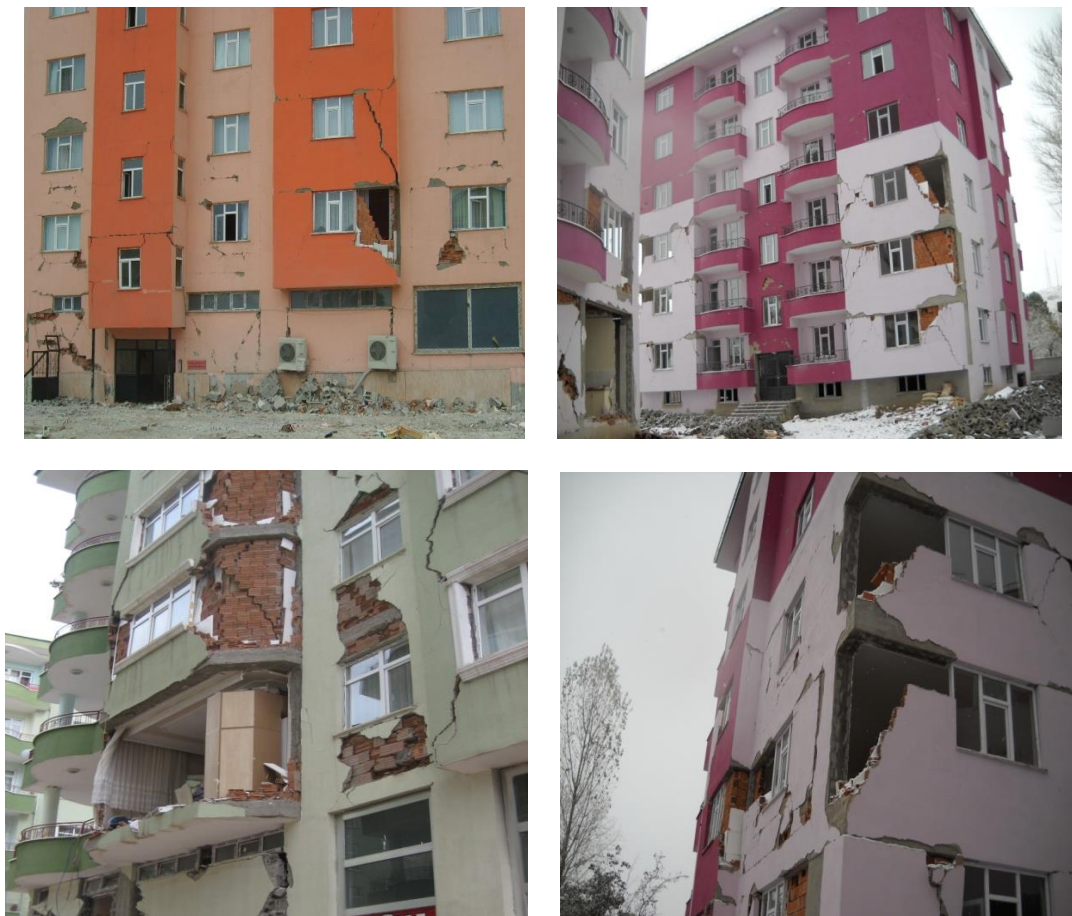
In Turkey, infill walls of R/C buildings have been constructed by using unreinforced brick masonry and cement mortar. In the earthquake area brick masonry exterior infill walls had been generally constructed two layers due to sound and heat isolation while interior infill walls had been built with one layer. But, it was seen that the layers of the exterior walls behave separately from each other since layers are poorly connected to each other and frames. Thus, these exterior walls suffered from out of failure mechanism. However, damage levels of these walls increased due to heavy and large overhangs in which the cantilever length may be reach generally 1-1.5 m. Fig. 22 shows these type damages in the earthquake region. To prevent this kind of failures it must be avoided from this wrong application in seismic regions.

Fig. 22 Damages of exterior walls

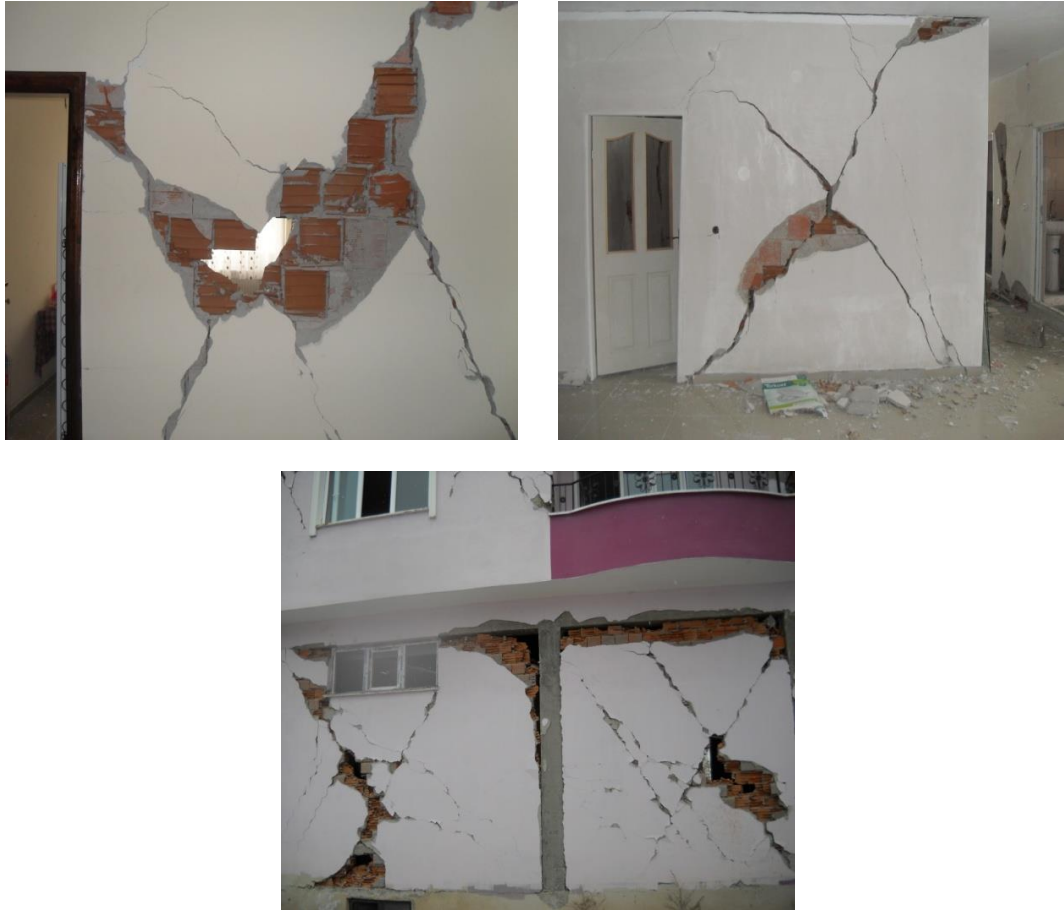
Shear damages are seen as common failure mechanism in infill walls which are constructed between frames. These walls contribute to lateral resistance of buildings significantly. During an earthquake diagonal cracks (X-shape) which originate at the corners of openings occur in plane of infill walls since unreinforced brick masonry walls have lower deformation capacities than the R/C structural elements. Fig. 23 shows in plane failures at various buildings.

Fig. 23 In plane failure mechanism in infill walls at some R/C buildings
