Structural repairing of damaged reinforced concrete beam-column assemblies with CFRPs

Özgür Yurdakul^{*1} and Özgür Avşar^{2a}

Keywords: CFRP; beam-column joint; reinforced concrete; structural repair

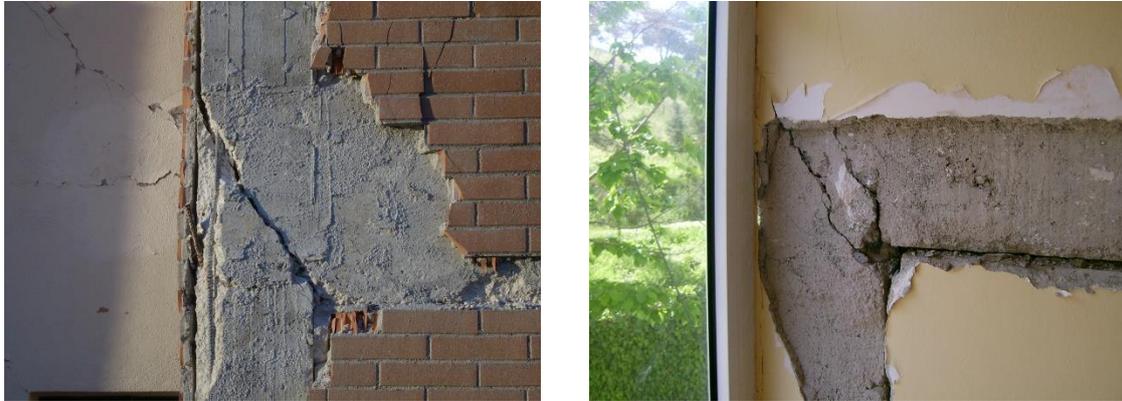
Fig. 1 Beam-column joint shear failure

(a) L'Aquila-Italy (2009) Earthquake

(b) Simav-Turkey (2011) Earthquake

beam-column joint. This can result in moderate to severe structural damage or even the total collapse of moment-resisting frame buildings (see Figs. 1(a)-(b)). RC buildings with moderate to severe structural damage after the earthquakes should be demolished or repaired depending on the damage level. Different techniques exist to repair the damaged RC buildings according to their damage level. Repairing the non-structural components can be sufficient for lightly damaged RC buildings. Moderately damaged RC buildings can only be serviceable after the application of sufficient structural repairing techniques.

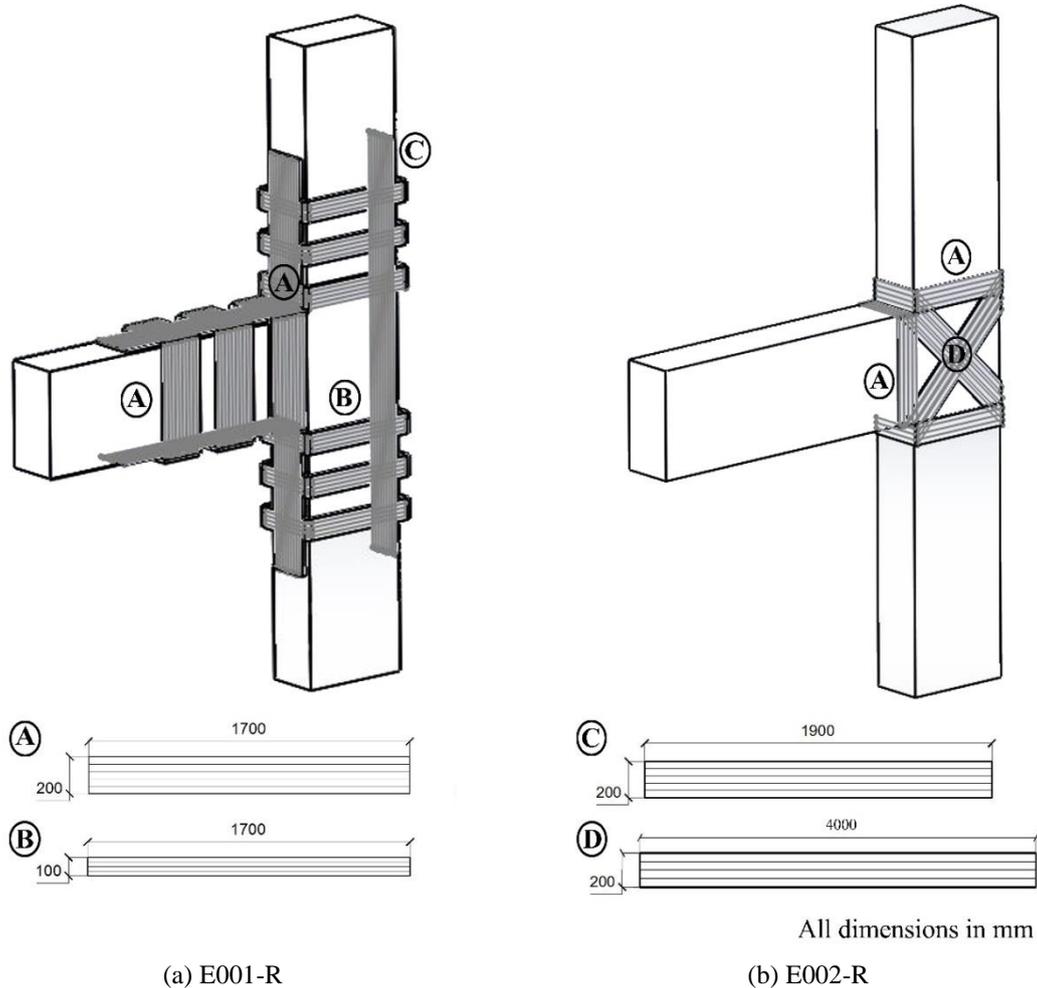
Fig. 4 Schematic representations of CRFP repairing

A ductile performance was observed in E001 specimen and plastic hinges took place in the beam. For this reason, a one layer CFRP with 200 mm width was applied to the top and bottom

surfaces of beam and anchored by three CFRP sheets with 200 mm width, 1700 mm length (see Fig. 4(a)). The sheets used for anchoring were placed at 100 mm in transverse direction. These transverse direction CFRP sheets also increased the shear resistance of the beam. For a ductile behavior of the specimen, plastic hinges are expected to occur in the beam. Since the beam was repaired, strong beam weak column case could occur. Then, the flexural capacity of column could be exceeded before the beam reached to its flexural capacity. For this reason, while the beam was repaired, the column was repaired as well. A one layer CFRP with 200 mm width was applied at the front and back surfaces of upper and lower story columns. Six 100x1700mm CFRP sheets were placed in the transverse direction with spacing of 100 mm to anchor longitudinal CFRPs and to increase the shear capacity of the column. It was known from the experiment of E001 that, the member capacities could not exceed the beam-column joint capacity for this specimen. Therefore, no repairing action was taken for the beam-column joint.

The failure mechanism was brittle joint shear failure for E002 specimen. Therefore, joint region was repaired to attain the initial shear capacity of the joint. Before the application of CFRPs, spalled concrete at the joint was removed after testing E002. Then, repair mortar was placed in place of removed concrete in the joint. Two layers of CFRP sheets with 200 mm width and 4500 mm length were orientated $\pm 45^\circ$ with respect to beam axis. These diagonal sheets were anchored to the beam and column at upper and lower story level by means of three 200x1700 mm CFRP sheets by wrapping the RC components with a single layer of CFRP (see Fig. 4(b)).

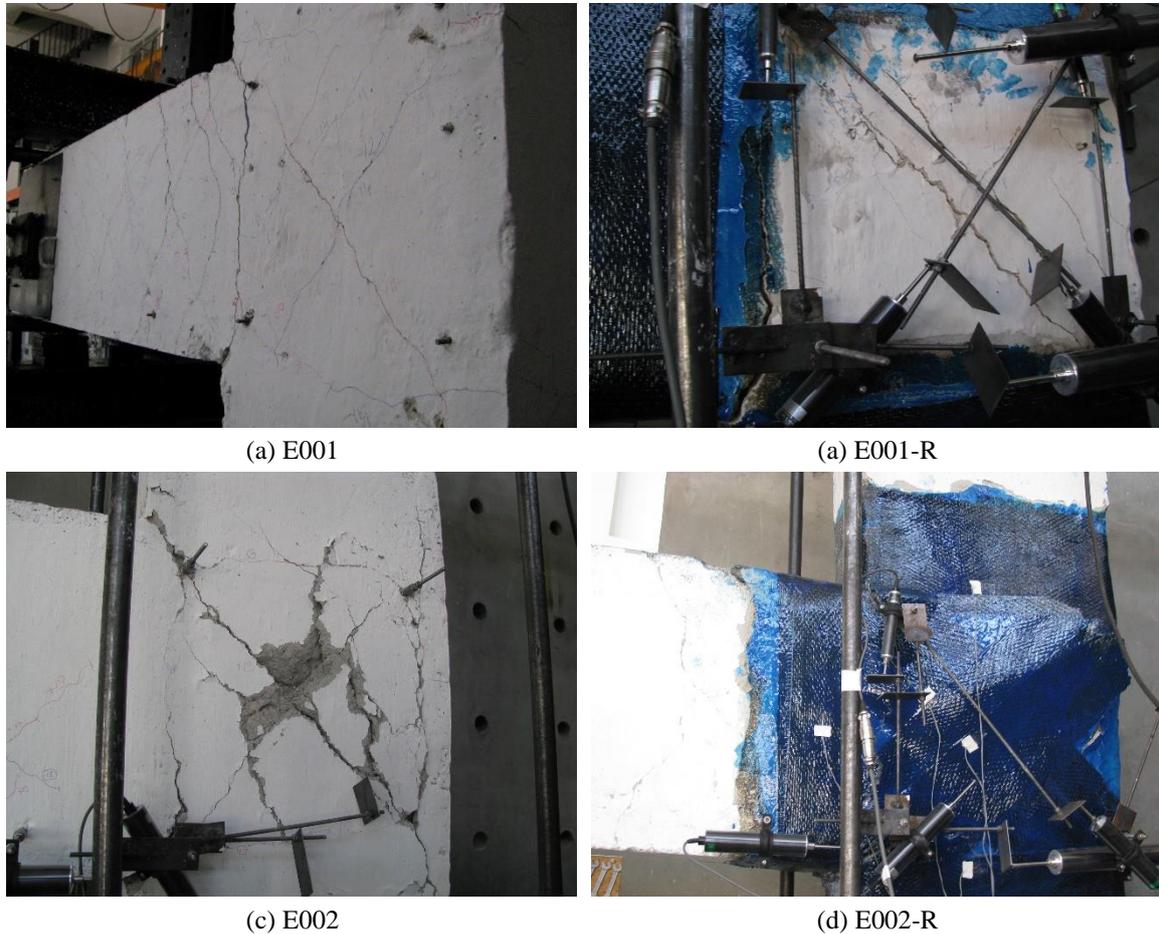
Fig. 9 Damaged photograph of specimens at 4% drift ratio

whole beam length evenly and plastic hinge initiated at beam joint interface due to flexure. The first observed inclined joint crack was at 0.50% drift ratio. Then, although the flexural capacity of beam did not exceed the joint shear capacity, hairline cracks in the joint were observed but these cracks in the joint did not widen. In the last loading stages of the specimen, hairline flexural cracks developed in the column but it did not affect the behavior of the specimen.

Unlike the first test series, the behavior of specimens E002 and E002-R was a brittle shear failure of the joint. The capacity of the specimens was limited by joint strength. The first flexural crack at beam, beam-joint interface and first inclined crack at the beam-column joint was observed at the same drift ratio, 0.20%, which formed at 29.5% of the ultimate load in the test of E002. As the imposed displacement increased, new cracks occurred at 0.5% and 1.5% drift ratios at joint parallel to the beam and column respectively. With the increase in the drift ratio of the beam-column assembly, widening of shear cracks at joint increased, and the concrete in the joint core crushed and spalled. Even though, the hooks of beam longitudinal bars were welded to column longitudinal bars, slippage problem was not fully prevented. As a result of slippage at the beam, welded hooks of beam longitudinal bars cause buckling of the column longitudinal bars and they did not keep their right angle anymore. The concrete cover at back side of column in the joint also spalled due to deformation of beam longitudinal reinforcement hooks at the beam end. Also, the shear and flexural cracks did not spread to the whole length of the beam (see Fig. 9(c)). The cracks were generally concentrated at the beam-column joint and beam-column interface. A large flexural crack initiated at the beam-column interface and the crack width widened with the increasing drift ratio due to presence of plain round bars in the beam. The plastic flexural capacity of the beam for E002 specimen, which corresponds to the lateral force capacity of the beam-column assembly, is 69 kN determined from section analysis. As shown in Fig. 10(c), the hysteretic response of E002 obtained from the test did not reach to beam flexural capacity. For this reason, the ductile behavior could not be observed due to the fact that the beam-column joint reaches to its shear capacity before the beam attains its flexural capacity.

The observed failure mode of E002-R was shear failure at joint as also observed for the reference specimen, E002. The performance of repaired specimen was quite satisfactory until debonding of the diagonal CFRP sheets on the joint surface. The first CFRP debonding was observed at 0.40% drift ratio which corresponds to 50% of maximum lateral load. However, the flexural crack was observed in the beam at 0.20% drift ratio which is before the occurrence of CFRP debonding. This implies that the application of diagonal CFRPs at the beam-column joint has changed the behavior of the beam-column assembly and flexural deformations in the beam dominated the overall response before the fracture of CFRPs. After several cycles of the first debonding, fracture of the CFRPs was initiated as shown in Fig. 9(d).

The reason of failure in the E002-R specimen was the fracture of diagonal CFRPs (see Fig. 9(d)) and as a consequence the spalling of repair mortar at joint core was occurred. The first CFRP fracture at joint occurred at 2% drift ratio. After this point, the capacity of the repaired specimen was diminished by the shear failure of the beam column joint leading to a brittle type of failure. In the design of CFRP sheets for repairing the damaged E002 specimen, two layers of CFRP sheets with 200 mm width was selected to be applied diagonally at the beam-column joint. In the design stage, the full CFRP sheet area was considered to be in tension. However, one side of the CFRP sheet was exposed to larger stress due to the eccentricity and hence total CFRP section did not work as it was designed. This led to tearing of the CFRP sheet from one side that had higher axial stress. Therefore, it is inferred that more layers of diagonal CFRP sheets should have been used for the applied repairing technique to be more effective for the higher drift ratios. Even the application of two layers of CFRP sheets with 200 mm width result in more flexural deformations in the beam leading to a more ductile behavior compared to the reference specimen. Propagation of flexural cracks was in the uncracked beam sections as well as widening of crack width in the existing cracks observed in the repaired specimen before the fracture of diagonal CFRPs.
