Investigation of blast-induced ground vibration effects on rural buildings

Abstract. In this paper, blast-induced vibration effects on buildings located in rural areas were investigated. Damages to reinforced concrete, adobe and masonry buildings were evaluated in Ç atakköprü and Susuz villages in Silvan district of Diyarbakır, Turkey. Blasting of stiff rocks to construct highway at vicinity of the villages damaged the buildings seriously. The most important reason of the damages is lack of engineering services and improper constructed buildings according to the current building design codes. Also, it is determined that, inappropriate blast method and soft soil class increased the damages to the buildings. The study focuses on four points: Blast effect on buildings, soil conditions in villages, building damages and evaluation of damage reasons according to the current Turkish Earthquake Code (TEC).

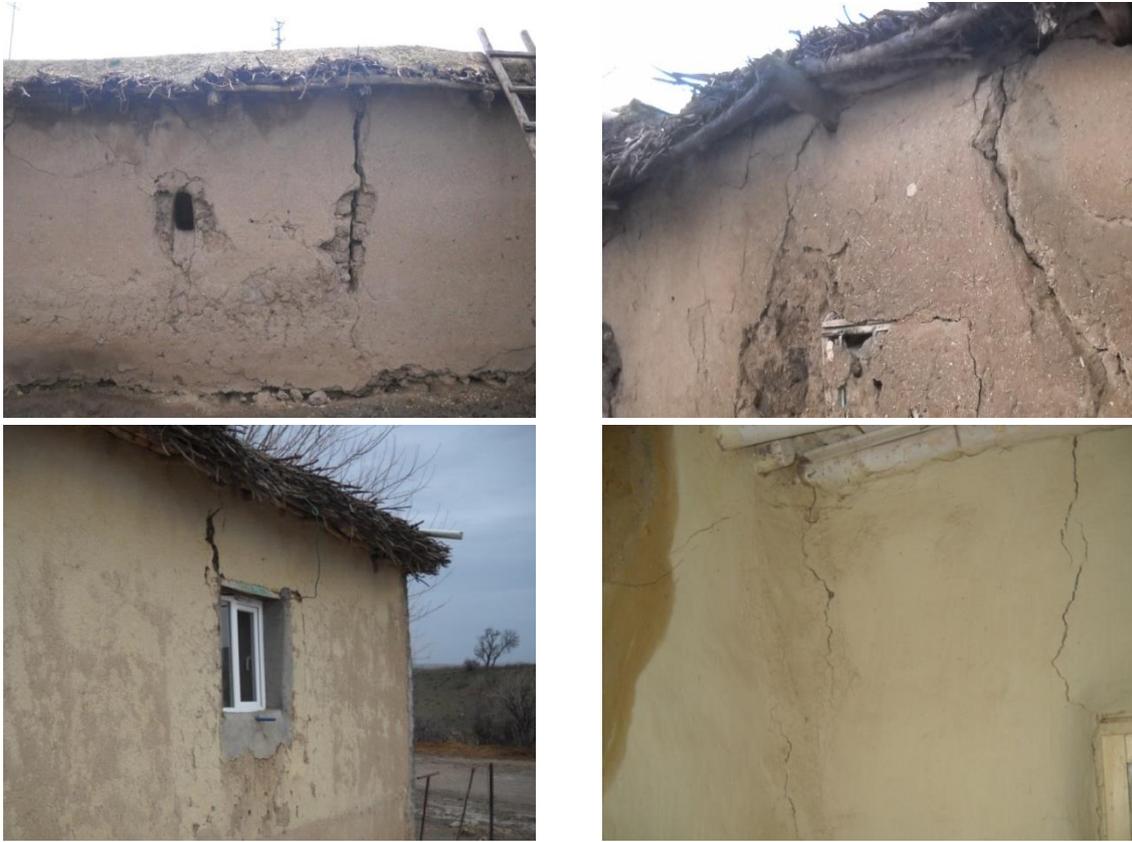
Fig. 3 Flexural failure and diagonal crack at various adobe buildings

Low resistance of the adobe materials and existence of heavy earthen roofs caused flexural failure, in which vertical compression cracks occurred due to cracking of adobe material. Also, these reasons caused increasing in shear stress effects and diagonal cracks (Fig. 3).

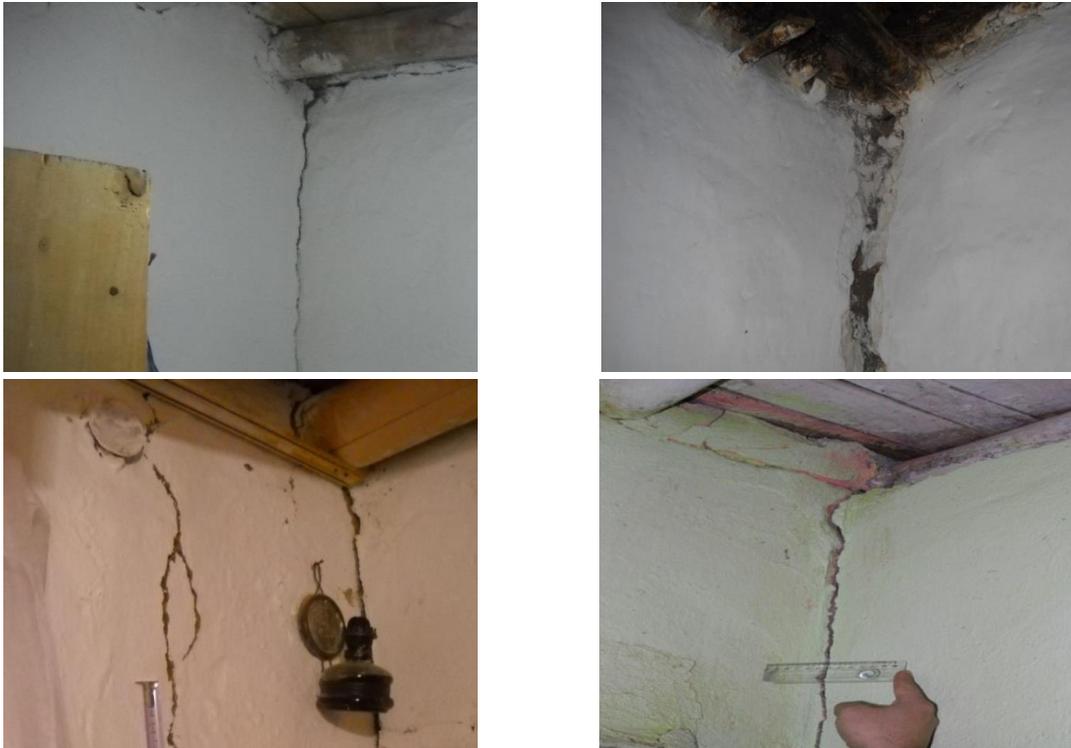
Fig. 4 Damages at corner walls of adobe buildings

One of the major reasons of failures is the deficiencies of the tie beams at walls and inadequate connection at corner of the building walls. This type of wrong application caused serious damages. This type of damage is shown in Fig. 4.

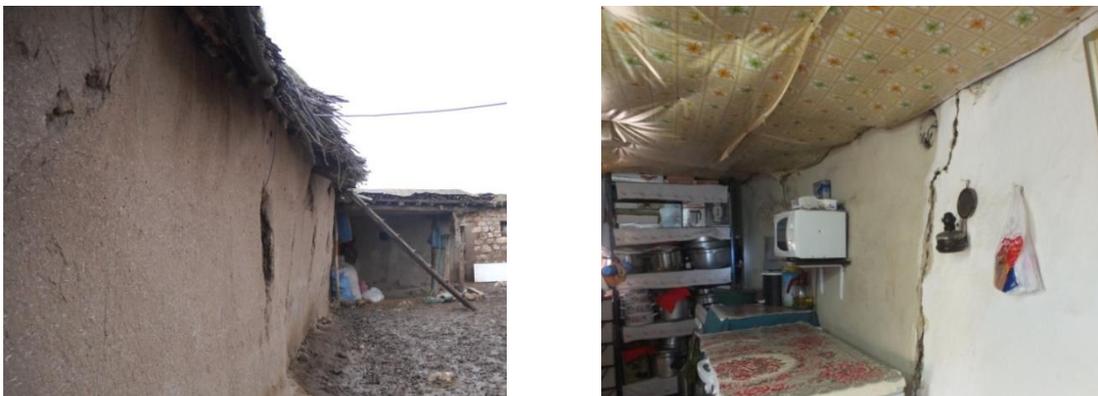
Fig. 5 Out of plane mechanism arose from blast-induced vibration for various adobe buildings

Inappropriate connection detailing between wall and roof and between wall and wall, lack of tie beams and existence of heavy earthen roofs caused out-of plane failure mechanism in some adobe

buildings. These damages are illustrated in Fig. 5 for different buildings.

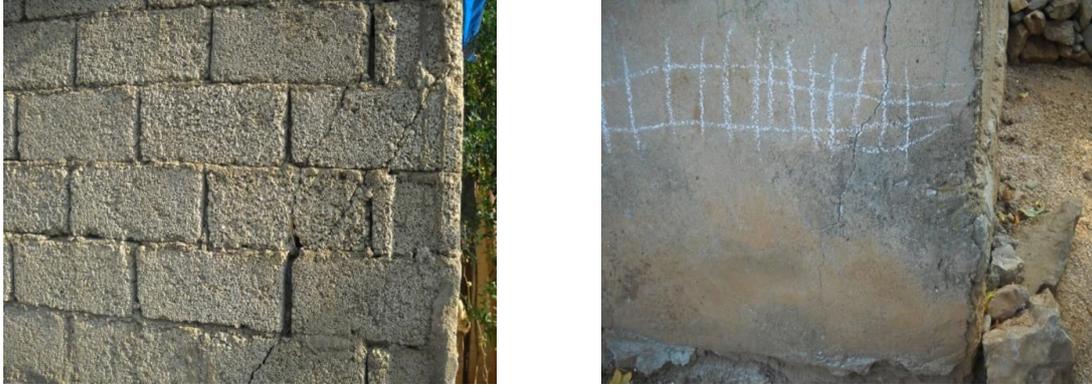
Fig. 6 Corner damages at various brick masonry building

Brick masonry buildings in the affected villages were generally unreinforced and most of them did not have sufficient and appropriate horizontal tie beams and tie columns. Especially, lack of these beams at the corners of walls led to severe damages. Fig. 6 shows damages to brick masonry arising from blast effect. For these types of buildings, the TEC indicates that horizontal tie beams should be built monolithically with the reinforced concrete slabs. In addition to this, height of horizontal tie beams should not be less than 200 mm and their width should be equal to the width of wall. Also, the reinforced concrete tie columns should be constructed in building height on the corners of buildings, along the vertical intersections of the load-bearing walls and on both sides of

the door and window openings. Also, dimensions of the tie columns should be equal to thicknesses of corner walls.

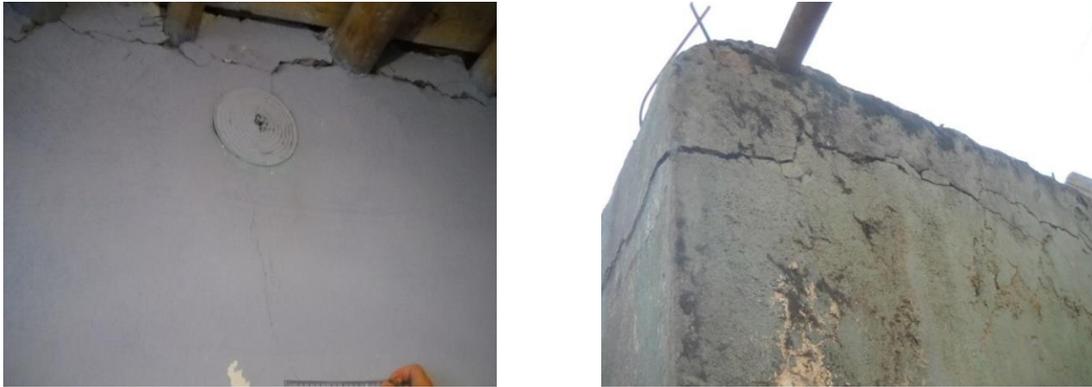
Fig. 7 Sliding failures in different brick masonry buildings

The blast effect caused the sliding failure in some buildings. This failure caused horizontal cracks at the longitudinal bed joints divided in two segments which slide along the fracture surface. Fig. 7 shows sliding failure in different brick and stone masonry buildings.

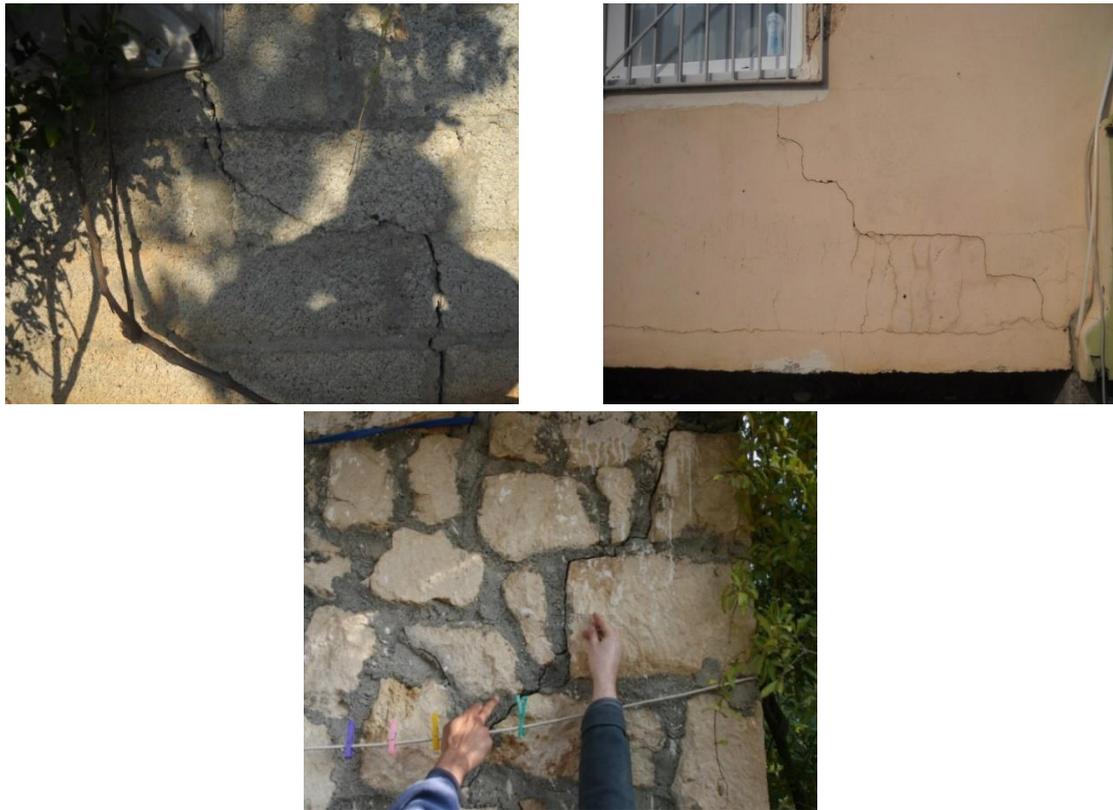
Fig. 8 Diagonal stepped cracks in various brick and stone masonry buildings

Stepped cracks from the bed to head joints or head to bed were seen in the affected region. When lateral displacement is low, the failure occurs as flexural stepped crack form. However, for higher displacements, the shear strength of the bed joints is overcome and diagonal stepped failure occurs along head and bed joints at the wall corners or edge of windows and doors. Fig. 8 shows diagonal stepped cracks in various brick and stone masonry buildings in the affected villages.

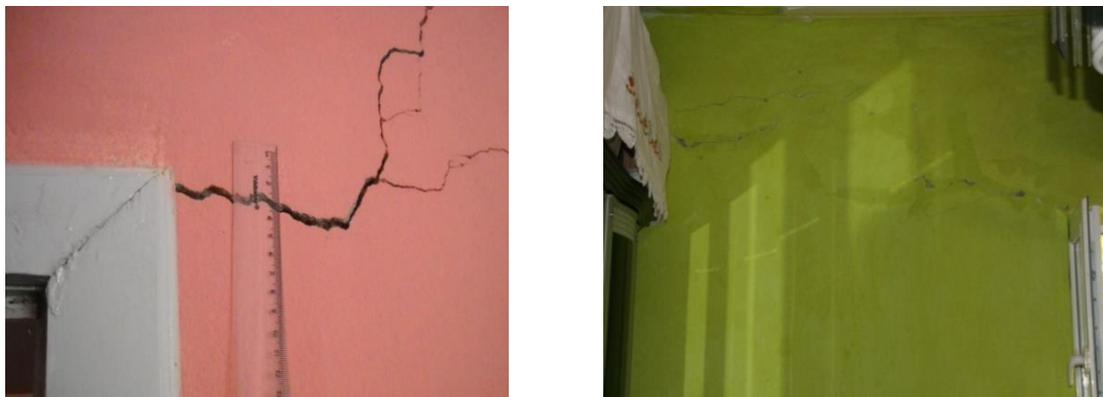
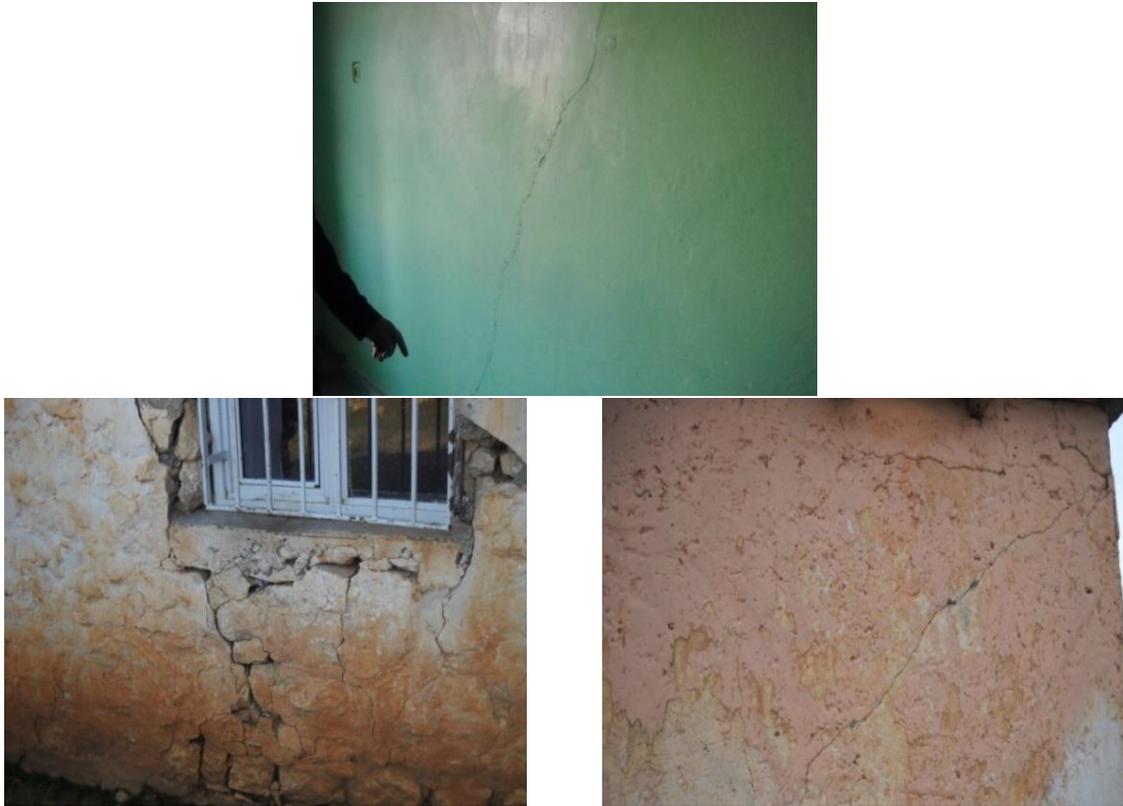
Fig. 9 Diagonal shear cracks in different brick and stone masonry buildings

Fig. 9 Continued

Shear diagonal failures are commonly seen at the edge of openings and in plane of walls at masonry buildings. Inappropriate window and door openings or their locations in wall enhance shear stresses under lateral load effects. Thus, stiffness of the wall decreases and diagonal crack occurs at the edges of openings. To prevent this type of damages, TEC requires using of horizontal tie beams and tie columns. Fig. 9 shows diagonal shear cracks in different brick and stone masonry buildings in the villages.

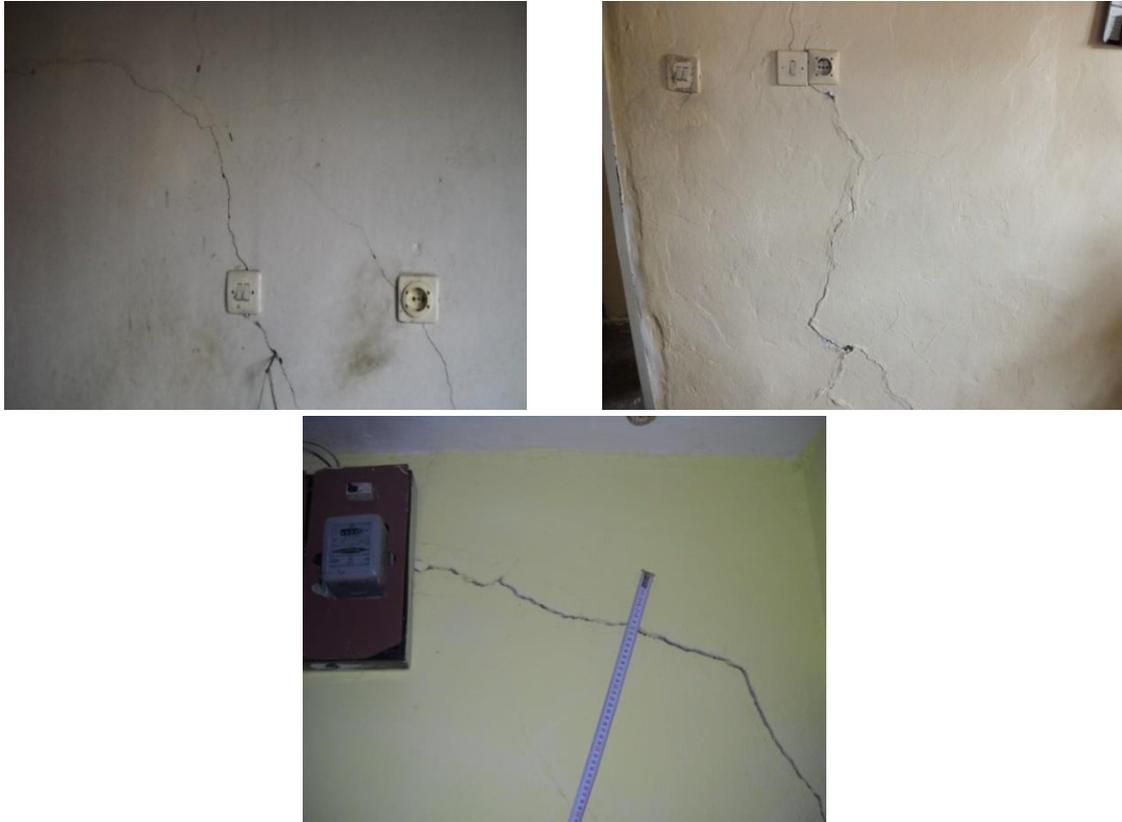
In some masonry buildings some light damages were determined arising from deficiencies of electrical wiring. Diagonal or vertical cracks occurred along the installation cables. Fig. 10 shows these types of failures.

Fig. 10 Diagonal and vertical cracks arising from deficiencies electrical wirings

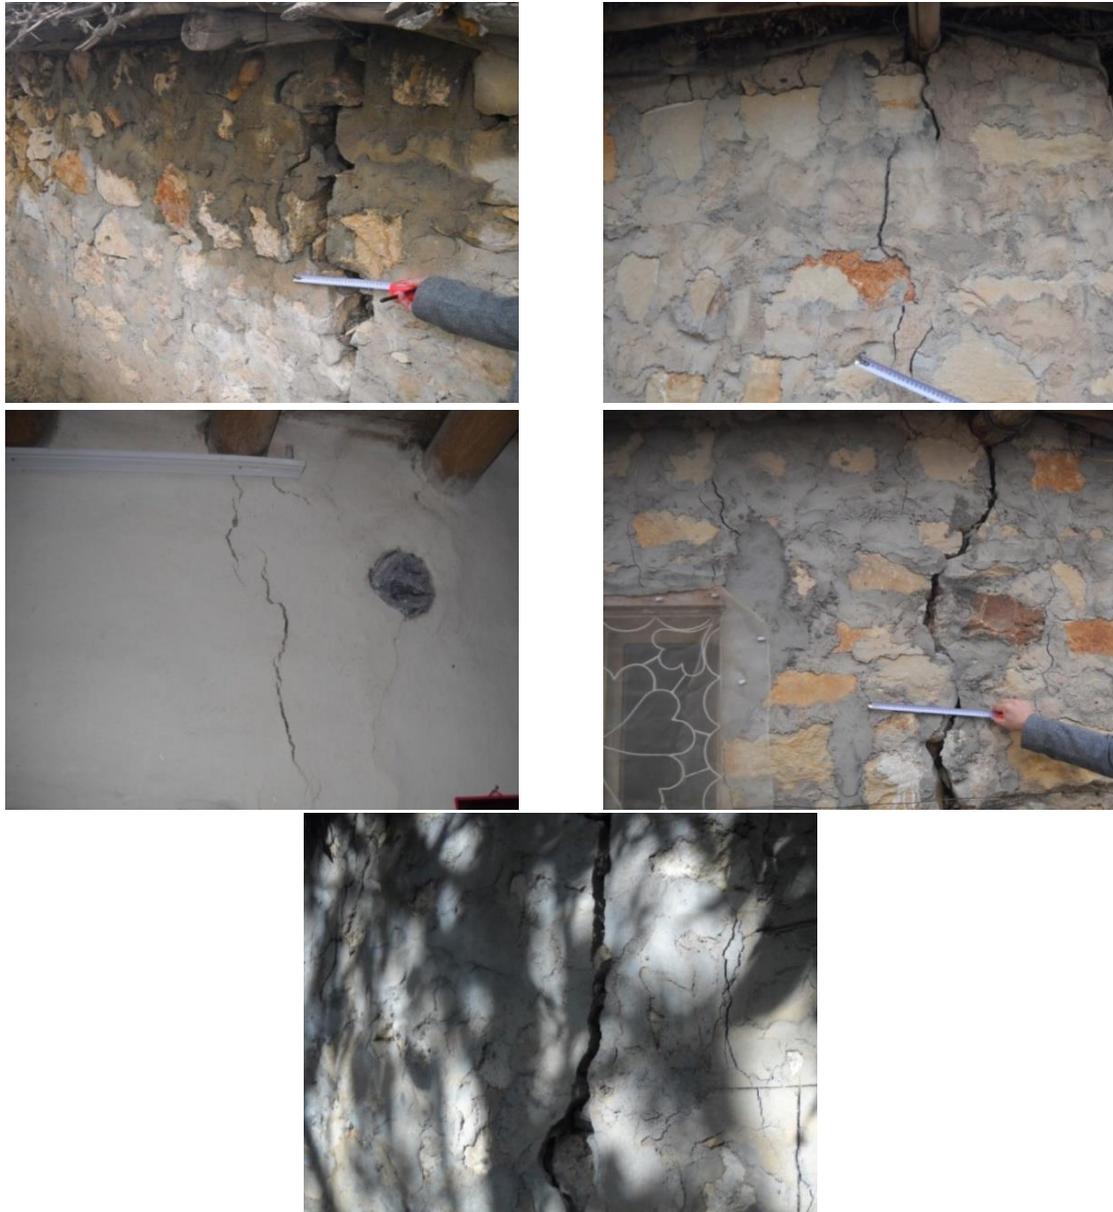
It was observed that, especially stone masonry buildings suffered from flexural failure in which vertical compression cracks occurred in plane of wall because of yielding of masonry material. However, this mechanism is complex: That is, when lateral load enhances, shear failures that are more obvious than the flexural cracks occur in plane of masonry wall. This type of damage is shown in Fig. 11.

Fig. 11 Flexural cracks in various masonry buildings

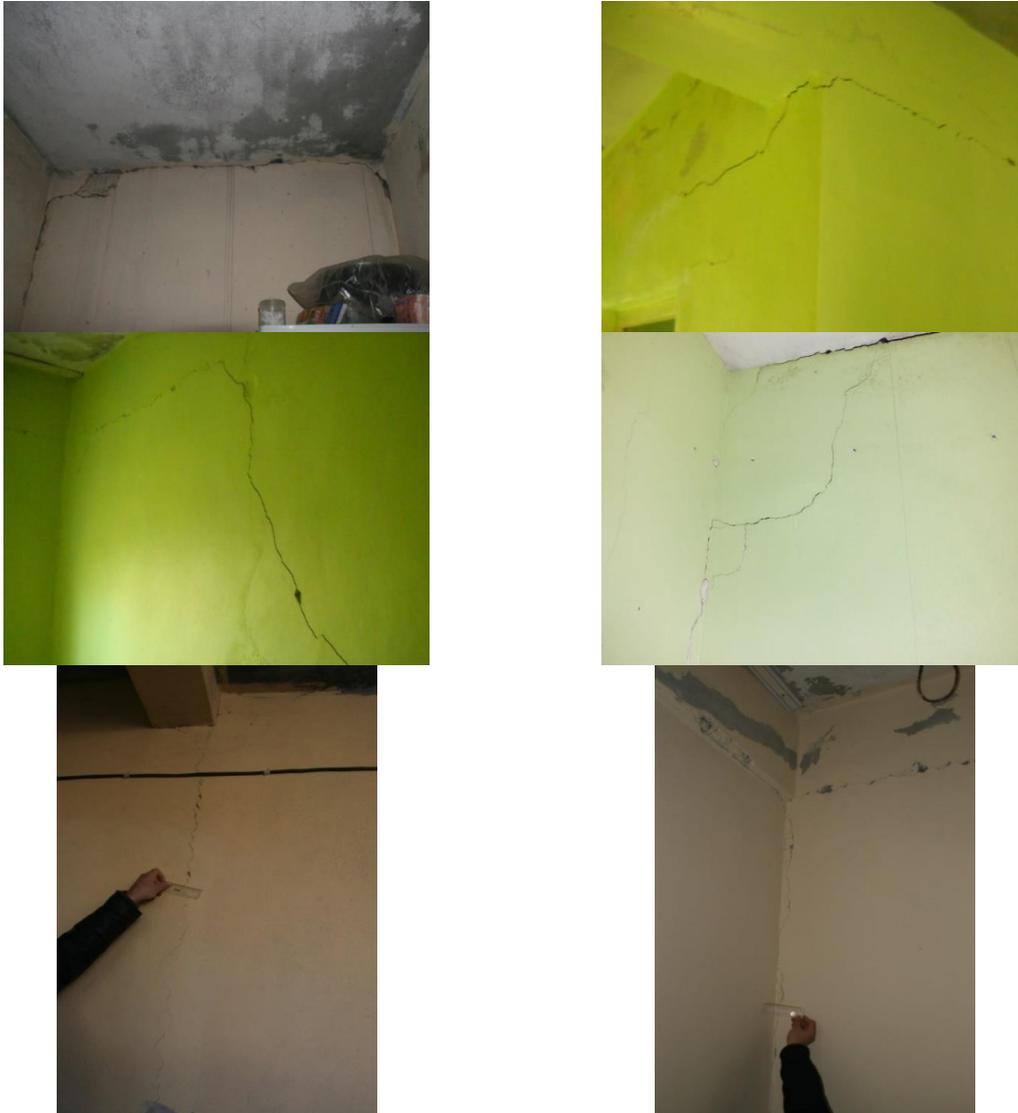
In Turkey, non-bearing infill walls of reinforced concrete buildings have been constructed by using unreinforced brick masonry and cement mortar. Infill walls contribute to structural performance of buildings by increasing rigidity and, by limiting to the storey displacement. But, unreinforced brick masonry walls have lower deformation capacities than the reinforced concrete members. There are not any significant damages at structural element of the reinforced concrete buildings located in the affected villages. However, severe failures were observed at non-structural elements of these buildings. In the affected area, cracks occurred between column and beam and surrounding non-bearing infill walls. Crack widths at these walls were measured between the range of 2 mm and 10 mm. This type of damages can be considered as light damage. Fig. 12 shows this kind of damages at the buildings in the villages.

Fig. 12 Damages to infill walls in various reinforced concrete buildings

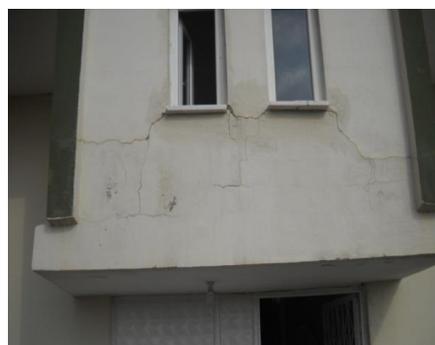
Dimensions of plan of the upper storeys of the buildings were changed because of need for larger usage area in the houses in the villages in Turkey. The increased area of upper storey of the building behaves as cantilever beam bearing heavy wall load at the unsupported end. The cantilever length may reach generally to 1-1.5 m. This wrong application causes additional weight and irregularity. Additional stresses and torsional moment takes place due to eccentricity. Fig. 13 shows this kind of damage in the affected area.

Fig. 13 Damage arose from heavy cantilever in the reinforced concrete building

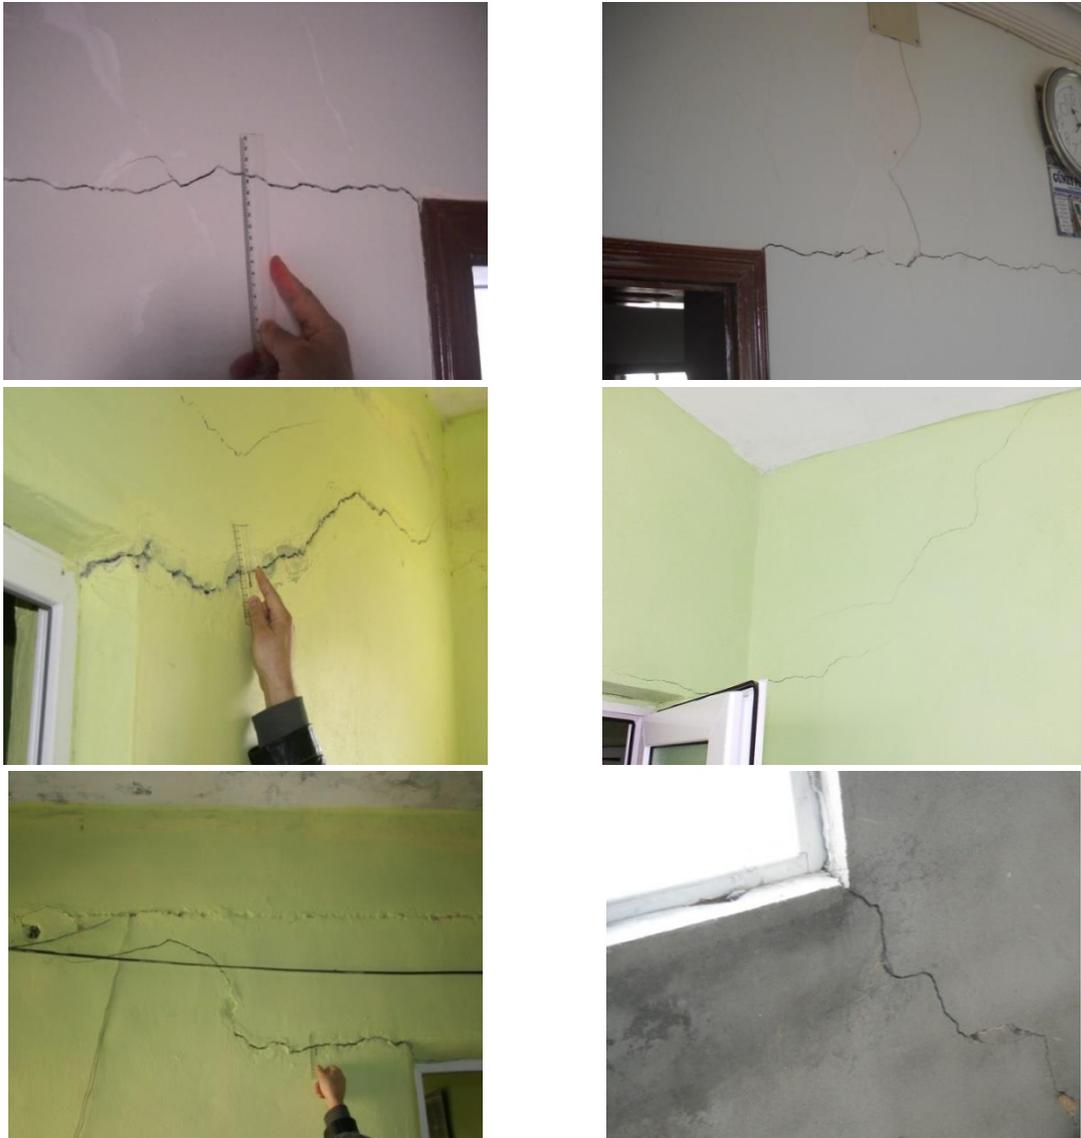
Shear damages are seen commonly at non-bearing infill walls which are constructed between frames. In the case of a lateral force such as earthquake, blast etc. cracks which originate from the corners of openings occur in plane of these walls since unreinforced masonry walls have lower deformation capacities than the reinforced concrete structural elements.

These kinds of damages which occurred due to blast effect were observed in reinforced concrete buildings in the villages. Fig. 14 shows in plane failures in various reinforced concrete buildings.

Fig. 14 In plane failures in various reinforced concrete buildings
