Evaluation of shelter performance following the 2013 Moore tornado

Pataya L. Scott^{*1} and Daan Liang^{1,2a}

¹National Wind Institute, Texas Tech University, Lubbock, Texas 79409, USA

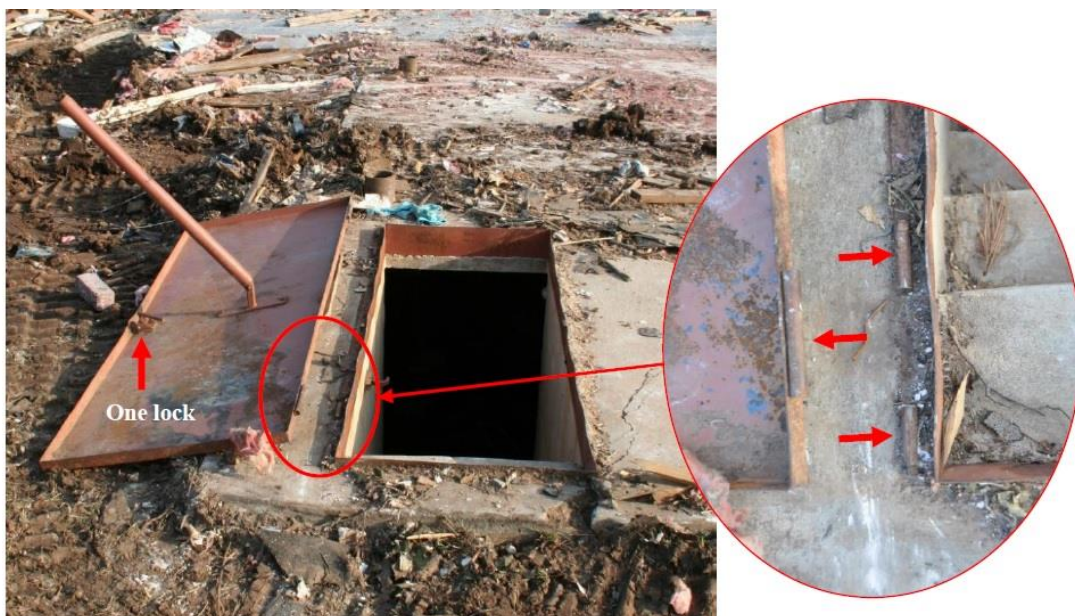
The team documented eight flush-to-the-ground shelters, all of which had hinged swinging doors. One shelter sustained a significant failure as the door was blown off due to sheer failure of rusty hinge pins (seen in Fig. 2). Proper maintenance could have prevented this, as well as having door assembly complying with ICC 500 or FEMA P-361 criteria. The door of another shelter was stuck shut and the homeowner, an elderly man, opted to take shelter in an interior bathroom of his home with his pets. Again, proper maintenance of the door may have prevented this issue. Additional deficiencies with shelters of this type were related to door thickness, locking systems, hinges, stairs, and drainage. Many of such shelters were not properly designed with beveled edges to allow water runoff to flow around the opening, and had been flooded with 6 inches to 48 inches of water. Flooding was a common complaint among homeowners, however, many homeowners were under the impression that they were safer in below ground shelters and were unaware of shelter installation and testing guidelines and standards.

Fig. 2 Door failure when accessing shelter with only a single lock point (No 47). Photo credit: Larry Tanner

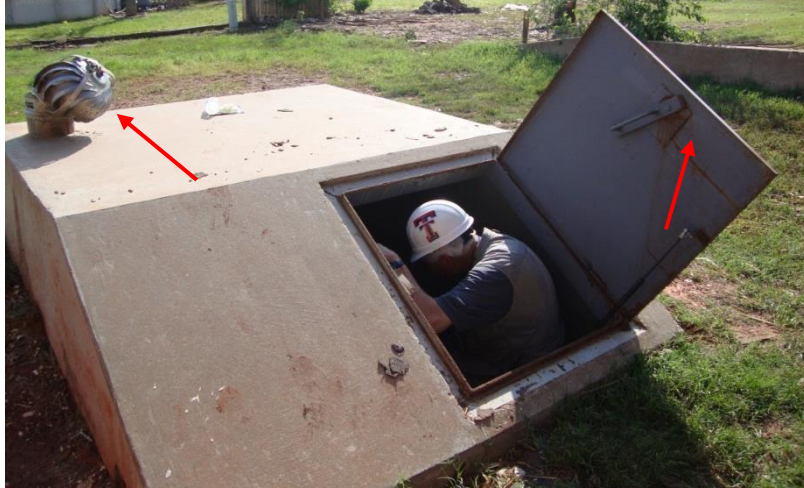
Fifteen clam shell shelters were documented with no observed major failures. However, deficiencies were found consistently in doors and ventilators. Many doors had only one locking latch and an insufficient number, and inadequate type of hinges. In Fig. 3, a clam shell shelter was designed with only one lock, two hinges, and sustained vent damage at an EF-2 rated location. In Figure 4, a clam shell shelter with a tested door that included three locks and three hinges was documented at an EF-4 rated location.

Fig. 3 Clam shell shelter with an insufficient locking system and damaged vent at an EF-2 rated location.
Photo credit: Pataya Scott

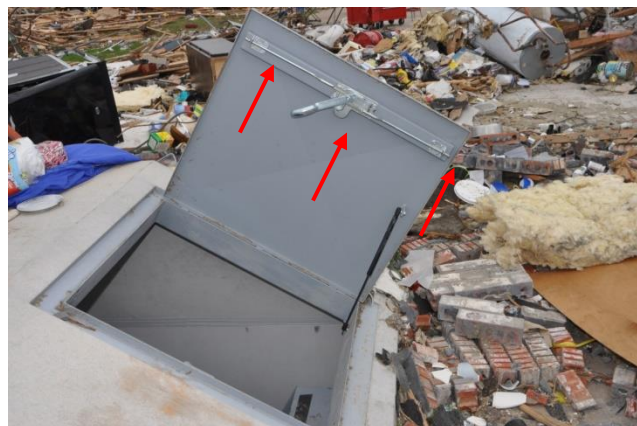
Fig. 4 Clam shell shelter with a tested door that has three locks and three hinges at an EF-4 rated location.
Photo credit: Larry Tanner

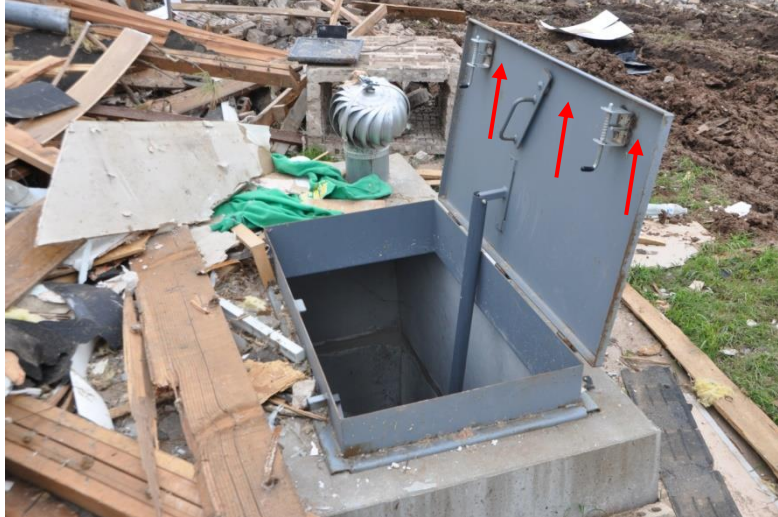
A flat-top clam shell shelter was documented in an EF-2 rated location, as seen in Fig. 5. Performance of these types of shelters was good. Accessibility to the shelters can be an issue because these types of shelters are located outdoors and the distance people must travel to take shelter must be considered when deciding placement. One shelter was located about 100 feet from the house, which could pose a greater threat to potential occupants if they need shelter quickly. Although the ICC 500 requires shelters to be 150 feet or less to the residence it is serving, it is advisable to place shelters as close and easily accessible as possible to reduce the threat of injury from debris while traveling to the shelter and to reduce the time it would take to get to the shelter. Standing water up to several inches was commonly observed in these as well.

Fig. 5 Flat-top clam shell shelter with three locks at an EF-2 rated location. Photo credit: Pataya Scott

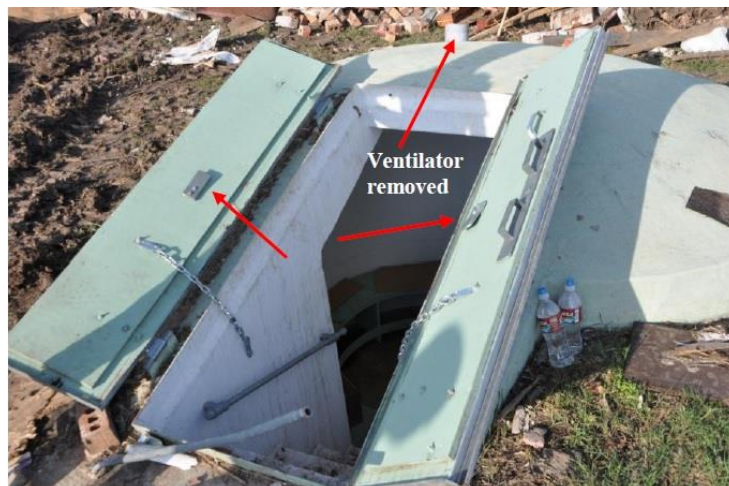
Two dome style shelters were inspected. The shelter pictured in Fig. 6 was cast in place concrete with double plywood doors with light gauge steel skin cladding, one lock, and two hinges per door. The shelter was observed at an EF-3 rated location. This shelter also had a few inches of standing water in the bottom. The other dome shelter the team documented had 3 heavy-gauge locks with a 1/8 inch steel door. It was partially above-ground, located in an EF-4 rated location, and is shown in Fig. 7. Both appeared to have survived the storm with no major failures, although the construction of the door assemblies were inadequate per ICC 500 and FEMA P-361.

Fig. 6 Dome shelter with an inadequate door system that included a plywood and light gauge sheet metal clad door, single locking point, and ventilator removed at an EF-3 rated location. Photo credit: Larry Tanner

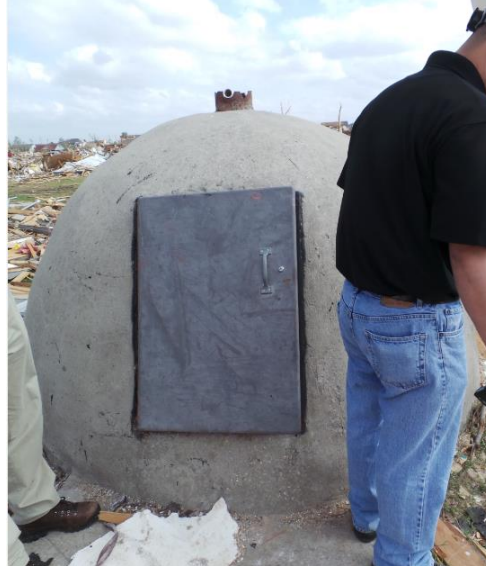
Fig. 7 Dome shelter partially above-ground located in an EF-4 rated location. Photo credit: Stephen Morse

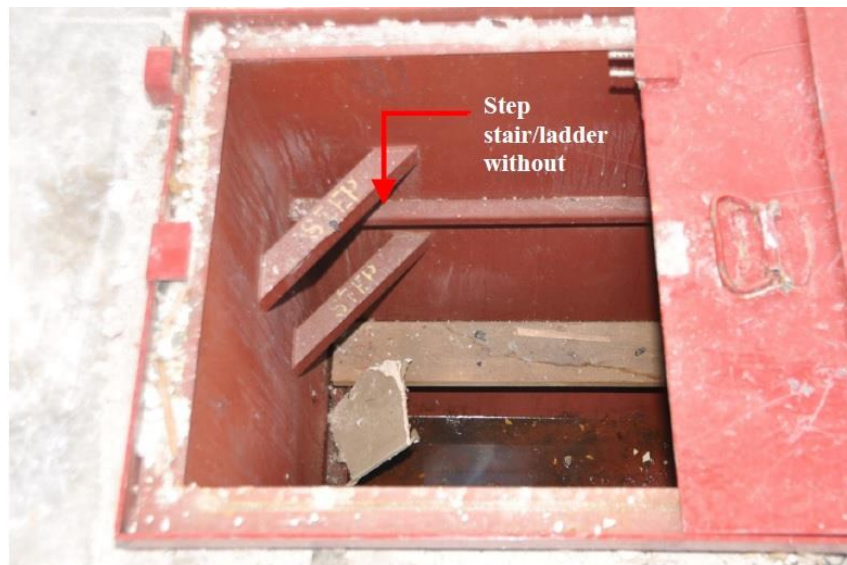
Fig. 8 In-garage shelter with inadequate stairs, locking system, and flooding in the bottom at an EF-3 rated location. Photo credit: Larry Tanner

have performed reasonably well, with no major failures. Fig. 8 shows a shelter in an EF-3 rated location with a stair/ladder entry that would not allow for easy access, an inadequate locking system, and some flooding in the bottom. Parked cars over the shelter proved to be a hindrance on accessibility to the shelter in some instances. When a car is pulled forward over the shelter, people who are mobile enough could gain access, however, access could be prevented if the car is not far enough forward or people accessing the shelter have limited mobility. Other issues were similar to exterior below ground shelters such as: door thickness, locking systems, roller bearings, stairs, and drainage. Flooding from drainage seemed to be a problem not fully considered, homeowners did not need to worry about flooding of the shelter when it was protected by the garage structure. After the tornado destroyed the garage around the shelter, then water would drain into them from rain, broken water lines, or even ruptured above-ground swimming pools. Figs. 9 and 10 are tested shelters that performed very well in an EF-4 and EF-0 rated locations respectively. Homeowners indicated they preferred the in-garage style shelter because it was cheaper, installation was quick, it did not take up any space, and it gave them confidence by being underground.

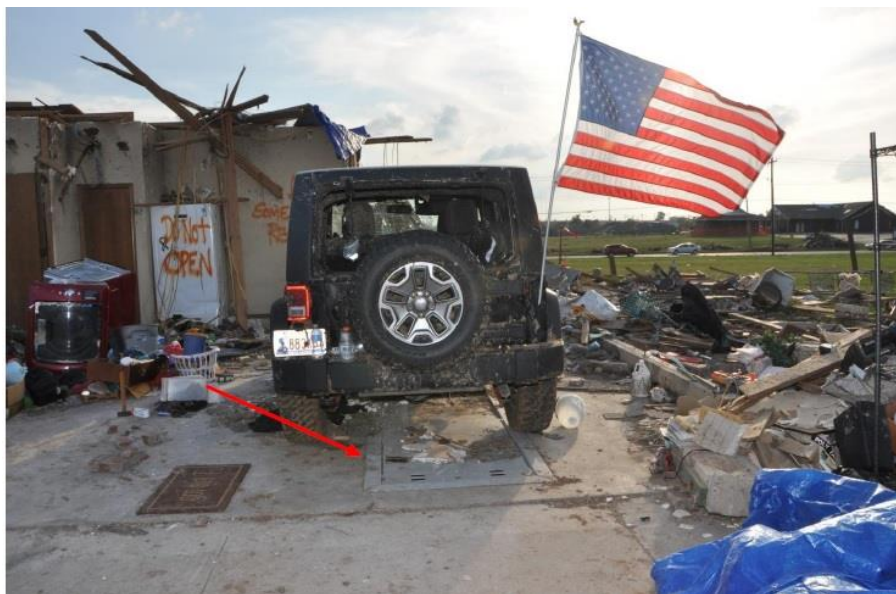
Fig. 9 Tested shelter at a location assigned an EF-4 rating. Photo credit: Pataya Scott

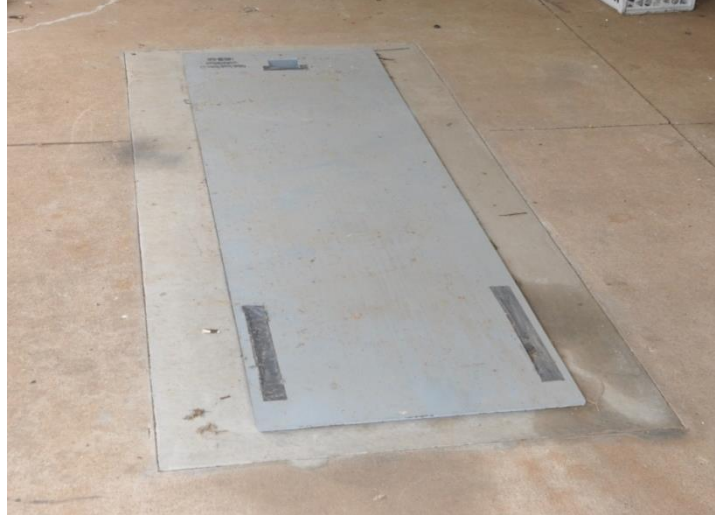
Fig. 10 Tested NSSA shelter at a location assigned with an EF-0 rating. Photo credit: Pataya Scott

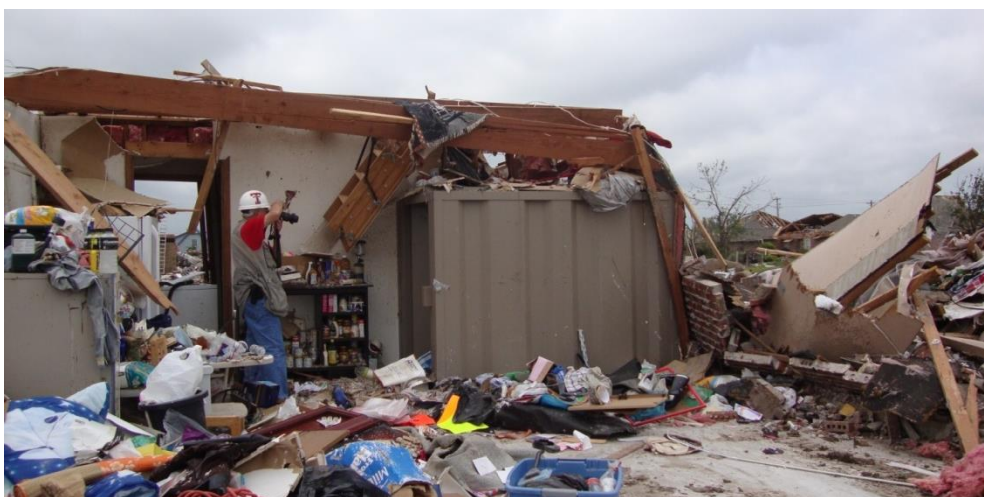
Eight above-ground shelters were documented. Six had been tested, and it was noted that most of these shelter manufacturers displayed their company name on their products while most of the underground shelters did not. Fig.11 is an untested above-ground shelter that was in the garage of the home in an EF-4 rated location, and survived without any failures, even though the rest of the home was destroyed. The other two shelters that were not tested were located on the same street of a fairly new, well built neighborhood. These were builder installed walk-in closets made of concrete. The concrete portions of the shelters had been tested, however, the door assemblies did not appear to be tested. One of these shelters is shown in Fig.12.

Fig. 11 An above-ground tested shelter that survived EF-4 wind speeds. Photo credit Pataya Scott

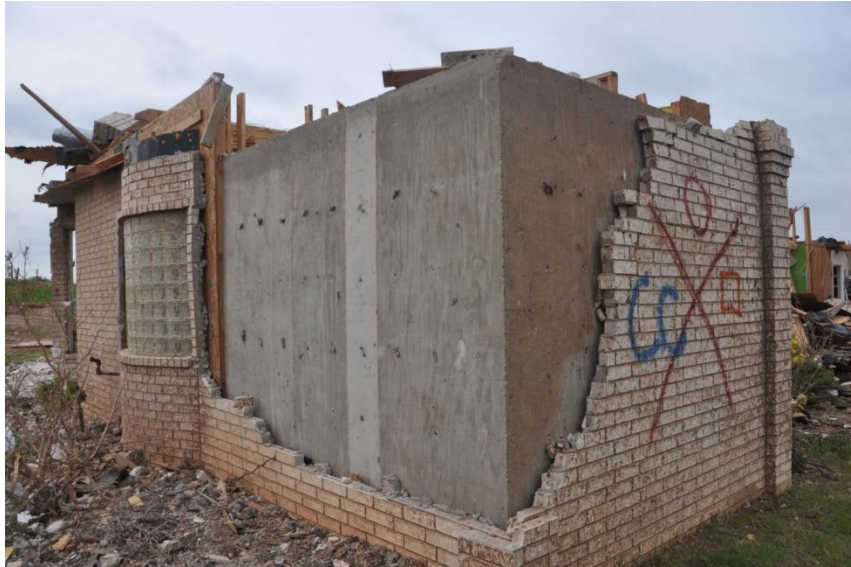
Fig. 12 An above-ground, concrete shelter that also served as a walk-in closet at an EF-2 rated location. The concrete was tested, but the door was not. Photo credit: Larry Tanner

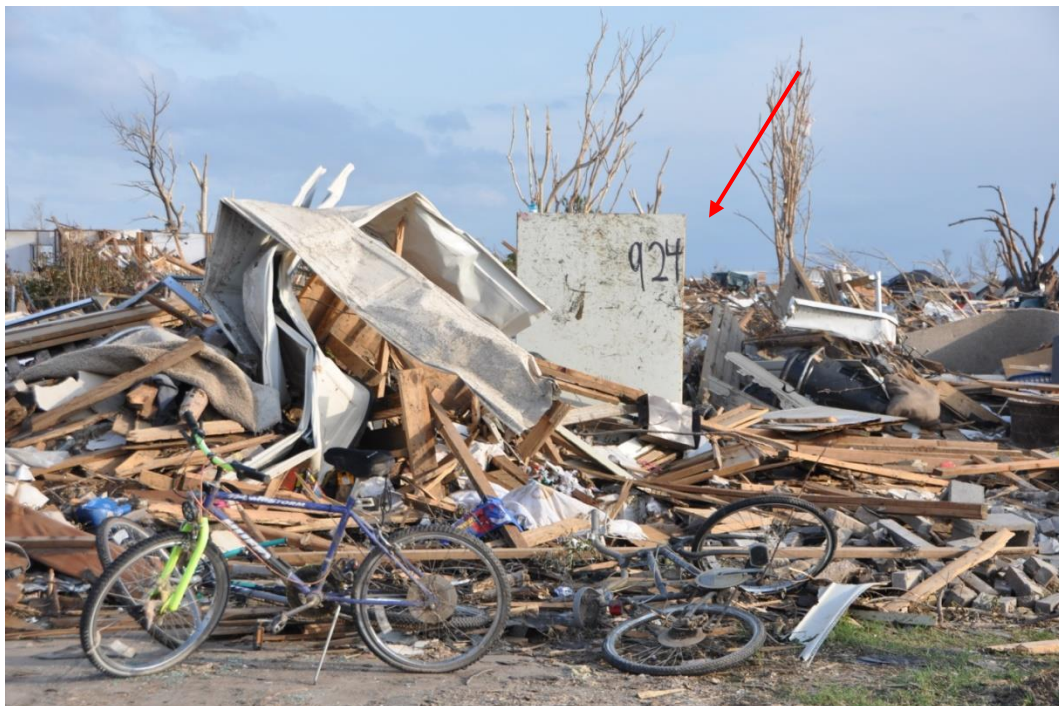
Fig. 13 shows a tested steel shelter that performed very well. Some above-ground shelter owners still questioned if they were safe because they were not below ground. Other investigation teams had documented an above-ground, insulated concrete form (ICF) waffle grid shelter in Newcastle, Oklahoma that had been hit by the tornado and suffered perforations in the walls from metal rods (FEMA 2014, Standohar-Alfano *et al.* 2014). This occurrence, among other issues with the construction and inability to ensure that the waffle grid system is sufficiently filled during the building process, has led to the deletion of the waffle grid ICF safe room design information in future versions of the FEMA guidelines.

Fig. 13 Above-ground tested steel shelter that performed very well in an EF-3 rated location. Photo credit: Larry Tanner
