# Construction failures of masonry and adobe buildings during the 2011 Van earthquakes in Turkey

# Erkut Sayın<sup>\*</sup>, Burak Yön, Yusuf Calayır and Mesut Gör

Civil Engineering Department, Fırat University, 23119, Elazığ, Turkey

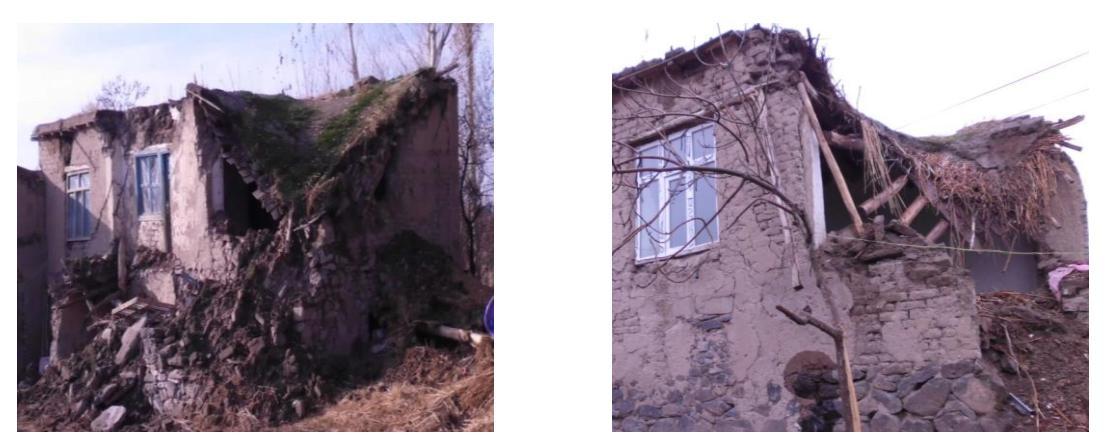
Fig. 7 Damaged buildings due to a heavy earthen roof

One- and two-story adobe buildings are common in the region because they require easy workmanship and are built using local materials. These buildings are vulnerable to ground motions. Generally, earthen roofs are constructed over wooden logs to provide thermal and water insulation. However, these roofs lose their effectiveness because of weather conditions, such as rain and snow. To repair these roofs, the residents place a new earthen cover on top of the existing roof. Thus, the weight and thickness of the roof increase over time. According to the TSC, a soil roof should not be made in the first and second seismic zones for adobe buildings. This type of roof increases the mass of the building and causes large inertial forces during earthquakes. Our field observations indicated that a thick and heavy earthen roof (approximately 40-60 cm) caused heavy damages. Fig. 7 illustrates these failures.

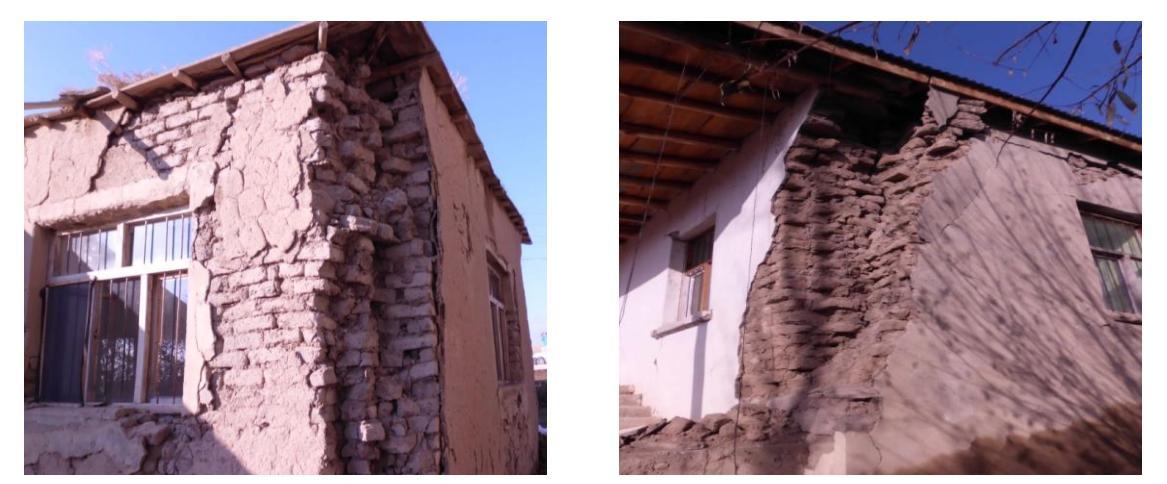
This type of mechanism generally occurs at wall to wall and wall to roof connections when subjected to out-of-plane displacements. The stress concentrations at the intersection of the walls increase during an earthquake. To decrease these effects, the TSC requires reinforced concrete vertical bond beams, which increase the seismic performance of masonry buildings. Fig. 8 shows vertical bond beams at load-bearing walls. In these beams, the compressive strength of concrete should be at least 16 Mpa and  $\emptyset$  8 stirrups, and a maximum spacing of 200 mm should be used together with longitudinal reinforcement.

Fig. 9 Corner damage of adobe buildings

These bond beams should be used for the entire height on the corners of buildings, along the intersections of the load-bearing walls, and on both sides of the openings. The cross section of these beams should be equal to the thicknesses of the walls that intersect at the corners of the buildings. Furthermore, the other cross-sectional dimension should not be less than 200 mm. Corner damages were common in the adobe and masonry buildings in the earthquake region. Poor connections between adjacent walls and the absence of bond beams caused serious damages. In addition, there were no appropriate connections at the corner of the walls in damaged buildings. This type of damage for adobe and masonry buildings is shown in Figs. 9 and 10, respectively.

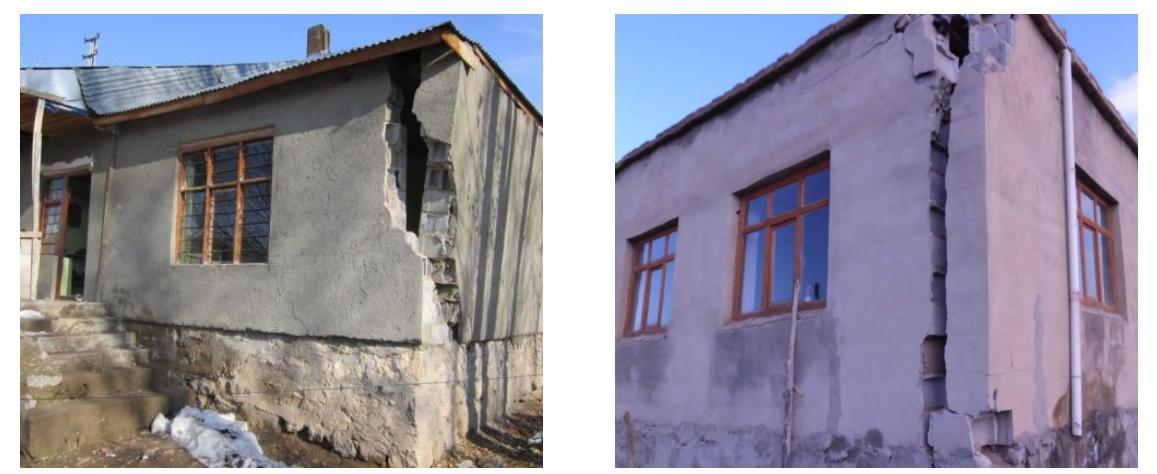
Fig. 10 Corner damage of briquette masonry buildings

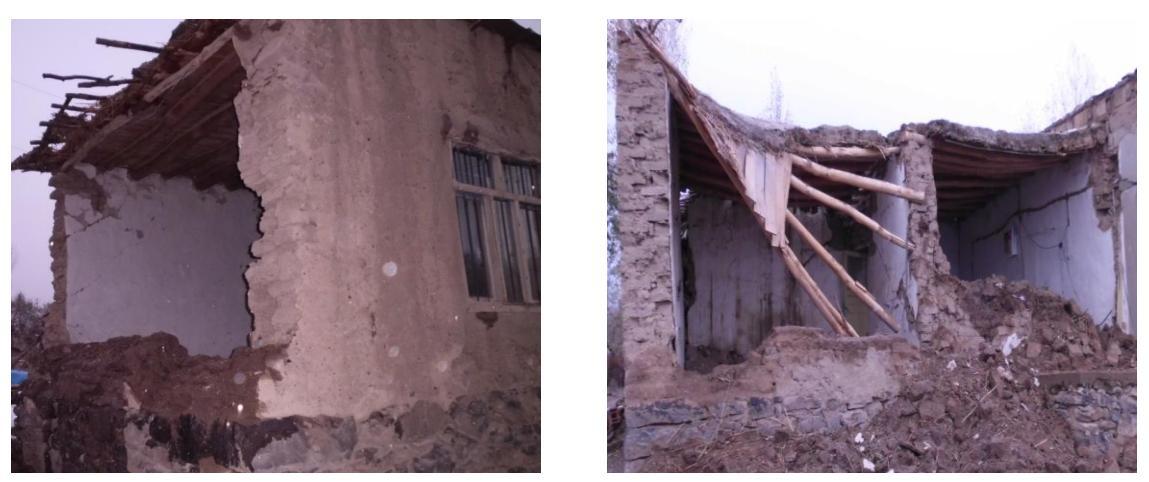
Fig. 11 Out-of-plane mechanism of adobe buildings

wall lengths cause the separation of walls and cause damage to occur via the of out-of-plane mechanism. Thus, the whole of the wall or a significant part of it falls down during the earthquake. Wooden logs that bear the weight of the floor of the building are placed on load bearing walls in only one direction. Thus, earthquake loads are transferred to perpendicular walls to wooden logs. The walls that are not supported by the wooden logs may easily overturn out-of-plane. This failure mechanism was commonly observed in the earthquake region. Figs. 11 and 12 illustrate the out-of-plane mechanism of the adobe and briquette masonry buildings, respectively.

To prevent this type of damage to adobe buildings, the TSC requires using timber bond beams. These timber beams should be two elements of square sections of  $100 \times 100$  mm and should be placed with the outer faces coinciding with the exterior and interior wall surfaces. These pieces should be tied to each other every 500 mm with nail jointed timber elements with a cross section of  $50 \times 100$  mm. However, there were no bond beams in the damaged adobe buildings. Fig. 12 illustrates that the exterior load bearing walls that are parallel to the wooden logs were overturned out-of-plane because of the lack of bond beams, poor connections, and unsupported wall lengths.

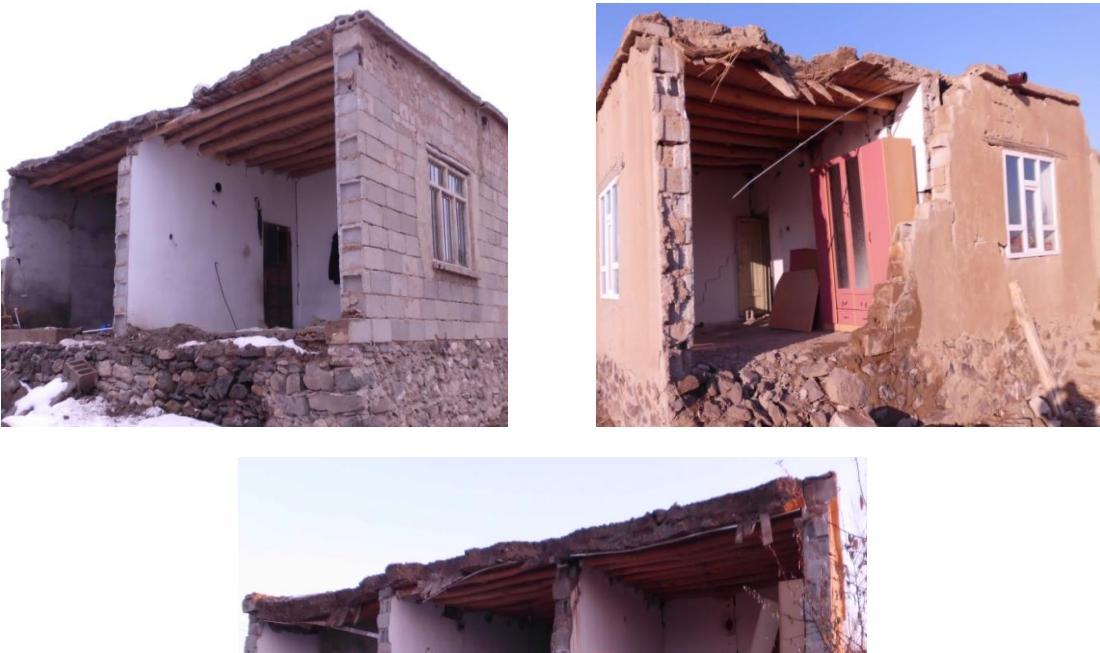
Fig. 12 Out-of-plane mechanism of briquette buildings

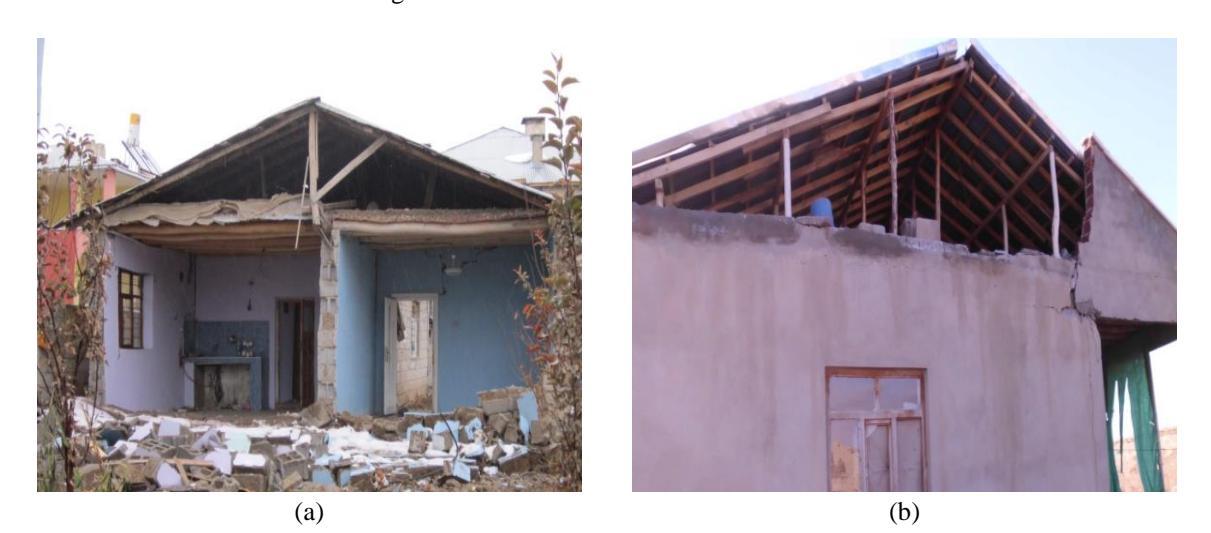
Fig. 15 Gable wall damages

The gable walls of some masonry buildings were affected by the out-of-plane mechanism. The main reasons for the damage to the gable walls include their height, poor connections (wall to wall and wall to roof), and lack of bond beams. Fig. 15(a) illustrates the out-of- plane mechanism that occurred together with the load bearing walls and gable walls, and Fig. 15(b) illustrates the gable wall damage only.

To prevent damage to the gable wall, the TSC requires that the height of the gable wall resting on the horizontal bond beam at the top storey exceed 2.0 m. Furthermore, vertical and inclined reinforced bond beams should be constructed in these walls. Fig. 16 shows the construction details of the gable wall.

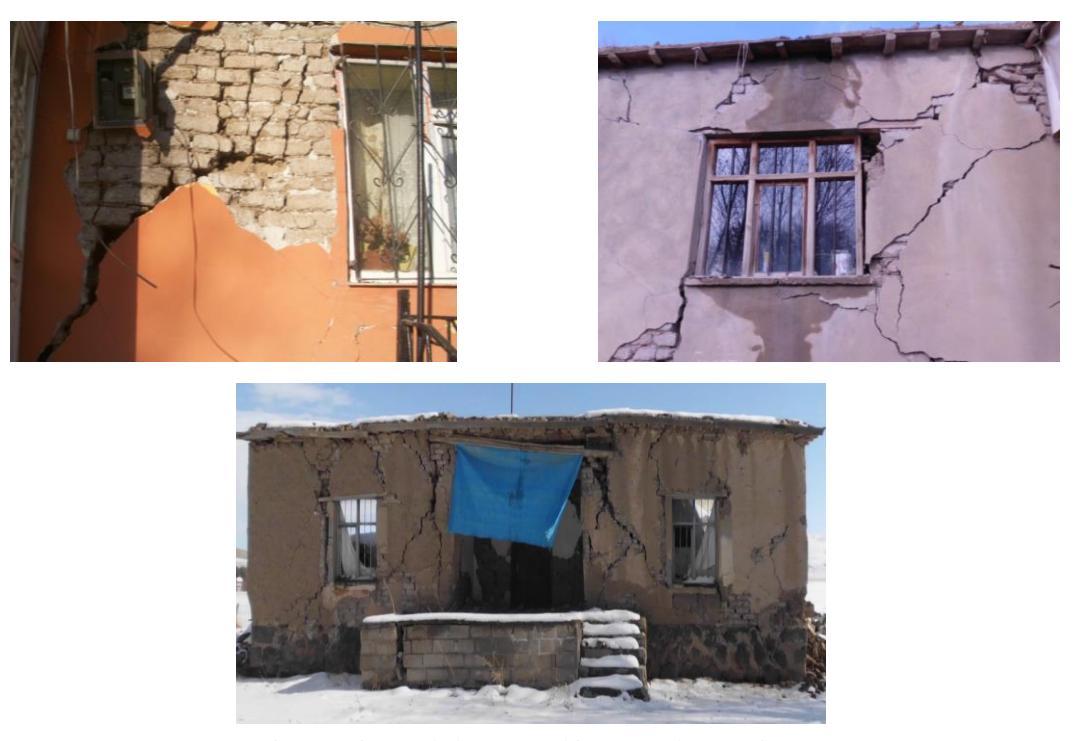
Fig. 17 Diagonal shears cracking near the openings

buildings are generally observed in the earthquake area, namely, diagonal shear failures that proceed through masonry units and mortar (Fig. 17), sliding consisting of straight failure at the horizontal bed joints, and stepped failures from the head to bed or bed to head joints (Fig. 18).

Our observations in the earthquake region indicated that most masonry buildings did not have sufficient and proper bond beams to enhance the lateral strength of the walls. Furthermore, large openings that decrease the stiffness of the walls increased the shear effects. To limit this type of failure, the TSC requires that the reinforced concrete bond beams should be used (Figs. 8 and 14). The requirements of the openings of load-bearing walls are illustrated in Fig. 19.

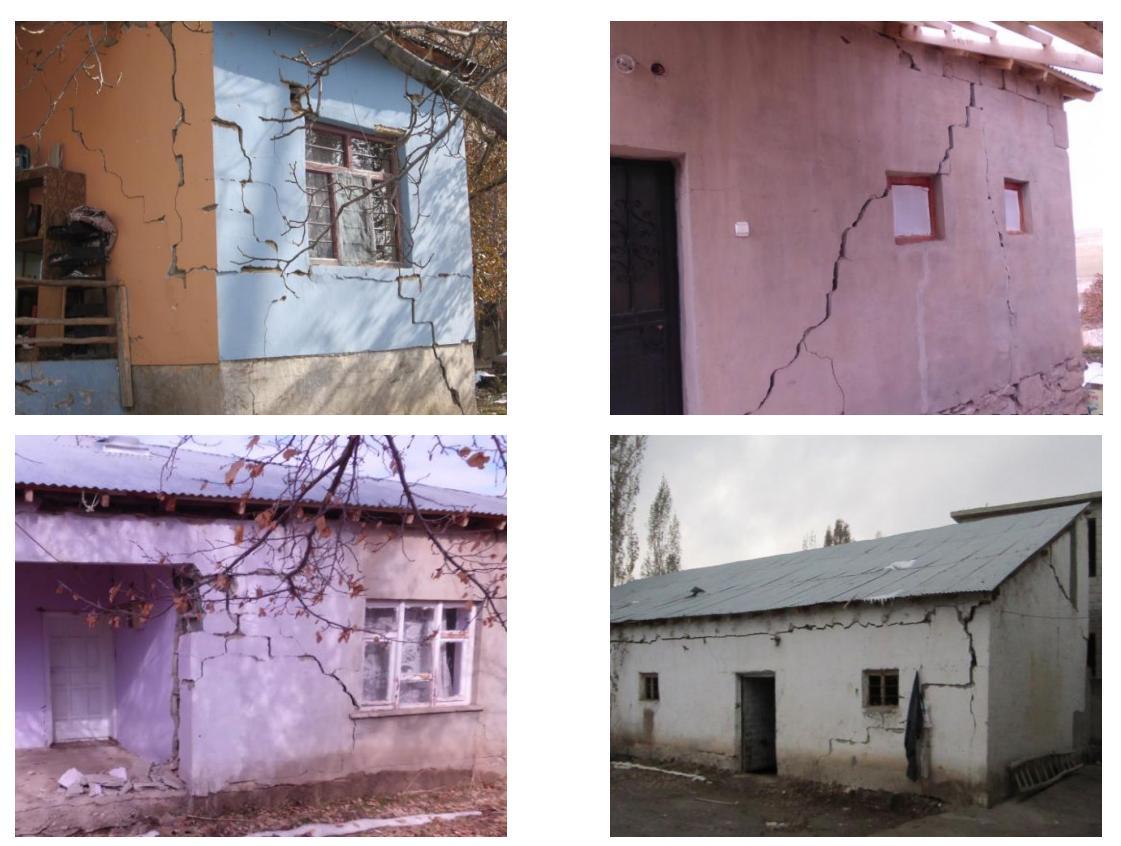
Fig. 18 Horizontal and stepped failures

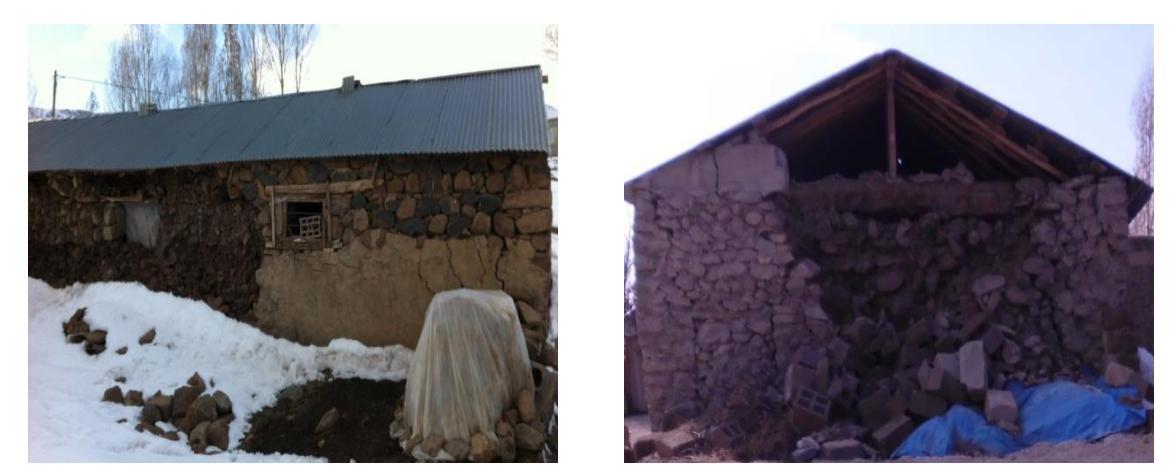
Fig. 20 Disintegration in stone masonry buildings

This type of failure commonly occurs because of earthquakes. Some reasons such as the quality of construction, poor workmanship, and the use of improper materials increase the intensity of the disintegration. Fig. 20 presents this failure in stone masonry buildings.

The main reason for the failure in the region was due to the as multi-layers of the walls, in which there was no adequate connection between the layers. Large coarse stones were used as the outer layers of the walls, while small size stones were used as the inner layer of the wall. Mud mortar was used as a binder instead of cement mortar. Therefore, inadequate connections occurred between the inner and outer layers of the walls, and the layers of these walls separated during the earthquake.
