Damaging wind storms in North Eastern Argentina: seven case studies

Keywords: wind; damage; civil structures; infrastructure.

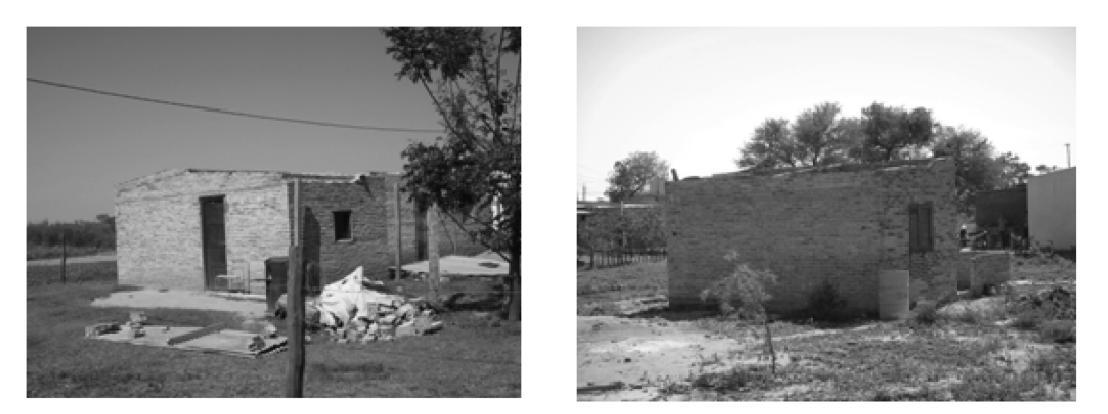
from Class1 to Class 2A structures as soon as they can afford bricks and steel sheets. Fig. 9 shows archetypical houses of this style. It has been observed that, in the vast majority of cases, the roof is lost, whereas the walls, windows and doors remain intact (Fig. 9). This is the result of poor assembly of the roof structure to the walls, which could be easily prevented by campaigns of popular education and training.

Fig. 9 These are examples of typical Class 2A structures. Both houses were unroofed during the storm described in section 3.5

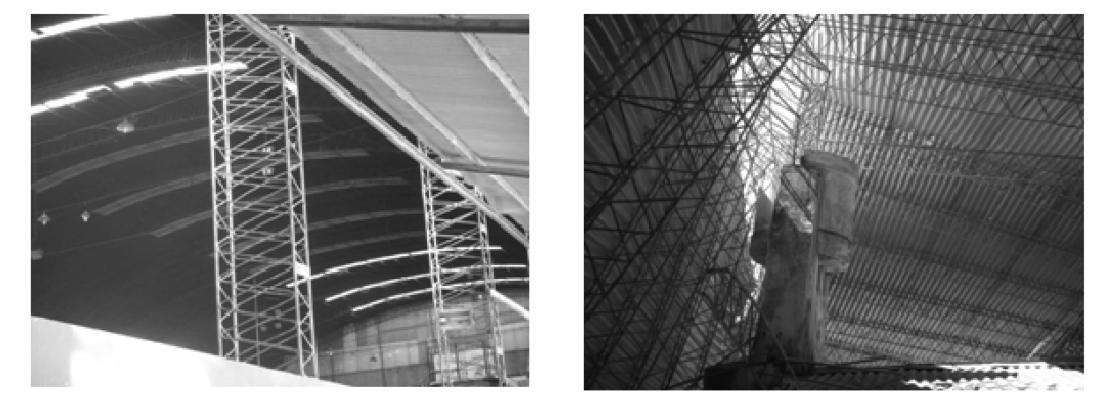
Class 2B structures are the next most commonly damaged structures. They are commonly used as shelter in schools, athletic courts, carpenter's workshops and garages. They have a particularly vulnerable structure made of steel rods that form a lattice (Fig. 10). They are cheap, easy to build and vastly used in Argentina and Paraguay. Building of 2B structures is part of the local culture and is currently out of control. Balbastro and Sonzogni (2008) reported the same issue of vulnerability in these structures in the Province of Santa Fe.

Fig. 10 Details of lattice structures made with steel rods. Left: The supporting columns of a 35-m spanning roof; right: the collapsed frames of a 20 m × 45 m vaulted canopy roof

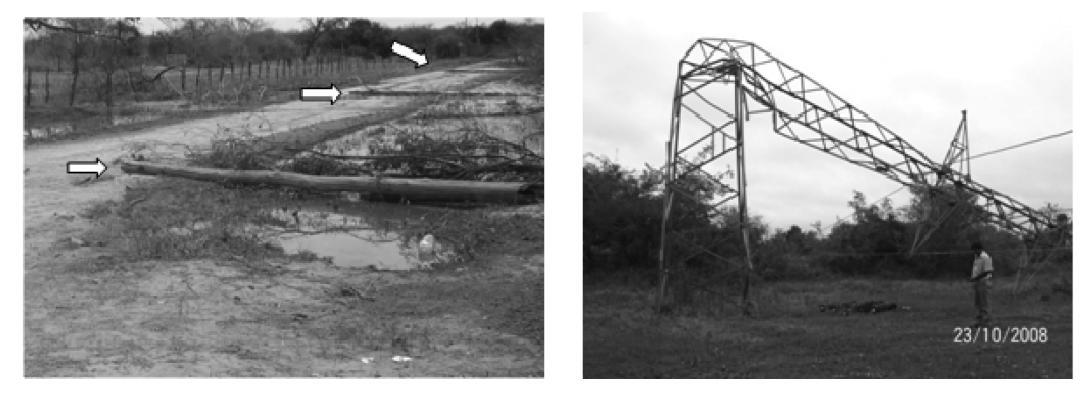
Class 3C are the only vulnerable Class 3 structures. There are records of failures of virtually every kind of line, comprising any voltage and typology of poles, but a close inspection of the records shows frequent failures of two poles: creosote-treated timber poles used in low-voltage lines and the metallic trussed towers of 132-KV lines. Creosoted poles also support telephone lines. It has been presented that low-voltage lines failed in 53% of the events registered in Chaco. Fig. 11 shows a typical collapse involving several poles. Twenty-four metallic towers of 132-KV lines, like the

Fig. 11 Vulnerable electricity line poles. Left: Creosote-treated timber poles used in low-voltage lines; right: a 132-KV line supporting tower (photograph courtesy of Ing. Miguel Malarin)

one shown in Fig. 11, failed in five of the thirty-four events recorded in the province of Chaco. All twenty-four were suspension towers. These failures are a matter of concern by the different electricity service companies of NEA. The causes of the vulnerability of these kinds of poles have not yet been systematically studied.
