Expansion behavior of low-strength steel slag mortar during high-temperature catalysis

Wen-Ten Kuo^{*} and Chun-Ya Shu^a

Abstract. This study established the standard recommended values and expansion fracture threshold values for the content of steel slag in controlled low-strength materials (CLSM) to ensure the appropriate use of steel slag aggregates and the prevention of abnormal expansion. The steel slags used in this study included basic oxygen furnace (BOF) slag and desulfurization slag (DS), which replaced 5-50% of natural river sand by weight in cement mixtures. The steel slag mortars were tested by high-temperature (100°C) curing for 96 h and autoclave expansion. The results showed that the effects of the steel slag content varied based on the free lime (f-CaO) content. No more than 30% of the natural river sand should be replaced with steel slag to avoid fracture failure. The expansion fracture threshold value was 0.10%, above which there was a risk of potential failure. Based on the scanning electron microscopy (SEM) analysis, the high-temperature catalysis resulted in the immediate extrusion of peripheral hydration products from the calcium hydroxide crystals, leading

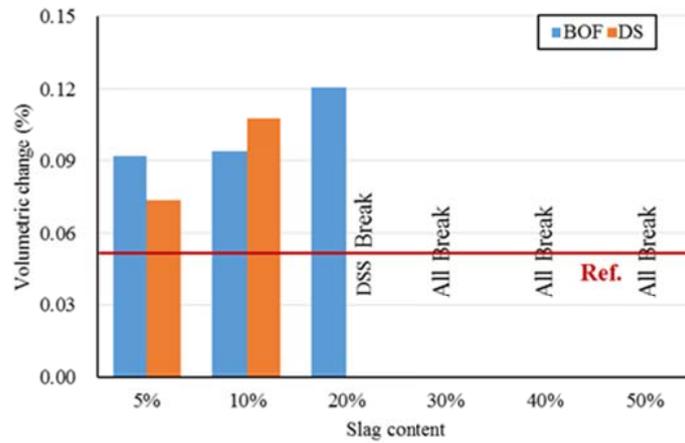
Fig. 2 shows the volume expansion capacity of low-strength mortar with different amounts of slag after the autoclave expansion. When the BOF replaced less than 10% of the natural river sand,

the expansion capacity was 0.090%, which was higher than that of the control group (0.048%). When 20% of the natural river sand was replaced by the BOF, the expansion capacity was as high as 0.120%. Cracks were observed in the mortar due to the expansion. When more than 30% of the natural river sand was replaced with BOF, fracturing and deformation were observed, and the measurement failed to continue. When DS replaced 10% of the natural river sand, the expansion capacity was 0.110%, which was much higher than the expansion capacity when the BOF was used. When more than 20% of the natural river sand was replaced with DS, fracturing occurred directly, and the expansion capacity could not be measured. Show the high free lime content tends to cause higher autoclave expansion (Krittiya *et al.* 2013). Fig. 3 shows the photo image of the sample with 20% BOF. The sample was cracked and damaged severely.

Fig. 2 The volume expansion capacity of low-strength mortar with different amounts of slag after the autoclave expansion

Figs. 5 and 8 show the volume expansion capacity results for the mortars with different amounts of steel slag after high-temperature catalysis. According to the trend curve, the expansion behavior of the DS mortar with a higher f-CaO content was more apparent than that of the BOF mortar with a lower f-CaO content after the high-temperature catalysis, indicating that the hidden f-CaO obviously expanded after the hydration was accelerated by the high temperature. This result is consistent with Kuo (Kuo and Shu 2014), the application of high-temperature catalytic technology can accelerate free lime reaction. When more than 20% of the natural river sand was replaced by DS, giving a mortar with a high f-CaO content, the samples fractured after 48 h of

catalysis. For the BOF mortars with lower f-CaO contents, fracturing did not occur until 30% of the natural river sand was replaced with BOF. The expansion capacity of the 20% BOF mortar was almost less than 0.9%. The DS mortar exhibited obvious swelling as the amount of DS increased. Based on the autoclave expansion results, when the expansion capacity exceeded 0.10%, fracturing occurred, the volume stability and durability were affected. The same trend was observed for the damage area ratios shown in Figs. 6 and 9. The damage area ratios of the stable mortars with less than 10% steel slag were less than 0.6%. However, when the damage area ratio was significantly higher than 0.8%, fracturing might have occurred.

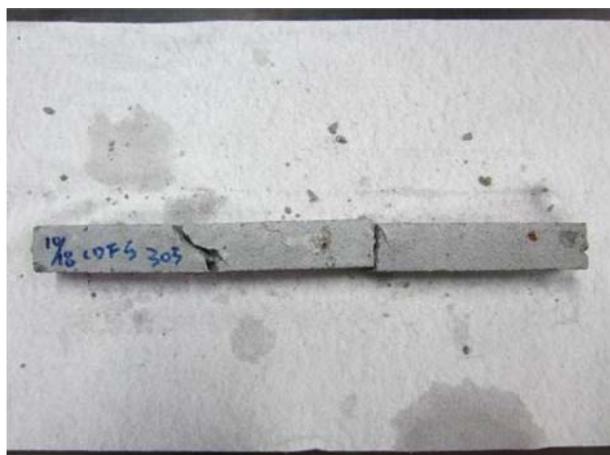
Fig. 4 The photo image of the sample with 30% DS (after the autoclave expansion)

White powdered crystals were observed after peeling off the cracks. Fig. 4 shows the photo image of the sample with 30% DS. Severe point-like bursts were observed on the surface, and the sample was severely fractured. White powdered crystals were also detected on the failure plane of this sample. The XRD analysis showed that the principal components of the white crystals were $\text{Ca}(\text{OH})_2$ and $\text{Mg}(\text{OH})_2$. If the free calcium or magnesium oxides (CaO or MgO , respectively) came into contact with water, their hydrated products formed tufa. Tufa is a spongy, porous mineral precipitate that is fragile and crumbles easily. If a slag contains a significant fraction of either free lime (CaO) or magnesia (MgO), it can expand if moistened, which could cause any paving, foundations or walls located above the slag to buckle or heave [Beaver Valley Slag]. Based on these results, when the expansion value was higher than 0.10%, the potential for damage was high, and point-like bursts or direct fractures could form. The use of excessive steel slag would cause destructive expansion.

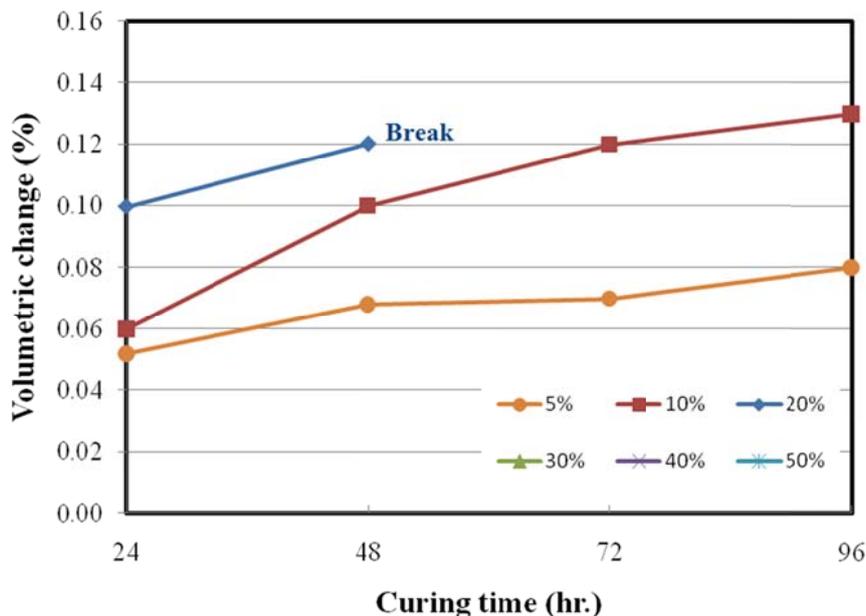
Fig. 5 shows the volume expansion capacity of the mortar with different amounts of DS after high-temperature catalysis. After the 10% DS sample underwent 48 h of catalysis, the expansion capacity was 0.10%, and a burst trace began to occur on the sample surface. The burst and expansion capacity increased with the catalysis time. The expansion capacity of the 10% DS sample was 0.13% after 96 h, and the 20% DS sample fractured after 48 h of catalysis. Fig. 6 shows the damage area ratios of the low-strength mortar with different amounts of DS after high-temperature catalysis. When DS replaced 10% of the natural river sand, the surface fracture increased continuously with the catalysis time. The damage area ratio was as high as 1.10% after 96 h. The samples with a DS content higher than 30% fractured after 24 h of catalysis, and the failure surface area could not be quantified. Fig. 7 shows the failure images of the mortars with different amounts of DS over time during the high-temperature catalysis. Figs. 7(a) and 7(b) show that the failure mostly occurred in corners for the 10% DS sample. Fig. 7(c) shows that when 20% of the natural river sand was replaced with DS, the expansion capacity increased after 24 h of catalysis, and a point-like burst was observed. Fig. 7(d) shows that fracturing occurred at 48 h, and no further measurements were performed. Fig. 8 shows the results for the mortars with different

Fig. 5 The volume expansion capacity of the mortar with different amounts of DS after high-temperature catalysis (30%~50% of the samples, after 24 hours catalytic samples have been break, cannot be measured)

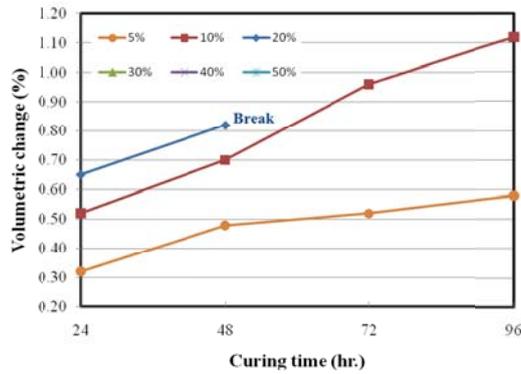
Fig. 6 The damage area ratios of the low-strength mortar with different amounts of DS after high-temperature catalysis (30% ~50% of the samples, after 24 hours catalytic samples have been break, cannot be measured)

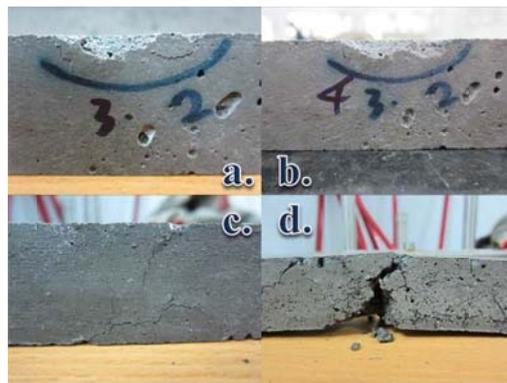
Fig. 7 The failure images of the mortars with different amounts of DS over time during the high-temperature catalysis (a) 10%, 72 hr, (b)10%, 96 hr, (c) 20%, 24 hr, (d)20%, 48 hr

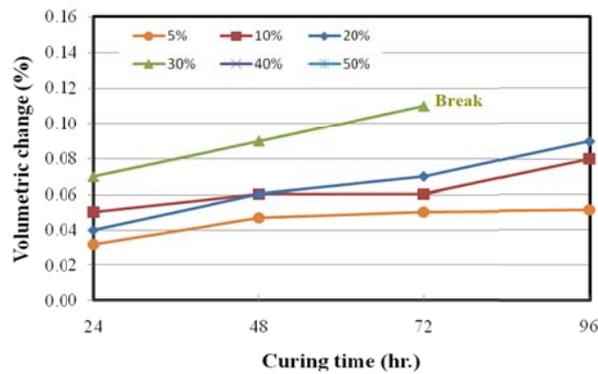
amounts of BOF. The expansion capacity was 0.05% after 96 h of catalysis for the 5% BOF sample, and no burst or failure was observed at the specimen surface. When BOF replaced more than 10% of the natural river sand, the expansion capacity increased with the catalysis time. For the 30% BOF sample, fracturing occurred after 72 h of catalysis, and no further measurements were performed. The results showed that the replacement aggregate expanded when the expansion capacity was greater than 0.05%, and the risk of potential failure was high for expansion capacities greater than 0.10%. Fig. 9 shows the damage area ratios of the low-strength mortars with different amounts of BOF after high-temperature catalysis. The damage area ratio was lower than 0.60% after 96 h of catalysis for the 10% BOF sample. When 20% of the natural river sand was replaced by BOF, the failure surface area was almost 0.70% after 96 h. When BOF replaced 30% of the natural river sand, the surface fractured in several places after 48 h of catalysis, and the damage area ratio was higher than 0.6%. Therefore, when the damage area ratio was 0.70%, the BOF mortar might have failed. Fig. 10 shows the failure images of the mortars with different amounts of BOF over time during high-temperature catalysis. Fig. 10(a) shows the image of the 20% BOF sample after 48 h of catalysis. Point-like prominent cracks were observed near the corners. Fig. 10(b) shows the image of the 30% BOF sample after 48 h of catalysis. White powdered crystals were observed in the corners of the screw side, and severe failure was detected. Fig. 10(c) shows the image of the 30% BOF sample after 72 h of catalysis. Severe fracturing occurred, and white powdered crystals were found in the cracks. Fig. 10(d) shows the image of the 10% BOF sample after 96 h of catalysis. Extensive spalling occurred, and white powdered crystals were observed in the failure. In contrast to the samples with higher BOF contents, this phenomenon occurred locally.

Fig. 8 The results for the mortars with different amounts of BOF (40%~50% of the samples, after 24 hours catalytic is break)

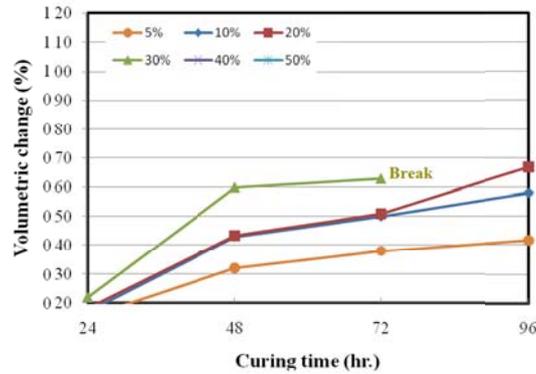
Fig. 9 The damage area ratios of the low-strength mortars with different amounts of BOF slag after high-temperature catalysis (40%~50% of the samples, after 24 hours catalytic is break)

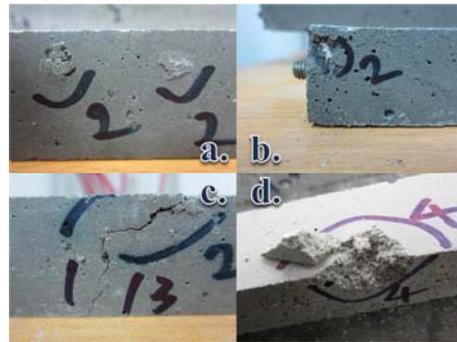
Fig. 10 The failure images of the mortars with different amounts of BOF slag over time during high-temperature catalysis (a) 20%, 48 hr, (b) 30%, 48 hr, (c) 30%, 72 hr, (d) 10%, 96 hr

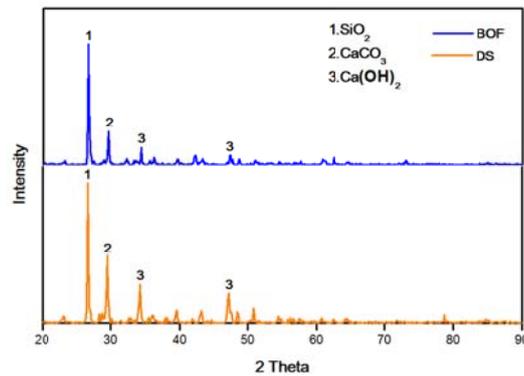
Fig. 11 XRD of the BOF slag and DS slag

The BOF and DS were analyzed by X-ray diffraction (XRD), and the results are shown in Fig.

11. The principal component of the two steel slags was found to be a Ca-based constituent. The relatively large peaks were due to $\text{Ca}(\text{OH})_2$, CaCO_3 and SiO_2 . The main constituent of the natural river sand was SiO_2 , and a small amount of KAlSi_3O_8 was also detected (Wang 2008). The Ca content, however, was insignificant. In contrast, the steel slag contained more $\text{Ca}(\text{OH})_2$ but less SiO_2 . The natural river sand exhibited high chemical stability because of its high SiO_2 content (Wang 2008). However, the steel slag had lower chemical stability because of its higher $\text{Ca}(\text{OH})_2$ content, which led to the expansion failure. In addition, the peak strength of DS was higher than that of BOF, meaning that the DS steel slag aggregate was more unstable than the BOF aggregate. Based on the real expansion values and damage area ratios, the DS samples underwent greater expansion and exhibited more failure than the BOF samples.

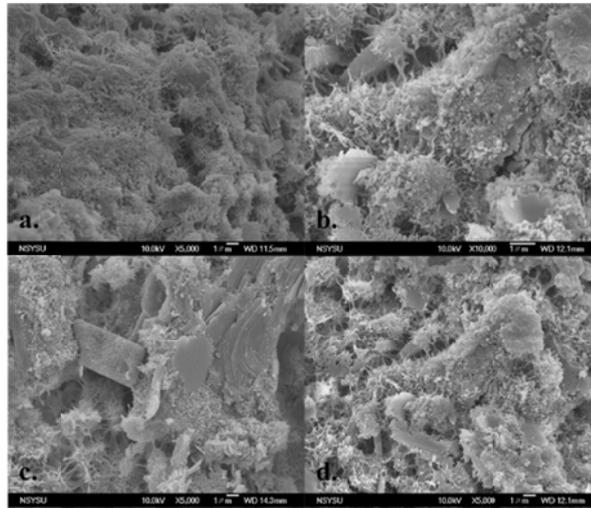
Fig. 12 The SEM microstructure of the DS low-strength steel slag mortar after high-temperature catalysis

Fig. 12 shows the SEM microstructure of the DS low-strength steel slag mortar after high-temperature catalysis. Fig. 12(a) shows the result for the 20% DS sample. After 24 h of catalysis, a C-S-H colloid and laminar calcium hydroxide (CH) were observed, along with a small amount of lime (CaO), and the structure became more porous. Fig. 12(b) shows that after 72 h of catalysis, the amount of the C-S-H colloid increased as the amount of laminar calcium hydroxide (CH) decreased. Fig. 12(c) shows the image of the 30% DS sample after 24 h of high-temperature catalysis. In this case, laminar calcium hydroxide (CH) occupied most blocks, and the C-S-H colloid only occupied a small area. Fig. 12(d) shows that after 72 h of catalysis, the amount of the C-S-H colloid increased while the amount of laminar calcium hydroxide (CH) decreased. The 30% DS sample had more calcium hydroxide (CH) than the 20% DS sample. Fig. 13 shows the SEM microstructure of the low-strength BOF steel slag mortar after high-temperature catalysis. Fig. 13(a) shows the image of the 20% BOF specimen after 24 h of catalysis. A large amount of calcium hydroxide (CH) was observed, but no C-S-H colloid was apparent in the image. Fig. 13(b) shows that after 72 h of catalysis, the calcium hydroxide (CH) content increased, and the structure was compact. Fig. 13(c) shows the image of the 30% BOF specimen after 24 h of catalysis. The laminar calcium hydroxide (CH) and C-S-H colloid were found to intercross each other. Fig. 13(d) shows that after 72 h of catalysis, the calcium hydroxide (CH) content increased, but no C-S-H colloid was observed. Based on these results, similar hydrates of mostly laminar calcium hydroxide (CH) and a small amount of C-S-H colloid were produced after 24 h of catalysis regardless of the BOF content. After 72 h of catalysis, the hydration products varied as the BOF content increased. As the BOF content increased from 10% to 30%, the calcium hydroxide (CH) content decreased, and the amount of the C-S-H colloid increased in most cases. However, for BOF contents of 40% and 50%, the calcium hydroxide(CH) content increased, and the amount of the C-S-H colloid decreased to zero. In the DS sample with a higher f-CaO content, the micropores between the crystals were not filled with the C-S-H colloid or ettringite. The f-CaO hydration produced flaky calcium hydroxide crystals distributed throughout the bulk. As f-CaO was slowly hydrated, the calcium hydroxide crystals grew continuously, extruding peripheral hydration products (Mu *et al.* 2001). Therefore, the differential expansion pressure resulted in microcracks and initiated differential expansion burst. Under rapid catalysis at high temperatures, the calcium hydroxide crystals extruded peripheral hydration products instantly, making it difficult for the other hydration products to diffuse into the gaps between the flaky calcium hydroxide particles. The gaps between the crystals could not be filled, resulting in a local stress concentration and, eventually, deformation and cracking.

- Based on the SEM analysis, the calcium hydroxide crystals extruded peripheral hydration products instantly during the rapid high-temperature catalysis, resulting in a local stress concentration and, eventually, deformation and cracking.

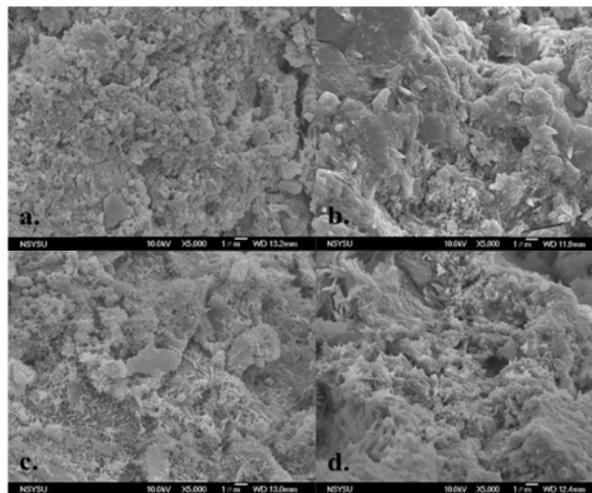
Fig. 13 The SEM microstructure of the low-strength BOF steel slag mortar after high-temperature catalysis
