A study on seismic behaviour of masonry mosques after restoration

Keywords: historical masonry structures; Kaya Çelebi mosque; restoration; seismic earthquake response; seismic spectral analysis; Turkish Earthquake Code

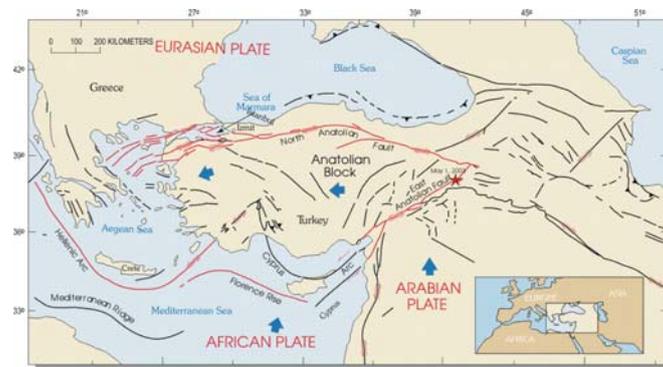
Fig. 1 Tectonic map of Turkey (USGS 2015)

Turkey, with intensive earthquake history, is located on the active seismic zone between the Arabian, Eurasian and African plates (Fig. 1). Many destructive earthquakes occurred during last two decades. Thousands of people died and millions of structures such as buildings, bridges, towers, mosques etc. were collapsed or heavily damaged.

As seen in Fig. 1, eastern part of Turkey has active seismic faults such as north and east Anatolians and many movements have been measured at this region by Kandilli Observatory and Earthquake Research Institute (KOERI 2011). Table 1 summarize the big earthquakes occurred in this region and around between 1903 and 2000.

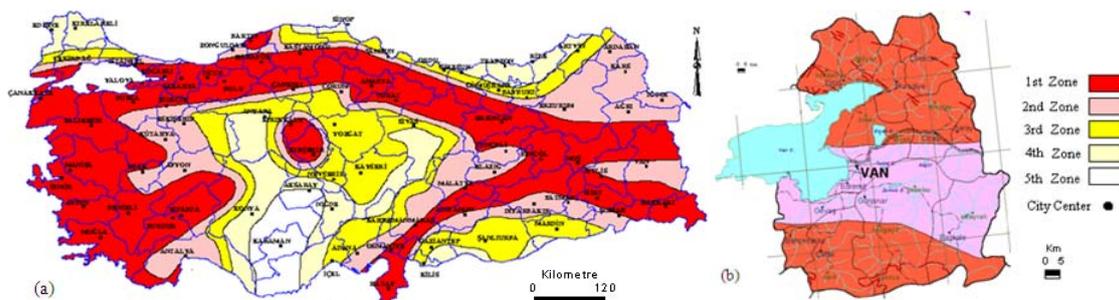
Fig. 2 Seismic zoning map of Turkey (a) and Van (b) (AFAD 2015)

According to the Seismic Zone Map, which is published by the Ministry of Public Works and Settlement of Turkey in 1996, the whole country is divided into five (5) seismic zones considering the maximum earthquake acceleration (Fig. 2(a)). It can be seen from this figure that big part of the Van city located at the first degree and the other regions located at the second degree earthquake zone (Fig. 2(b)) (AFAD 2015). The regional active fault map of Van is shown in Fig. 3.

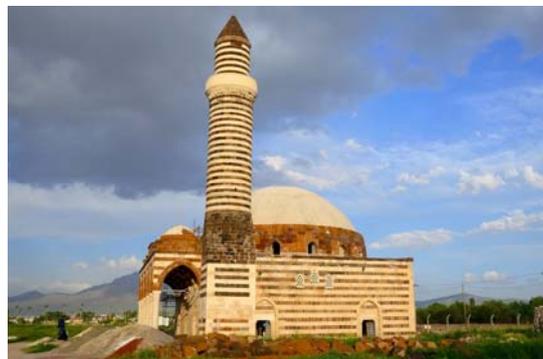
Fig. 4 Kaya Çelebi Mosque (URL-1)

Kaya Çelebi Mosque was repaired in 1993 for opening the devotion. After, the restorations were carried out to strengthen the structural system between 2007 and 2011. A some view of the restored mosque is shown in Fig. 4.

The mosque, which is settled on 16.20 m×16.20 m square area, has one dome with 7.50 m radius and one minaret with 27.50 m height. The prayer place is surrounded with 1.8 m thickness walls and dome seats on eight arches. The minaret located on the north western region. Different material characterization can be found in the mosque. The dome consists of cut stone and brick, the side walls consist of cut and artless stone, arches and minaret consist of cut stone, respectively.

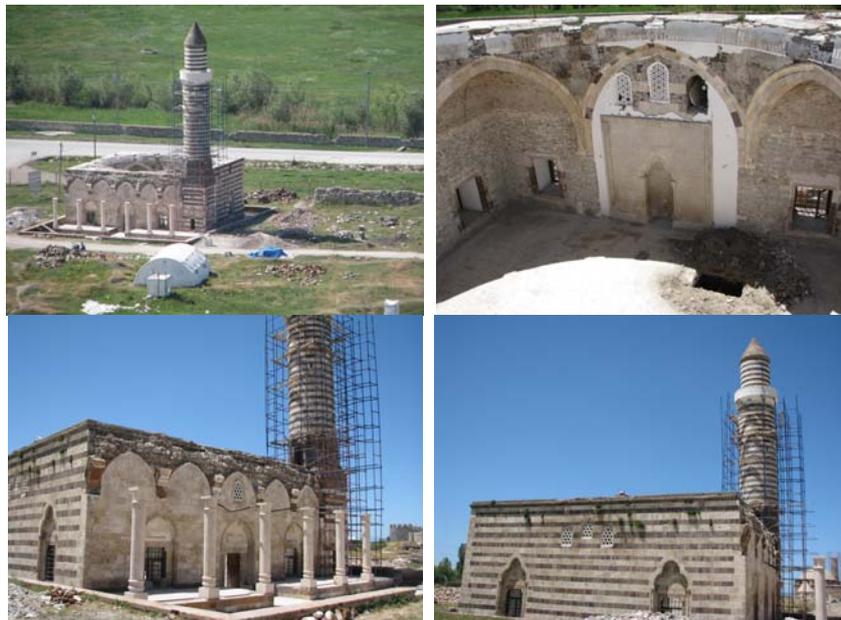
Fig. 5 Some views of the mosque after two destructive earthquakes

Kaya Çelebi Mosque was heavily damaged at 23 October and 9 November 2011 Van earthquakes. The cone part of the minaret and the dome of the mosque collapsed. Some views of the mosque after two destructive earthquakes are shown Fig. 5.

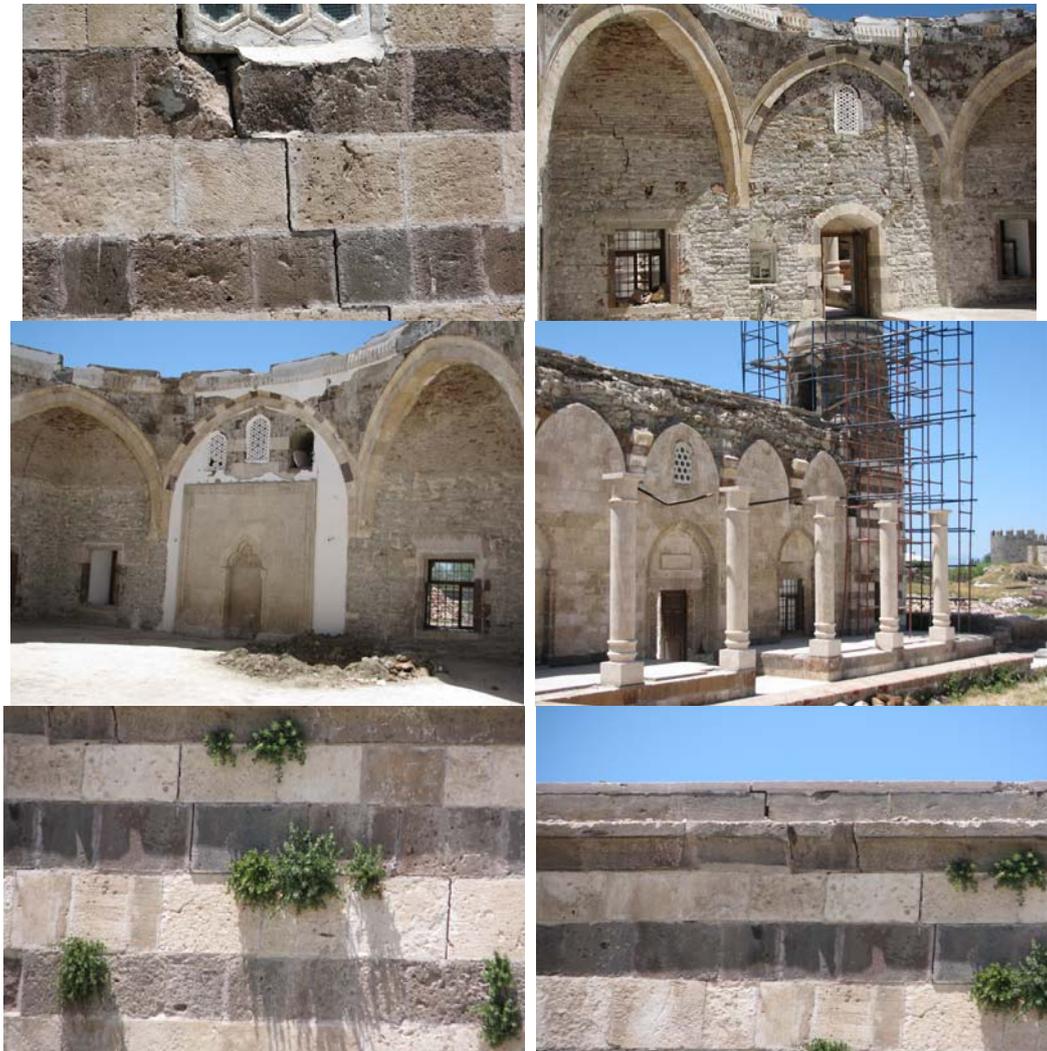
Fig. 6 Some views of the deteriorations

After the 23 October and 9 November 2011 Van earthquakes, it is observed some deterioration which affects the structural system of the mosque severely such as (see Fig. 6);

- Cracks
- Material deformation and deterioration
- Joints debonding
- Rupture, dislocation, decomposition of stones
- Environmental condition effect such as humidity, age, temperature, vegetation

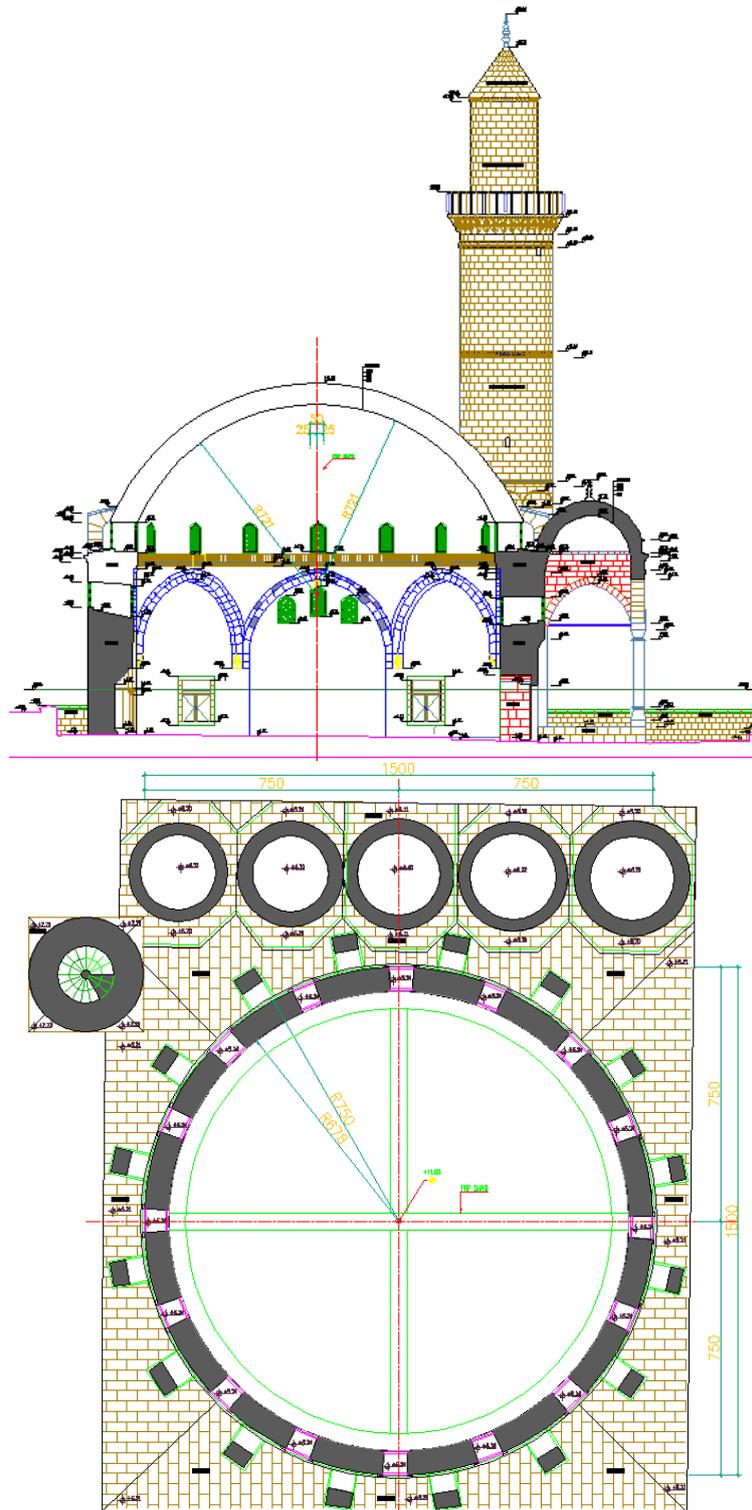
Fig. 7 Some views of the restoration project

After two destructive earthquakes, the mosque was closed to worship. The restoration process has still continued, and the mosque has been planned to open in five months. Some views of the restoration project can be shown in Fig. 7. Different parts of the structure are described by introducing plan and elevation drawings. Also, characteristics of the different materials adopted in the different parts of the mosque can be seen.

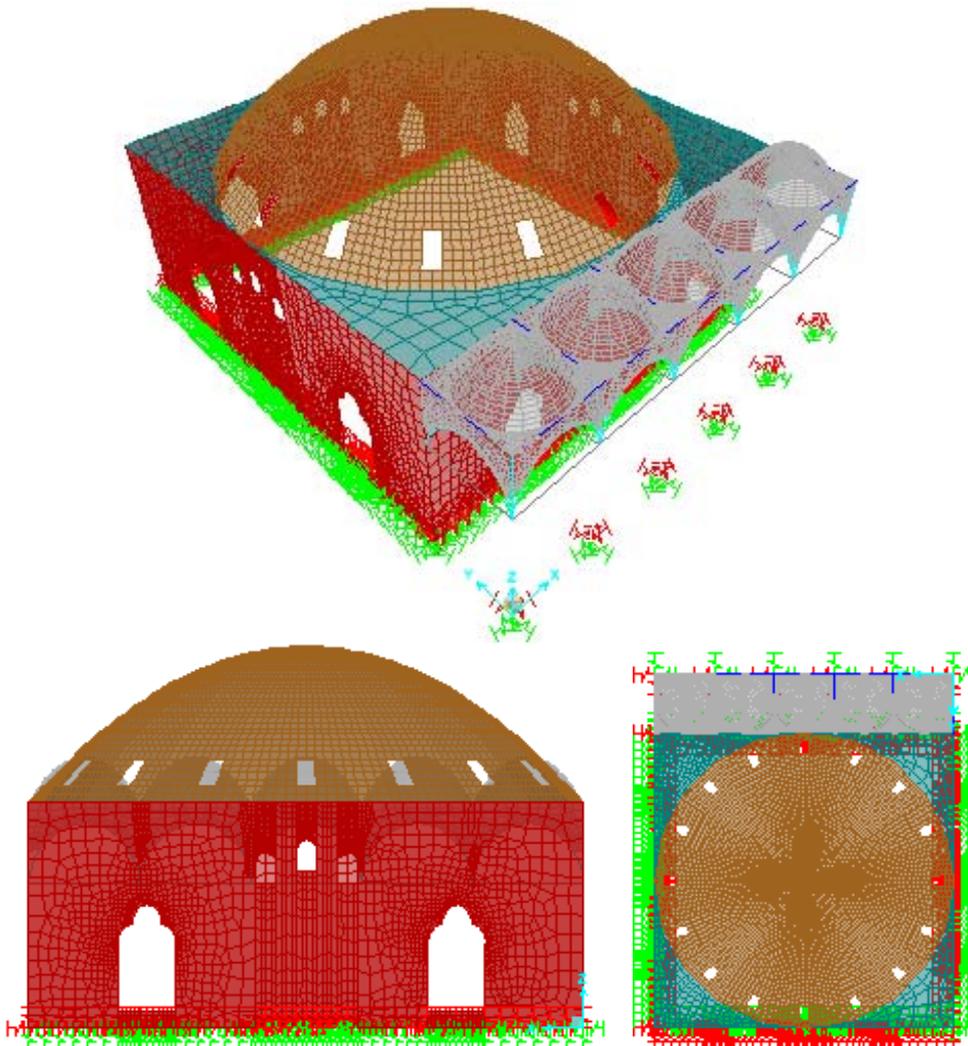
Fig. 8 Finite element model of Kaya Çelebi Mosque

Finite element model of Kaya Çelebi Mosque are constituted using restoration drawings in SAP2000 software (SAP2000 2015). General information, structural dimensions and material properties are taken from restoration project, calculation and art history reports. The finite element model of the mosque consist of two nodes bar, four nodes area and twelve nodes 3D solid elements. Each node has three degrees of freedom: translations in the nodal x , y , and z directions. The model has 29567 nodes, 270 bar elements, 27123 area elements and 108585 3D solid elements (Fig. 8).

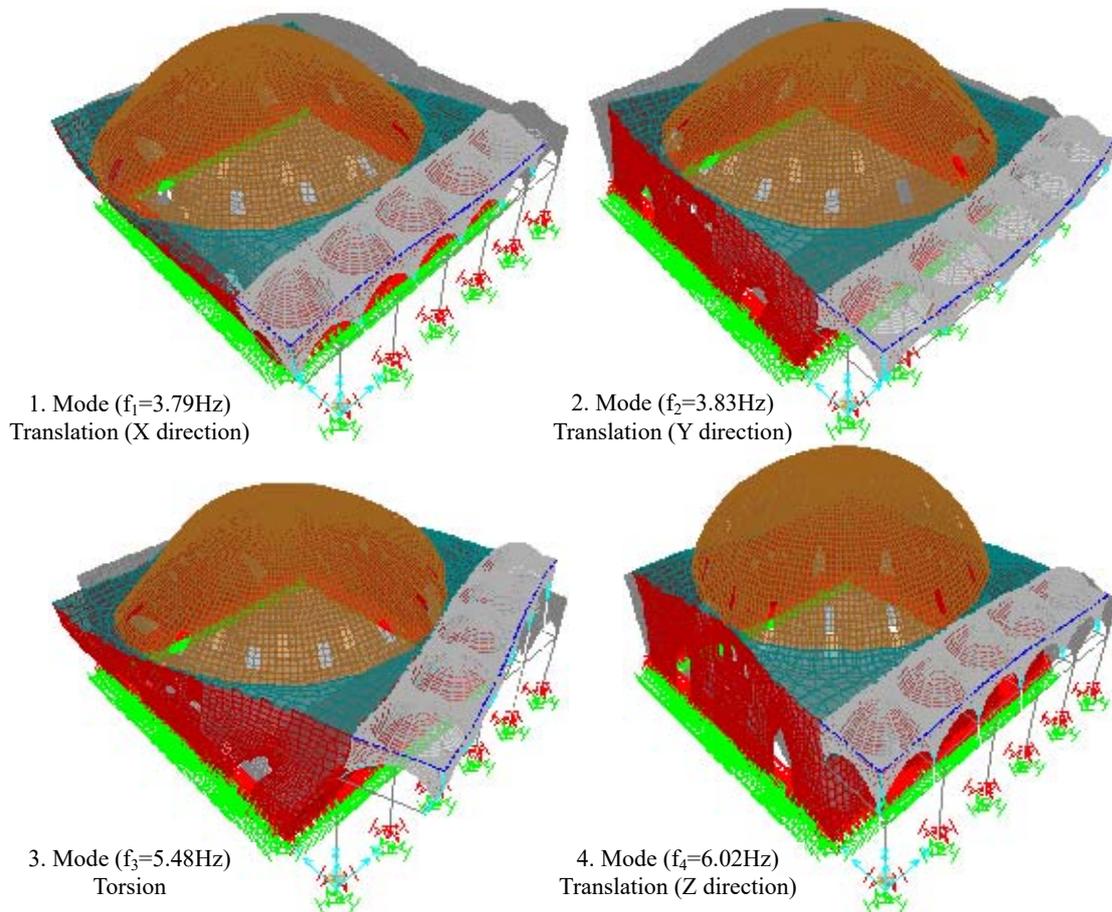
Fig. 9 The first four mode shape and related the frequencies

The dynamic characteristics such as natural frequencies and mode shapes are obtained from modal analyses of Kaya Çelebi Mosque. The first four natural frequencies are obtained between 3.79 Hz and 6.02 Hz. The mode shapes are given in Fig. 9. As seen from the figure that the first and second modes are translational modes in x and y directions, respectively. The third mode is torsional mode with 5.48 Hz. The fourth mode is obtained similar to the first and second modes with 6.02 Hz.

- The dynamic characteristics such as natural frequencies and mode shapes are obtained from modal analyses. The first four natural frequencies are obtained between 3.79 Hz and 6.02 Hz. The first and second modes are translational modes in x and y directions, respectively. The third mode is torsional with 5.48 Hz. The fourth mode shapes is obtained as similar to first and second mode shapes with 6.02 Hz.

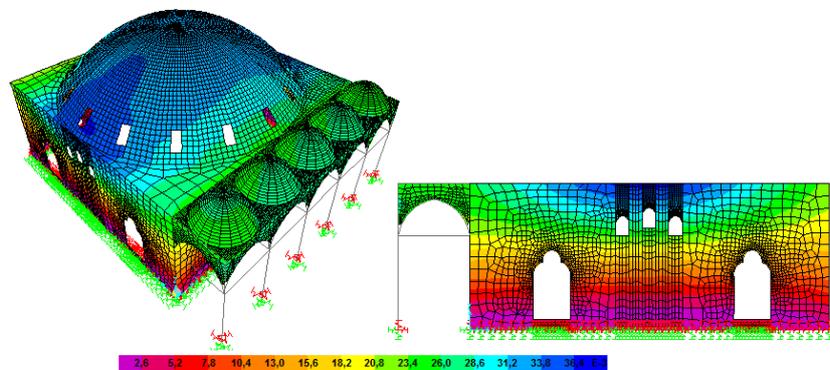
Fig. 10 Maximum displacements contour diagram

The maximum displacements contour diagram of the mosque is shown in Fig. 10. It is seen that the displacements have an increasing trend from the bottom to upper part of side walls, and towards to central point of the dome. The maximum displacements are obtained as 36.4 mm at the central point of the dome.

- The displacements have an increasing trend from the bottom to upper part of side walls, and towards to central point of the dome. The maximum displacements are obtained as 36.4 mm at the central point of the dome. The maximum relative displacement is calculated approximately 0.003. This value remains within acceptable limits.

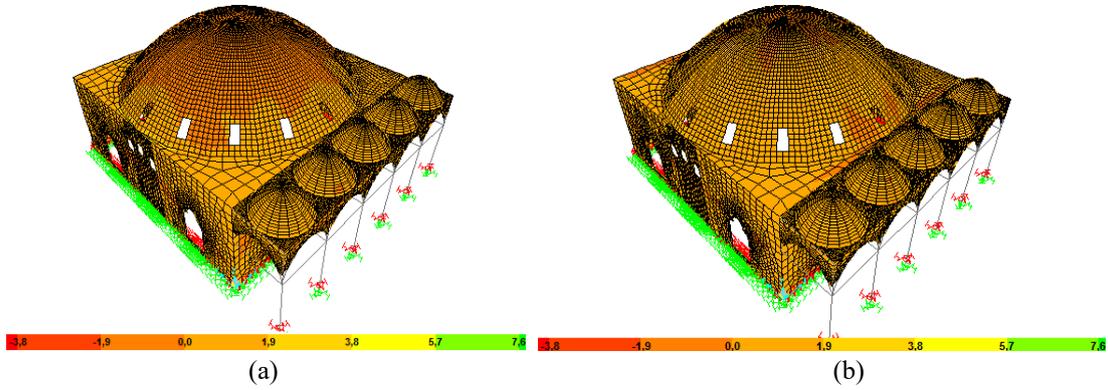
Fig. 11 Maximum tensile stresses contour diagram for outer (a) and inner (b) surfaces

The maximum tensile stresses contour diagram of the mosque is shown in Figs. 11(a)-(b) for outer and inner surfaces, respectively. It is seen from the Fig. 11 that maximum tensile stresses for outer surface occurred at side part of the dome and near the window spaces as 0.75 MPa. For inner surface, maximum tensile stresses are 0.85 MPa.

- The maximum tensile stresses for outer surface occurred at side part of the dome and near the window spaces as 0.75 MPa. For inner surface, maximum tensile stresses are obtained as 0.85 MPa.

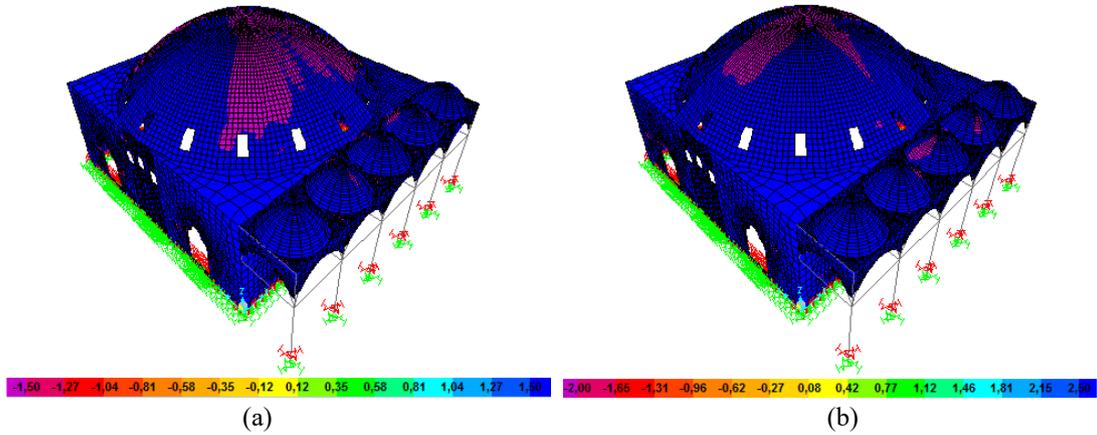
Fig. 12 Maximum compression stresses contour diagram for outer (a) and inner (b) surfaces

The maximum compressive stresses contour diagram of the mosque is shown in Figs. 12 (a)-(b) for outer and inner surfaces, respectively. It is seen from the Fig. 12 that maximum compressive

stresses for outer surface occurred at the dome and side wall intersection points as 1.65 MPa. Also, some stress intensity regions are obtained at the window spaces. For inner surface, maximum compression stresses are 1.45 MPa.

- The maximum compressive stresses for outer surface are occurred at the dome and side wall intersection points as 1.65 MPa. Also, some stress intensity regions are obtained at the window spaces. For inner surface, maximum compressive stresses are obtained as 1.45 MPa.

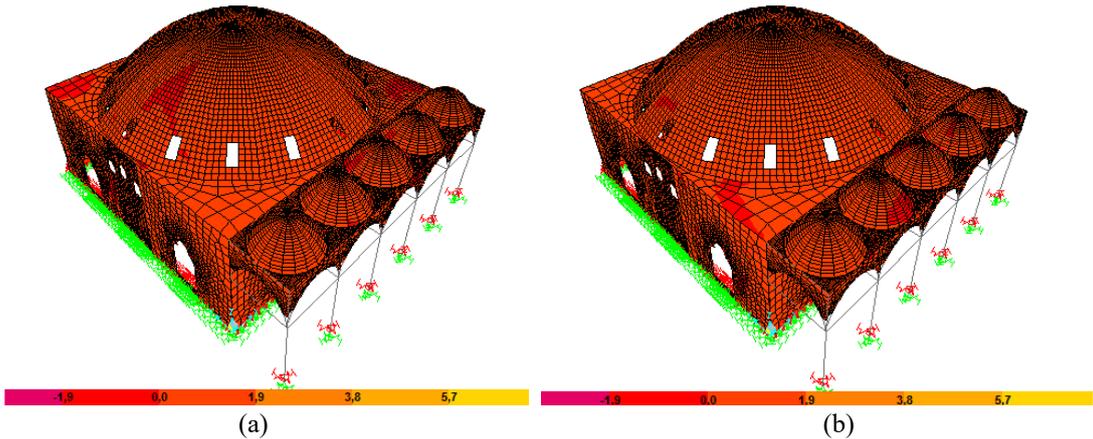
Fig. 13 Maximum shear stresses contour diagram for outer (a) and inner (b) surfaces

The maximum shear stresses contour diagram of the mosque is shown in Figs. 13 (a)-(b) for outer and inner surfaces, respectively. It can be seen from the Fig. 13 that maximum shear stresses

are obtained as 0.50 MPa and 0.40 MPa for outer and inner surfaces, respectively.

- The maximum shear stresses are obtained as 0.50MPa and 0.40MPa for outer and inner surfaces, respectively.
