Observational failure analysis of precast buildings after the 2012 Emilia earthquakes

Fabio Minghini^{*1}, Elena Ongaretto^{2a}, Veronica Ligabue^{2b}, Marco Savoia^{2c}
and Nerio Tullini^{1d}

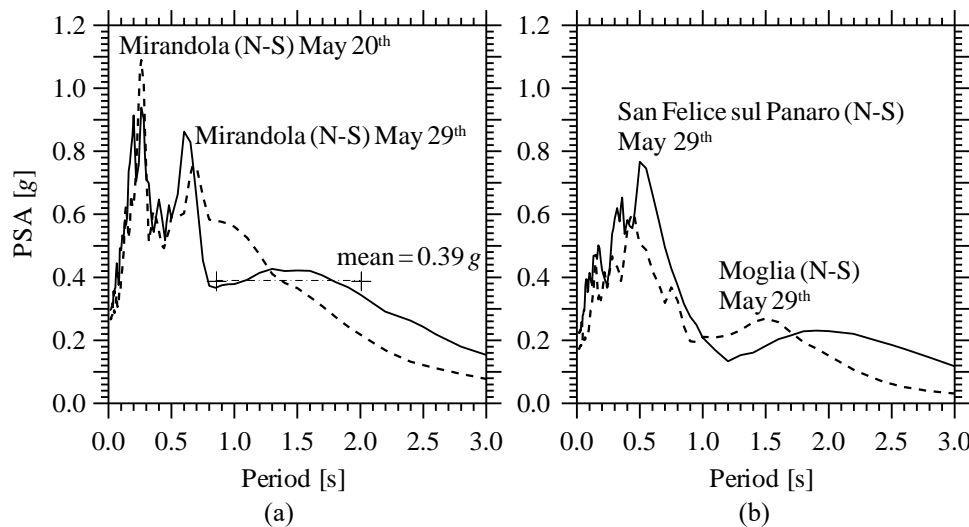
Fig. 1 Horizontal PSA versus period for (a) the seismic station at Mirandola (first and second mainshocks), and (b) those at San Felice sul Panaro and Moglia (second mainshock)

was selected in the present study as the closest to the main vibration period of the buildings. Anyway, at least for the spectra of the records collected during the second mainshock, PSA at 1 s represents a good approximation of the mean value of the PSA in the interval 0.85–2 s (see Fig. 1).

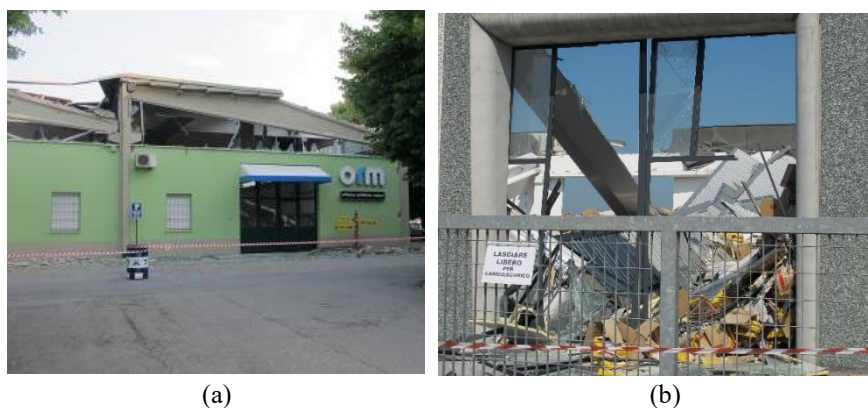
Fig. 2(a) shows the falling of a precast beam from the column support due to the interaction with the front masonry curtain wall. During the roof oscillation, the infill wall alternatively exerted an additional constraint to only one of the two adjacent columns, leading to a significant increase in the translational stiffness of that column. Therefore, most of the horizontal force was transferred to one beam-column support only, overcoming the friction capacity of the support. This failure was very common in buildings with strip windows between the precast beam and the curtain wall. Fig. 2(b) shows an extended roof collapse in a modern precast building due to the absence of slab-beam connections.

Fig. 2 Roof collapses in precast buildings: (a) partial collapse due to interaction with masonry curtain walls; and (b) extended collapse in a modern prefabricated building

mechanisms can be activated, depending on parameters not strictly related with the building characteristics: one of these causes can be the falling of the roof elements, or even main girders from their support (see Fig. 2(a)), which is related to the overcoming of the friction resistance at the support level. Actually, the slope changes shown in Fig. 15 are a consequence of the non-uniform distribution of buildings and of the spatial distribution of the parameters of seismic intensity. Only for the uniform distribution of the undamaged buildings (D0) the slope change is absent.

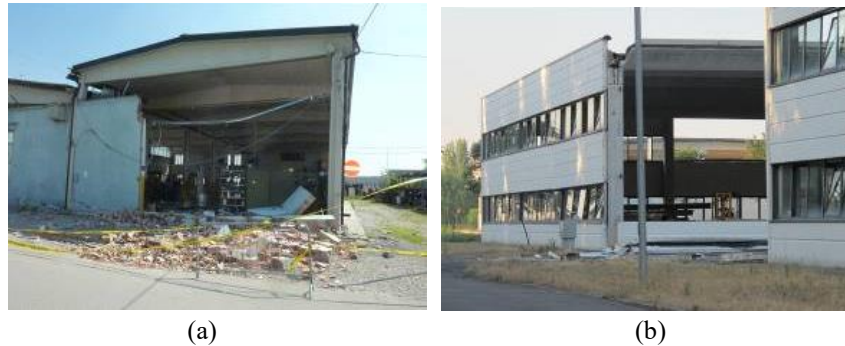
Fig. 3 shows the falling of curtain walls. In the case of Fig. 3(a), the collapse of the masonry curtain wall was caused by the insufficient restraint exerted on the wall by RC columns and upper beam, due to the presence of the strip window. Sometimes, before the collapse of the masonry

Fig. 3 Collapse of (a) a masonry curtain wall not restrained by the RC structure; and of (b) RC cladding panels due to failure of the steel channel profiles supporting them

infill, column damages occurred because of the interaction with the wall: in Fig. 3(a), note also the short column failure of the left column. Short column failure mechanisms were also documented in Figs. 11-13 reported by Liberatore *et al.* (2013), and in Fig. 10 reported by Bournas *et al.* (2014). The picture of Fig. 3(b) illustrates the falling of RC cladding panels due to the damage of the retaining systems, represented by steel channel profiles cast in the column concrete cover. These devices are typically designed against horizontal forces acting perpendicularly to the panels and are not able to support the large building displacements in the direction parallel to the curtain front during the earthquake. This kind of collapse was common in precast buildings with horizontal cladding panels.

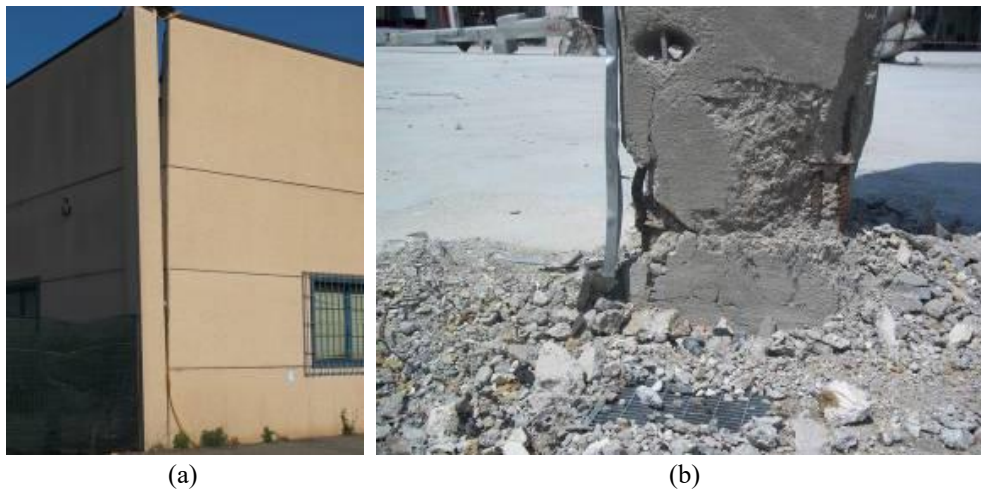
Fig. 4 Damages in precast RC columns: (a) rotation of external columns; and (b) large base rotation due to formation of a plastic hinge with yielding and buckling of longitudinal steel bars

Rotations of precast RC columns not designed for the earthquake resistance due to damages at the column base are shown in Fig. 4. In the case of Fig. 4(a), the rotation was caused by the formation of a plastic hinge at the base. A detail of a plastic hinge, with yielding of longitudinal steel bars in tension and buckling of bars in compression is shown in Fig. 4(b).

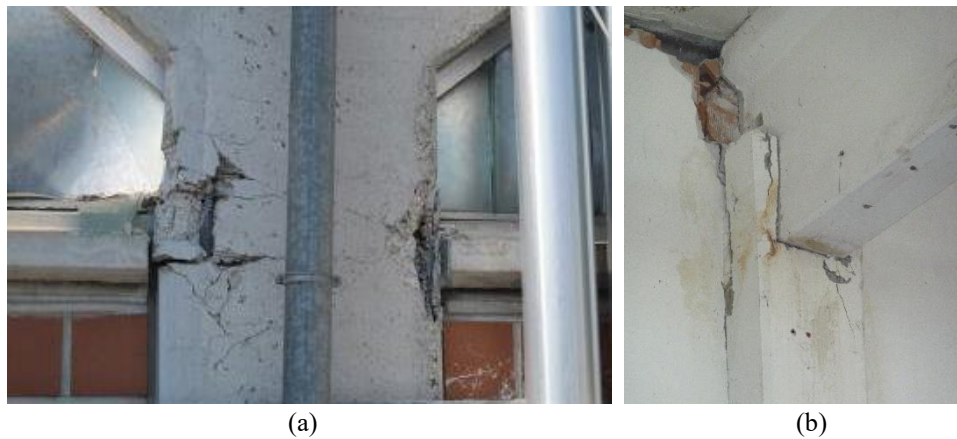
Local damages occurred frequently in columns due to the interaction with masonry curtain

walls (Fig. 5(a)), or in the forked supports at the column top (Fig. 5(b)), generally not designed to avoid overturning of the beams during seismic excitations. Typically, these damages were repairable and were restricted to some elements in the building only.

Fig. 5 Local damages in precast RC columns: (a) failure mechanism due to interaction with masonry infills; and (b) damage of the upper fork of a column due to flexural-torsional displacements of the precast beam

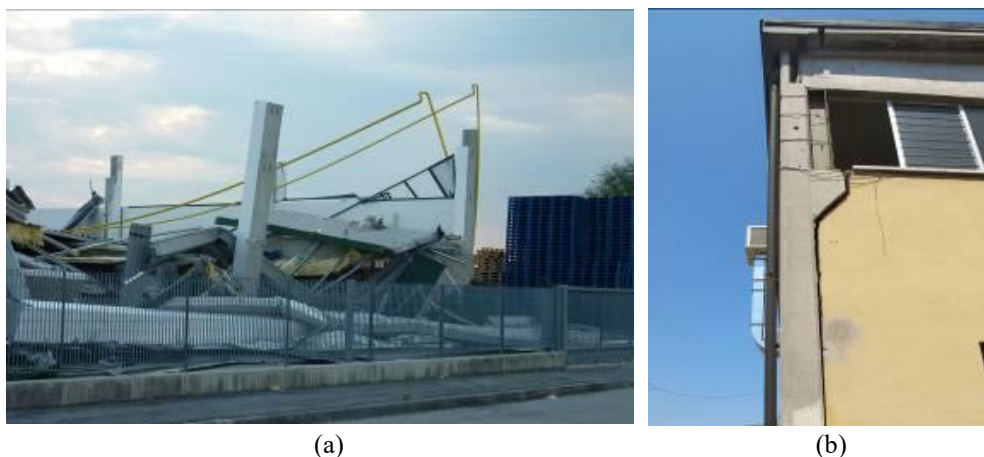
Sometimes, rigid rotations of columns occurred due to settlements at the foundation level or failure of the precast sleeve footing. In few cases, very large column rotations occurred with very extended collapses (Fig. 6(a)), probably due to the use of fully precast sleeve footings simply-supported on the cast in situ RC foundation. This technology was often used in recent years in order to speed up the construction, but this kind of foundation structure does not exhibit any overstrength capacity when the external bending moment overcomes the stabilizing moment. In other cases, the presence of a RC pavement avoided excessive column rotation and falling of the upper beam (Fig. 6(b)). With regard to the overturning failure of precast RC columns, an analysis was recently presented by Kafle *et al.* (2015).

Fig. 6 Damages in precast RC columns: (a) extended building collapse caused by large column rotation due to foundation settlement; and (b) column rotation due to settlement at the foundation level, counteracted by the presence of an industrial concrete pavement

Earthquake-induced foundation settlements are also considered by the recent updates of Regional Decree No. 57/2012, but they do not appear explicitly in Table 1. As a matter of fact, rotations of the pocket foundation at the column base, observed in some cases (Fig. 6), may be taken into account in the form of a permanent column drift.

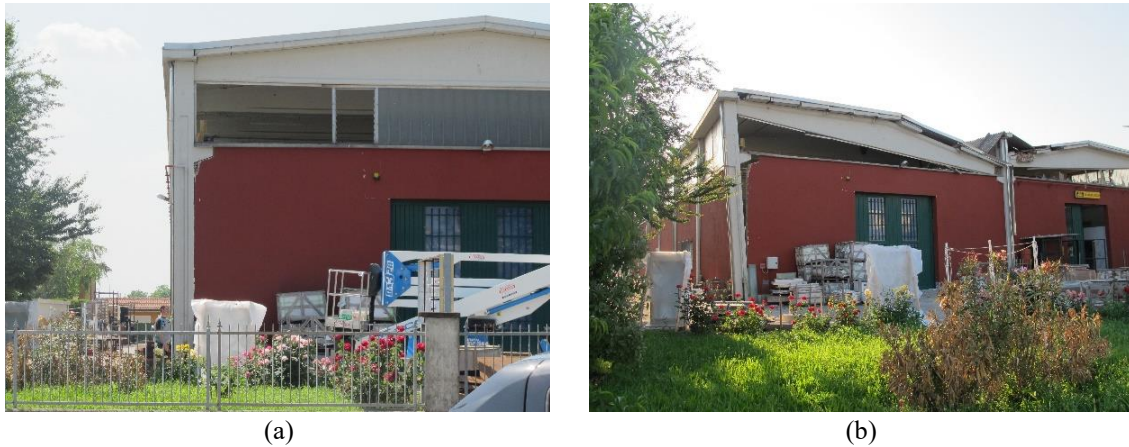
As an example, two pictures of a single-storey two-bay industrial building with variable height roof beams simply-supported in correspondence of the columns and perimeter masonry curtain walls, taken after the first and the second mainshock, are reported in Fig. 7(a) and Fig. 7(b), respectively. The maximum accelerations in that area were comparable, but the effects of the second mainshock on many buildings were significantly heavier. In that building, May 20th earthquake caused only the detachment of a masonry curtain wall on the front without any displacement between beams and columns at the roof level. On the contrary, May 29th earthquake caused the falling of the two front beams with a mechanism analogous to that shown in Fig. 2(a).

Fig. 7 Industrial building in San Giacomo Roncole (Mirandola, MO): (a) the building after May 20th earthquake, and (b) after May 29th earthquake

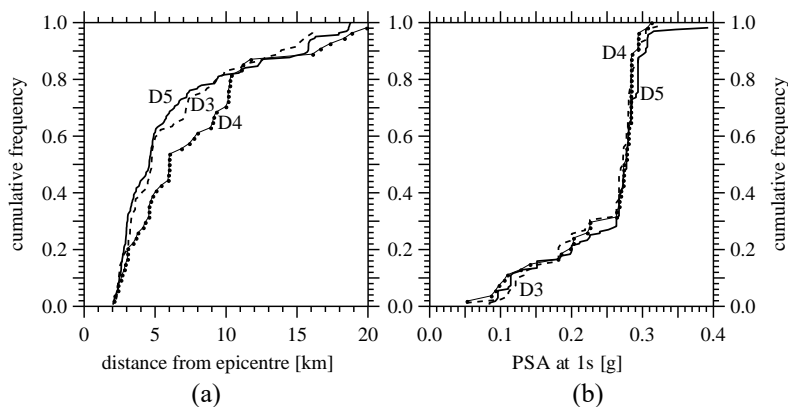
Fig. 9 Cumulative frequencies of buildings belonging to damage levels D3 (dashed lines), D4 (line with symbols) and D5 (solid line) versus (a) distance from the nearest epicentre, and (b) corresponding PSA at 1 s

For instance, the distinction between the distributions of buildings with damage levels D3, D4 and D5 is not clear (see Fig. 9).

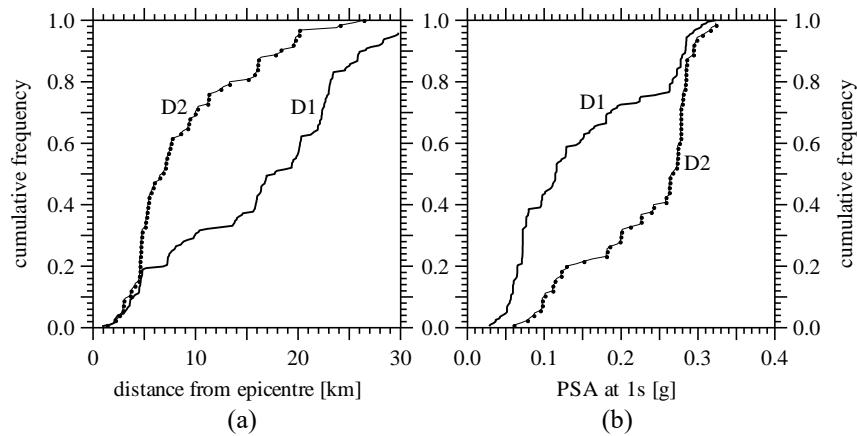
Fig. 11 Cumulative frequencies of buildings belonging to damage levels D1 and D2 versus (a) distance from the nearest epicentre, and (b) corresponding PSA at 1 s

The locations of the buildings with slight to moderate damages (levels D1 and D2) are reported in Fig. 10, where they appear scattered over the struck area, with the highest density in the Modena county. For the same buildings, the plots of the cumulative frequencies versus distance from the nearest epicentre and corresponding PSA at 1 s are reported in Fig. 11(a) and Fig. 11(b), respectively. The cumulative frequencies for damage levels D1 and D2 are referred to 196 and 125 buildings, respectively (Table 3). All buildings with moderate damages lie at an epicentral distance not larger than 26 km, and 20% of them are located at less than 5 km from the nearest epicentre (D2 in Fig. 11(a)). Moreover, 20% of the buildings with moderate damages experienced a PSA larger than 0.28 g (D2 in Fig. 11(b)). Finally, for 20% of the buildings with slight damages, the minimum epicentral distance does not exceed 7 km (D1 in Fig. 11(a)), and the experienced PSA at 1 s is larger than 0.27 g (D1 in Fig. 11(b)).

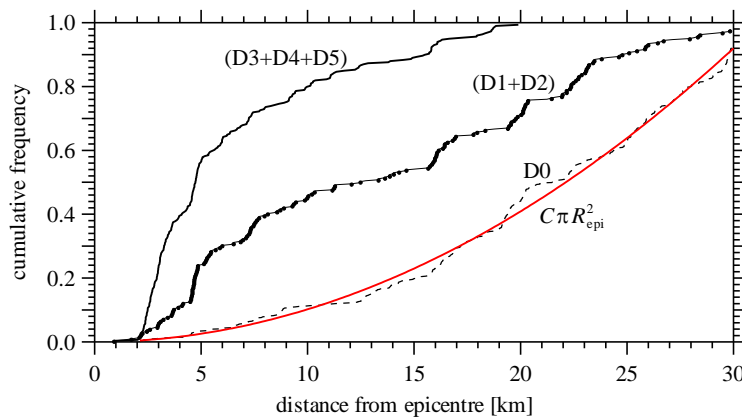
Fig. 13 Cumulative frequencies of the three classes of damage levels plotted versus the distance from the nearest epicentre

Since very heavy damages and collapses were observed in a significant number of buildings up to about 15 km from the epicentres, and moderate damages affected buildings located up to 25-30 km from the epicentres (Fig. 13), future developments of the present investigation will be dedicated to a deeper analysis of the most common typologies of precast buildings, in order to put in evidence all possible sources of seismic vulnerability.

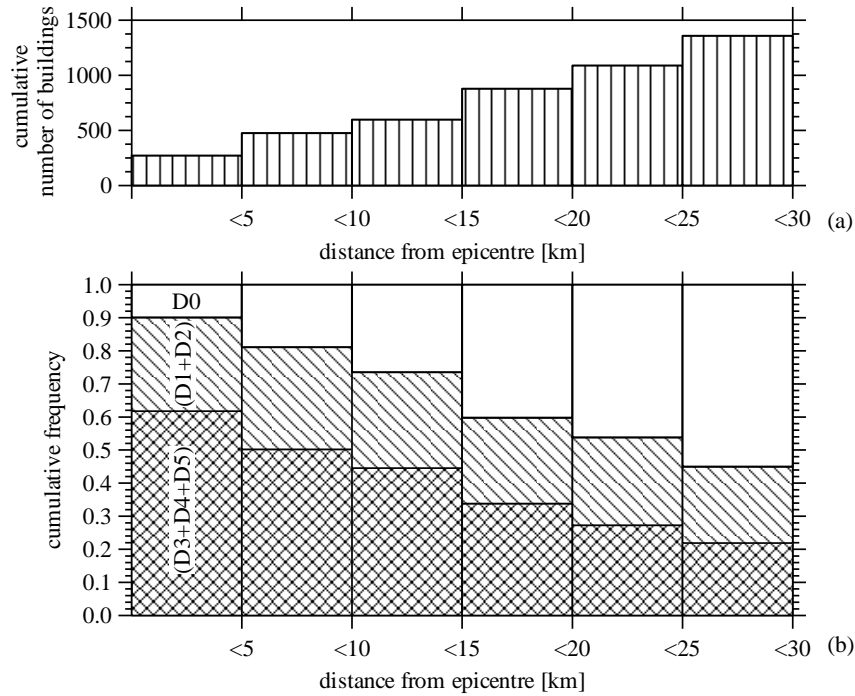
The data are presented in an alternative form in Fig. 14, to underline the percentages of buildings with different levels of damage as a function of their epicentral distance. In particular, the cumulative sum of buildings investigated is reported in Fig. 14(a), whereas the percentage distribution of the buildings belonging to the three damage classes is reported in Fig. 14(b). The 1358 investigated buildings with $R_{\text{epi}} \leq 30$ km are distributed among the three damage classes according to the following percentages: 22% (D3+D4+D5), 23% (D1+D2) and 55% (D0). The buildings with severe damages up to collapse (D3+D4+D5 in Fig. 14(b)) are 62% of all buildings in the range 0-5 km, and about one half of the total stock for epicentral distances up to 10 km. Nevertheless, it is worth noting that 19% of the buildings within 10 km from the epicentre did not suffer any damage (D0 in Fig. 14(b)).

Fig. 14 Bar charts with (a) cumulative number of buildings investigated, and (b) cumulative frequencies of buildings versus epicentral distance for the three classes of damage levels

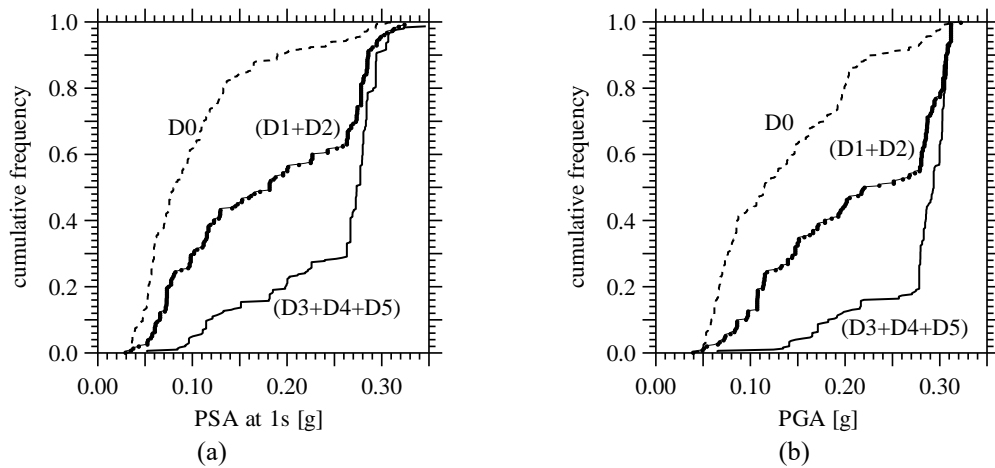
The cumulative frequencies of the buildings belonging to the different classes of damage levels are reported in Fig. 15(a) versus the PSA at 1 s corresponding to the nearest epicentre. It can be observed that 90% of buildings with severe damages up to collapse (D3+D4+D5) experienced a PSA larger than 0.12 g and 10% of them was subject to a PSA larger than 0.29 g. Moreover, 90% of buildings with slight to moderate damages (D1+D2) experienced a PSA larger than 0.06 g.

Distributions of the damage classes D1+D2 and D3+D4+D5 similar to those reported in Fig. 15(a) are finally presented in terms of the maximum experienced PGA in Fig. 15(b). It is worth noting that these curves show a sudden slope change at $\text{PGA} \approx 0.28$ g, with a significant increase of

Fig. 15 Cumulative frequencies of the three classes of damage levels versus (a) PSA at 1 s corresponding to the nearest epicentre, and (b) maximum experienced PGA

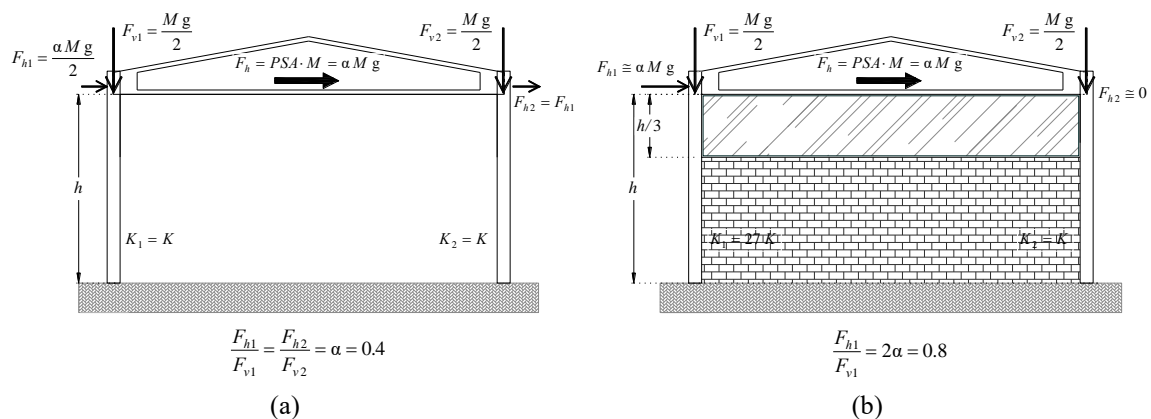
Fig. 16 Single-storey single-bay precast frame (a) without masonry infill and (b) with an infill wall provided with a strip window between precast beam and wall

As a second case, consider a front frame with a masonry infill wall and a strip window on the top of it, whose height is $h_1=h/3$ (see Fig. 16(b)). When the roof is oscillating due to the seismic excitation, the two columns exhibit different lateral stiffnesses because of the interaction with the infill: under the assumption that the left column has a deformable length equal to h_1 , and thus behaves as a cantilever with the fixed cross-section located at $h-h_1=(2/3)h$ from the base, the lateral stiffness of the right column is $K=3EI/h^3$, whereas that of the left column is 27 times greater. Hence, almost the whole horizontal force will be carried out by the left column (Fig. 16(b)), i.e., $F_{h1} \cong \alpha Mg$ and $F_{h1}/F_{v1}=2\alpha=0.8$. Though ignoring the possibility of a short column failure for the left column, such a ratio between horizontal and vertical forces, certainly greater than the concrete-to-concrete friction coefficient, indicates that the falling down of the beam from the column is to be expected. In the pushover curve of Fig. 2.4 reported by Casotto *et al.* (2015), the collapse due to connection failure is reached before the attainment of the flexural strength in the columns.
