# Web based evaluation of earthquake damages for reinforced concrete buildings

**Keywords:** earthquake; damage assessment; reinforced-concrete; web based; database

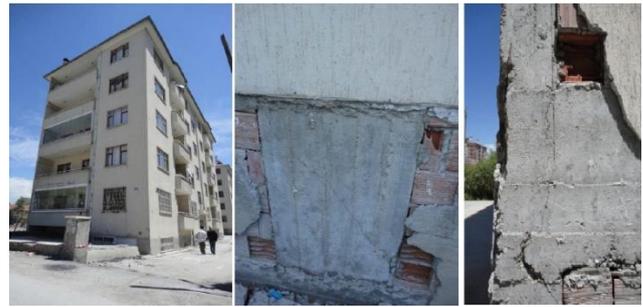
Fig. 1 Pictures of 1. building

consisted a total of 6 stories, it was observed that the greatest damage occurred on the ground floor on a reinforced concrete frame building. In the building, no partial or total collapse condition was observed. Also, no heavy closure condition, no soft/weak story condition and no short column condition were detected. There was no evidence of liquefaction in the examinations made on the ground. Roof/gamble wall damage, chimney/parapet damage, infill walls damage and staircase damage were not observed in the damage assessments made for non-structural system elements in the general area of the building. From 26 bearing elements that can be examined in the building; 1 heavy damaged columns, 9 medium damaged columns, 8 slightly damaged columns and 8 no damage columns were detected. Commonly, column-beam joint damage has been detected. Experiments carried out on the core samples taken to determine the concrete strength have showed that the concrete strength was 10.66 N/mm<sup>2</sup> (C10). Fig. 1 shows some images from the building number 1.

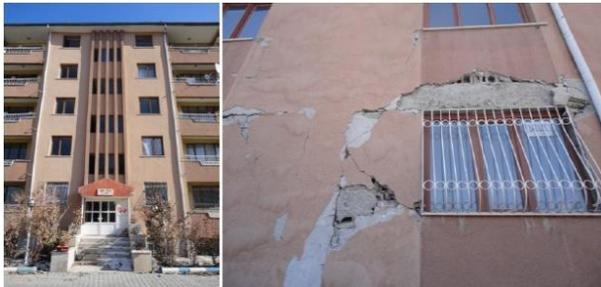
Fig. 2 Pictures of 2. Building

From the building in the form of B+Z+4NK which is consisted a total of 6 stories, it was observed that the greatest damage occurred on the ground floor on a reinforced concrete frame building. In the building, no partial or total collapse condition was observed. Also, no heavy closure condition, no soft/weak story condition and no short column condition were detected. There was no evidence of liquefaction in the examinations made on the ground. Roof/gamble wall damage and staircase damage were not observed in the damage assessments made for non-structural system elements in the general area of the building; however, chimney/parapet and shear damage in infill walls was observed. From 19 bearing elements that can be examined in the building; 2 heavy damaged columns, 5 medium damaged columns, 5 slightly damaged columns and 7 no damage columns were detected. Commonly, column-beam joint damage has been detected. Experiments carried out on the samples taken to determine the concrete strength have showed that the concrete strength was 10.65 N/mm<sup>2</sup> (C10). Fig. 2 shows some images from the building number 2.

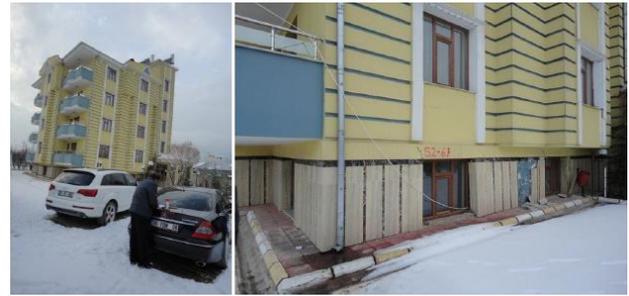
Fig. 3 Pictures of 3. Building

From the building in the form of B+Z+3NK which is consisted a total of 5 stories, it was observed that the greatest damage occurred on the ground floor on a reinforced concrete frame building. In the building, no partial or total collapse condition was observed. Also, no heavy closure condition, no soft/weak story condition and

no short column condition were detected. There was no evidence of liquefaction in the examinations made on the ground. There was no RC wall in the building. Roof/gamble wall damage and staircase damage were not observed in the damage assessments made for non-structural system elements in the general area of the building; no damage at chimney) parapet however, shear damage in infill walls was observed. Damage in infill walls was observed commonly.

Diagonal cracks, out-of-plane overturns have formed in the infill walls. From 24 bearing elements that can be examined in the building; 4 slightly damaged columns and 20 of the have no damage columns were detected. Commonly, column-beam joint damage has been detected. Experiments carried out on the samples taken to determine the concrete strength have showed that the concrete strength was 17.22 N/mm<sup>2</sup> (C16). Figure 3 shows some images from the building number 3.

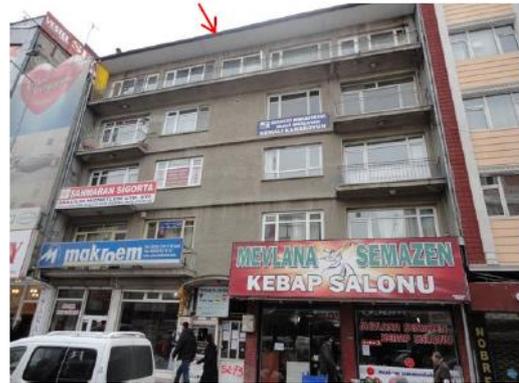
Fig. 4 Picture of 4. Building

From the building in the form of Z+4NK which is consisted a total of 5 stories, it was observed that the greatest damage occurred on the ground floor on a reinforced concrete frame building. In the building, no partial or total collapse condition was observed. Also, no heavy closure condition, no soft/weak story condition and no short column condition were detected. There was no evidence of liquefaction in the examinations made on the ground. There was no RC wall in the building. Roof/gamble wall damage, chimney/parapet damage, infill walls damage and staircase damage were not observed in the damage assessments made for non-structural system elements in the general area of the building. From 36 bearing elements that can be examined in the building; 36 of the have no damage

columns were detected. Experiments carried out on the samples taken to determine the concrete strength have showed that the concrete strength was  $17.73 \text{ N/mm}^2$  (C16). Fig. 4 shows some images from the building number 2.

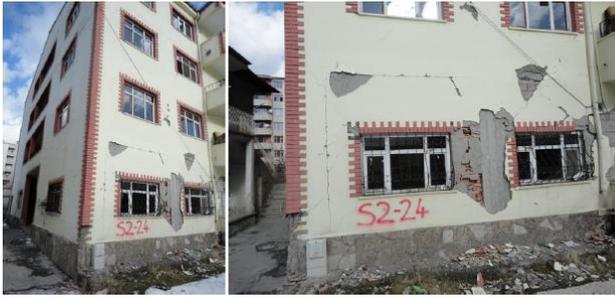
Fig. 5 Pictures of 5. Building

From the building in the form of Z+3NK which is consisted a total of 4 stories, it was observed that the greatest damage occurred on the ground floor on a reinforced concrete frame building. In the building, no partial or total collapse condition was observed. Also, no heavy closure condition, no soft/weak story condition and no short column condition were detected. There was no evidence of liquefaction in the examinations made on the ground. Roof/gamble wall damage, chimney/parapet damage and staircase damage were not observed in the damage assessments made for non-structural system elements in the general area of the building; however, shear damage in infill walls was observed. From 20 bearing elements that can be examined in the building; 5 medium damaged columns, 3 slightly damaged columns and 12 no damage columns were detected. There were no RC walls in the building. Commonly, column-beam joint damage has been detected. Shear cracks were found in the columns. Experiments carried out on the samples taken to determine the concrete strength have showed that the concrete strength was  $9.85 \text{ N/mm}^2$  (C9). Figure 5 shows some images from the building number 5.

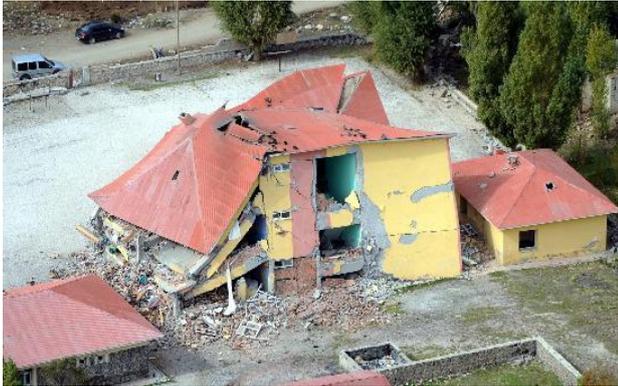
Fig. 6 Picture of 6. Building

shape. The RC walls, though quite large, they still failed at the ground floor. The RC walls, though quite large, they still failed at the ground floor. The structural members were observed to be laid out improperly in some of the buildings. Improper layout of the structural members was conceived to be one of the major causes of collapse of school building in Gedikbulak village. Gedikbulak School building has been collapsed by the moving of RC walls from their axes (Kutanis *et al.* 2013).
