Experimental study on mechanical performances of lattice steel reinforced concrete inner frame with irregular section columns

Abstract. Based on the test on a 1/2.5-scaled model of a two-bay and three-story inner frame composed of reinforced concrete beams and lattice steel reinforced concrete (SRC) irregular section columns under low cyclic reversed loading, the failure process and the features of the frame were observed. The subsequence of plastic hinges of the structure, the load-displacement hysteresis loops and the skeleton curve, load bearing capacity, inter-story drift ratio, ductility, energy dissipation and stiffness degradation were analyzed. The results show that the lattice SRC inner frame is a typical strong column-weak beam structure. The hysteresis loops are spindle-shaped, and the stiffness degradation is insignificant. The elastic-plastic inter-story deformation capacity is high. Compared with the reinforced concrete frame with irregular section columns, the ductility and energy dissipation of the structure are better. The conclusions can be referred to for seismic design of this new kind of structure.

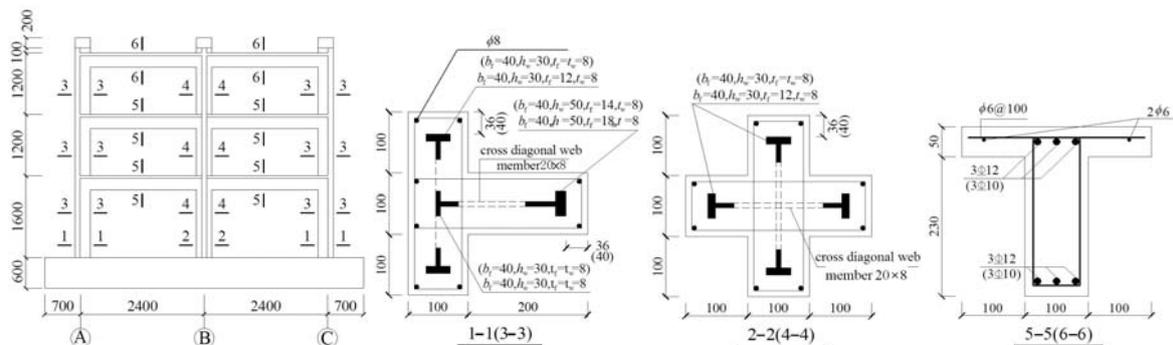
Fig. 1 Geometry and steel layout of the test specimen

According to the seismic intensity of degree 8, a 1/2.5-scaled specimen of a lattice SRC inner frame with irregular section columns was designed, which consisted of reinforced concrete beams and lattice SRC irregular section columns. The bottom level, the intermediate level, and the top level were selected as the first-, the second- and the third- story of the prototype respectively for the analysis. The geometry, steel and reinforcement layout of the test specimen are shown in Fig. 1.

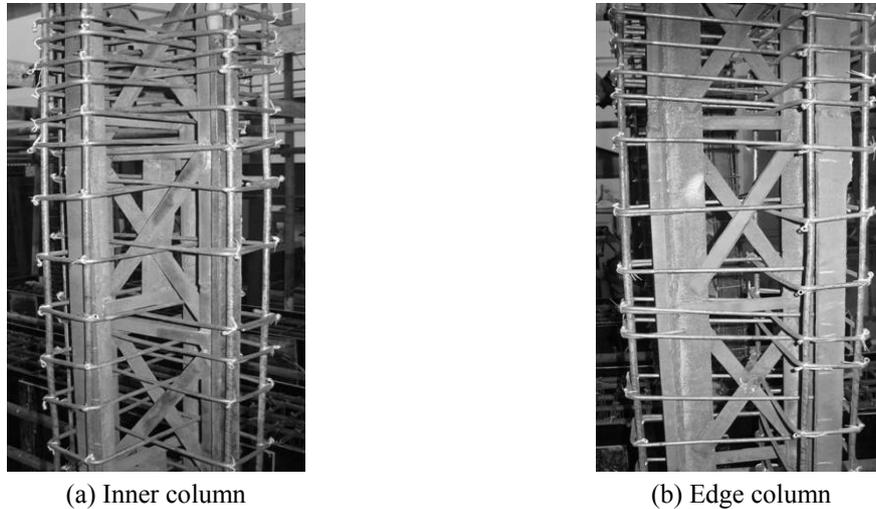
Fig. 2 Steel skeleton

The test specimen was cast using fine aggregate commercial concrete, and the cubic concrete compressive strength measured at the 28th day was 30.35MPa. Grade Q235B steel was used as the steel skeleton in columns. The T-shaped steel was welded by using steel plates in relevant specification in form of double-sided fillet welt. Flat steel with 20 mm in width and 8mm in thickness was used as the horizontal and cross diagonal web members to form the steel truss (Fig. 2). The average steel reinforcement ratio of the edge column and inner column was 5.76% and 5.12%, respectively. $\phi 8$ bars were used as the longitudinal steel bars in columns, and the reinforcement ratio was 0.85%. $\phi 12$ bars were used as the longitudinal steel bars in first- and second-story beams, the reinforced bars were placed symmetrically and the reinforcement ratio

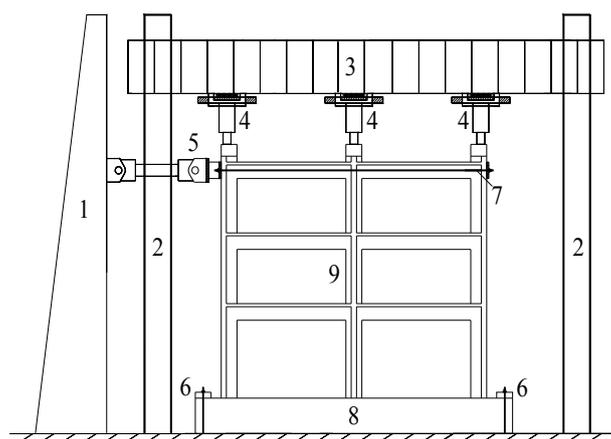
Fig. 3 Test setup

The load was applied by three hydraulic jacks on the top of each column of the test specimen. 255.6 kN force was loaded axially on top of each edge column, and 511.2 kN force was loaded

axially at the top of the inner column, the design value of axial compression ratio of the edge columns and the inner column is 0.2 and 0.4, respectively. The values of vertical load remain constant during the whole loading process. The lateral low-cycle reversed load was applied at the top beam end by the MTS electro-hydraulic servosystem. Horizontal movement of the footing during loading was restrained by the friction force between the footing and the floor. The pressure was applied to the footing by two steel blocks, which were connected to the test floor by 4 post-tensioned high strength threaded rods. The footing rotations were also restrained by the two steel blocks. Strain gages were mounted at critical positions on the steel, longitudinal steel bars and stirrups to measure the strain history during the test. The first critical section was the beam end section (Nie *et al.* 2004, Ju *et al.* 2009), which was 100 mm away from the nearest surface of the columns. The second critical section was the column end section (Karimi *et al.* 2012), which was 100 mm away from the nearest surface of the beam-column joints. The third one was the midst of beam-column joints (Kawano *et al.* 2012). Unidirectional strain gages were attached on top and bottom flanges at these sections. All the data was collected by TDS-602 static data acquisition instrument. The test setup is shown in Fig. 3.

1 reaction wall; 2 reaction steel frame; 3 reaction girder; 4 vertical actuator;
5 1000kN horizontal actuator; 6 tie bolt; 7 horizontal braces; 8 footing; 9 test specimen

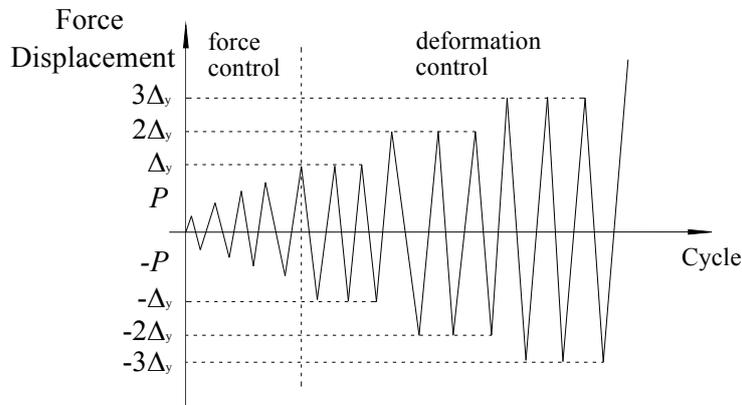
Fig. 4 Loading control process

A load-displacement hybrid control program was applied, in which the lateral loading sequence was controlled by force for the initial loading cycles till the yielding initiation of the test specimen was observed. This observation was accomplished by monitoring the reaction forces of the MTS horizontal actuator. From 30 kN, every load level was applied for one cycle in an increment of 30 kN. When the test specimen started yielding, the loading sequence was controlled by displacement. On the basis of the yield displacement, the target displacements for the cyclic loading were set as the multiple of the yield displacement (Δ_y), the cyclic loadings were repeated three times at each target displacement. Loading was terminated until the reaction force descended to about 85% of the maximum value. The loading process is shown in Fig. 4. During the test, the load/displacement was kept constant at several loading stage so that the data could be recorded by the acquisition instrument, cracks could be marked, crack width could be measured, and pictures could be taken.

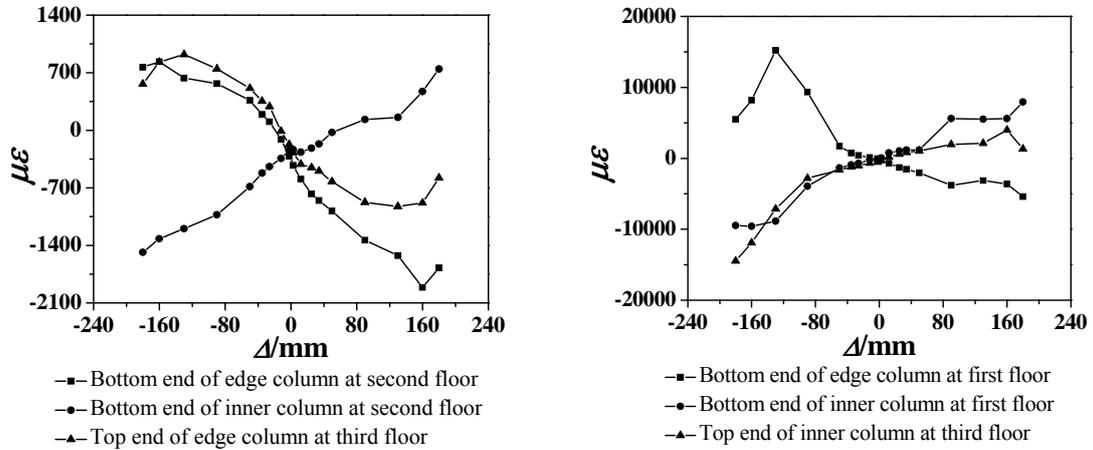
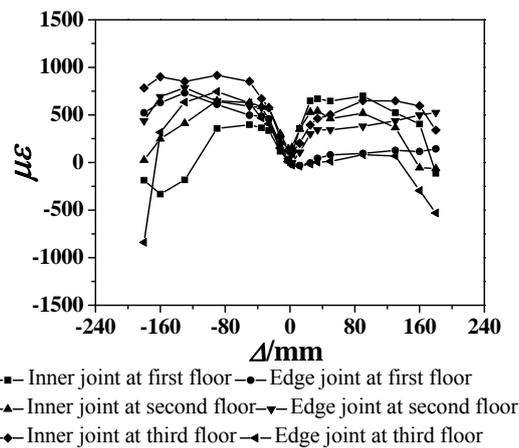
Fig. 5 Strain of the shape steels

(a) Steel strain at non-plastic hinge field of column (b) Steel strain at plastic hinge field of column

(c) Strain of horizontal web steel at panel zone

Under a lateral loading of 90 kN, horizontal cracks occurred at each bottom end of the first-story column web. As the lateral loading increased, horizontal cracks formed at the flange of the first-story column bottom ends. When the lateral displacement of the top beam reached 90 mm and was repeated 3 times (the corresponding horizontal load was 242 kN), cover concrete spalling developed at the web of the first- and the third-story column bottom ends. With further increment of top beam lateral displacement, concrete crushed and dropped at column bottom and column webs of each story, vertical cracks formed at the position of stirrups, and longitudinal steel bars and stirrups were exposed. When the displacement of the top beam reached 180 mm and was repeated 3 times (the corresponding horizontal load was 168 kN), a great number of longitudinal steel bars and stirrups were exposed at the web of column bottom ends, but few concrete at column flange was crushed for the first-story columns. For the second-story columns, longitudinal steel bars were exposed at the inner column bottom end. For the third-story columns, concrete was crushed and dropped more, and the longitudinal steel bars at the web of column bottom ends were compressed to be unstable. From the strain distribution of the column steel it can also be concluded that no plastic hinges developed at most column ends (Fig. 5(a)), except for the ends at the first story column and the upper end of the inner column at the third story (Fig. 5(b)).

Under a horizontal loading of 90 kN, the cracks at beam end extended to the marginal area of beam-column joints. Under a loading of 150 kN, tiny diagonal shear cracks occurred at the middle area of each beam-column joint. When the loading sequence was controlled by displacement, cover concrete spalling developed at each beam-column joints. When the displacement of the top beam reached 180 mm and repeated for 3 times (the corresponding horizontal load was 168 kN), concrete spalling of each story grew continuously, the stirrups and longitudinal steel bars were exposed, but the horizontal web steel did not yield at last (Fig. 5(c)).

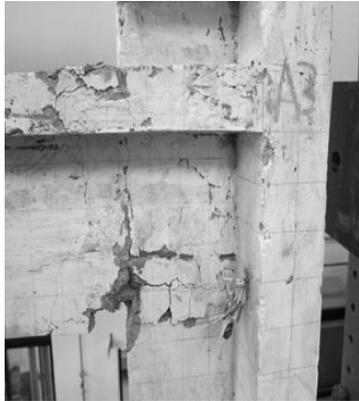
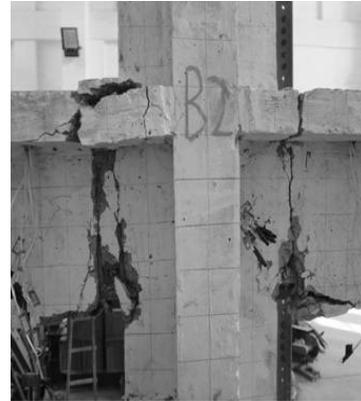
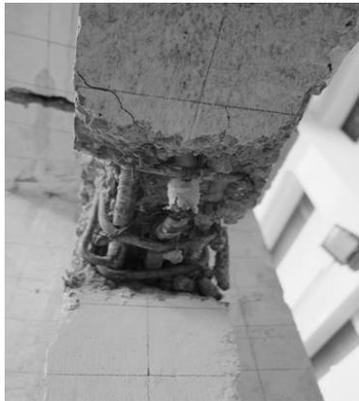
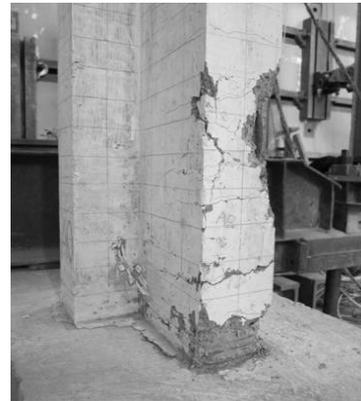
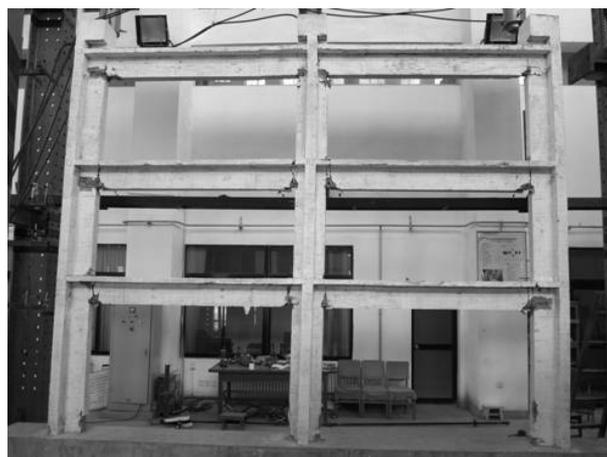
Fig. 6 Failure modes of test specimen

(a) The edge joint at third-story

(b) The inner joint at second-story

(c) The breaking of longitudinal steel bars at the base of beam end

(d) The edge column bottom end of first-story

(e) Test specimen after failure

of the top beam reached 90 mm and was repeated 3 times (the corresponding horizontal load was 242 kN), concrete crushed and dropped at the bottom side of the first and second-story beam ends, stirrups at the flange of the beam end were exposed, and the main flexural cracks formed at the third-story beam ends. When the displacement of the top beam reached 160 mm and was repeated 3 times (the corresponding horizontal load was 203 kN), the concrete dropping from the beam base ends and flanges increased, concrete at the top of the flange plate was crushed, and the longitudinal steel bars at first-story beam were exposed. When the displacement of the top beam reached 180 mm and was repeated 3 times (the corresponding horizontal load was 168 kN), a large amount of concrete at each beam end dropped, some longitudinal steel bars at bottom side of beam end fractured, and the concrete crushing at the top of the flange plate grew continuously.

(Tago *et al.* 2012). The failure mode of the test specimen is shown in Fig. 6, the ultimate cracking pattern is shown in Fig. 7, in which the positive and negative direction represents the push and pull direction of loading, respectively. The subsequence of plastic hinges of the test specimen is shown in Fig. 8.

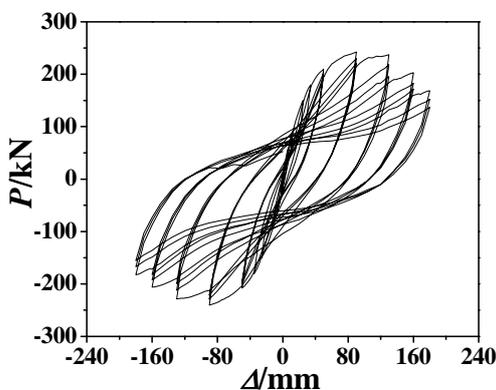
Fig. 9 P - Δ hysteresis loops of test specimen

The hysteresis loops and skeleton curves reflect the relationship between the load and the deformation of the whole structure comprehensively. They are the macroscopic reflection of the seismic performance of the structure and the main basis of the elasto-plastic dynamic response analysis. The lateral load-displacement hysteresis loops and skeleton curve obtained from the test are shown in Figs. 9 and 10, respectively. The figures suggest that

- (1) At the early stage of loading, the area of the hysteresis loops was very small. There was a linear relationship between the lateral force and the displacement. Stiffness variation was insignificant, and the residual deformation was negligible.

- (2) With the increment of lateral load, the hysteresis loops became plumper. Obvious residual deformation was formed, and the test specimen was in the nonlinear stage.

- (3) After the test specimen yielded, the lateral load of the specimen gradually increased with the increasing of the lateral displacement, till the peak load was reached. The bearing capacity began to descend. The area of the hysteresis loops continued enlarging. Under the cyclic loading, the damage on the test specimen accumulated gradually, and the stiffness of the structure degraded slowly.

- (4) The hysteresis loops in positive and negative direction were symmetric; the hysteresis loops were in spindle shape, and then transformed into bow shape, indicating that the test specimen had a good seismic performance.

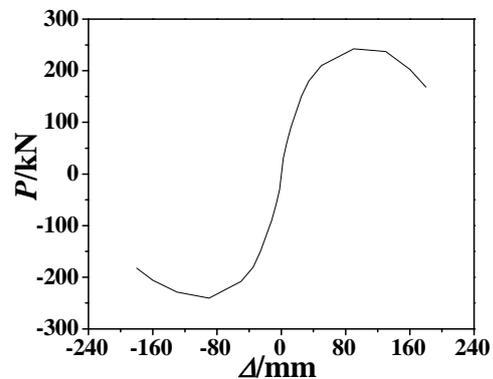
Fig. 10 P - Δ skeleton curve of test specimen

- (5) During the whole loading process, the test specimen exhibited large initial stiffness, load bearing capacity, and deformation capacity. The skeleton curve of the test specimen possessed a long descent trajectory, and the descending branch was gentle. This indicated that the structure had good ductility and energy dissipation capacity.

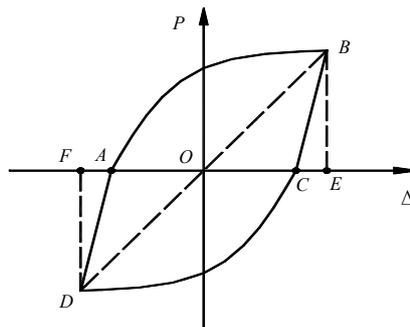
Fig. 11 The calculation of equivalent viscous damping coefficient

$$h_e = \frac{1}{2\pi} \cdot \frac{S_{(ABCD A)}}{S_{(OBE+ODF)}} \tag{1}$$

in which $S_{(ABCD A)}$ represents the area of the hysteresis loop ABCDA, $S_{(OBE+ODF)}$ represents the area of the triangles OBE and ODF, as indicated in Fig. 11. The calculated results of the test specimen are shown in Table 4, in which h_{ey} , h_{ep} and h_{ef} stand for the yield, peak and failure equivalent viscous damping coefficient, respectively. The relevant research papers show that, the equivalent viscous damping coefficient of frame structure ranges from 0.05 to 0.25 (Wang *et al.* 2008). The equivalent viscous damping coefficient of the test specimen falls right in the range. Compared with the reinforced concrete frame with irregular section columns whose h_{ey} , h_{ep} and h_{ef} is 0.069, 0.132 and 0.160 respectively (Wang *et al.* 2008), the energy dissipation capacity of the lattice SRC frame is better.

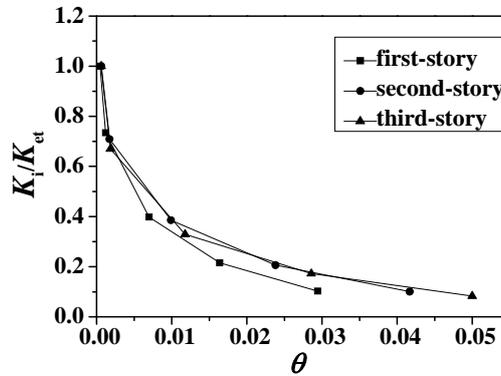
Fig. 12 The relationship between inter-story drift ratio and the stiffness degradation

The inter-story stiffness degradation is relevant to the occurrence and development of cracks in different parts of the test specimen in the loading process. At first, cracks occurred at the beam ends, the corresponding lateral load was about 30 kN, which was about 12.4% of the lateral peak load. Then cracks occurred at the column ends, the corresponding lateral load was about 90 kN, 37.1% of the lateral peak load. When the lateral load was 150 kN, cracks occurred in the beam-column joints, and the ratio of 150 kN to lateral peak load was 61.9%. When the main flexural cracks formed at the beam ends, the test specimen was observed to yield, and the corresponding lateral load was about 190 kN, 79.2% of the lateral peak load. Fig. 12 shows the relationship between inter-story stiffness degradation and the change of inter-story drift ratio, K_i stands for the inter-story stiffness under different loading level, K_{ei} stands for the initial elastic inter-story stiffness, θ stands for the inter-story drift ratio.

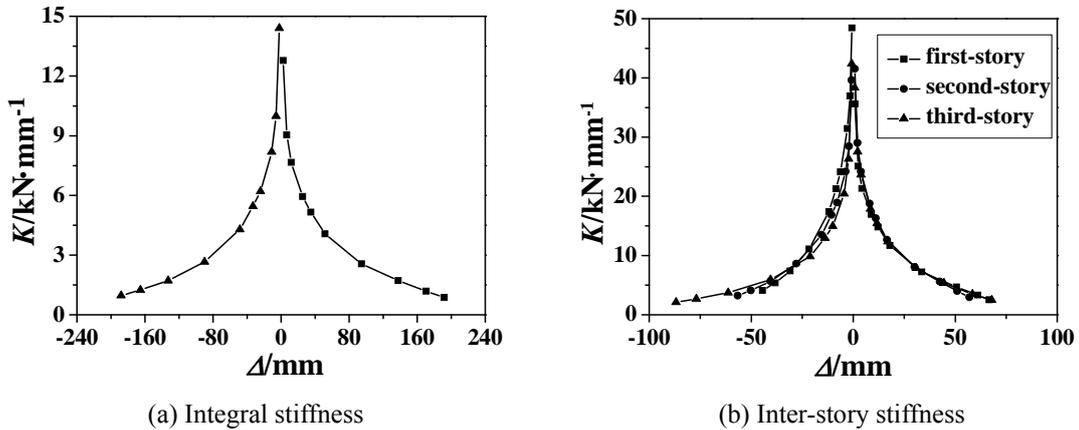
Fig. 13 Curves of stiffness degradation

The integral and inter-story stiffness degradations of the test specimen under different loading levels are provided in Fig. 13. Fig. 13(a) shows that the initial stiffness in positive and negative direction of the test specimen was similar, and the extent of stiffness degradation was symmetric. Before the test specimen yielded, a lot of concrete cracks occurred which led to fast stiffness

degradation. With the development of plastic deformation, the stiffness degradation slowed down gradually. Fig. 13(b) shows that the inter-story stiffness degradation follows the same pattern with the integral stiffness degradation. Although the first-story height is larger than the other two stories, the first-story column ends have been strengthened. Therefore, the test specimen has uniform vertical stiffness in the entire loading process.
