Static test on failure process of tubular T-joints with initial fatigue crack

Keywords: tubular T-joints; fatigue crack; residual static strength; failure mode; experimental test

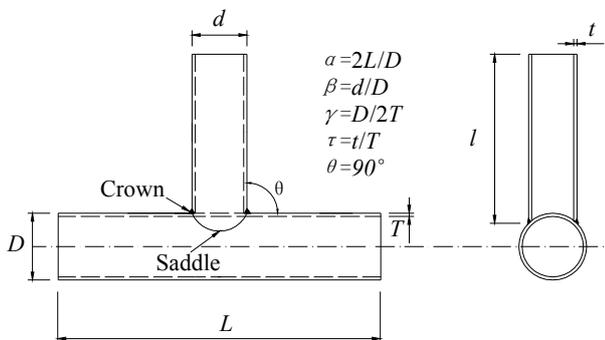
Fig. 1 A typical circular tubular T-joint

The specimens in the experimental tests are circular hollow section tubular T-joints. A typical circular tubular T-joint is shown in Fig. 1. A brace member is welded onto the outer surface of a chord member by using penetration weld. After welding, the weld quality is checked through ultrasonic technique to ensure that there is no initial defect such as crack along the weld toe. Some normalized parameters, which are generally used to denote the geometry of a tubular joint such as β , γ , τ and α , are also defined in Fig. 1. Overall three groups of specimens are designed as tabulated in Table 1. In each group, four specimens with same dimensions are fabricated. One of them is used to study the static strength without crack, and the other three specimens are designed to experience fatigue test firstly to produce fatigue crack at the weld toe. Then, the three specimens are tested statically to study the failure process and the fracture behavior. From the comparison between static performance of both the un-cracked and the cracked specimens, the deterioration of the static strength of the cracked tubular T-joints can be evaluated.

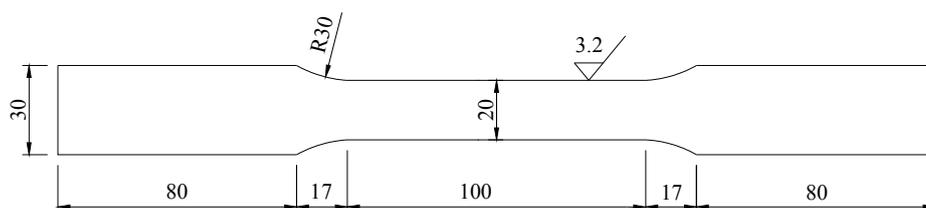
Fig. 2 Coupon test specimens (dimensions in mm)

cation of the specimens, the material properties of the braces and the chords are measured from uni-axial tensile tests for the coupons as shown in Fig. 2. The yield strength, the tensile strength and the elongation percentage of the steel materials are listed in Table 2. It should be noted that the specimens in the group CTJ219 and CTJ159 are classified into two types based on their slightly different material properties from experimental measurements.

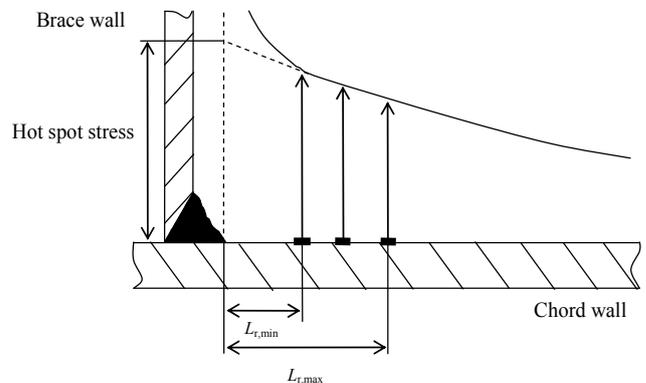
Fig. 4 Extrapolation region

It is well known that the stress is generally calculated from the strain measured from strain gauge placed on the specimen. However, the strain gauge cannot be placed directly at the weld toe because the weld surface and the chord surface are not located in a same plane. To overcome this problem, the strain gauge can be arranged in a region close to the weld toe, and this region is called “extrapolation region” as shown in Fig. 4. The extrapolation region is determined by the geometry of the tubular joint. In CIDCET (Wardenier *et al.* 2008), the specified extrapolation region for a circular tubular joint is listed in Table 3. R and r in Table 3 are the radii of the chord and the brace respectively. For a circular tubular joint, CIDCET (Wardenier *et al.* 2008) recommends to calculate the hot spot stress at the weld toe by using linear extrapolation method, i.e., two strain gauges perpendicular to the weld toe can be placed in the extrapolation region. Huang (2002) verified the accuracy of the linear extrapolation method for

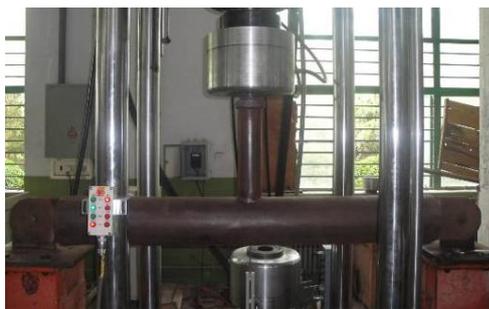
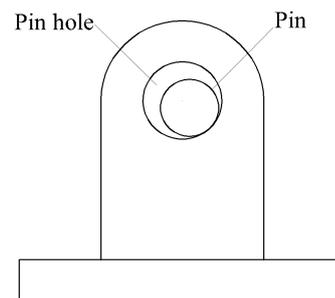
Fig. 3 Test rig

(a) View of tested specimen

(b) Pinned connection at support

shown in Figs. 7(a)-(c) for the specimens in the group CTJ159, CTJ219 and CTJ180 respectively. As mentioned previously and illustrated in Fig. 3, each specimen during the fatigue test is pinned at both ends of the chord. Diameter difference between the pin and the hole in the supports exists for the ease of connection between them, which produces a small clearance between the pin and the hole. Such gap can cause oscillation of the specimen and big noise during the fatigue tests. To avoid such phenomenon, the minimum amplitude of the cyclic loading is set to be a little bigger than zero to ensure that the specimen is always in a tensile state and the pin cannot move apart from the edge of the hole. The maximum amplitude of the cyclic loading is designed to produce hot spot stress at the weld toe which is in linear and elastic stage and close to the yield stress of the steel materials. Such loading design can ensure the fatigue tests to be completed quickly. Finally, the loading frequency is not very low to ensure that the fatigue tests are not conducted in a long time. Meanwhile, the loading frequency is not very high to ensure that the test rig has no strong vibration during the fatigue tests.

The static tests are also carried out in the test rig as shown in Fig. 3. For the specimens with and without fatigue crack, they are subjected to tensile load at the brace end till failure. During the test, an LVDT is placed at the bottom of the mid-span for the chord to measure the displacement as shown in Fig. 10. The displacement at the brace end is recorded automatically during the test by data acquisition system. The difference between the above two displacements

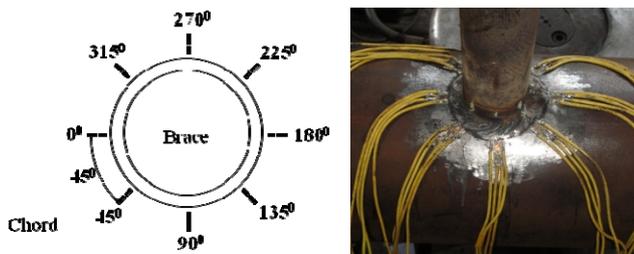
Fig. 5 Placement of strain gauges

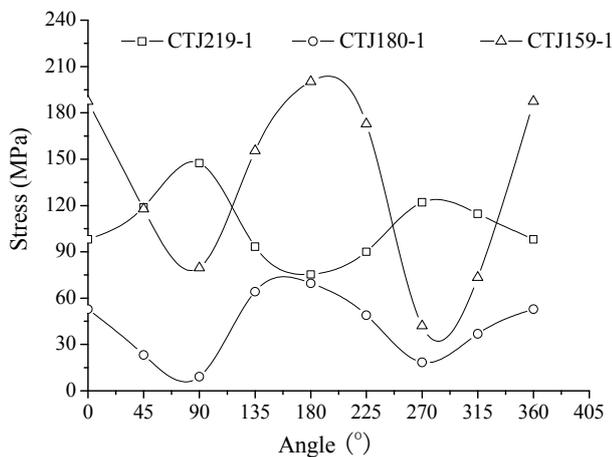
Fig. 6 Hot spot stress distribution around weld toe

The tested results show that the maximum hot spot stresses for the specimens in the groups of CTJ159 and CTJ180 are all located at 180° while such position for specimens in the group of CTJ219 is located at 90° . The above results indicate that the fatigue cracks for the specimens in the groups of CTJ159 and CTJ180 are expected to initiate at the crown while the saddle is the expected initiation position of the fatigue cracks for the specimens in the group of CTJ219. It is noted here that the location of the peak stress at the weld toe of a tubular T-joint was proved to be possibly located at crown or saddle based on the joint's geometry (Shao 2007) although previous static tests on cracked tubular T-joints were all assumed that the fatigue crack was located at the saddle position.

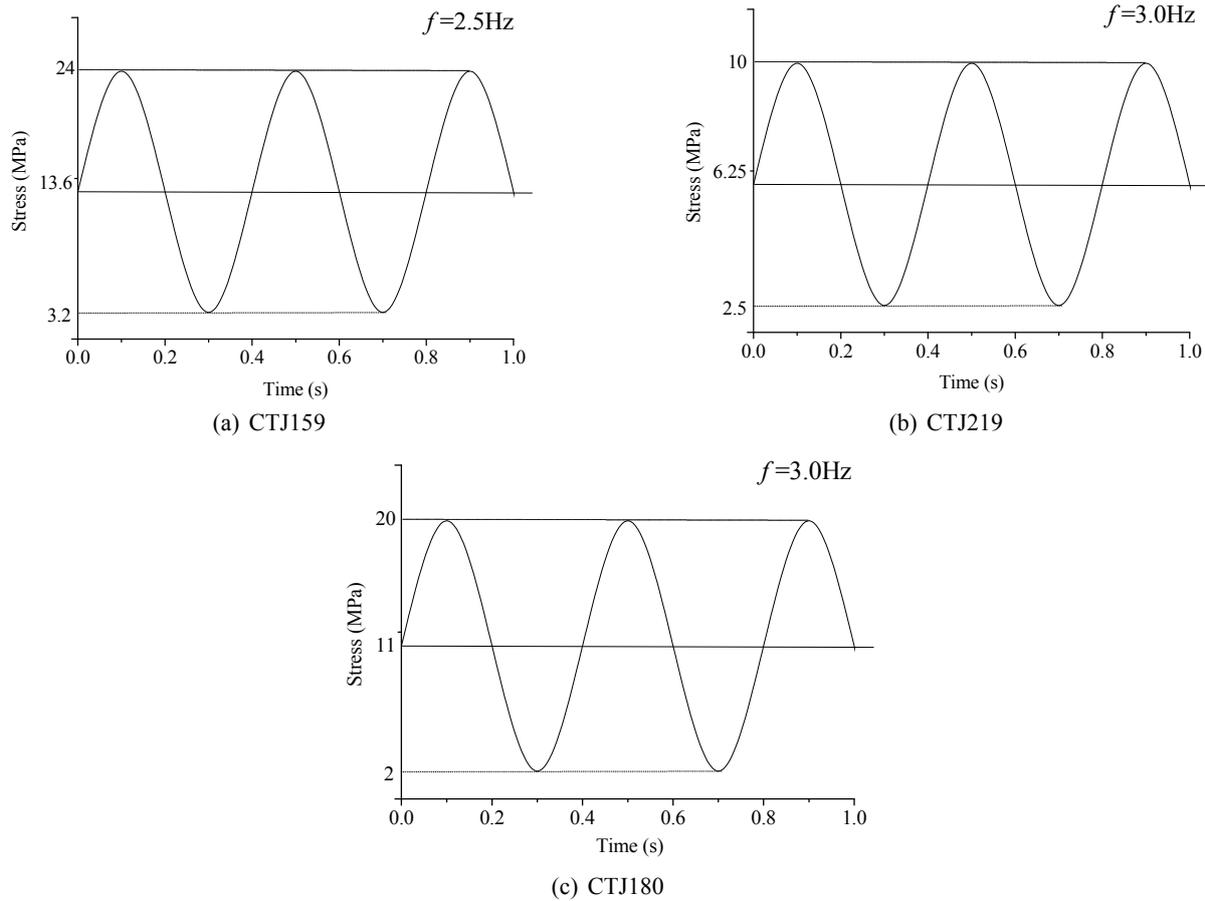
Fig. 7 Schemes of cyclic loading

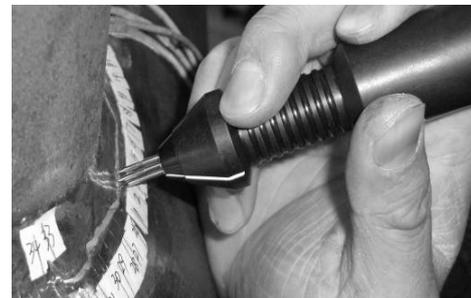
Fig. 8 Crack gauge for measuring crack depth and length

The crack development during the fatigue test is monitored by using crack gauge as shown in Fig. 8. The crack gauge measures the depth of the fatigue crack located at the weld toe based on alternate current potential drop (ACPD) technique, and such technique was introduced in details by Huang (2002) and Shao and Cao (2005). The accuracy of the crack depth measured by the crack gauge is

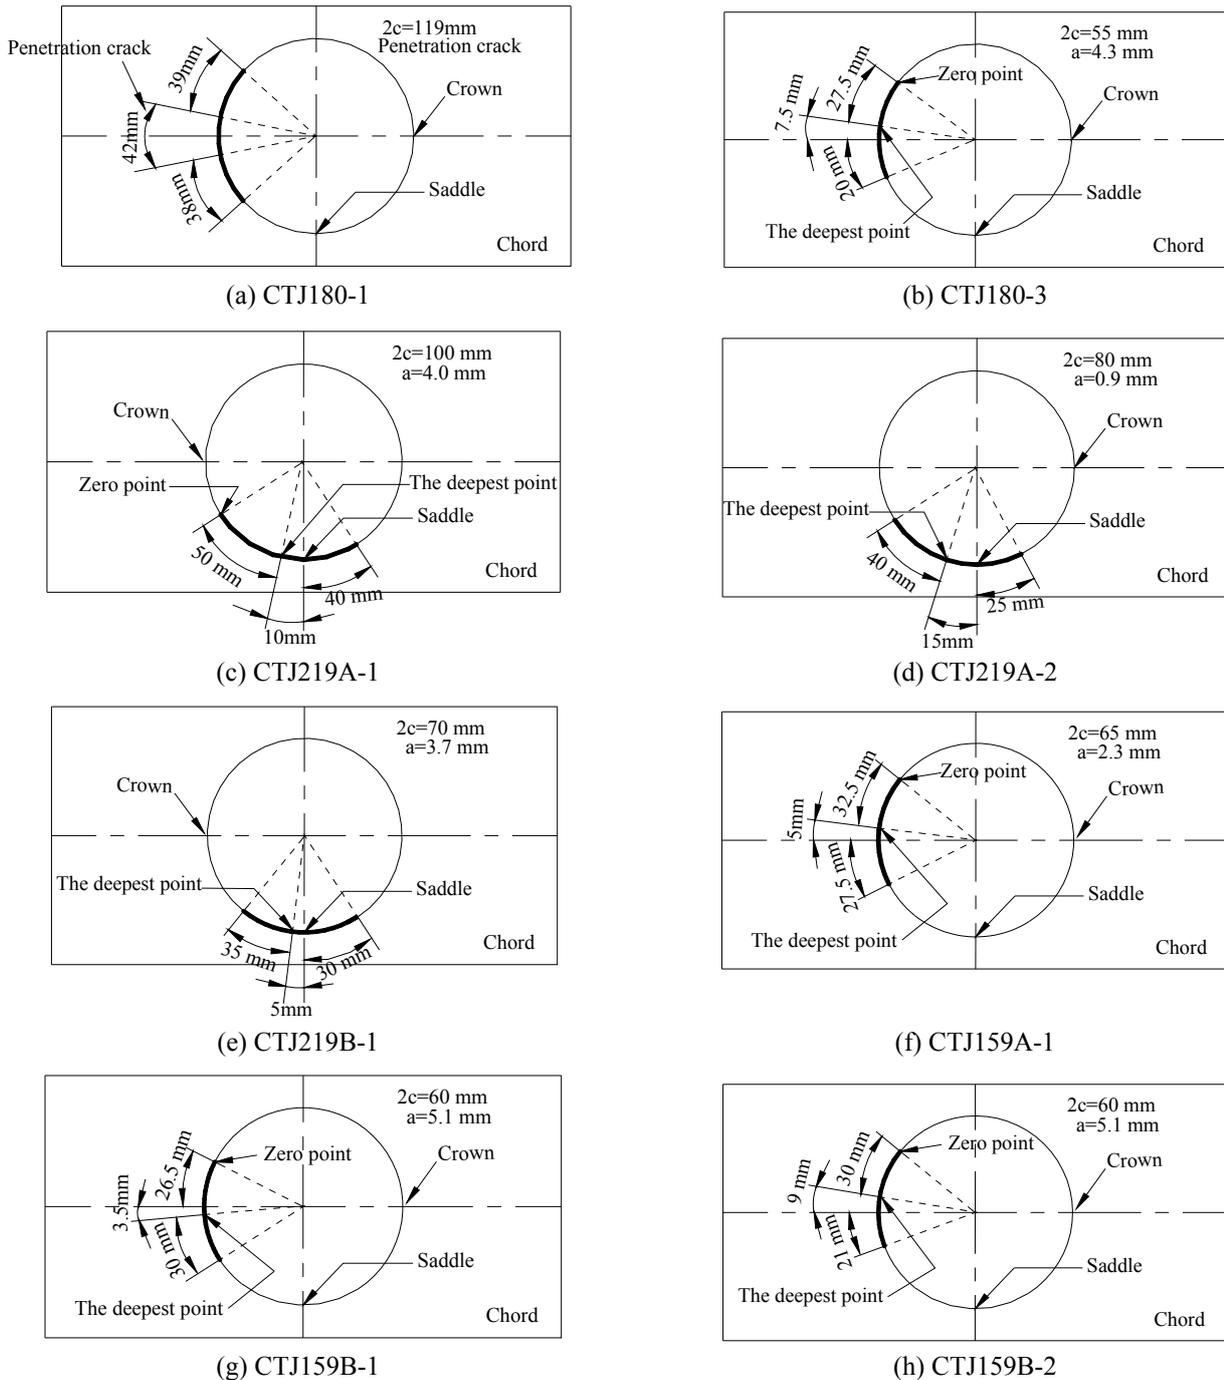
Fig. 9 Details of fatigue crack

From Table 4 and Figs. 9(a)-(h), it is found that the previous prediction on the crack locations for all the specimens is coincident with the experimental observations. Specimen CTJ180-1, which has a lower number of loading cycles at failure, is designed to be subjected to a larger loading amplitude range. The numbers of loading cycles after fatigue tests are found to be much similar for the specimens subjected to same loading cycles in each group. In addition, the fatigue crack in specimen CTJ180-1 already penetrates the chord wall. For other specimens, all the cracks do not penetrate the chord wall after the fatigue tests, i.e., all of them are surface cracks.

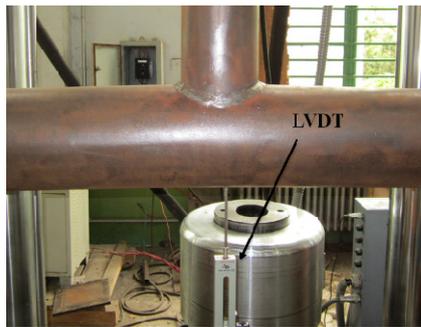
Fig. 10 LVDT at the bottom of the chord

ments is defined as the deformation of the chord, and it also refers to the joint’s ovalisation. Such definition is acceptable because the tension of the brace is much smaller compared to the radial deformation of the chord since the axial stiffness of the brace is generally much bigger than the radial stiffness of the chord.

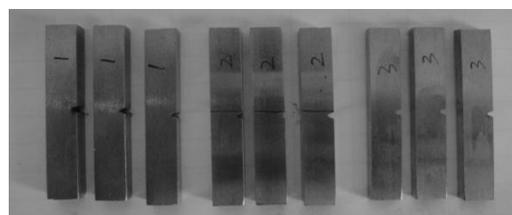
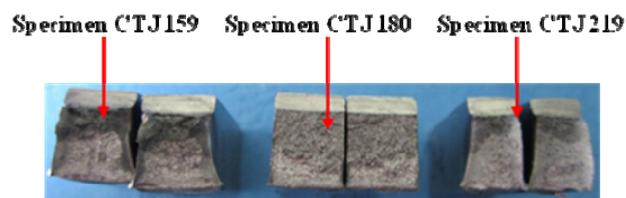
Fig. 11 Specimens in Charpy test

(a) Before test

(b) After test

to fabricate the coupon for Charpy test. The size of the coupon is 10 mm × 5 mm × 55 mm (width × height × length) for the specimens in the group of CTJ219 and 10 mm × 7.5 mm × 55 mm for the specimens in the groups of CTJ159 and CTJ180, as shown in Fig. 11(a). The fractured section of the specimens after impacting tests is shown in Fig. 11(b), and it is found that the fractured section of the specimens in the group of CTJ180 is smooth and bright with very little residual deformation. For the specimens in the groups of CTJ219 and CTJ159, the fractured section is relatively dark and coarse, which indicates that plastic deformation occurs during the impacting tests.

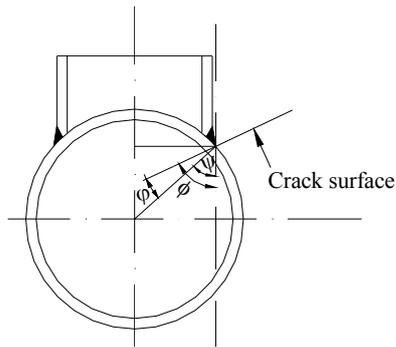
Fig. 12 Inclination angle of a crack in a tubular joint

After the static tests, the crack surface is opened, and the crack propagating angle φ , also called the inclination angle of the crack surface as shown in Fig. 12, is also measured.

In Fig. 12, ψ is the angle between the vertical direction and the direction of the line passing through the weld toe and the centroid of the chord's cross section. ϕ is the angle between the vertical direction and the direction of the line passing through the weld toe and the actual crack surface. The inclination angle of the fatigue crack φ is then calculated from the following equation

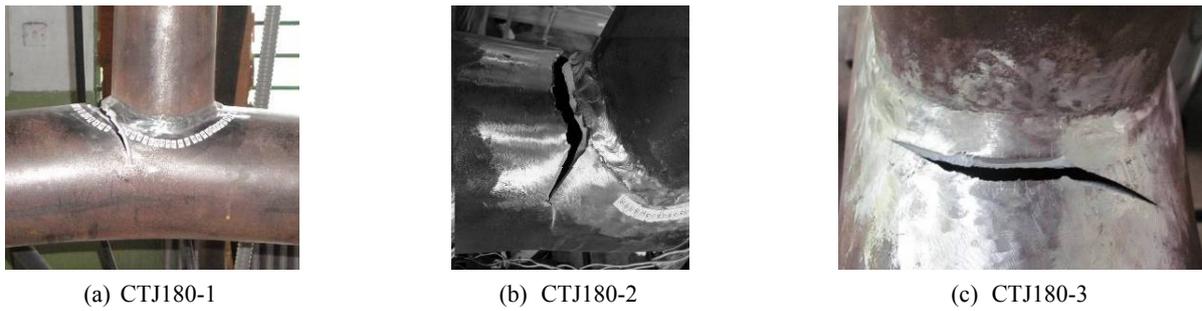
Fig. 14 Failure mode of cracked specimens in group CTJ180

For the specimen CTJ180-1, the maximum stress at the weld toe in the cyclic loading exceeds the yield strength of the steel material, and hence the fatigue crack propagates very fast. After the fatigue test, it is found that the crack already penetrates the chord wall. In the static test, the specimen is suddenly fractured in the chord and the crack propagates very fast along its two ends when the load exceeds a critical value. The final failure mode is shown in Fig. 14(a). For the other two specimens CTJ180-2 and

CTJ180-3, the cracks are not penetrating through the entire chord wall after the fatigue tests. In the static tests, the two specimens are also suddenly fractured at critical loads, and the final failure modes of the two specimens are shown in Figs. 14(b) and (c).

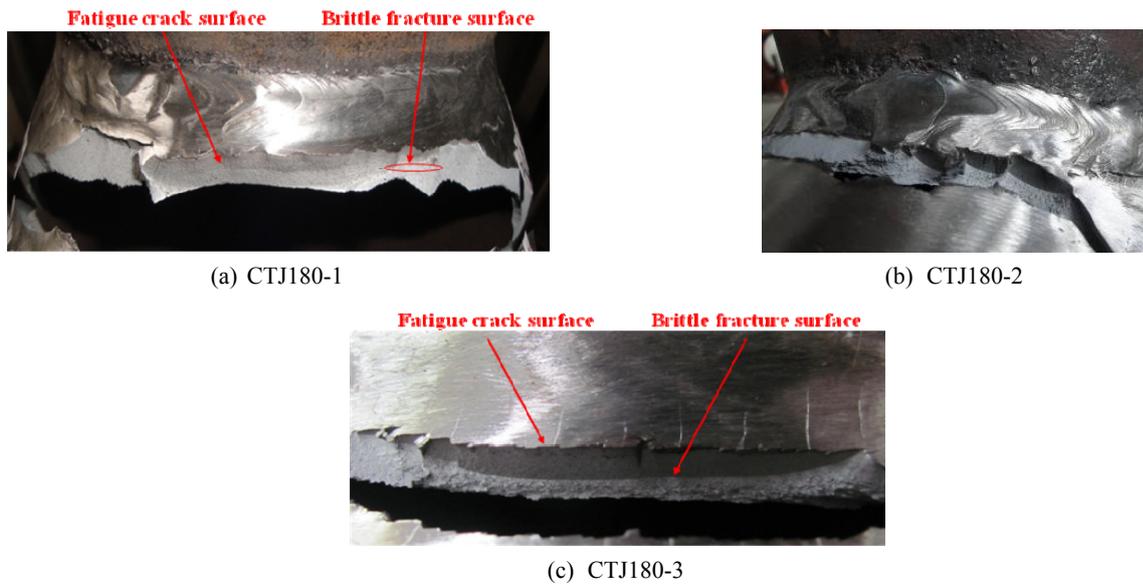
Fig. 15 Crack surfaces of the specimens in group CTJ180

From Figs. 15(a)-(c), it can be found that the crack surfaces of the specimens CTJ180-1 and CTJ180-3 can be divided into two types: a dark and smooth surface produced from the fatigue test, and a bright and rough surface caused by brittle fracture. No clear ductile shear crack surface is found from the observations. For specimen CTJ180-2, the crack surface is not observed because the crack surface is very rough.

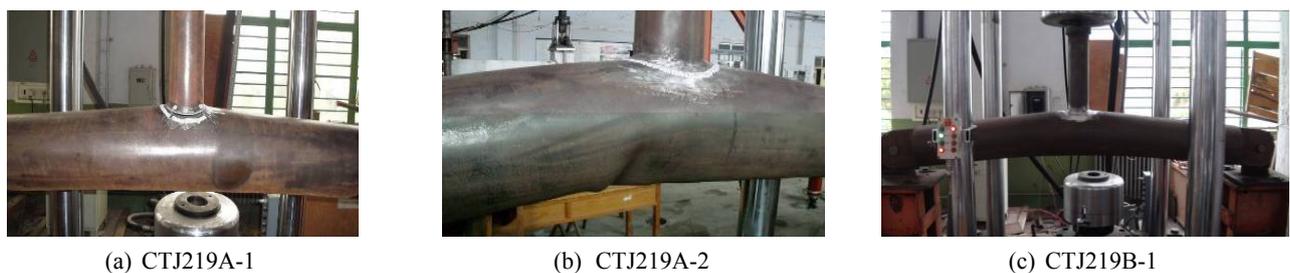
Fig. 16 Failure modes of the specimens in group CTJ219

of specimen CTJ219B-1 is smaller than that of specimen CTJ219A-1. During the static test, it is found that specimen CTJ219A-2 experiences a very large plastic deformation in the chord while no clear crack propagation is observed, as shown in Fig. 16(b). For specimen CTJ219A-1, the crack is propagating continuously during the loading process till it penetrates the chord wall as shown in Fig. 16(a). It is also observed from Fig. 16(a) that the chord ovalisation of the specimen is already very clear when the crack penetrates the chord wall. The failure mode of specimen CTJ219B-1 is observed from Fig. 16(c), in which it is clear that both the chord ovalisation and the chord's bending deformation are very big after the static test. However, it is measured from the crack gauge that the crack does not penetrate the chord wall although it propagates to a large depth.

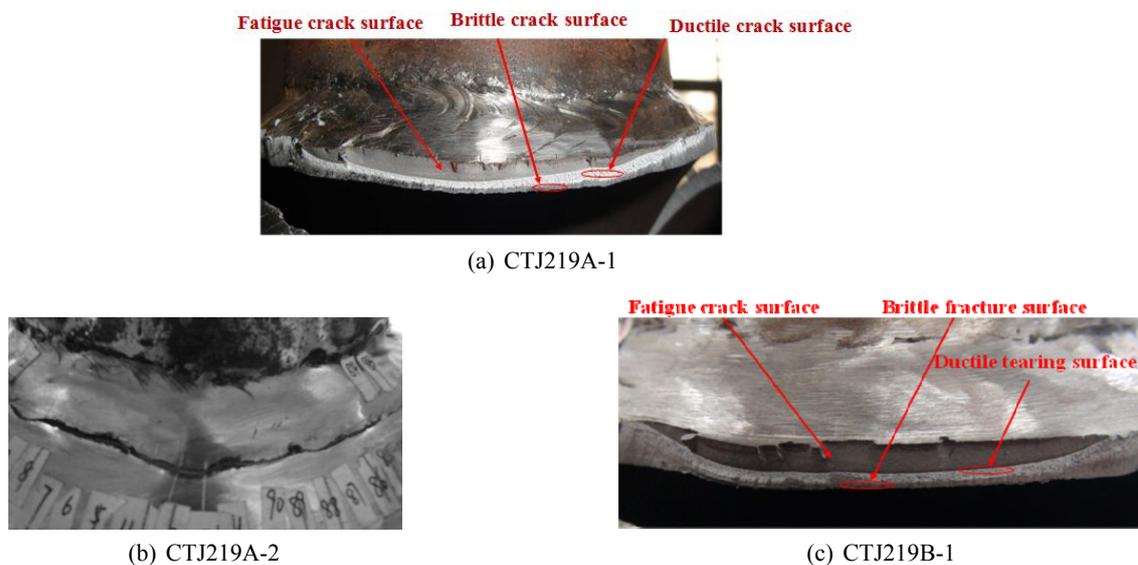
Fig. 17 Crack surfaces of the specimens in group CTJ219

After the static tests, specimens CTJ219A-1 and CTJ219B-1 are splitted into two parts along the crack surface at the weld toe to observe the crack propagating process. The crack development in the two specimens can be seen in Figs. 17(a) and (c). Because only a small crack with much minor depth is located in specimen CTJ219A-2 and no crack propagation is monitored during the static test, specimen CTJ219A-2 cannot be splitted just from tensile loading at the brace end. However, it can be found from Fig. 17(b) that only a slight opening of the crack mouth is observed after the static test.

It is clear that the crack propagation of the specimens in the group of CTJ219 (except CTJ219A-2) is much different with the crack development of the specimens in the group of CTJ180. As seen from Fig. 17(a), the crack surface of specimen CTJ219A-1 during the static test includes three different sections: fatigue crack surface, ductile crack surface and brittle crack surface. The fatigue crack surface is dark and smooth, and it is produced during fatigue test before the static test. The ductile crack surface, which is also relatively smooth and bright, is produced during the static test before final sudden fracture failure. The brittle crack surface is produced suddenly after the load is increased to a critical value. The sudden fracture causes the

brittle crack surface to be rough and bright. In specimen CTJ219B-1, the fatigue crack also propagates in the thickness direction of the chord wall during the static test. However, no brittle failure occurs in this specimen before the test is finished, which may be due to the smaller crack depth compared to specimen CTJ219A-1. After the static test, the specimen is loaded till the fatigue crack is splitted into two separate surfaces suddenly as shown in Fig. 17(c). The final crack in Fig. 17(c) is clearly consisted of three surfaces: fatigue crack surface, ductile crack surface and brittle crack surface. Similarly, the fatigue crack surface and the ductile crack are produced in the fatigue test and in the static test respectively. The brittle crack surface, not produced in the static test, is generated artificially after the static test.

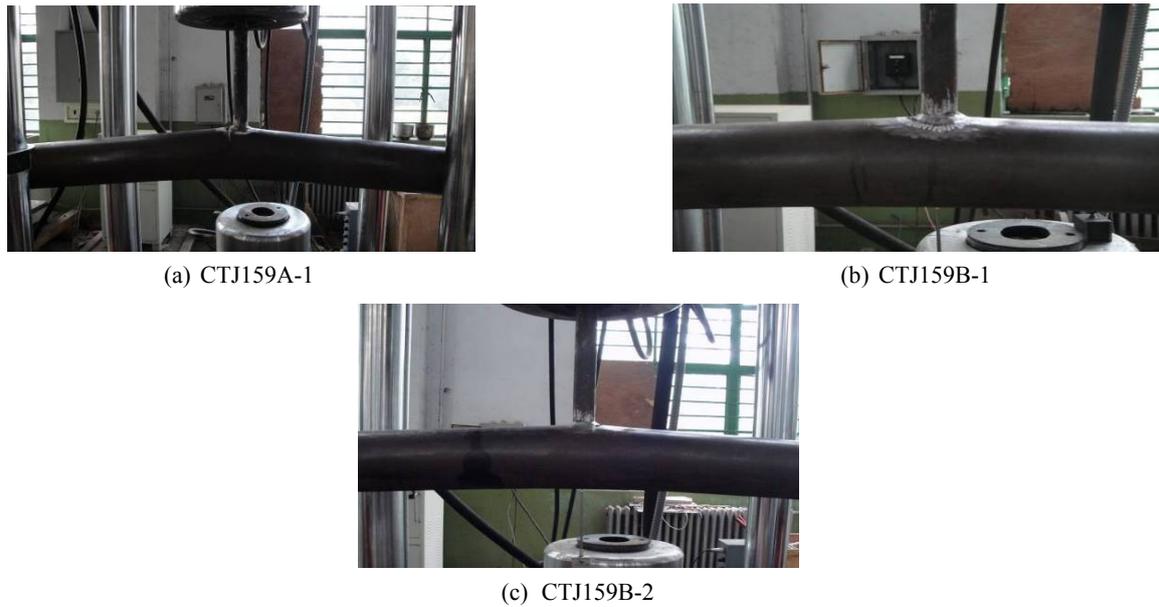
Fig. 18 Failure modes of the specimens in group CTJ159

The final failure modes of the specimens in the group of CTJ159 are illustrated in Figs. 18(a)-(c). For specimen CTJ159A-1, both local ovalisation and bending deformation of the chord are quite big as shown in Fig. 18(a). When the load is increased to a critical value, a brittle fracture occurs suddenly. Similar failure process occurs for the other two specimens as shown in Fig. 18(b) and (c).

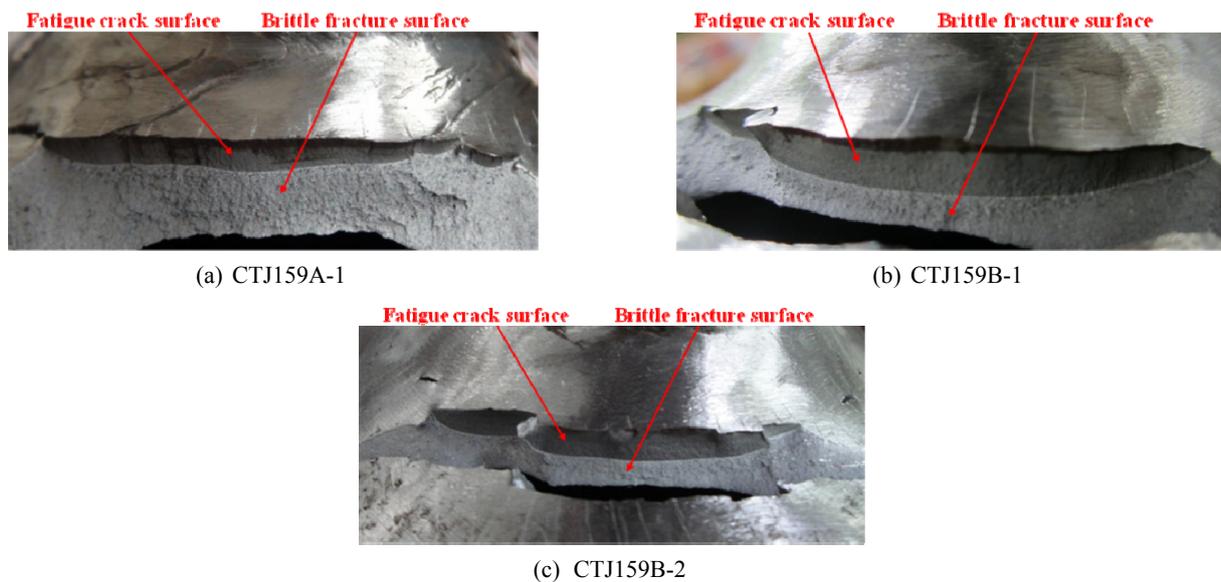
Fig. 19 Crack surfaces of the specimens in group CTJ159

From the careful observation for the crack surfaces of the three specimens, as shown in Figs. 19(a)-(c), the crack surface includes two clear parts: fatigue crack surface and brittle crack surface. Although the toughness of the steel materials is satisfied with the specification in Chinese code (National Standard of the People's Republic of China 2007), these specimens also show a final brittle fracture failure, which is different with the observations for the specimens in the group of CTJ219. This may be caused by the geometry of the specimens. The brace-to-chord diameter

ratio β is the only different geometrical parameter in the specimens between the groups of CTJ219 and CTJ159. A smaller value of β definitely causes more severe stress concentration at the weld toe in a tubular T-joint. As tri-axial stress state exists easily in a region with high stress gradient caused by severe stress concentration, such stress state causes the material to become much more brittle, and thus it is more sensitive for the T-joint to lose its loading carrying capacity in fracture failure.

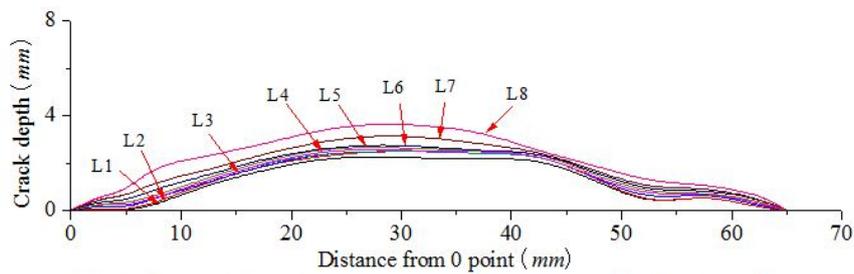
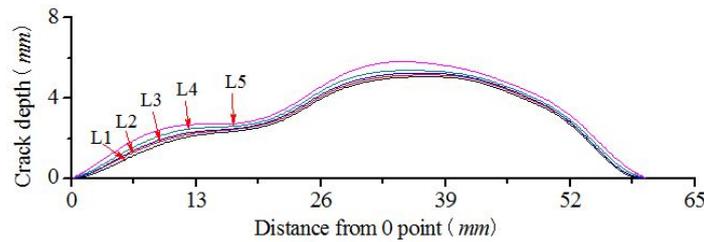
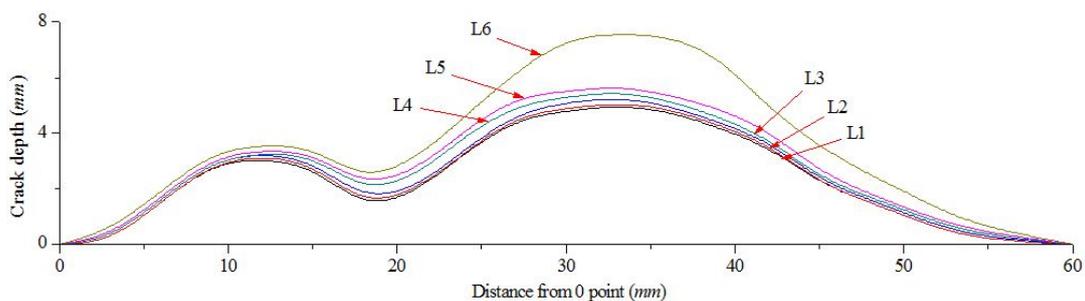
Fig. 22 Crack development for specimens in group CTJ159

L1: P=80kN L2: P=100.05kN L3: P=121.5kN L4: P=133kN L5: P=138.6kN
L6: P=142kN L7: P=145kN L8: P=148kN

(a) CTJ159A-1

L1: P=60kN L2: P=100kN L3: P=110kN L4: P=124kN L5: P=125kN

(b) CTJ159B-1

L1: P=30kN L2: P=90.15kN L3: P=114.7kN L4: P=121kN L5: P=126kN L6: P=124.6kN

(c) CTJ159B-2

Generally, the crack developments of the three specimens in the group of CTJ159 are similar to those of the specimens in the group of CTJ180, as shown in Figs. 22(a)-(c). There is a gradually propagating process before final fracture failure in the static tests. When the crack depth exceeds to a certain value, a fast crack propagation occurs with a minor increase of the load to show that a

brittle fracture failure occurs along the crack tip (from L6 to L7 for specimen CTJ159A-1, from L5 to L6 for specimen CTJ159B-2, and from L4 to L5 for specimen CTJ159B-1).

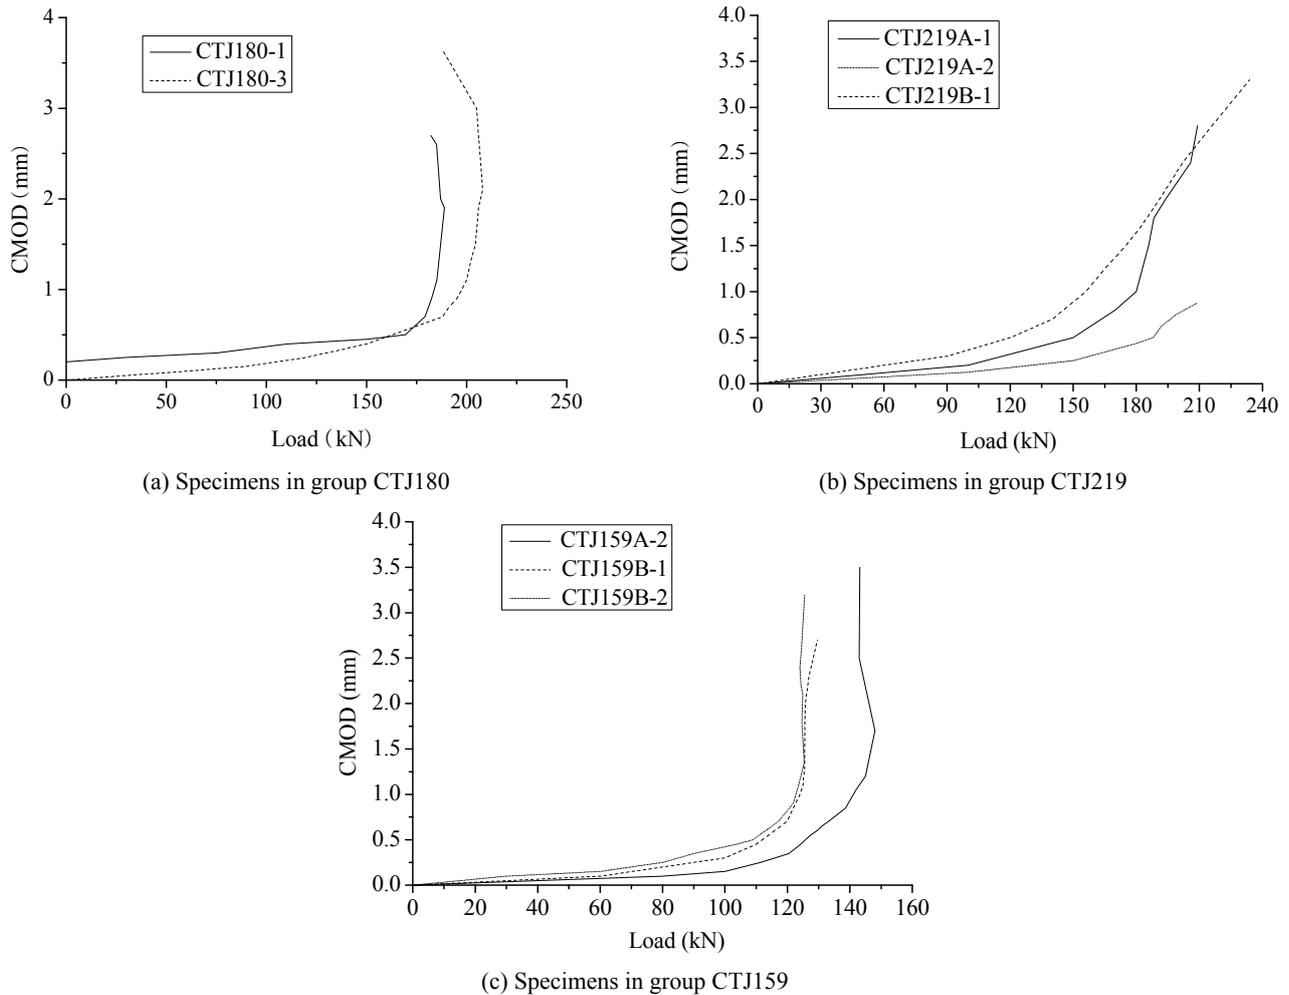
Fig. 23 Opening displacement of crack mouth development

CMOD-load curve for each specimen. For all the specimens in the static tests, the CMOD-load curves are plotted in Figs. 23(a)-(c). It should be noted here that CMOD in Figs. 23(a)-(c) is the maximum value along the crack length. Generally, the CMOD-load curves can be classified into two principal stages: approximately linear stage and clearly nonlinear stage. In the approximately linear stage, the CMOD is increasing with the increase of the applied axial load, and the relationship between them is close to be linear. In this stage, the fatigue crack opens in a linear and elastic state, and hence the CMOD is proportional to the applied load. Plastic deformation only exists in a small region around the crack tip. With the increase of the applied load, the plastic region around the crack tip becomes larger, and the crack becomes blunted. In this case, the value of the CMOD increases quickly with relatively minor loading increment, and this stage is defined as the nonlinear stage. A blunted crack is much more feasible to propagate in a ductile form, and it occurs more easily when the toughness of the steel material is high and stress concentration is not much severe at the crack tip.

in the specimens in the groups of CTJ180 and CTJ159. Such observations also support the CMOD-load curves of these specimens. In Figs. 23(a) and (c), it is clear that the CMOD almost increases in an upward direction in the nonlinear stage for the specimens in the groups of CTJ180 and CTJ159, and a load drop can be found after the COMD is beyond a critical value. The above phenomenon implies that the CMOD increases sharply with almost no increase of the load. This situation occurs due to the brittle fracture failure because the specimens cannot sustain an increasing load at such state. However, the CMOD increases gradually with the increase of the load for the specimens in the group of CTJ219 as shown in Fig. 23(b), and there is no sharp increase of the CMOD within a slight loading increase. This phenomenon is caused by a ductile crack propagation rather than a brittle fracture failure process. The development of CMOD of specimens in group CTJ180 and CTJ159 in the second stage is much different with previous studies (Talei-Faz *et al.* 2004, Zerbst *et al.* 2002) in which ductile tearing process of the surface cracks in the specimens were observed and measured.

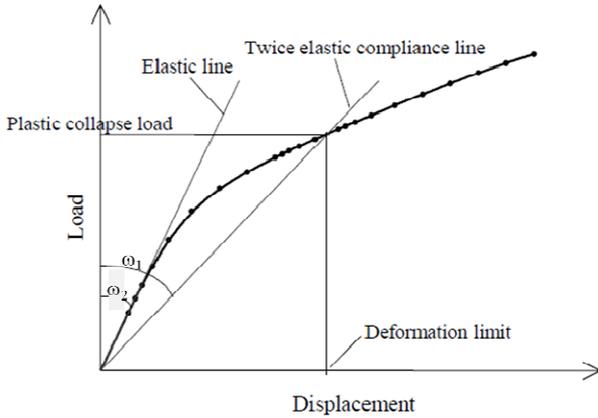
Fig. 24 Twice elastic compliance criterion

According to the definition of the twice elastic compliance criterion on the load carrying capacity of a tubular joint, the load carrying capacities of all the specimens are generalized in Table 7. P_u and P_c in table represent the load carrying capacities of the specimens without and with fatigue crack respectively. For the specimens in the group of CTJ180, the load carrying capacities of all the cracked specimens decrease. However, the decreasing magnitude for specimen CTJ180-1 is much bigger because the fatigue crack already penetrates the chord wall. For the other two specimens, the decrease of the load carrying capacity is much slight, which implies that the surface crack has a minor influence on the static strength.

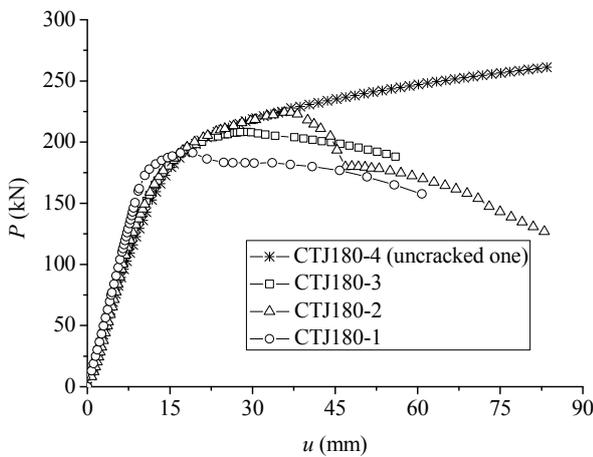
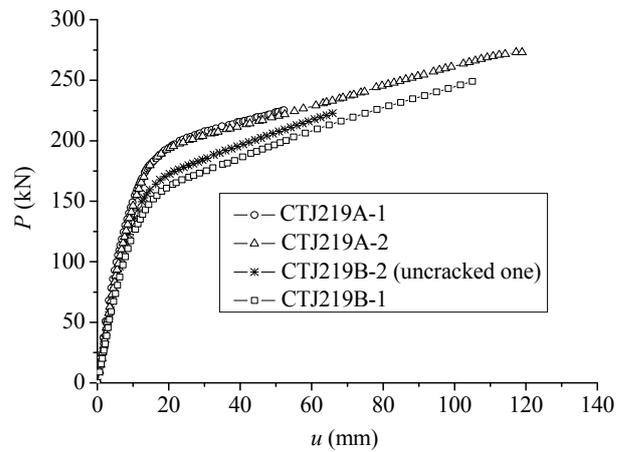
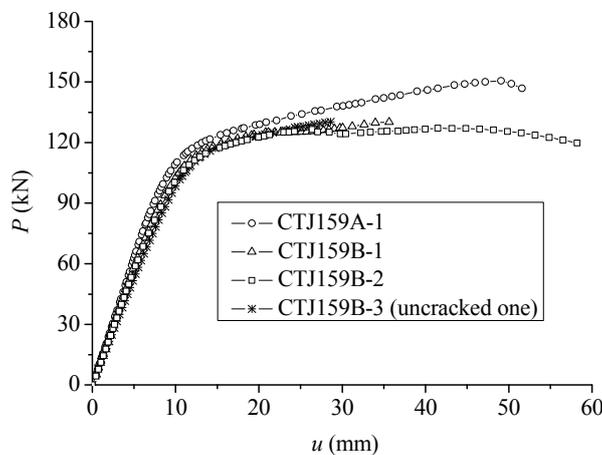
Fig. 25 Load-displacement curves

(a) Specimens in group CTJ180

(b) Specimens in group CTJ219

(c) Specimens in group CTJ159

The experimental results of the load-displacement curves for all the specimens are plotted in Figs. 25(a)-(c). For the specimens in the group of CTJ180 as shown in Fig. 25(a), the load-displacement curves of the cracked specimens all have a peak point, and the load reduces due to brittle fracture after that point. For the uncracked specimen, there is no peak point on the load-displacement curve although a knee point exists to indicate the nonlinear stage.

For the specimens in the group of CTJ219 as shown in Fig. 25(b), the load-displacement curves of both uncracked and cracked specimens have no peak points, and only knee points are found to be located at the curves, which proves that no brittle fracture occurs in the static tests. For the specimens in the group of CTJ159, it is found that there is also a load drop in the load-displacement curve for the cracked specimens. However, such load drop is relatively much minor and it occurs at a very large displacement.

The loading drop after the peak value for the specimens in group CTJ180 as shown in Fig. 25(a) indicates that the through crack has effect on both failure load and failure mechanism, which is different from the reported conclusions of previous studies (Talei-Faz *et al.* 2004, Zerbst *et al.* 2002) that surface crack has very minor effect on the static strength and the failure of the specimens containing crack is ductile.
