Effects of deficiency location on CFRP strengthening of steel CHS short columns

Razieh Shahabi^a and Kambiz Narmashiri^{*}

Department of Civil Engineering, Zahedan Branch, Islamic Azad University, Zahedan, Iran

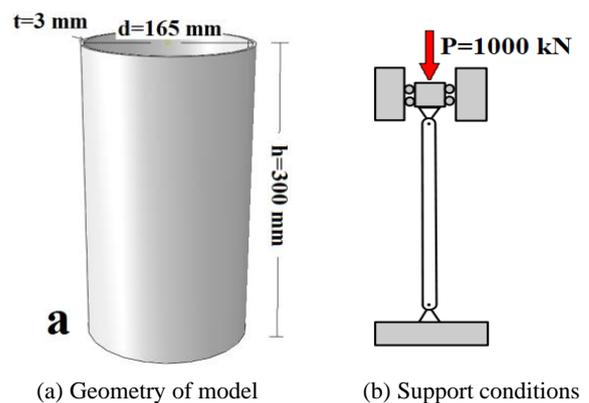
Fig. 1 Schematic of the model

Circular Hollow Section (CHS) (Height = 300 mm, Outer Diameter = 165 mm, Thickness = 3 mm, Yielding Stress = 315, Ultimate Stress = 382 MPa, and Ultimate Strain = 19.8%) was taken into account. The columns dimensions and material properties which were obtained by coupon test were tabulated in Table 1. Figs. 1 and 2 show the support and loading conditions, geometric characteristics of columns, and the locations of defects. The height of the columns was chosen as the slenderness ratio of the columns is ranged in the short columns range. In this case, local buckling is taken place as will show in the most

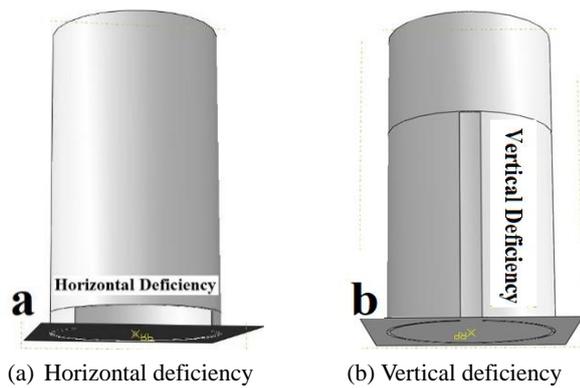
Fig. 2 Deficiency types

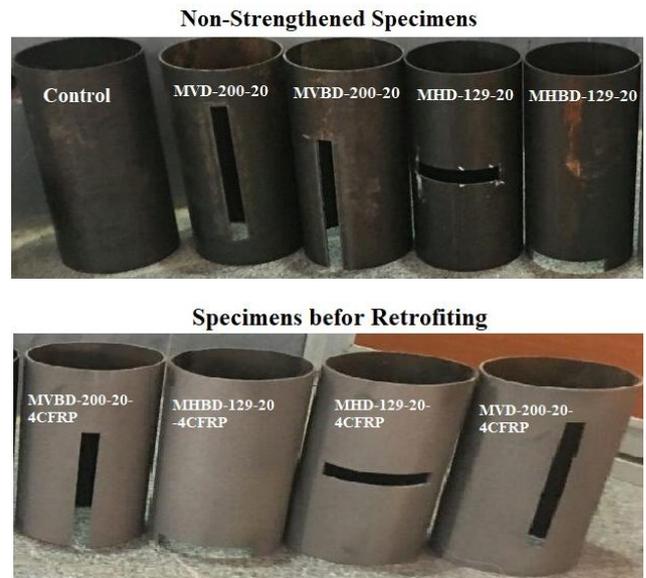
Fig. 3 Laboratory specimens before and after sandblasting

section (CHS). One specimen had no deficiency and was chosen as the control one. All other specimens had deficiency with different dimensions, orientations and locations. Some of the specimens had horizontal deficiency and other ones had vertical deficiency. Five of the columns were investigated both experimentally and numerically. All other columns were only simulated numerically. Table 4 shows the steel column characteristics. The specimens' dimensions were measured after cutting and before sandblasting. The reduction of the dimensions due to sandblasting was neglected. All defect lengths were measured for the curvature ones. Acronyms were used to label the specimens as follows: *H* and *V* shows Horizontal and Vertical defects, respectively. *M* and *C* show Middle and Corner defects. *T*, *M* and *B* indicate deficiency location at Top, Middle and Bottom of the columns, respectively. *D* shows that the specimen had deficiency. Four CFRP layers were used for strengthening. Two traverse and two longitudinal layers were employed. Note that Control has no defects. Fig. 3 shows the experimental specimens prior to the test.

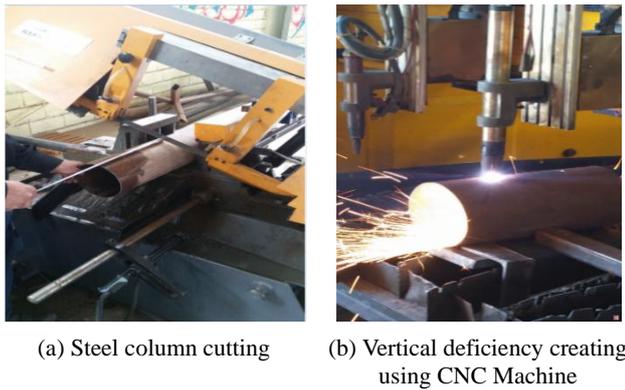
Fig. 4 Experimental specimens preparation

In the experimental study, horizontal and vertical defects were created at the middle and bottom of the steel columns using Computer Numerical Control (CNC) machine. Fig. 4 shows the cutting procedure by CNC. To create clean and corrosion-free specimens, 9 cut steel columns were transferred to the factory. Steel columns were sandblasted in order to attach CFRP sheets. Sandblast degree was chosen 2.5 according to the Swedish Standard (SIS 05 59 00, 1967-Pictorial Surface Preparation Standards for Painting Steel Surfaces). Fig. 5 shows a set of sandblasted steel columns with defects.

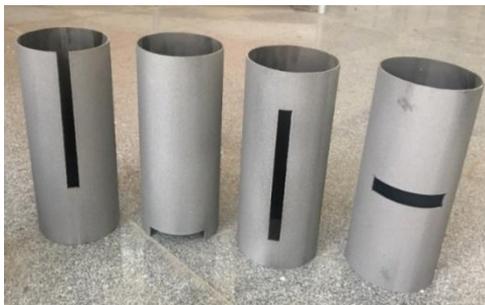
Fig. 5 Sandblasted specimens

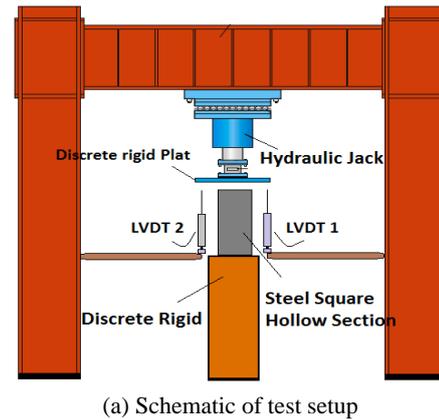
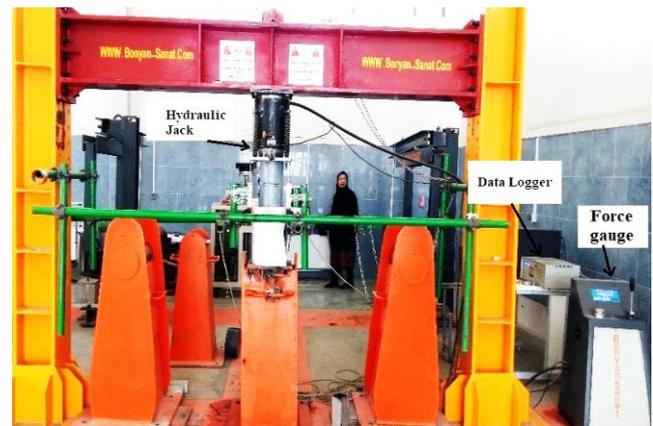
(a) Schematic of test setup

(b) Experimental test setup

Fig. 6 Test setup

In order to study the effect of deficiency location on bearing capacity of CHS short steel columns, the specimens were placed on the base with the consideration of hydraulic jack axis. The force was axially applied. Displacement was measured by two LVDTs. Fig. 6 shows the compression test in the laboratory. LOADCELL and LVDT were connected to the DATA LOGGER in order to record and save the data. The load was gradually imposed by the jack. The test method was load-control type, and the minimum loading rate was used. When the ultimate load was decreased suddenly by 20%, then the loading was stopped automatically due to safety. Afterward, the manual loading method can be used. Finally, the bearing capacity and deformation were accurately saved.

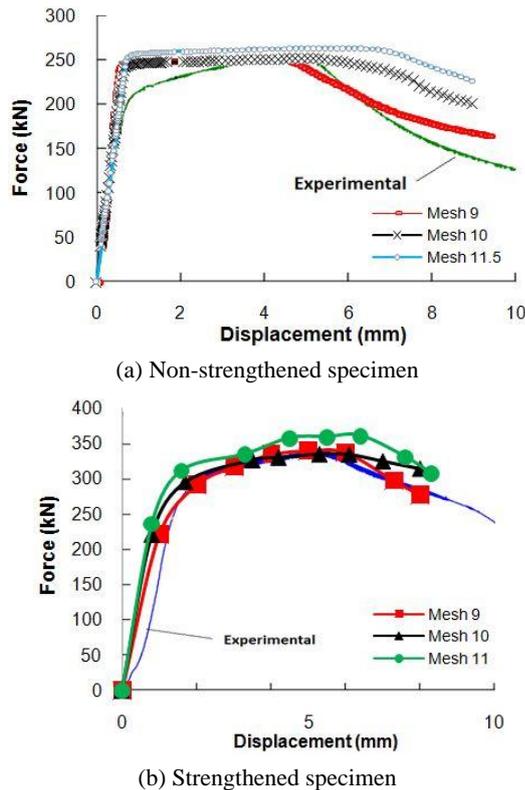
Fig. 7 Force-displacement validation using different meshing sizes

were used for modeling both strengthened and non-strengthened specimens investigated by Haedir and Zhao (2011). Fig. 7 indicates axial load-axial deformation of their specimens. According to Fig. 7(a), the bearing capacity difference percentage for non-strengthened specimen is seen 8% in 11-mm for non-strengthened specimen compared to 9-mm mesh. 10 mm-mesh had similar capacity to 9-mm one. In terms of fail time, 9-mm mesh showed better compatibility. The compatibility of 9-mm mesh modeling with laboratory specimen for both strengthened (Fig. 7(b)) and non-strengthened specimens (Fig. 7(a)) shows the correct selection of mesh, optimal boundary conditions, and appropriate software modeling.

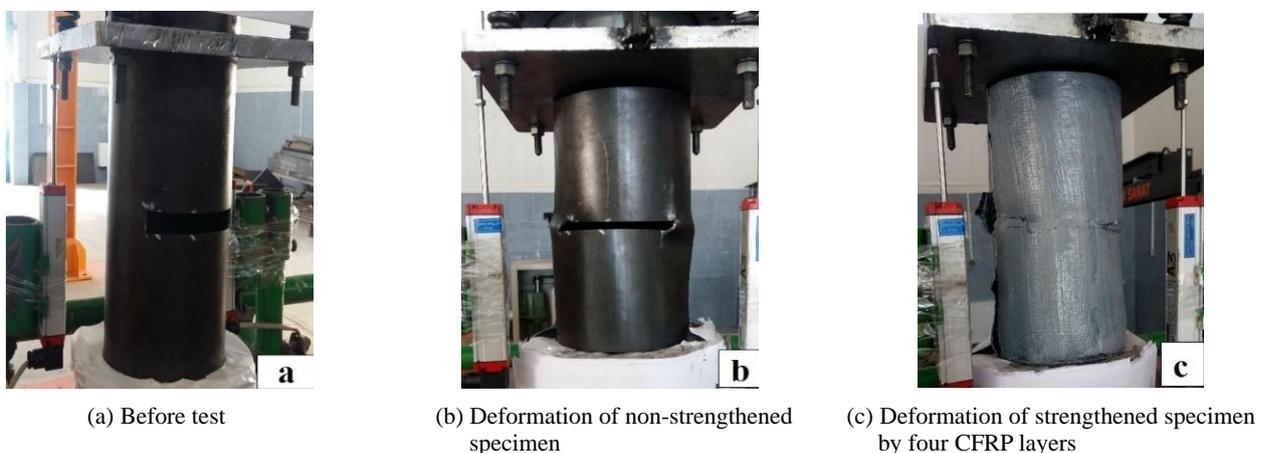
Fig. 8 Column with horizontal deficiency at the middle of column

As it can be seen in Fig. 8(b), the deformation caused by compression loading of steel columns with horizontal defect caused the rupture and decrease in defect width at the middle of the element. This was responsible for the decrease in resistance and stiffness. Table 4 shows that the defect was responsible for the decrease in bearing capacity by almost 23.15% compared to the control. As it is evident in Fig. 8(c), strengthening by four CFRP layers in the steel column with horizontal defect increased the stiffness and delayed rupture in the walls. This was responsible for the increase in resistance and bearing capacity by up to 370 KN. Note that the initial failure of carbon fiber was observed at 200 KN in steel columns strengthened by four CFRP layers. Loading time increased contributed to greater failure percentage and rupture at CFRP zone.

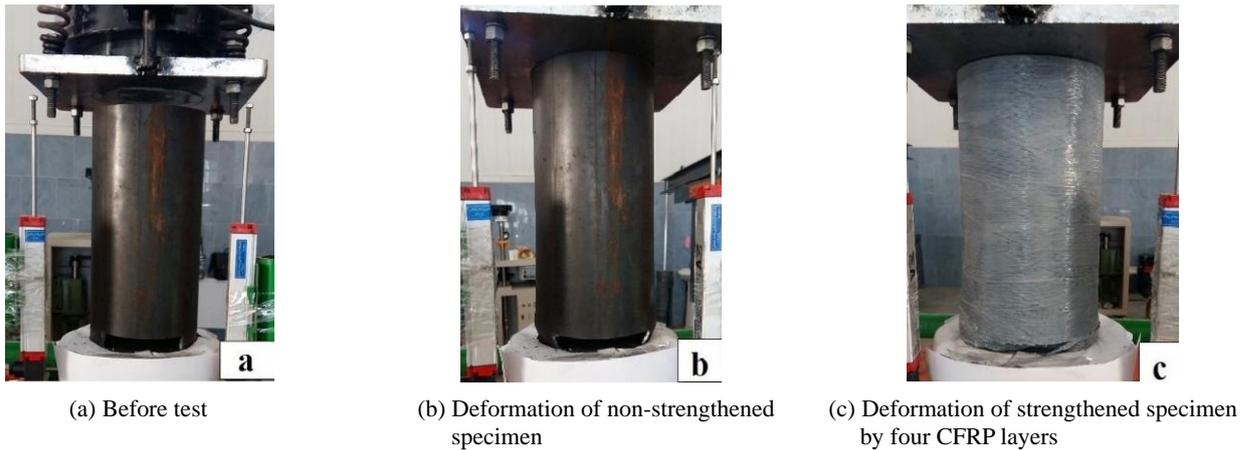
Fig. 9 Column with horizontal deficiency at the bottom of column

According to Fig. 9(b), horizontal defect at the bottom of the steel column (MHBD-129-20) increased deformation around the defect and, accordingly, rupture and accretion. This was responsible for the decrease in bearing capacity by almost 20.26% compared to control. Note that the defect was not effective in buckling. Strengthening coupled with the significant decrease in compressive stress at the defect zone improved the performance and increased the bearing capacity by 381 KN (Fig. 9(c)).

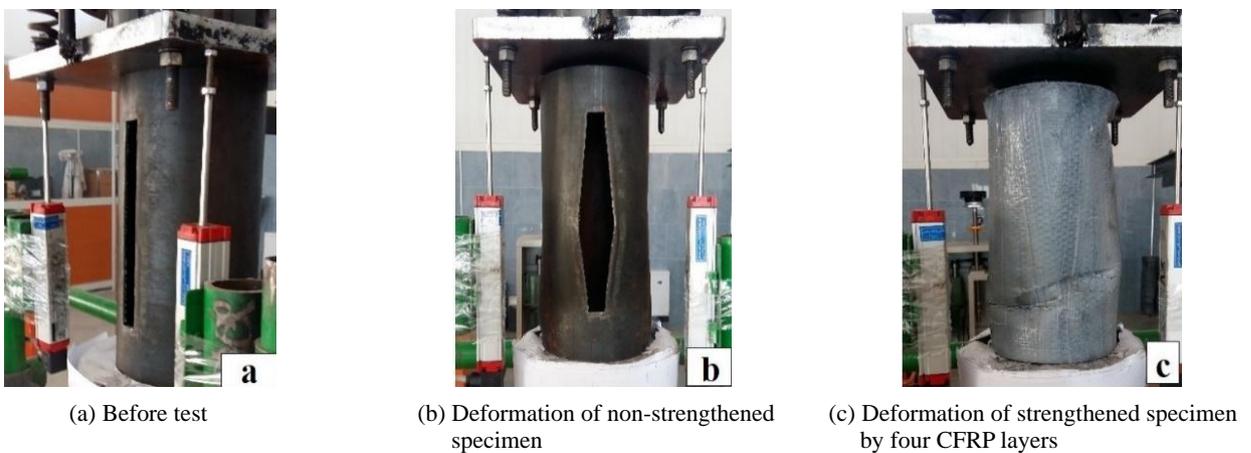
Fig. 10 Column with vertical deficiency at the middle of column

Fig. 10(b) shows the vertical defect at the middle of the column. The resistance decrease in bearing capacity was

responsible for the increase in defect length and Von-Mises intensification including compressive and shear stress at defect edges and tensile stress at the middle of the defect. Bearing capacity decrease was reported by 14.73% compared to the control. Using CFRP increased the bearing capacity by up to 460 kN. Such resistance increase met the shortcoming. Fig. 10(c) shows the deformation of the

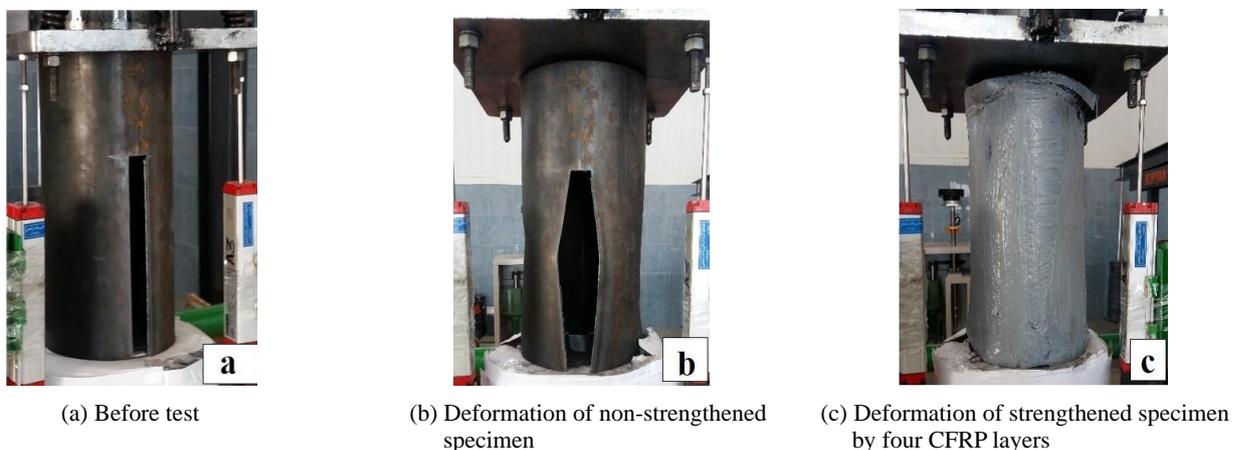
Fig. 11 Column with vertical deficiency at the bottom of column

the decrease in bearing capacity as a result of vertical defect decreased by almost 13.15% compared to the control. Fig. 11(c) shows that carbon layers covered and strengthened the element undergoing compressive loading, which was responsible for the increase in stiffness. Using four layers of CFRP contributed to the increase in the bearing capacity of the column with vertical defect by up to 466 kN.

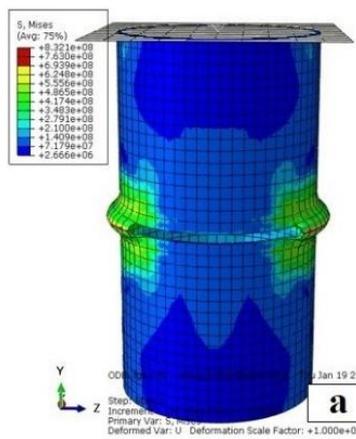
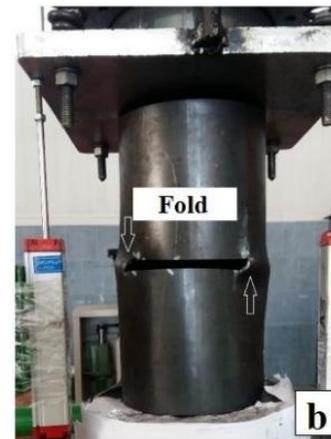
Fig. 13 Ultimate deformation of non-strengthened steel column having horizontal deficiency at the middle of column

Fig. 13 shows the horizontal defect at the middle of the CHS columns. After completed axial loading, it was found that the horizontal defect at the middle caused great deformation, reduced stiffness, and increased local buckling at the middle walls. Rupture began at almost 144 kN. Axial deformation continued until 292 kN. As it is evident, after finishing loading, the defect width decreased and accretion was observed at the defect zone. Fig. 14 shows the

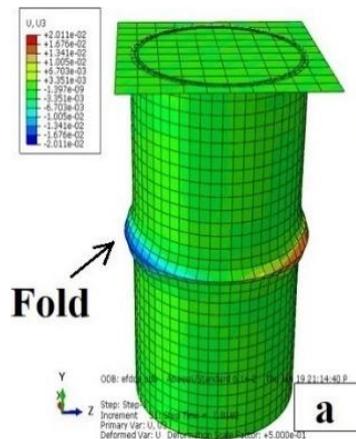
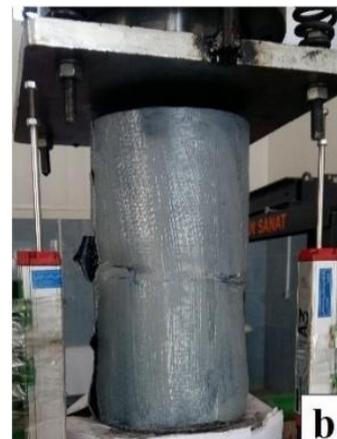
Fig. 14 Ultimate deformation of strengthened steel column having horizontal deficiency at the middle of column

strengthened column with horizontal defect using four CFRP layers. Strengthening horizontal defect increased the resistance. The failure and fiber separation occurred at the defect zone at the middle of the compressive element. The horizontal defect at the bottom of the steel column caused axial deformation compared to the control. As it is evident

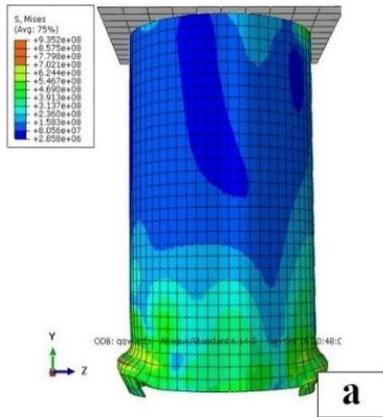
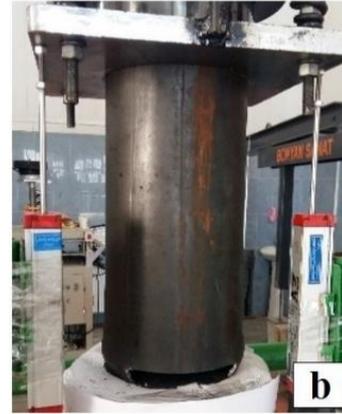
Fig. 15 Ultimate deformation of non-strengthened steel column having horizontal deficiency at the bottom of column

in Fig. 15, the increase in length caused increased yielding at the support zone. This damage at the end of the steel column increased the compression at support zone under axial loading. Using carbon fiber for strengthening the columns with horizontal defect showed that the defect was capable of improving the performance (Fig. 16).

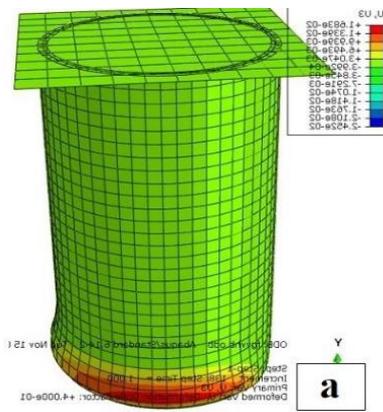
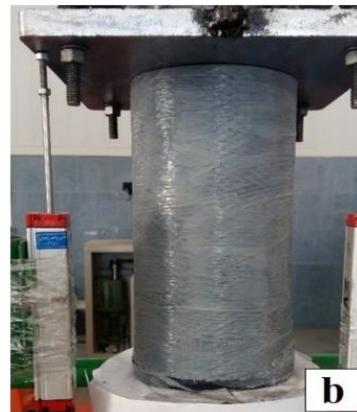
Fig. 16 Ultimate deformation of strengthened steel column having horizontal deficiency at the bottom of column

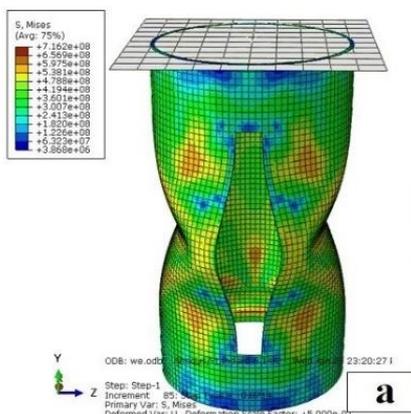
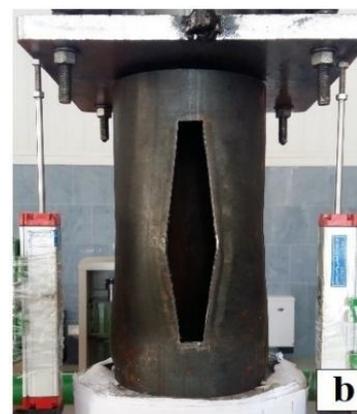
Fig. 17 Ultimate deformation of non-strengthened steel column having vertical deficiency at the middle of column

Fig. 17 shows the vertical defects at the middle of the CHS columns. Axial loading showed that the vertical defect in the middle of the column opened the defect width. It was also responsible for the decrease in stiffness and increase in

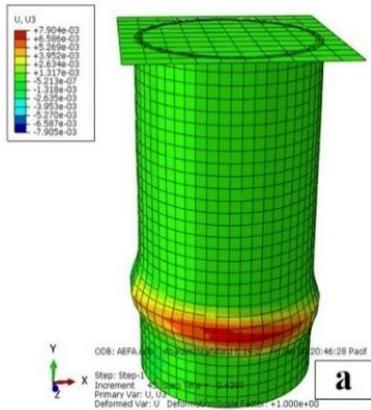
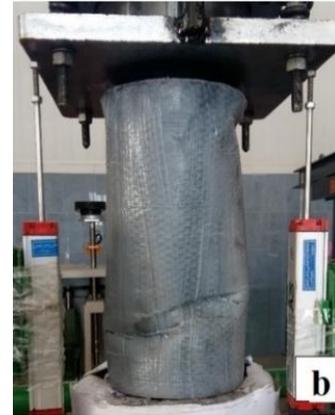
Fig. 18 Ultimate deformation of strengthened steel column having vertical deficiency at the middle of column

local buckling in middle walls. The rupture began at almost 198 kN. Axial deformations continued up to 324 kN. Fig. 18 shows the strengthening of columns with vertical defects using four CFRP layers. Vertical defect strengthening increased the resistance and controlled the local buckling. Carbon fiber rupture happened at the defect zone at the

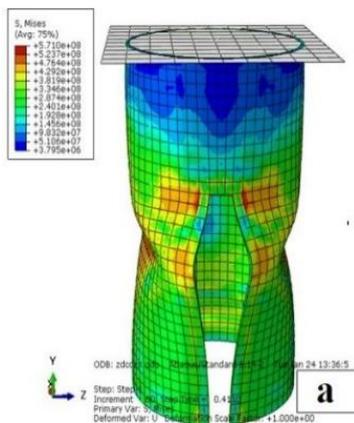
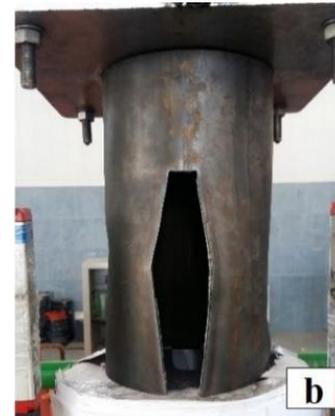
Fig. 19 Ultimate deformation of non-strengthened steel column having vertical deficiency at the bottom of column

Fig. 19 shows the vertical defect at the bottom of the column (MVBD-200-20). Axial loading on the columns with defect was associated with significant stiffness decrease compared to control. Horizontal defect had greater effect in resistance decrease and ultimate deformation compared to the vertical defect. CFRP composites played a key role in improving compressive element so that it increased the stiffness and resistance. Using CFRP was very effective in controlling elephant foot buckling. Fig. 20 shows the effect of CFRP.

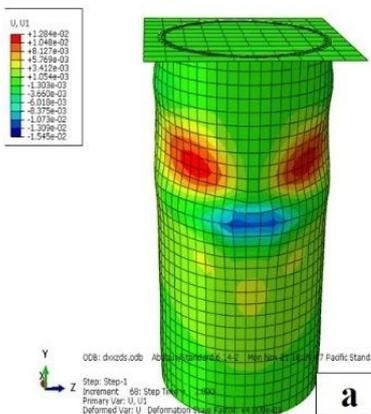
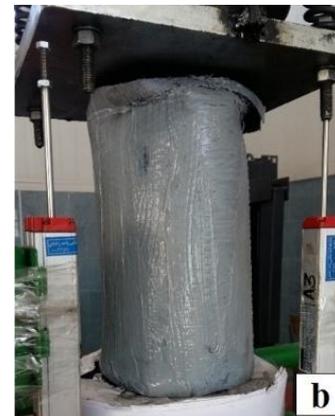
Fig. 20 Ultimate deformation of strengthened steel column having vertical deficiency at the bottom of column

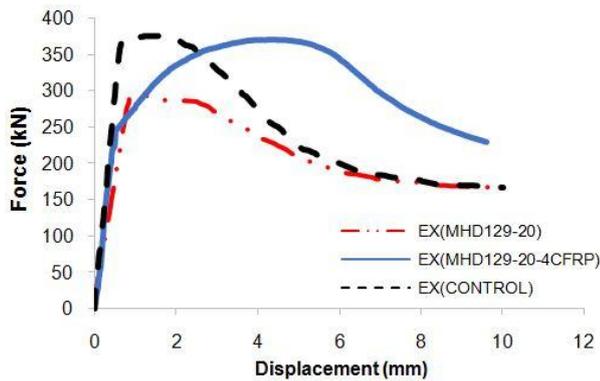
Fig. 21 Force-displacement graph for columns having horizontal defect at the middle

As it can be seen from Figs. 21 to 24, the columns with defects were compared with the control. The comparison of force-displacement of columns with defect showed that the defect columns experienced resistance drop and significantly reduced bearing capacity compared to control. The effect of using CFRP for improving the performance of columns showed that carbon fiber coverage at outer surface increased the stiffness and performance in line with the increase in bearing capacity. Using CFRP helped significantly to delay the local buckling of compressive element.

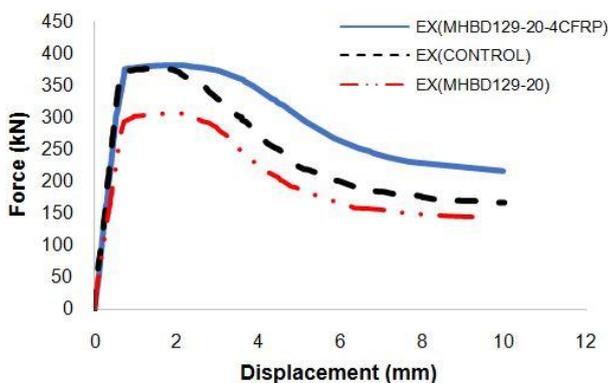
Fig. 22 Force-displacement graph for columns having horizontal defect at the bottom

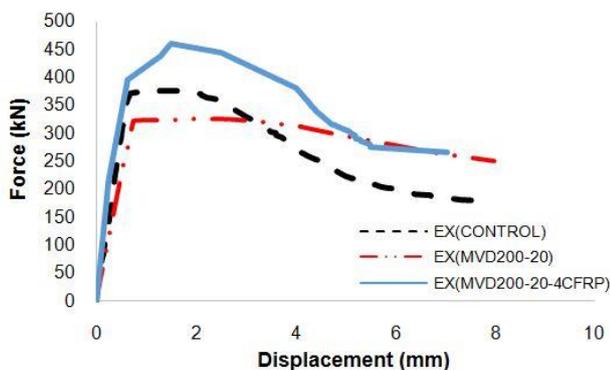
Fig. 23 Force-displacement graph for columns having vertical defect at the middle

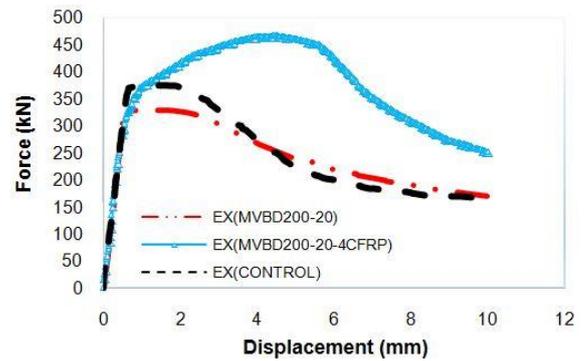
Fig. 24 Force-displacement graph for columns having vertical defect at the bottom
