## Experimental investigation of masonry walls supported by steel plate-masonry composite beams

**Keywords:** steel plate-masonry composite (SPMC) beam; masonry wall; arching effect; flexural stiffness; local buckling

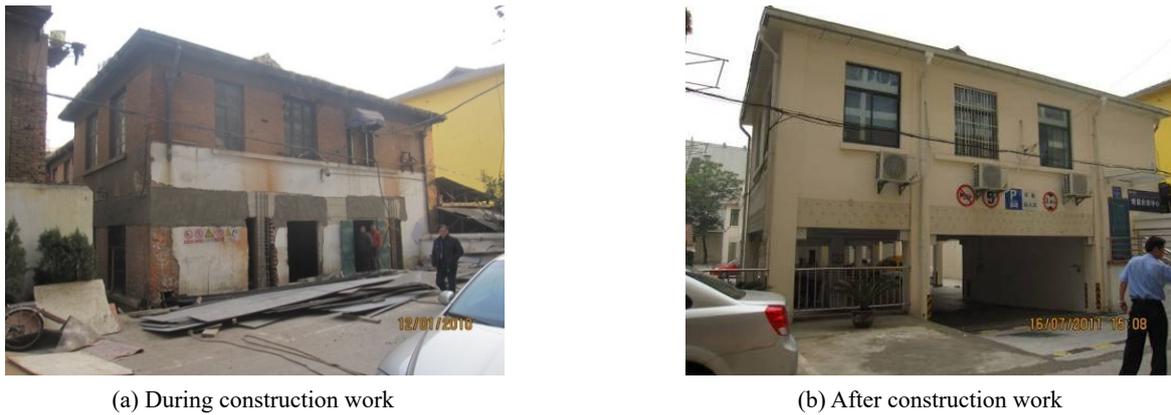
Fig. 1 A renovation project in Nanjing using SPMC beams

(a) During construction work

(b) After construction work

installation and minimal increase of dimensions. The technique has been used in a number of projects in China (Jing 2017). Fig. 1 shows a building during and after renovation in Nanjing, where the ground floor was opened as parking spaces.

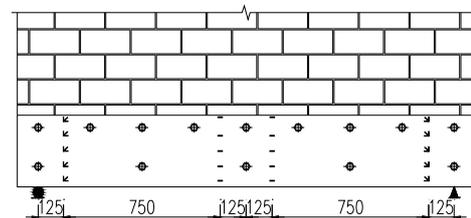
Fig. 5 Layout of strain gauges

(a) Side steel plates

(b) Bottom steel plate

↙ Strain rosette    -    Strain gauge

midspan displacement with a linear variable differential transformer (LVDT) at the midspan, and two dial indicators at both supports to record settlements. Strain gauges were bonded on the steel plates to monitor strain development. Twenty strain gauges in four rows were installed on each side of the steel plates at 125 mm from the mid span and from the two supports (see Fig. 5(a)). Three strain gauges were also installed on the bottom plate (see Fig. 5(b)). Both strains and displacements were recorded using a data logger (Data Taker DH3815) and the applied load was recorded using a load cell.

As shown in Fig. 5, multi-axial strain gauges (rosettes) were set to monitor the stress development of the steel plates near the supports. Based on the measured data, the maximum equivalent von Mises stresses of steel plates for specimens B1 to B5 are 174.3 MPa, 202.0 MPa, 140.3 MPa, 173.9 MPa and 243.0 MPa, respectively. The ratios of the calculated maximum equivalent von Mises stress to the yielding stress are 49%, 57%, 40%, 53%, and 69%, respectively indicating that the steel plate did not yield at failure. Also, local buckling near the supports did not take place.

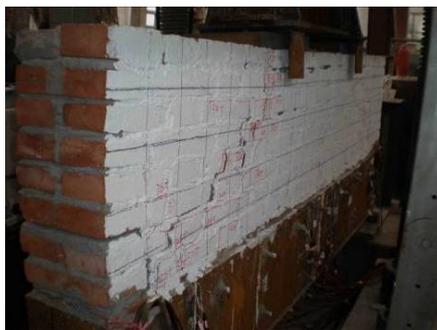
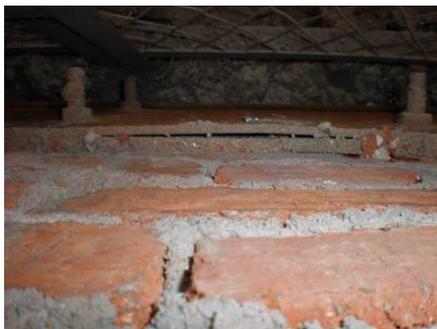
Fig. 6 Specimen B1 at failure

(a) Crack in the masonry wall

(b) Local buckling of the steel plate (view from above)

Specimen B1 failed in diagonal-tension. A crack of about 38-degree to the horizontal initiated along the mortar-brick interfaces at about midpoint between the loading point and the left support (see Fig. 6(a)). It propagated quickly at both sides and reached the support at the left and loading position at the right, well before final failure. The ultimate state was reached when the diagonal crack widened so much that the triangular block of masonry on the left side was completely detached. The side steel plates in the SPMC beam experienced local buckling shortly after the crack appeared in the masonry (see Figs. 6(b) and 7). This indicates that the top part of the plates experienced high compressive stresses. The masonry wall had a height-to-span ratio of 0.25 in this specimen.

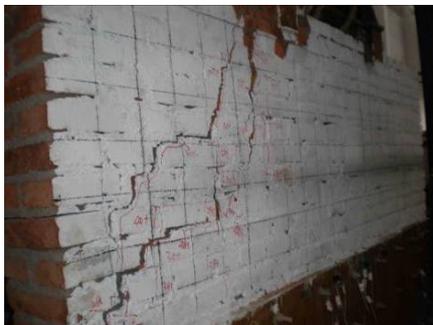
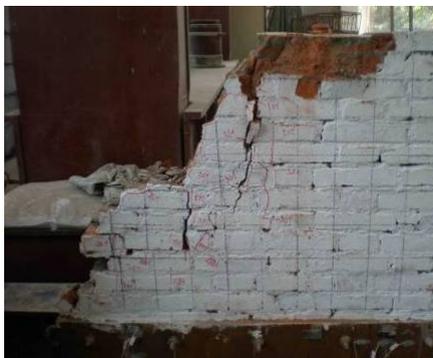
Fig. 11 Specimen B5

(a) Cracks during the test

(b) Final failure mode

Specimen B5 also had a masonry height-to-span ratio of 0.40 as specimen B2, but had a higher SPMC beam (see Table 1). The first crack initiated along the mortar-brick interfaces between the loading point and the support and propagated diagonally through the bricks as the load increased. Following the development of the above cracks,

a nearly vertical crack also occurred under the loading point (Fig. 11(a)), and small local buckling occurred in the steel plates near the midspan. When the vertical crack extended downwards at about 60% of the failure load, a small amount of the masonry under the loading point was crushed and part of it spalled, while another diagonal crack nearer the support was formed. The ultimate state was reached when a large block of the wall was detached (Fig. 11(b)). Note that the flexural stiffness of the SPMC beam was the largest among the five specimens. Under the same vertical loading, it thus had the smallest deflection leading to more evenly distributed beam-wall contact stresses. A mixed failure mode developed: a diagonal-tension failure mode and a shear-compression failure mode with several approximately vertical local compression cracks accompanied by local crushing and spalling (Fig. 11(b)).
