## Interface treatment in shotcrete jacketing of reinforced concrete columns to improve seismic performance

**Abstract.** An investigation of the effectiveness of the interface treatment when column concrete jacketing is performed is presented. Alternative methods of interface connection were used in order to investigate the performance of strengthened concrete columns. These connecting techniques involved roughening the surface of the original column, embedding steel dowels into the original column and a combination of these two techniques. The experimental program included three strengthened specimens, one original specimen (unstrengthened) and one as-built specimen (monolithic). The specimens represented half height full-scale old Greek Code (1950's) designed ground floor columns of a typical concrete frame building. The jackets of the strengthened specimens were constructed with shotcrete. All specimens were subjected to displacement controlled earthquake simulation loading. The seismic performance of the strengthened specimens is compared to both the original and the monolithic specimens. The comparison was performed in terms of strength, stiffness and hysteretic response. Th

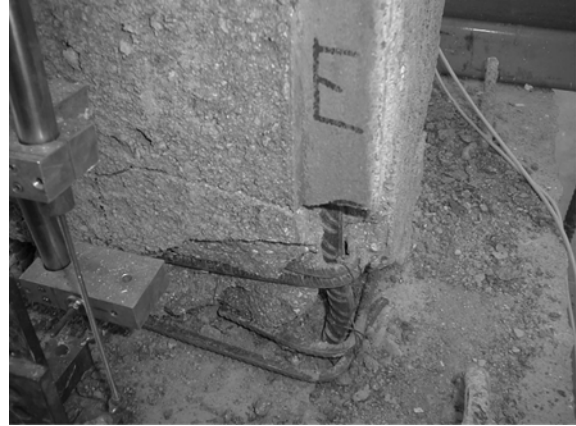
Fig. 8 Bar buckling due to stirrup end opening

The load against drift ratio curve for specimen R is shown in Fig. 7. Horizontal cracks first appeared when the drift ratio was 1.25%. When the drift ratio was 2.19%, cracks occurred parallel to the jacket longitudinal bars, indicating a loss of bond between the longitudinal bars and the jacket. These cracks extended to the whole of the specimen height, and part of the jacket cover peeled off. At the same time, a horizontal crack was observed at the base of the jacket and it extended through the jacket thickness. When the drift ratio was 4.69%, the lowest stirrup in the NE corner started to open at its ends and the longitudinal bar buckled, as shown in Fig. 8.

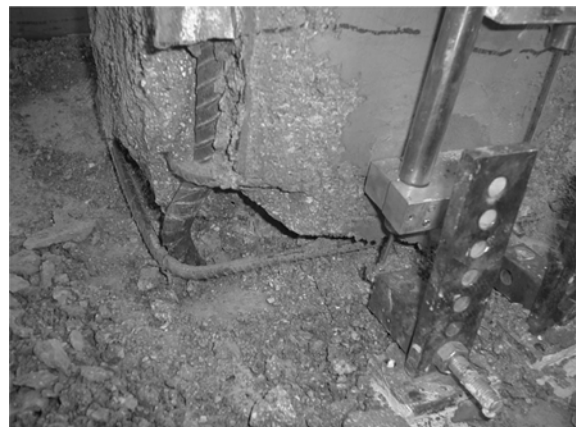
Fig. 11 Jacket bar fracture

approximately 68% of the maximum load. The bar that fractured bar was in the SW corner and a detail of the SW corner of the specimen is shown in Fig. 11. Most of the damage was concentrated at the base of the jacket in the region 300 mm above the footing but some cracks were observed higher up the jacket. The cracks were not symmetrical on the sides parallel to the loading. At the end of the test, the jacket was in very good condition. The bond between the original column and the jacket had remained for the duration of the test. Fig. 12 presents the crack patterns observed on the four sides of the specimen.

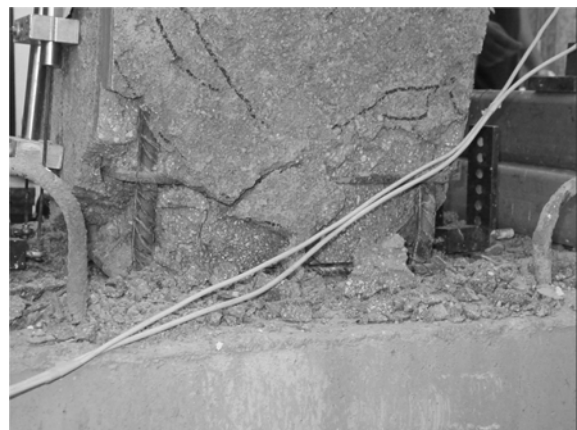
Fig. 14 Damaged region of specimen RD

The jacket condition was very good and all damage had occurred within the region 200 mm above the footing, as shown in Fig. 14. Even the cracks on the sides parallel to the loading direction were very limited. This was the only strengthened specimen where no cracks were observed parallel to the longitudinal reinforcement. The side crack pattern is presented in Fig. 15.

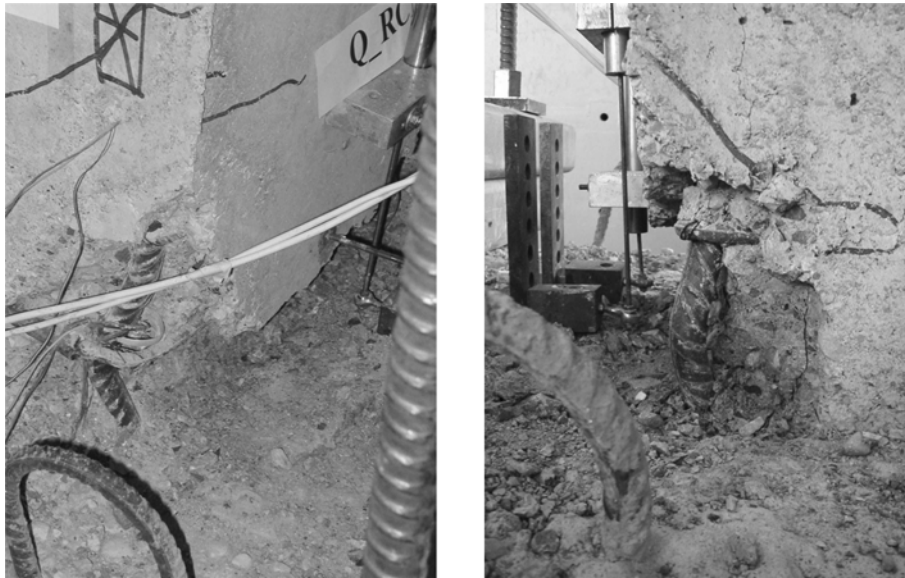
Fig. 17 Bar buckling of the monolithic specimen

above the footing. At the same time, small width cracks occurred from the specimen edges to the middle of the sides, 500 mm above the footing. Concrete crushing was observed when the drift ratio was 2.19%. When the drift ratio was 4.69%, the longitudinal bar in the SW corner buckled, as shown in Fig. 17.
