Repair of precracked RC rectangular shear beams using CFRP strip technique

Abstract. The exploitation of fibre reinforced polymer composites, as external reinforcement is an evergreen and well-known technique for improving the structural performance of reinforced concrete structures. The demand to use FRP composites in the civil engineering industry is mainly due to its high strength, light weight, and stiffness. This paper exemplifies the shear strength of partially precracked reinforced concrete rectangular beams repaired with externally bonded Bi-Directional Carbon Fibre Reinforced Polymer (CFRP) Fabrics strips. All specimens were cast in the laboratory environment without any internal shear reinforcement. The test parameters were longitudinal tensile reinforcement, shear span to effective depth ratio, spacing of CFRP strips, and orientation of CFRP reinforcement. It mainly focuses on the shear capacity and modes of failure of the CFRP strengthened shear beams. Results have shown that the CFRP repaired beams attained a shear enhancement of 32% and 107.64% greater than the control beams. This study underscores that the CFRP strip technique significantly enhanced the shear capaci

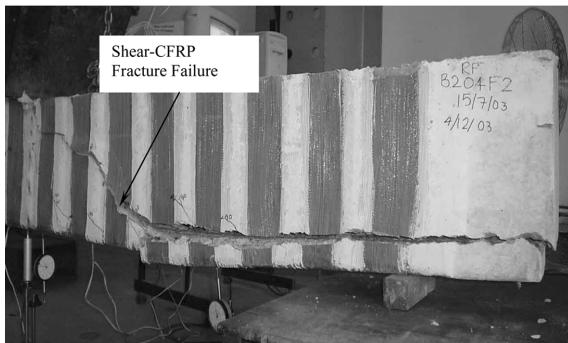
Fig. 3(e) Shear with CFRP fracture failure pattern for precracked/repaired specimen BT2-1

the soffit of the beam. These L or U-strips were provided after the application of 120mm wide CFRP strip along the bottom of beam. In the precracking phase the cracking pattern was similar to the control beam. After repairing, specimens BT2-1 and BT2-2 initiated diagonal cracks approximately at 95 kN and 108 kN respectively. As applied load increased, specimen BT2-1 was failed in shear with CFRP rupture or fracture at a peak load of 134.72 kN in the right shear span. Similarly the specimen BT2-2 failed in shear with CFRP rupture at a peak load of 121 kN however the failure occurred in the left shear span. The CFRP shear contribution of the specimens BT2-1 and BT2-2 were 69.84 kN and 56.54 kN respectively. Figs. 3(e) and 3(f) depict the failure pattern of specimens BT2-1 and BT2-2 respectively.

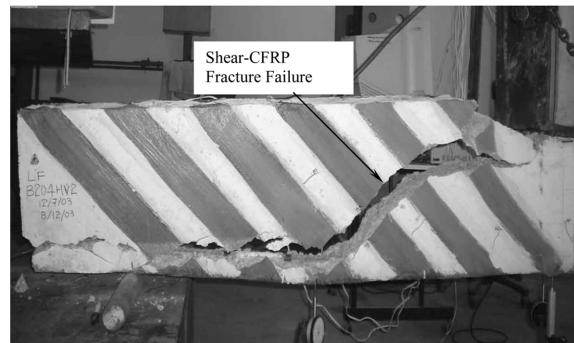
Fig. 3(f) Shear with CFRP fracture failure pattern for precracked/repaired beam BT2-2 (45/135 degree)

Orientation of CFRP strips: The strengthened specimen BT2-2 was damaged by formation of cracks through its depth during the handling operation. This damage was the prime reason for the reduction in ultimate load of beam BT2-2 (45/135 degree) in comparison to BT2-1 (0/90 degree U-strip). As a result, it is not possible to conclude effect of change in orientation of CFRP strips.
