An experimental study on strengthening of vulnerable RC frames with RC wing walls

M. Yasar Kaltakci^a and Gunnur Yavuz*

Engineering and Architecture Faculty, Department of Civil Engineering, Selcuk University,
Konya, Turkey

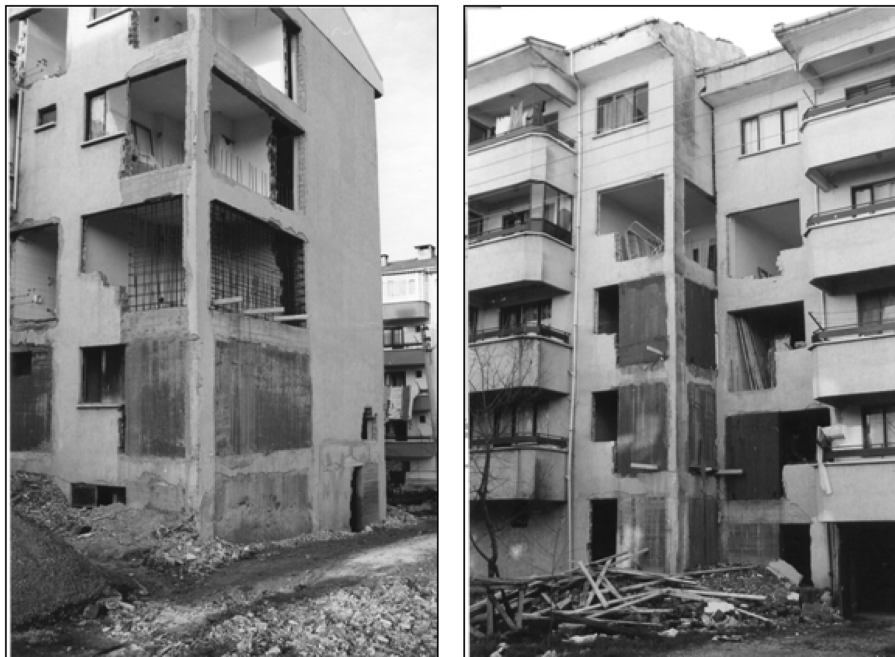
Fig. 1 Adding cast-in-place infill walls (from archive of Kaltakci, M.Y.)

One of the most effective and economical methods for the seismic strengthening of existing reinforced concrete frames is the introduction of reinforced concrete shear walls. Test results have shown that infill walls increased the lateral load-carrying capacities of the frames and reduced lateral drift, thereby increasing lateral stiffness. Generally, infill walls are placed between two frame columns by fully infilling the holes of the frames. In some cases, it is not possible for the infill wall to be located fully within the holes of frames because of architectural and constructional restrictions, such as doors or window openings (Fig. 1).

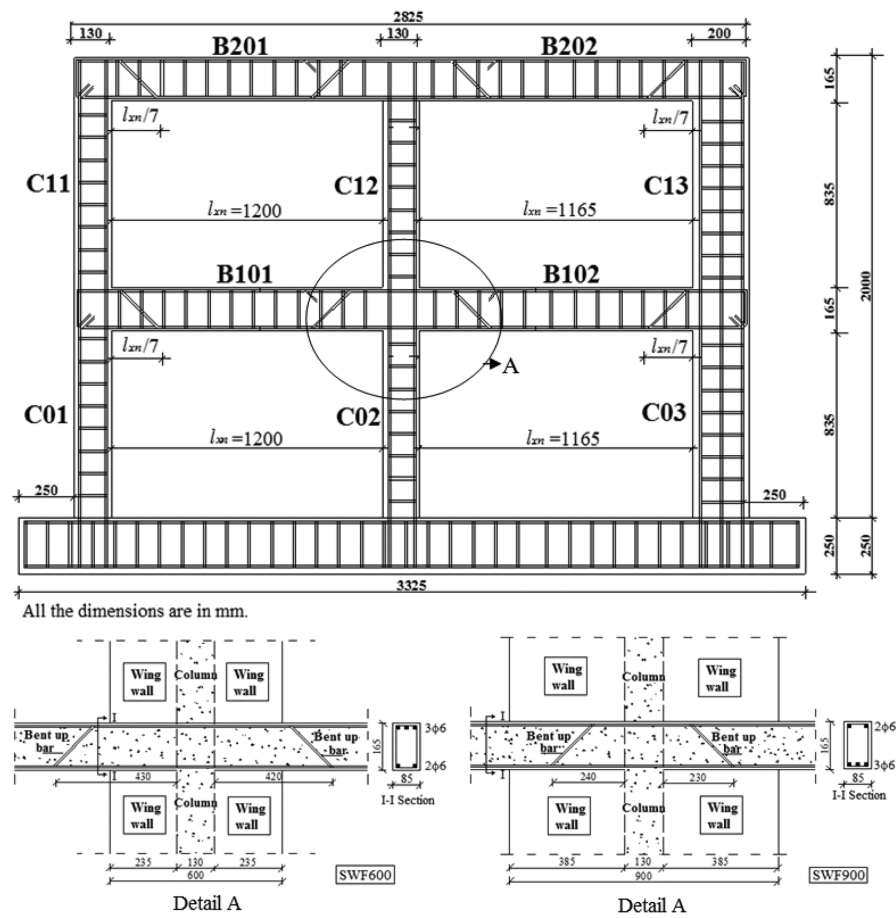
In the columns, plain bars with a diameter of 8 mm were used as longitudinal reinforcements, and plain bars with a diameter of 4 mm spaced at 100 mm were used as closed stirrups with 90° hooks through the column height. Three plain bars with a diameter of 6 mm were used as longitudinal reinforcements in the beams. Plain bars with a diameter of 4 mm spaced at 100 mm were used as closed stirrups with 90° hooks in the beams through the beam span.

Fig. 2 Dimensions and reinforcement details of unstrengthened frames

The dimensions and reinforcement details of the specimens are shown in Fig. 2. The dimensions and reinforcement layouts of the frame members (columns and beams) for all of the frames are shown in Table 2.

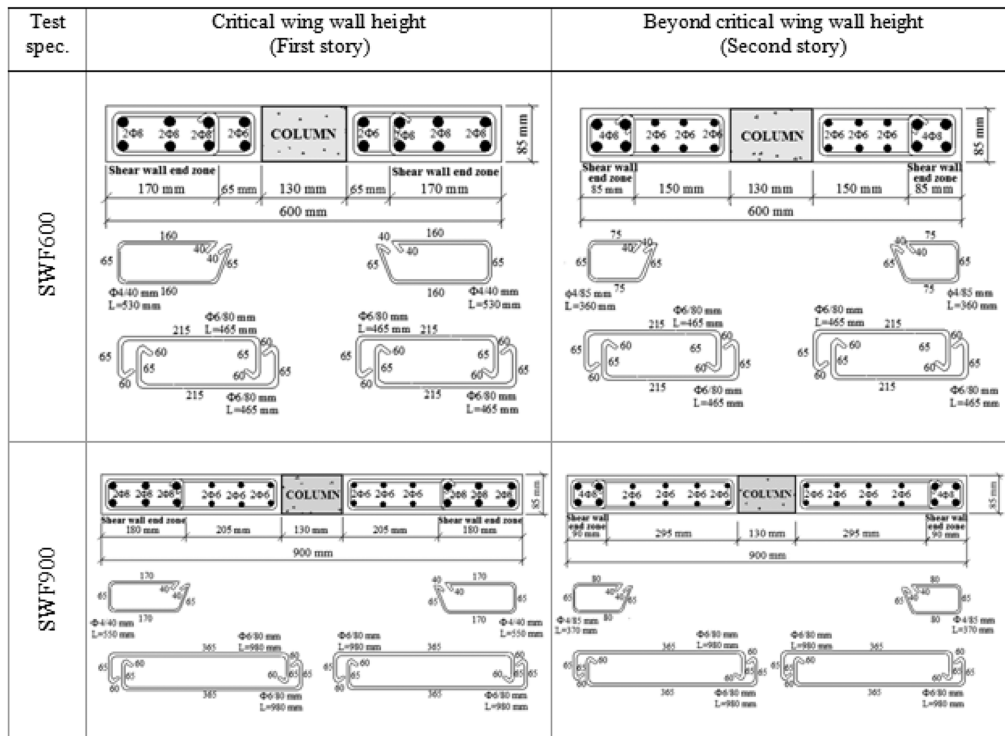
Fig. 3 Reinforcement layouts and dimensions of wing walls

The reinforcement layouts, the dimensions of the wing walls and the dowel spacing with the embedment lengths of the anchorage bars used in the strengthening of the frames are shown in Fig. 3 and Fig. 4. These reinforcement details were determined according to TEC 2007.

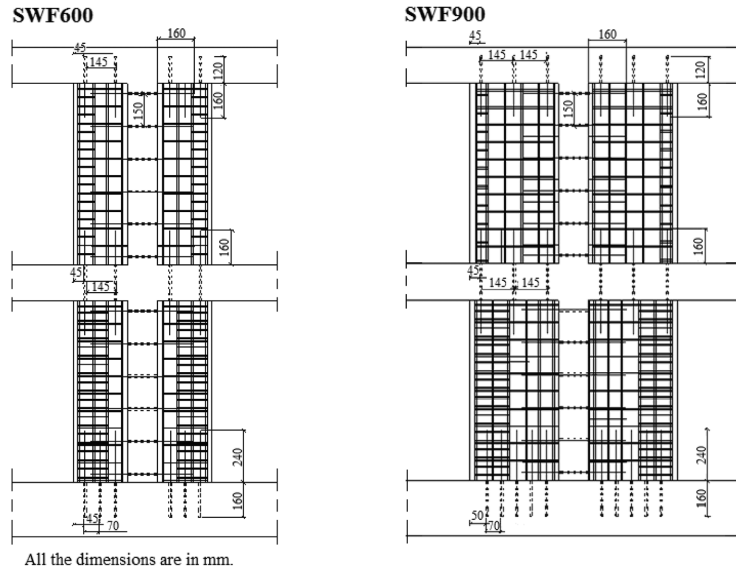
Fig. 4 Dowel spacing and embedment lengths of anchorage bars

which were placed in the holes and fixed by epoxy injection. Anchorage members were selected with a diameter of 8 mm for deformed bars, and holes were drilled with a diameter of 10 mm. The spacing of dowels was 150 mm, 145 mm and 70 mm for columns, beams and foundation levels, respectively. The embedment lengths of the anchorage bars into the wing walls were 160 mm (20ϕ) for beams and columns and 240 mm (30ϕ) for foundation levels. Each dowel consisted of one deformed bar centered at the face of the frame members. The frame specimens were cast in a horizontal position and tested in a vertical position. First, unstrengthened bare frames were produced and cured for 28 days under natural weather conditions. Then, in two frames, the dowels were drilled and anchored to the bare frames. After that step, the molds of the wing walls were placed on the frames with dowels, and the reinforcements of the wing walls were placed. Finally, the concrete in the walls was cast in situ horizontally. After the curing period of the wing walls was completed, the specimens were lifted to vertical using a special arrangement consisting of steel profiles surrounding the frame. This arrangement fixed the foundation of the specimen using transmission bolts.

Connections between the frame and the wing walls were achieved by using anchorage dowels,

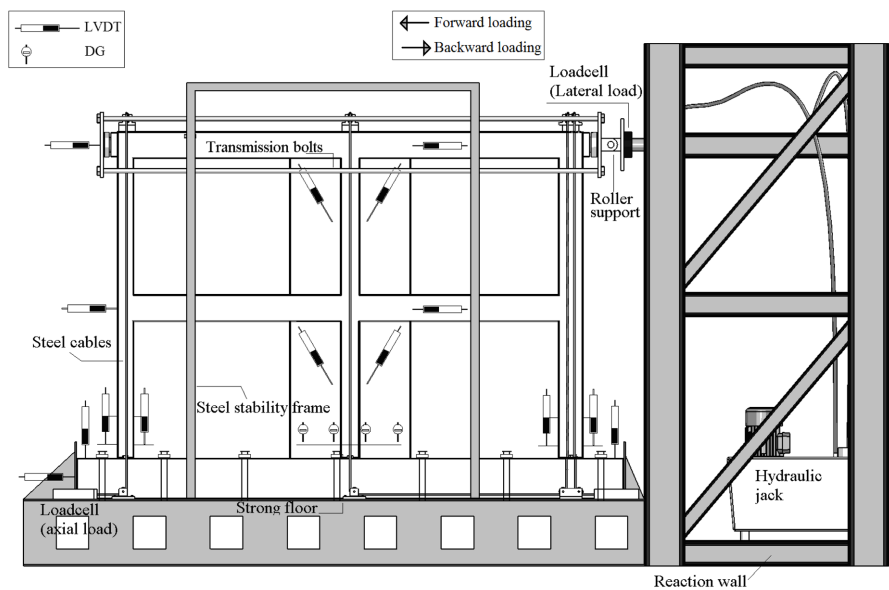
Fig. 5 Test set-up and instrumentation

The concrete in test specimens was cast in situ, and all of the cylindrical concrete samples were kept at air temperature for 28 days. The testing system consisted of the strong floor, the reaction wall, loading equipment, instrumentation, and a data acquisition system (Fig. 5). The foundations of the test specimens were fixed to the strong floor by high-strength steel bolts. The specimens were tested under a reversed cyclic lateral load that simulated the effects of an earthquake. A lateral load was applied to the top-story floor level using a hydraulic jack, and this load was transmitted to the frames using special countershafts. A steel stability frame was constructed around the test specimens to prevent out-of-plane movements. The lateral load value was measured by a bidirectional (compression-tension) load cell with a capacity of 500 kN. The lateral loading program was applied in a load-controlled manner until the yield stage, and it was subsequently applied in a displacement controlled manner in the following cycles until the end of the test.

The axial load was measured by one directional load cell with a capacity of 200 kN and was controlled continuously. The axial load was applied to each column using steel wire ropes placed in

a bobbin system prior to the application of the lateral load (approximately $0.10A_c f_c$ according to TBC500-2000). These limit values were determined according to the largest column cross-section for each test frame. The lateral displacements of the test specimens at each floor level were measured by displacement transducers (LVDT).

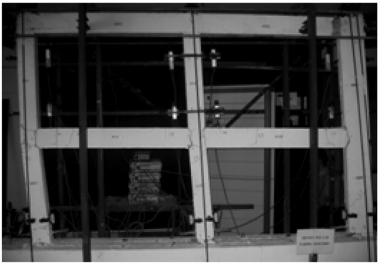
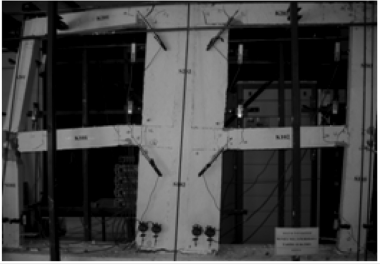
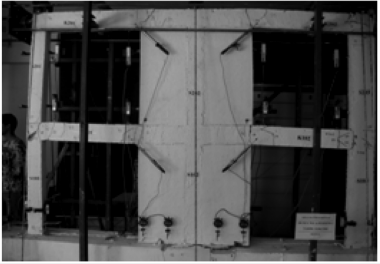
Specimen	a) Maximum lateral load level (Joint regions)	b) Failure (General view)
BF

Fig. 6 Failure patterns of test specimens

The nonstrengthened bare frame (BF) test provided reference data to allow for comparison with the performance of the wing wall-strengthened frames. The first crack in the nonstrengthened frame was detected in the right support of the first-story beam B102 at a load level of 15 kN during the 3rd forward cycle. The first cracking in the column was observed as a microcrack in the lower end of middle column at a load level of 20 kN during the 4th forward cycle. The maximum lateral load was 47.61 kN in the bare frame. At this load level, the top (upper story) lateral displacement of the frame was 51.60 mm. A 45° crack was observed in the upper end of the right exterior column (Fig. 6).

columns were observed at a lateral load level of 150 kN during the 10th backward cycle. The maximum lateral load was 174.64 kN for this frame. The lateral top displacement during this phase was 15.81 mm. After this phase, sliding appeared at the connection of the shear wall-foundation, and no important damage was observed in the frame members and the side columns as a result of energy dissipation by the shear wall (Fig. 6).

A general examination of the behavior of the nonstrengthened frame (BF) showed that there was hinge formation in the beam ends and column bases during the collapse phase, and vertical cracks were detected, particularly in all of the bent bar breaking zones of the first-story beams. In addition, a shear crack (at a 45° angle toward the horizontal surface) was detected on the side column, which was 200 mm in width (C03). A general evaluation of the behavior of the frames strengthened with wing walls showed that there were vertical cracks on the bent bar breaking zones of the beams and hinge formations on the beam ends and wall bases. The SWF600 test specimen showed vertical cracks in the shear wall section at a $(h_{beam}/4)$ distance from the outer edge of the shear wall, and a shear crack (with an approximate angle of 45°) was detected on the left side of the beam-column connection (C01-B101) because there was no stirrup in the column. Concrete crushing and catastrophic failure occurred in the left exterior first story beam-column joint in test specimen SWF600 during the last cycle. In test specimen SWF900, no concrete crushing occurred, and only the width of previously formed cracks developed in this region. Vertical cracks were observed at the beam support regions with a length approximately equal to the beam height. However, no significant damage was recorded in the side columns of both strengthened frames. Significant damage was recorded in the beam ends of the SWF600 test specimen. Generally, no significant damage was observed in the test specimen SWF900. The experimental observations indicate that the wing walls moved monolithically with the central column of the frame; the maximum lateral load

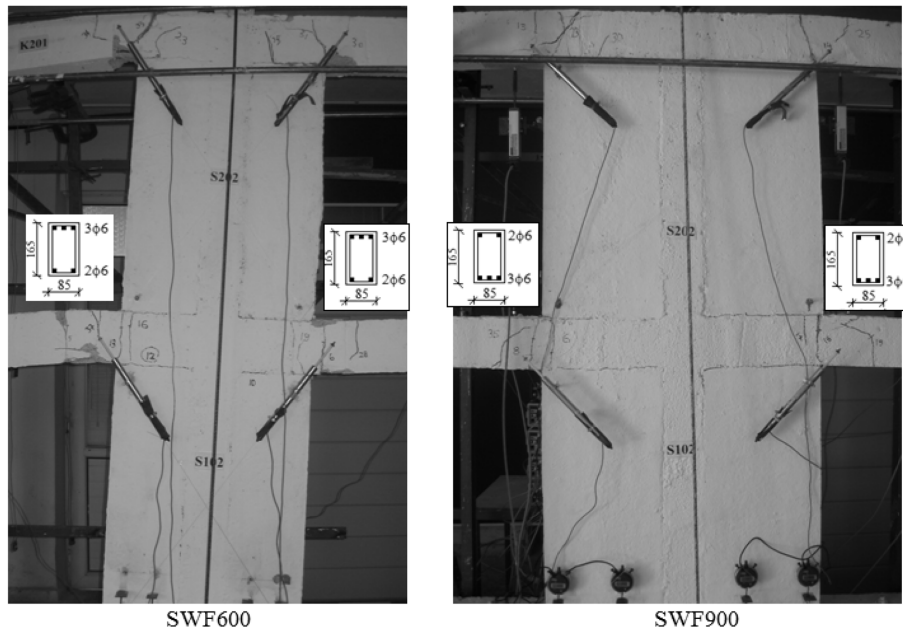
Fig. 7 Damage to the shear wall-beam connections

The tests were performed on undamaged, vulnerable RC frames. The most important outcome of these tests is that no important damage occurred on the side columns under weak earthquake activity until the load-bearing capacity of the shear wall was exceeded, which proves that shear walls are effective for lateral load bearing. The main damage accumulated at the ends of beams connected to the shear wall. The vertical cracks on the beams occurred in strengthened specimens. The cracks formed because of the insufficient capacity of beams under changing directions of moments, due to the effect of reversed cyclic loads. The positive moment capacities of beams at the support region (connection of the beam-shear wall) were 4378 kN mm for SWF600 and 6429 kN mm for SWF900. Less damage to beam-shear wall connections was observed in the SWF900 specimen compared with the SWF600 specimen because of the decrease of the ultimate displacement (Fig. 7).

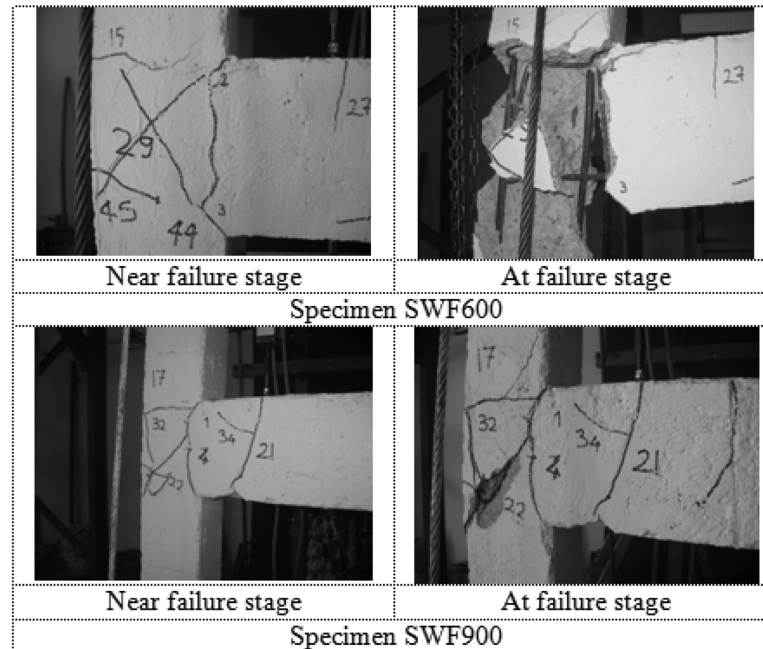
Fig. 8 Diagonal cracks from the left column to the beam joint

The first crack in the SWF600 test specimen was detected in the right end of the first-story right beam (B102) at a load level of 20 kN during the 4th forward cycle. In the 11th forward cycle, at a load level of 60 kN, a 5th crack was observed at 200 mm from the right support of the B101 beam (bent bar breaking point). The first hairline crack in the base of the shear wall was observed at a load level of 80 kN during the 13th forward cycle. The width and length of the crack were measured as 0.02 mm and 400 mm (from the right end of the wall), respectively. In the 14th backward cycle, at a load level of 90 kN, a vertical crack occurred at the beam in the shear wall at $h_{beam}/4$ (one quarter of the beam height) away from the wall side. In the 15th forward cycle, at a load level of 100 kN, hairline cracks were observed on the right bottom end of the C01 column. In this phase, the top displacement was measured as 9.05 mm. The maximum lateral load was determined to be 116.67 kN. After this stage, sliding was shown at the shear wall-foundation connection, and the damage increased rapidly. No significant damage was observed in the side columns as a result of the energy dissipation at the shear wall (Fig. 6). Vertical cracks were observed in the beams in an area extending from the internal surface of the support to a length equal to the beam's height (disturbed (D) regions, Fig. 7). In this experiment, shear cracks at an angle of 45° developed on the beam-column connection (joint) because of the lack of a stirrup (Fig. 8).

capacity of specimen SWF900 increased by 50% compared with test specimen SWF600, and the level of damage to the SWF900 frame was significantly reduced because of the 50% increase in the total length of the shear wall. The general behaviors of tested specimens are presented in Fig. 6 at maximum lateral load and failure load levels. In addition, the beam-column joint damage to the strengthened frames is shown in Fig. 8.

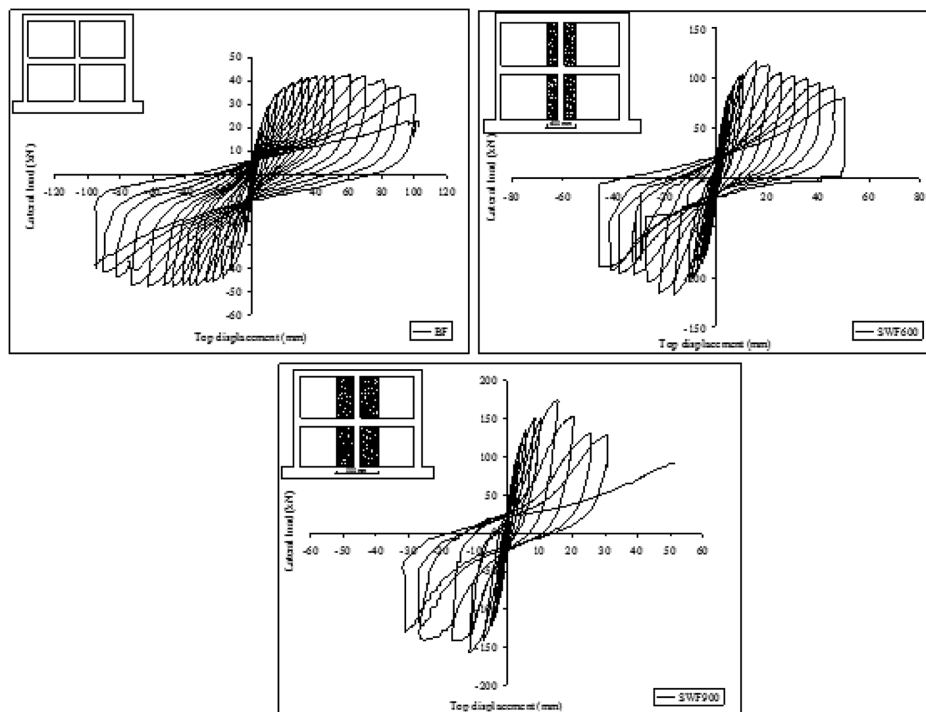
“Lateral load-top displacement” hysteresis curves of the test specimens are shown in Fig. 9. Lateral load-top displacement curves are used to observe the strength and stiffness values of a test specimen and to evaluate the general behavior of a frame. For lateral load-top displacement curves, the maximum lateral load-bearing capacities of the BF, SWF600 and SWF900 test specimens were 47.61, 116.67 and 174.64 kN, respectively. Using the reference frame (BF) as the baseline, the maximum increase in the load-bearing capacity was determined to be 145% for the system with a 600 mm shear wall (SWF600) and 267% for the system with a 900 mm shear wall (SWF900). The maximum displacements corresponding to a 20% decrease in lateral load capacity were measured as approximately 100, 40 and 25 mm for the BF, SWF600 and SWF900 test specimens, respectively.

Fig. 9 Hysteresis curves of the test specimens

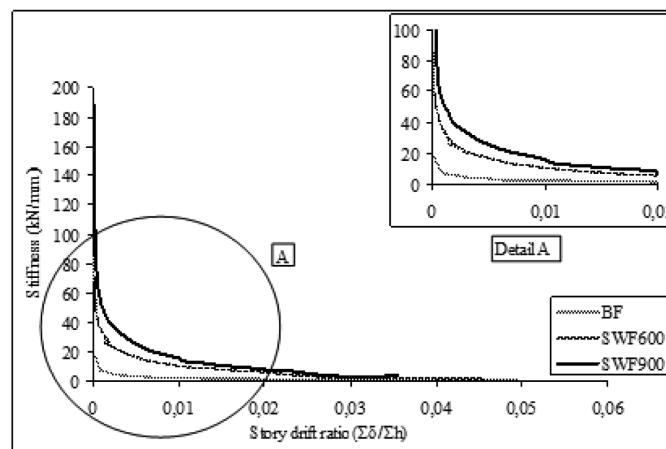
Fig. 10 Comparison of the stiffness degradation curves

stiffness is defined as the mean of the slope of the lines connecting the origin with the peak points of the collapse load. This stiffness value was determined using the ultimate displacement corresponding to a 20% decrease in the lateral load capacity. The initial stiffness of the BF, SWF600 and SWF900 specimens was calculated as 17.11, 84.70 and 188.06 kN/mm, respectively. The stiffness decreased during subsequent cycles (Fig. 10). An evaluation of the stiffness values on the basis of the reference test frame (BF) showed that the initial stiffness value of the SWF600 specimen increased 4.95-fold, and the SWF900 specimen increased 10.99-fold. The collapse stiffness value of the SWF600 specimen increased 7.10-fold, and the SWF900 specimen increased 19.85-fold. For both stiffness types, the SWF900 test specimen generated the highest stiffness values, and the BF specimen generated the lowest values. Accordingly, the bare frame (BF) produced the highest (97.60%) and SWF900 the lowest (95.67%) stiffness decrease in the collapse phase. For all of the test frames, the stiffness degradation values were determined to be similar.

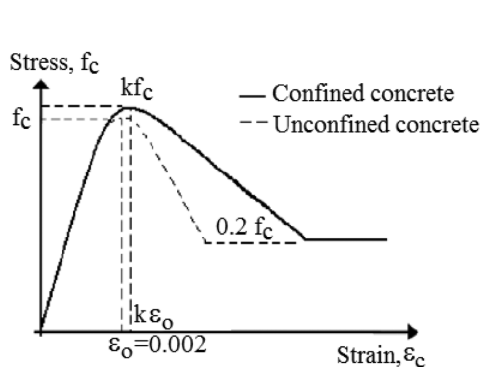
Fig. 11 Stress-strain relation of the concrete (Arslan 2010)

et al. 1982) was used. The stress-strain relationship in the proposed model given in Fig. 11 was developed for concrete that was confined by rectangular hoops. ε_{co} is the concrete strain at maximum stress, and k is a factor that accounts for the increase in strength caused by confinement. An idealized stress-strain relationship for a steel reinforcement is shown in Fig. 12. The reinforcement is modeled as a linear elastic, linear strain, hardening material under yield stress (Mander 1984). The behavior of the RC members is greatly affected by the yielding of steel when the section is subjected to monotonic bending moments (Arslan 2010).

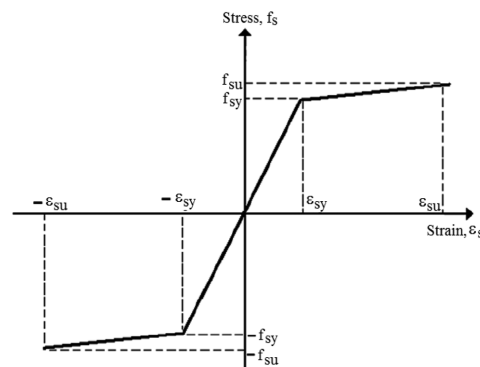
Fig. 12 Stress-strain relation of the steel (Arslan 2010)

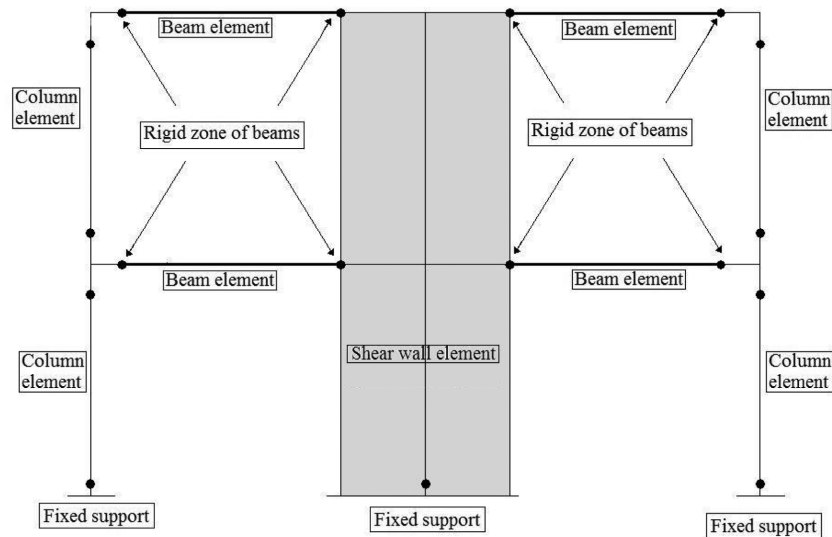
Fig. 13 Analytical model of specimens with shear walls

A lateral load was applied to the axis of the top story beam and to one of the mass-concentrated sections. An analytical model for specimens with shear walls is given in Fig. 13. The beams of the frame were modeled as two pieces and were connected to the middle axis of the shear wall.

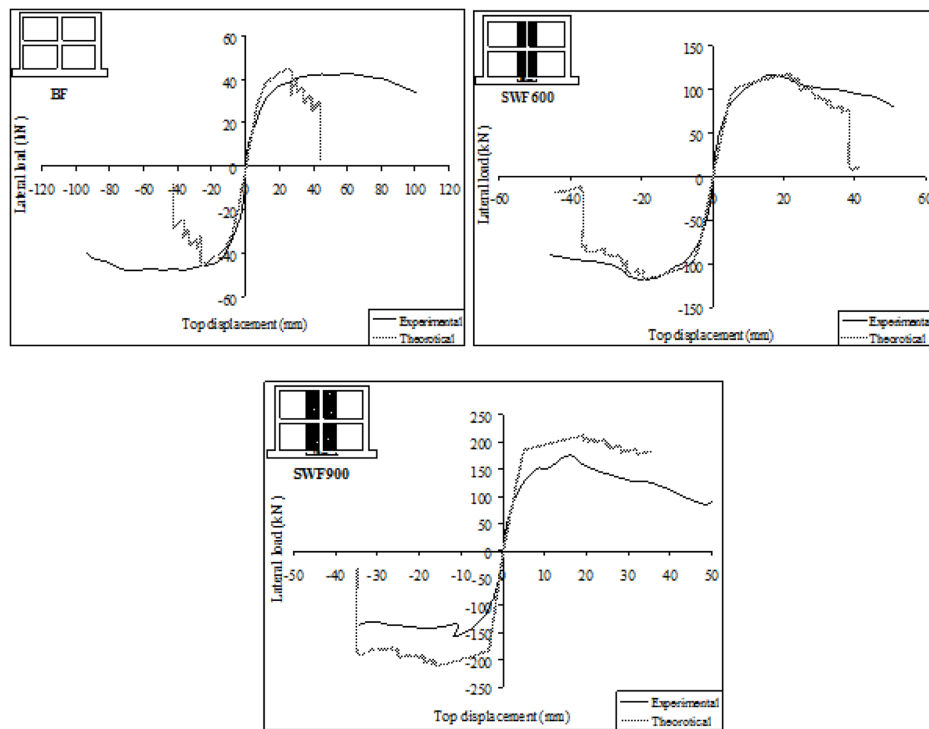
Fig. 14 Comparative lateral load-top displacement envelope curves of the test frames

Fig. 14 compares the experimental and analytical response envelope curves of the tested frames.

Table 6 shows that the experimental and analytical maximum lateral load-bearing capacities are similar for BF ($\pm 6\%$) and SWF600 ($+1\%$, -0%) specimens with analytical values. The greatest difference was recorded in the lateral load-bearing capacity of the SWF900 specimen ($\pm 26\%$). It is likely that different displacements also occurred. It is thought that these differences developed as a result of the sliding of the anchorage bars in the foundation such that the shear wall could not reach its full capacity. Another explanation for the difference is the occurrence of relatively slight damage to nodal zones, which were assumed to be rigid end zones during the experiment. Arslan *et al.* (2010) found the same differences in an analytical study that was performed for a two-story, two-bay RC frame.
