Fatigue experiments on steel cold-formed panels under a dynamic load protocol

Antonio J. García-Palencia^{1a} and Luis A. Godoy^{*2}

Abstract. A dynamic load protocol has been used to experimentally simulate fatigue behavior in cold-formed metal panels with screwed connections under wind loading. The specific protocol adopted is an adaptation of SIDGERS, originally developed for non-metallic membranes, which is composed of levels each under increasing load values. A total of 19 tests were performed on 3.35 m long by 0.91 m wide panels, identified as Type B-wide rib and Type E, both with screw connections at the edge and at the center, thus conforming two-span specimens. In some configurations the panels were fixed at the valleys, whereas crest-fixed connections were also investigated. Reinforcing the connections by means of washers was also investigated to evaluate their efficiency in improving fatigue capacity. The experimental results show maximum load capacities in improved connections with washers of approximately twice of those with classical connections.

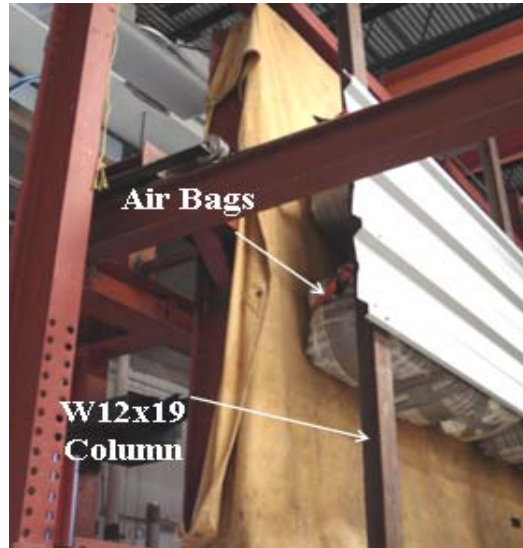
Fig. 2 Side view of test specimen, showing air bags. Panel Type E, gage 24

has dimensions of 3.35 m long by 0.91 m wide, as shown in Figs. 2-3. The first panel configuration is identified as Type B wide rib, which is one of the most commonly used in roof construction in Puerto Rico. This is available in gauges 18, 20 and 22, and is manufactured using grade 33 galvanized steel, with a yield stress of 230 MPa. A second configuration, identified as Type E, was also studied to take into account the performance of plates with low thickness (gauge 24); Type E has a different cross section, as shown in Table 1. Prototypes were tested to assess the fatigue capacity and to quantify the influence of employing washers on the fatigue behavior of panels in retrofitted configurations.

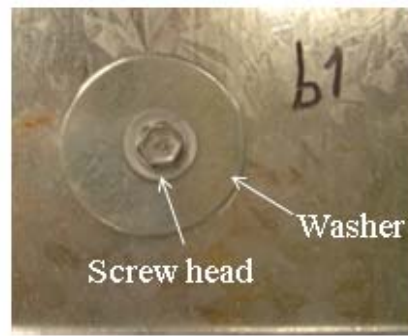
Fig. 5 Details of washer and improved connection

washers used have an internal diameter of 9.5 mm and 38.1 mm external diameter; these are placed under the neoprene washers that come included in the screws and are used as required by the connection patterns. During the installation process of the screws, special precautions were taken: (1) The screws were tightened until the neoprene washers allowed it, to avoid local buckling in the plate; (2) in the case of connection in the crests (Fig. 4), the holes were pre-drilled to ensure the least possible harm to the plate, and (3) it was ensured that the longitudinal axis of the screws remained perpendicular to the plane of the plate.

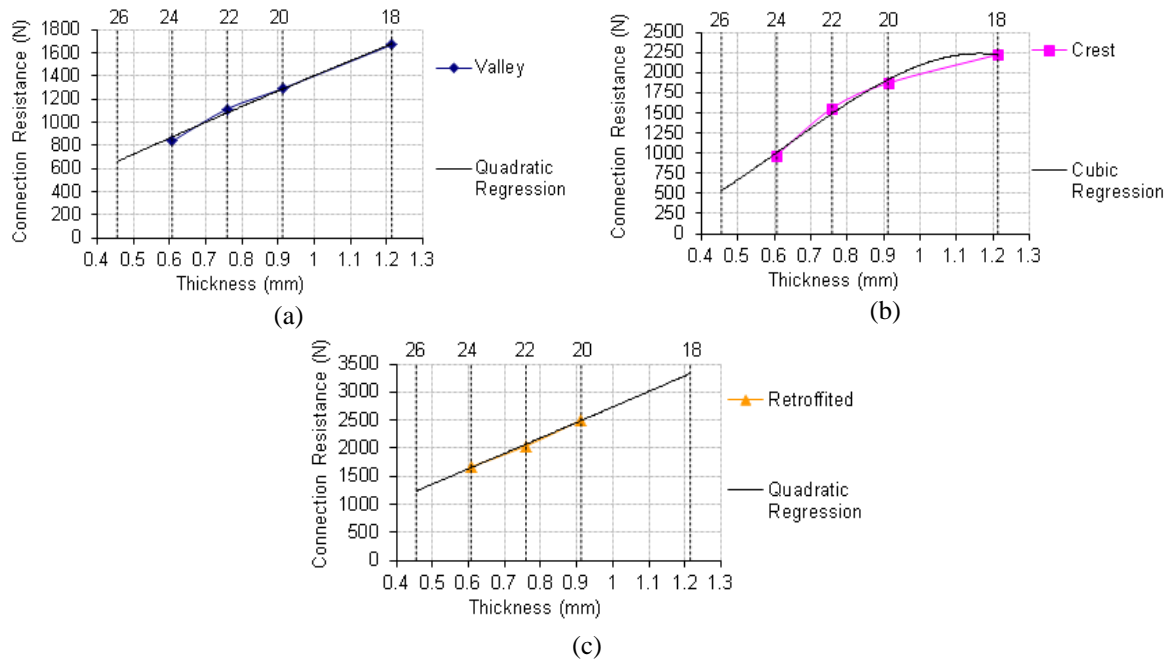
Fig. 10 Polynomial regressions for the strength of the tested prototypes: (a) Connections in Valleys; (b) Connections in crests; (c) Improved connections

where F represents the connection resistance (N), and t is the thickness of the plate (mm); the corresponding plots in SI units are shown in Fig. 10. The values of the coefficients A , B , C and correlation coefficients R^2 are listed in Table 3. The correlation coefficients obtained from the polynomial regression are greater than 0.99, which indicates a good fitting with respect to the proposed type of regression. Taking into account the regression equations of each prototype studied, the next term is the extrapolation of the missing resistances.
