Experimental investigations on the structural behaviour of a distressed bridge

Keywords: truss girder bridge; pipe rack; severe distress; bearing plate; remedial measures

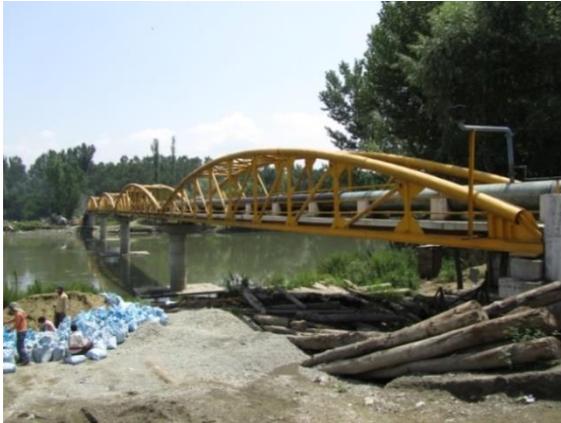
Fig. 1 A view of four span Pipe Bridge

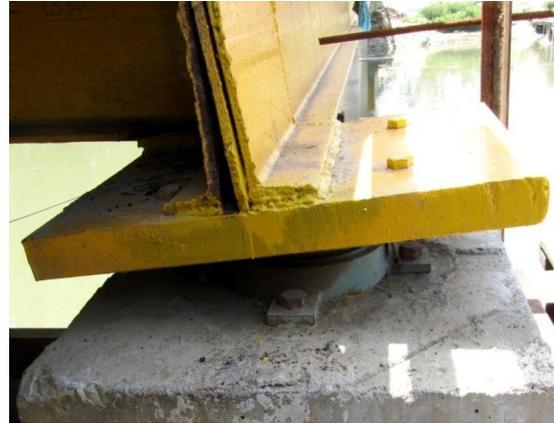
Fig. 2 A visible tilt in the bearing plate

Due to lack of proper coordination between site and fabrication teams, the length of each span of the truss was fabricated 37 m only instead of the desired 37.5 m. Miserably inadequate non-engineered measures were taken at site to make up for the deficiency in the desired span length. These non-engineered measures included the improper arrangement of bottom chord extension, highly insufficient channel section for top chord extension together with unsafe joint detailing. This totally non-engineered approach finally resulted in a structurally unsafe solution to the above quoted crucial problem of the structure. The proposed restoration scheme suitable for a structure in distress is governed by the nature and extent of distress the structure has undergone (Jagadish 1995, Limal *et al.* 2008, Peterson 2011, Edward *et al.* 2014). Before selecting the suitable and acceptable restoration scheme, it is important to critically examine the nature and extent of distress the structure has suffered (Arya *et al.* 1992, Mehta 2010, AASHTO 2011, Caglayan *et al.* 2012, Stamatopoulos 2013, Subramanian 2014). At times, it is also the imposed constraints from various considerations which play important role in the selection of suitable restoration scheme (Goel and Sanyal 1999, Ram Kumar *et al.* 1999, Williams 2013, Subramanian 2014). To explore the various alternative restoration schemes for the distressed pipe rack in the present study, it was necessary to

examine critically the nature and extent of distress. For this purpose few visits were paid to the site at a time when signs of distress were clearly noticeable as well as fabrication faults and errors were also visible. The distress in the pipe rack was observed in the form of noticeable tilt in one of the bearings and significant tilt in the girder supported by this bearing, as is clearly seen in Fig. 2. It was also observed that the end cross girders in all the spans were located about 250 mm away from the centre line of the bearings towards the river side, as seen in Fig. 3. In addition to this a prominent tilt measuring 1 in 9 in transverse direction and 1 in 45 in longitudinal direction was observed on the down-stream side of bearing in span 3 over Pier P3 as shown in Fig. 2. Wide gaps were also observed at number of joints as well as non-uniform gaps were visible at expansion joints. The newly constructed pipe rack was thus severely in distress. The pipe rack in such distressed condition was vulnerable to total collapse particularly under seismic loading of zone-V, resulting in the disruption of essential water supply service to millions of people across the river. Considering its vital importance, an urgent need was felt to take appropriate remedial measures of the distressed pipe rack to restore its safe structural capacity particularly during worst seismic loading condition in zone-V.

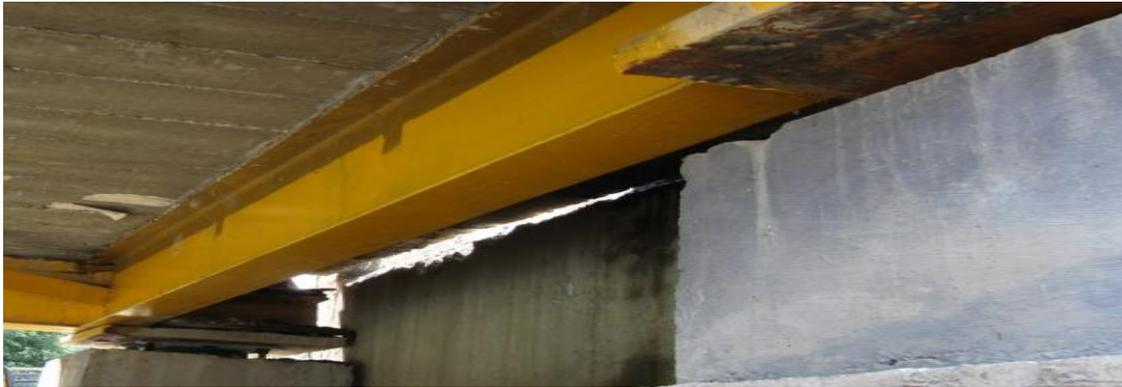
Fig. 3 Eccentric placement of cross girder over the bearing plate

Remedial Measure-1 includes addition of one more cross beam at the ends which is placed centrally over the bearings and properly made with sound connection details so that the two cross beams act as one built-up beam in order that the load transfer through this mechanism is at the ends and finally to the bearings as centrally as possible (Subramanian 2008).

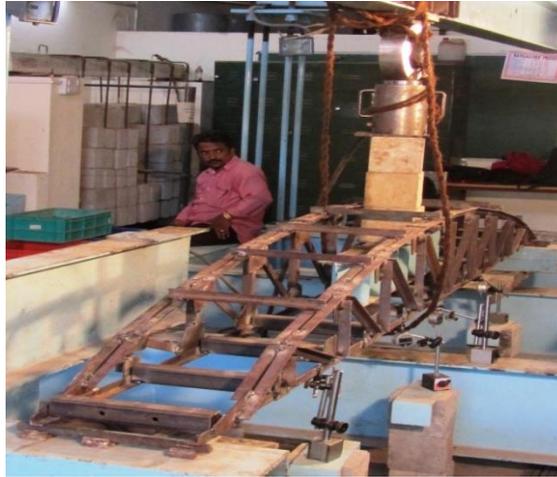
Fig. 5 Experimental setup and preliminary model under performance evaluation

on a 500 kN loading frame as shown in Fig. 5. The loading was applied symmetrically at two points on the span through a spreader rigid beam which was loaded centrally by the ram of the 500kN capacity hydraulic loading jack. All the tests were conducted with symmetric loading points at a distance of two fifth of the span from the supports. A proving ring of 200 kN capacity was mounted between the loading jack and frame as shown in Fig. 5 to record the load applied.

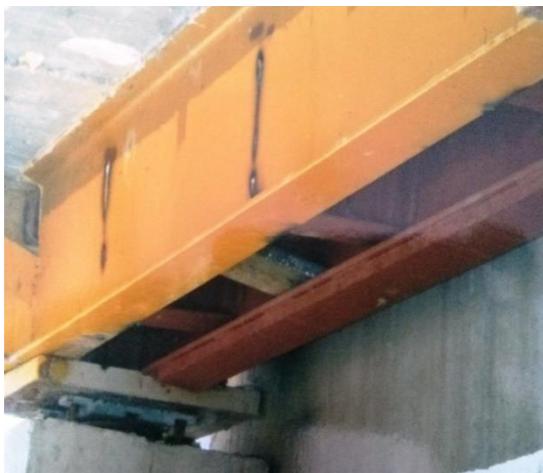
Fig. 11 Remedial Measure-I Implemented in real (i.e., as built) pipe-rack

The above experimentally validated remedial measures were applied to the real distressed pipe-rack with high degree of confidence. Fig. 11 shows implementation of remedial measure 1 i.e., addition of another cross beam at the ends to ensure load transfer at bearings as centrally as

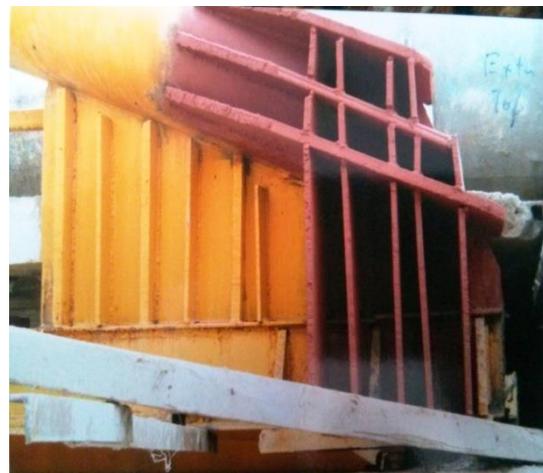
Fig. 12 Remedial Measure-II Implemented in real (i.e., as built) pipe-rack

possible. Fig. 12 shows implementation of remedial measure 2 i.e., adequate extension of top chord and bottom chord members to ensure that extension part acts as an integral part of the pipe-rack, thus making the structure to act as a truss. Since the total weight of the additional steel sections used for restoration is a very small fraction of the total weight of the bridge, thus will have negligible effect on the seismic response of the bridge.
