Anticipated and actual performance of composite girder with pre-stressed concrete beam and RCC top flange

K. Gurunaathan^{*1}, S. Christian Johnson^{2a} and G.S. Thirugnanam^{3b}

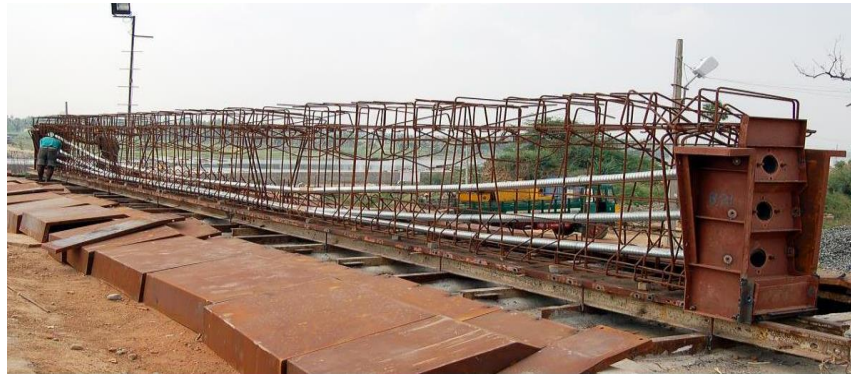
Fig. 1 Road bridge girder - skeleton reinforcement and sheathing pipes

- All cables are of 12 T 13 pre-stressing system with 66mm ID sheathing and are uncoated stress relieved low relaxation seven – ply strands conforming to IS: 14268 – 1995. The reinforcements were locally adjusted wherever they interfered with sheathing.

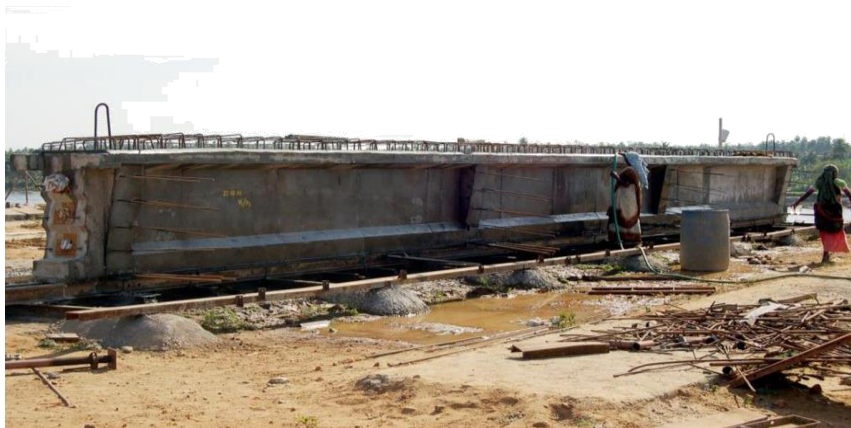
Fig. 2 Road bridge girder - after casting

The PSC girders of M40 grade have been cast & pre-stressed by post tensioning method. The entire pre-stress is applied to the precast girder only. After grouting and sufficient curing, they are launched to the required location and placed atop the pedestals on the piers. Subsequent to the erection of the PSC girders, a reinforced cement concrete deck slab is cast over the erected girders. The

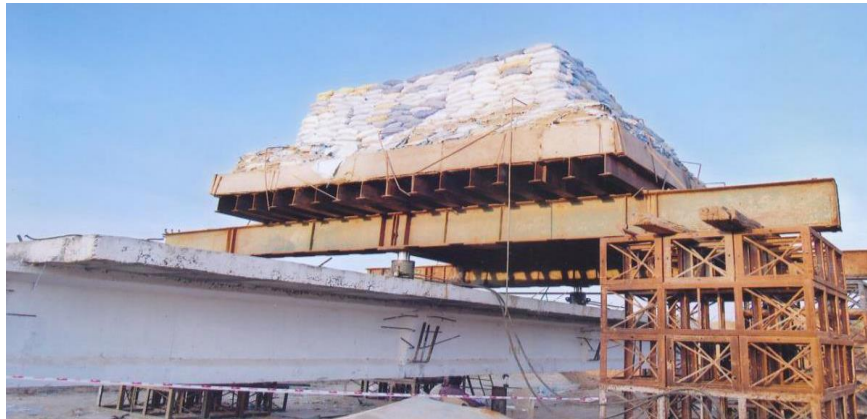
Fig. 3 Load test set up

slab cast atop the girder simulating the field conditions. For the load test, two point loads of equal magnitude are applied with one each at the middle third points (centre of the intermediate diaphragms) of the span. The test loads applied are of such a magnitude that the resulting bending moment at the mid span does not exceed the maximum bending moment caused by 1.25 times design superimposed loads.

The load test is carried out in stages of up to 1.25 times the design super imposed load. The total Kent ledge load arranged was 1530 kN. The total maximum test load applied in this test was 940 kN and the corresponding theoretical deflection was 12.26 mm. The load was applied on to the test girder as two loads of same magnitude at two points, one each at the location of the intermediate diaphragms by means of 2 numbers of hydraulic jacks of 1000 kN capacity each, operated in tandem. The test load was increased in stages from zero to the maximum test load of 940 kN (total) and this maximum load was maintained for 24 hours and thereafter the load was reduced to zero in stages. At each of the loading and unloading stages, the deflection of the girder at mid span was recorded using dial gauge.

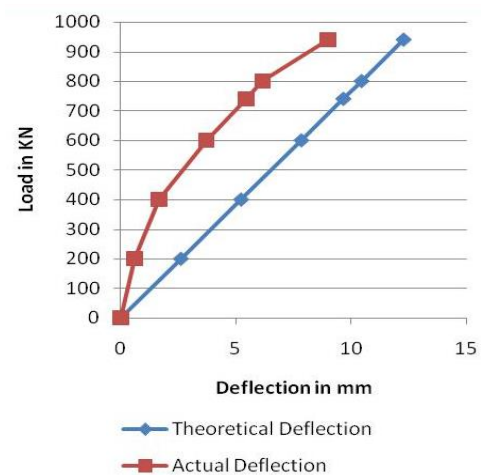
Fig. 4 Load- deflection curve during loading process

The actual and theoretical deflection values for various loads during the process of loading have been plotted and it is found that the actual deflection is far less than the theoretical values for all loads.

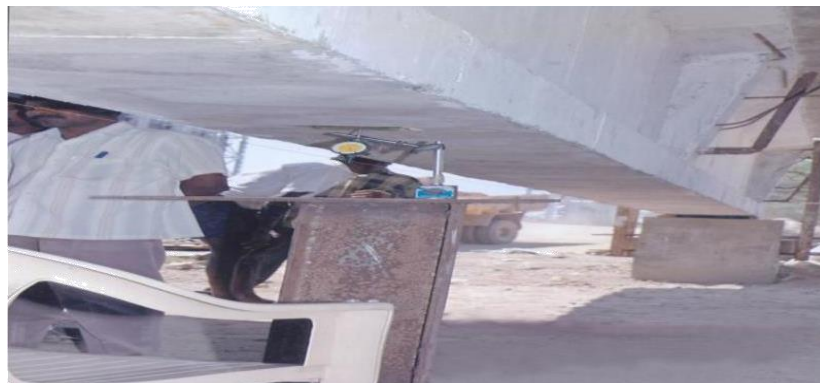
Fig. 5 Deflectometer placed on a firm support and below the girder at mid span

- The girders were examined thoroughly for any cracks or imperfections. Dial gauge was fixed at mid span to ensure that the plunger of dial gauge was having a firm contact with the bottom of girder.
- The superimposed load component (inclusive of self

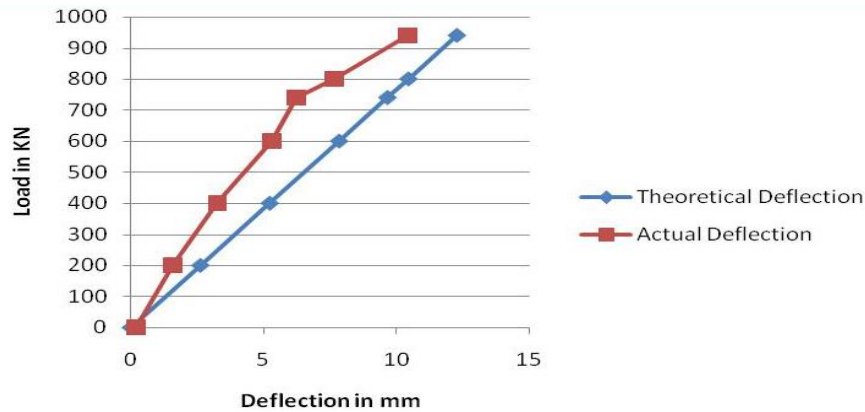
Fig. 6 Load- deflection curve during unloading process

The actual and theoretical deflection values for various

loads during the process of unloading have also been plotted and it is again found from this graph that the actual deflection is less than the theoretical values invariably at all loads.

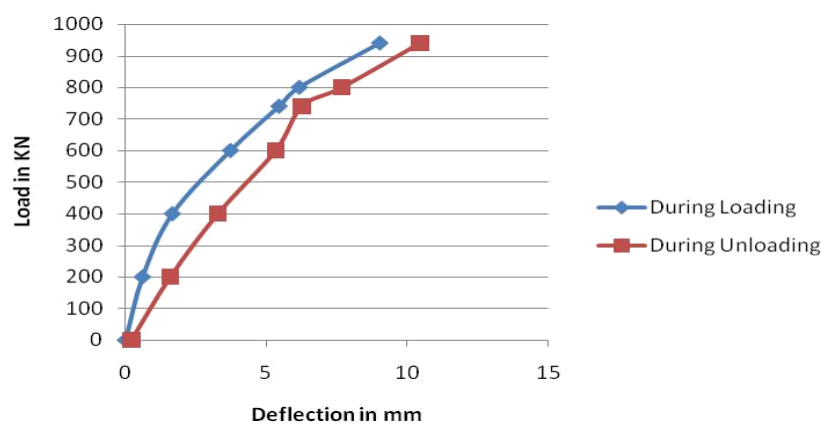
Fig. 7 Load- deflection curves during loading & unloading process

The actual deflection values for various loads during the process of loading and unloading have been plotted as well.

After the loading reached the maximum of 940 kN, it was noticed that the deflection was 9.01 mm. After sustaining the load for 24 hours, the deflection got increased to 10.45 mm, which was attributable to time dependent deformation. It was found from this graph that the actual deflection even after releasing the entire load on the girder was 0.2 mm, though the theoretical value was zero. Generally, the actual value and the theoretical one at no load condition will not be equal as ideal girder cannot be expected in reality.

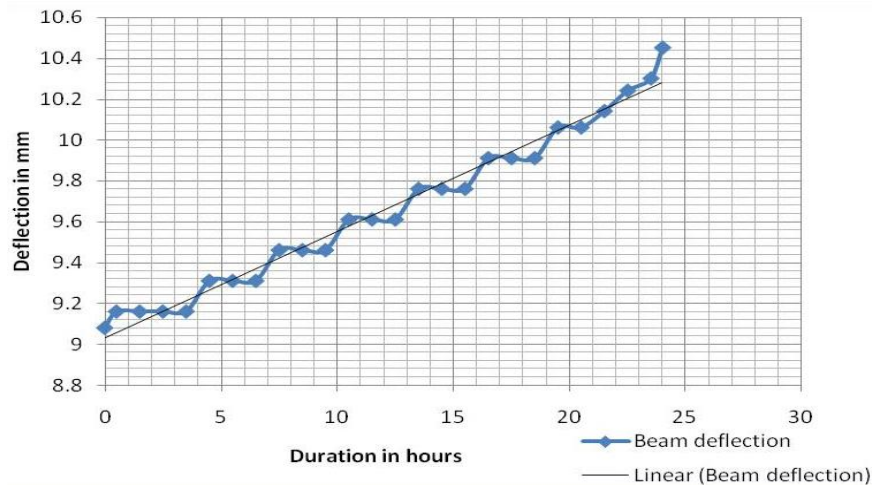
Fig. 8 Deflection during 24 hour period

The deflection readings were noted down for 24 hours at the sustained load and it is evident from Table 2 above that there is approximately a gradual increase of 0.15 mm for every two to three hours during the first eighteen hours and then it increases sharply every hour. The deflection increase in 24 hours during sustained loading is 1.29 mm (from 9.16 mm to 10.45 mm) which is 14.08% of the instantaneous deflection for the maximum load of 940 kN.
