# Experimental investigation into brick masonry arches' (vault and rib cover) behavior reinforced by FRP strips under vertical load

**Abstract.** The current experimental study is the reinforcement of the simple curvature vault masonry structures. In this study, we discuss complex structure include vault and rib cover with two radii and actual dimensions under a vertical load. The unreinforced structure data were compared with analysis data. The analysis data are in good agreement with experimental data. In the first experiment, a structure without reinforcement is tested and according to the test results, the second structure was reinforced using the carbon polymer fibers and the same test is done to see the effects of reinforcement. Based on the test results of the first structure, the first cracks are created in the vault. Moreover, the reinforcement with carbon fibers will increase the loading capacity of the structure around 35%.

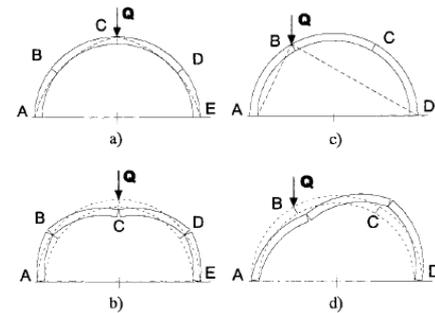
Fig. 1 Line of thrust and collapse mechanism of unreinforced arch subjected to vertical load applied to: (a, b) middle of arch span; (c, d) 1/4 of arch span (Valluzzi *et al.* 2001)

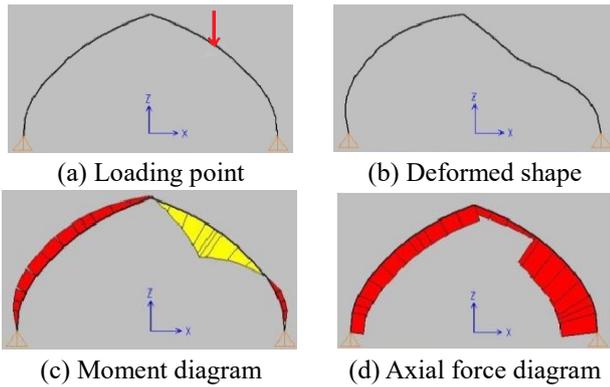
Fig. 2 Static analysis of mentioned arch

Loading point, deformed shape, moment diagram and axial force diagram are shown in Fig. 2. According to Fig. 2(c), bending moment at the loading point is positive and maximum. On the other hand, based on Fig. 2(d), the axial force is in the form of pressure. If the ratio of the axial force over bending moment, is greater than  $h/6$  ( $h$  is the thickness of the vault), the stretch is created in the section, but if the ratio is smaller than  $h/6$ , the pressure will be created. In this area, the ratio is much larger than the  $h/6$  (6 cm) and stretch is created in the section and because of the positive bending moment in this area, the bottom of the arc placed in stretch and cracks at the bottom of the arch began to grow. The same mechanism occurs in a point on the opposite side of the load, with a negative moment the cracks are created on the top of the arch. The locations of the cracks in model and experiments are almost the same. Fig. 3 shows the pressure line of the arch. The eccentricity can be calculated as a ratio of the bending moment to the axial force at each point and the arch pressure profile is achieved by connecting the eccentricity points. According to this figure, another crack occurs close to the springer.

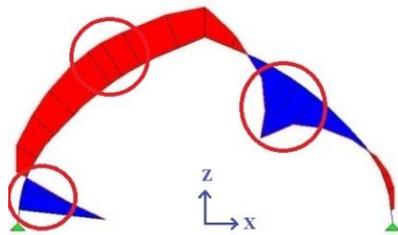
Fig. 3 Pressure line of the arch

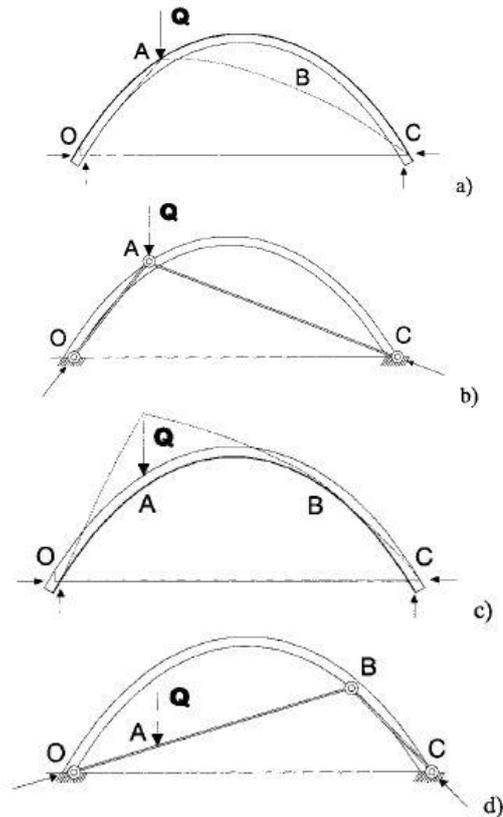
Fig. 4 Line of thrust and the static scheme of the reinforced vault at: (a, b) extrados; (c, d) intrados (Valluzzi *et al.* 2001)

Fig. 4 shows thrust line of the reinforced vault in the case of external strengthening. According to Fig. 4(a), the line of thrust can fall outside the lower edge of the vault without any structural collapse. For a vertical load applied to 1/4 of the structure span, the hinge formation in point B

is prevented. As a consequence, the vault becomes an isostatic structure (Fig. 4(b)). In the case of a structure reinforced at the intrados, Fig. 4(c), the line of thrust falls outside the upper edge of the structure and the fibers prevent the hinge formation close to the point of the load application (Fig. 4(d)).

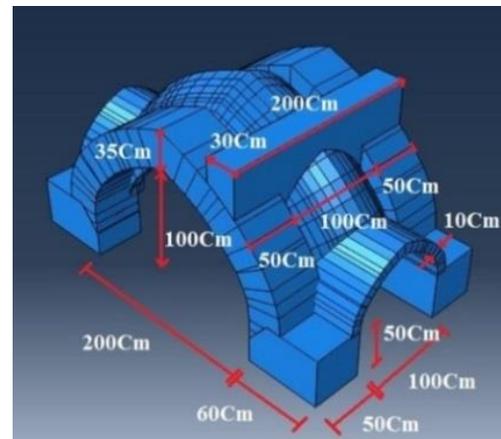
Fig. 5 Geometry of structure and load condition

The intended structure in this study consists of a vault and rib cover (Fig. 5).

Arch is six-part (with different radii). The clear span and height at the intrados are 200 cm and 100 cm, while the width of vault and rib cover are, 50 cm and 100 cm respectively. Also, the thickness of vault and rib cover is, 35 cm and 10 cm respectively. To connect arch to the rigid foundation, reinforced concrete foundations with dimensions of 50 cm×50 cm×40 cm is used. Reinforced concrete foundations with a slope of approximately 45 degrees have been made to prevent the possible bottom horizontal displacement of the vault. To implement this type of arch, the arch traced on the ground and then plaster stencil implemented. Plaster stencils have no structural function and only used to model the vault and the rib cover. Fig. 6(a) shows the plaster stencil. After installing plaster stencil at the beginning and end of the base, the vaults were built by pressure bricks and mortar contains gypsum, soil, and water. Each structure has four vaults and one rib cover. After completion of all the vaults, the rib covers are covered with brick and mortar. The rib covers are made with two arches, as a kind of dome. Fig. 6(b) shows the complete structure. In the reinforced structures, to have a better reinforcement, FRP fibers must be placed on a perfectly smooth surface. Due to the uneven surfaces vault and rib

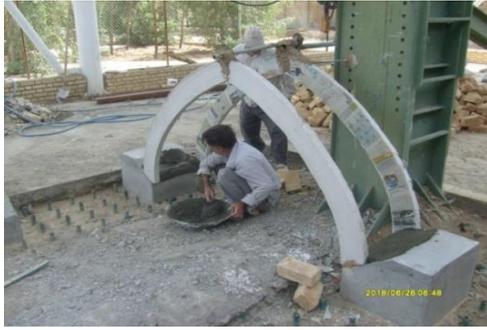
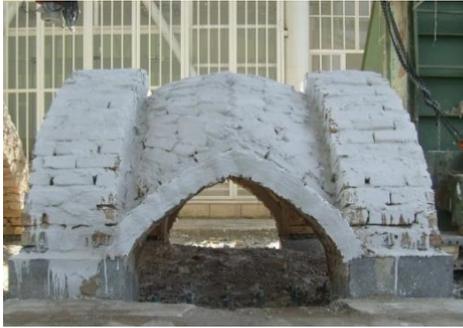
(a) Installation of the plaster stencil as a template

(b) Full view of the vault and the rib cover

Fig. 6 Construction processes of the vault and the rib cover

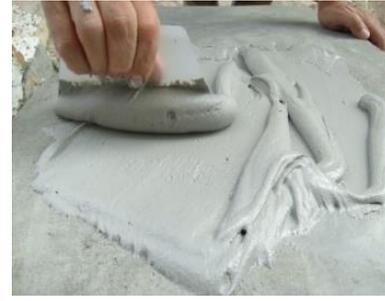
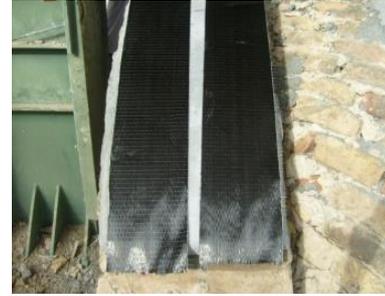
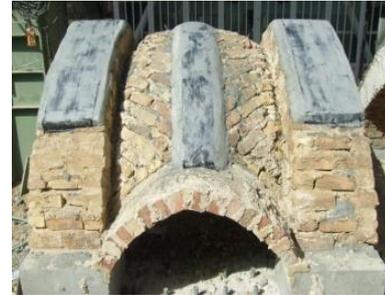
(a) Application of thin layer of primer to the surface

(b) Installing CFRP

(c) Structures view after reinforcement

Fig. 7 Stages of structural strengthening

CFRP strips with the width of 40 cm are attached using a layer of primer in the extrados and intrados of the vault. Also, CFRP strip with the width of 20 cm is attached in the center of the rib cover (Fig. 7).

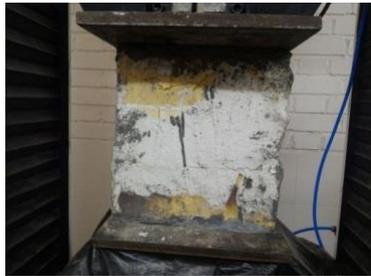
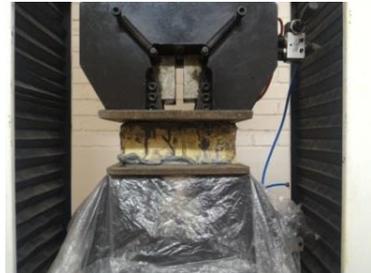
(b) Masonry test specimens (triplet)

(c) Compression bricks test

Fig. 8 Determination of compressive strength

The arches were constructed using a hydraulic mortar contains gypsum, soil, and water. To obtain the mechanical properties of the compressive strength tests (Fig. 8(a)) were performed according to the ASTM C472\_99 (2009). Compression tests were performed on six specimens. The compression strength is equal to 5.70 MPa.

properties of the bricks are obtained with testing six samples based on ASTM C1314-03b (2003). Uniaxial compression tests (Fig. 8(b), (c)) shows a mean strength variation of 22.50 Mpa for the bricks test and 11.20 MPa for the triplet.

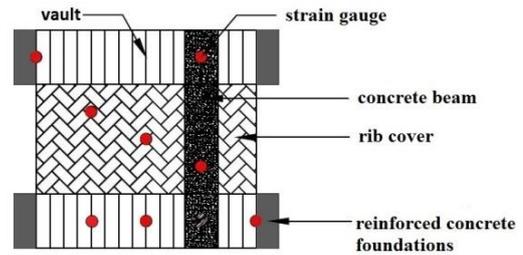
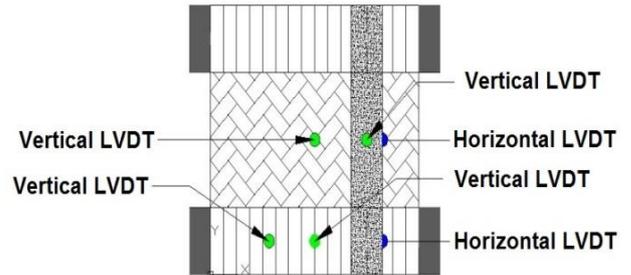
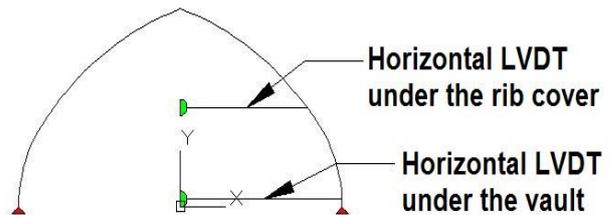
(a) Strain gauges disposition along the vault and rib cover in top view of the tested structure

(b) LVDT position in Structure plan

(c) LVDT position in Structural section

Fig. 9 Measurement systems distribution in the test setup

As shown in the Fig. 9, a concentrated load is applied to a quarter of the clear span, using a jack placed in series with a load cell of 250 kN capacity and distributed on the structures by a concrete beam. Eight strain gauges are placed on the CFRP material in reinforced structure and in the unreinforced structure, they placed along the brick (Fig. 9(a)). In each structure, eight linear variable differential transformers (LVDTs) were used to measure the displacement (Fig. 9(b), (c)).

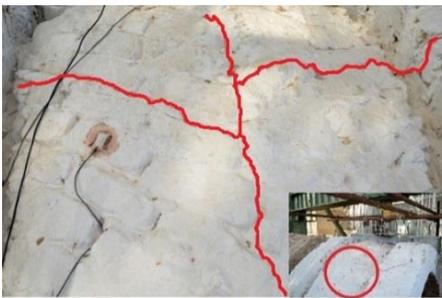
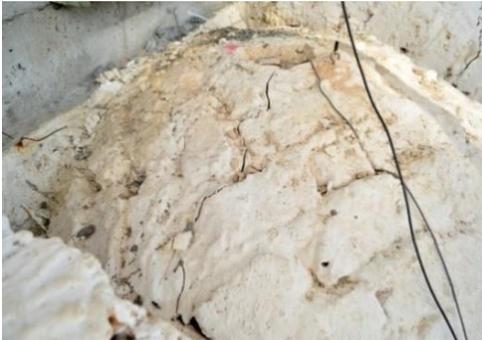
(a) Cracks with a cross shape in the rib cover under a load of 137 kN

(b) Longitudinal crack on the top of the rib cover after loading.

Fig. 11 Cracks in the unreinforced rib cover

gradually. Fig. 11 shows the cracks in the unreinforced rib cover. The first cracks with a cross shape in the rib cover were created at the load of 137 kN (Fig. 11(a)). The longitudinal cracks on the top of the rib cover can be seen in the final stage (Fig. 11(b)).

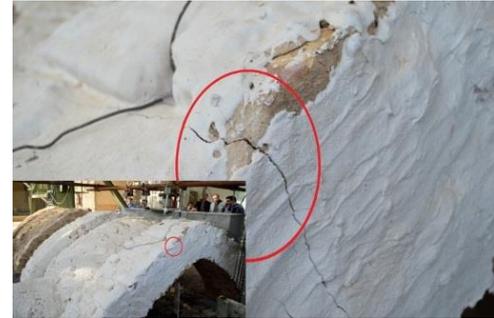
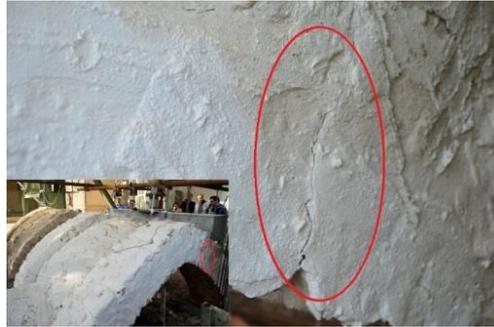
(a) Cracks in the vault under the load of 152 kN

(b) Cracks in the vault under the load of 171 kN

Fig. 12 Cracks in the unreinforced vault.

Fig. 12 shows the cracks in the unreinforced vault. With increasing the load up to 152 kN, a crack was seen in the vault that was started from the top of the vault (Fig. 12(a)). As a consequence of increasing the load up to 171 kN, another crack was seen in the vault (Fig. 12(b)). This crack, unlike the previous crack, was created in the bottom of the vault. Two plastic hinges in the vault, are important mechanisms that created in the structure. The locations of the cracks in model (Fig. 3) and experiments are almost the same. With an increasing load, the structure reaches ultimate capacity.

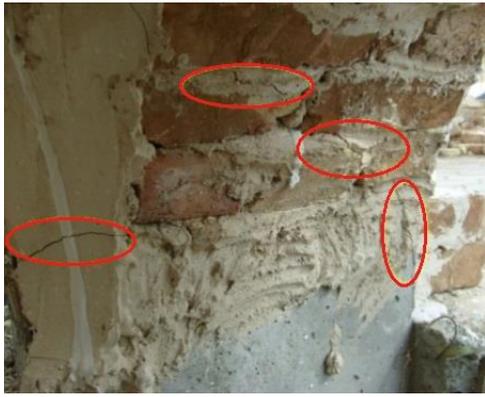
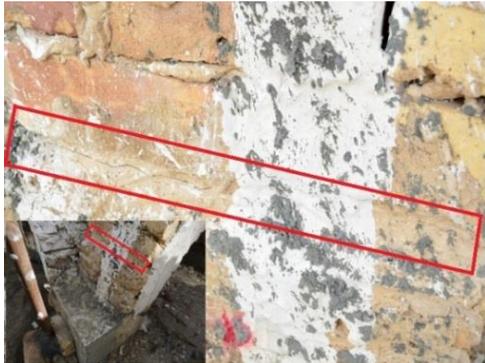
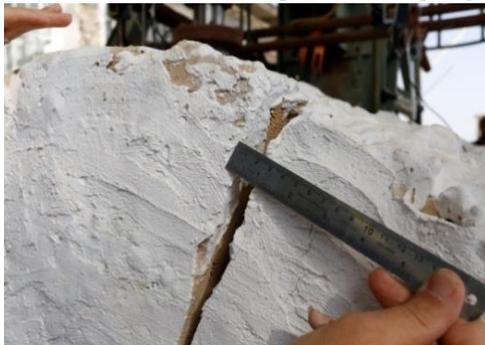
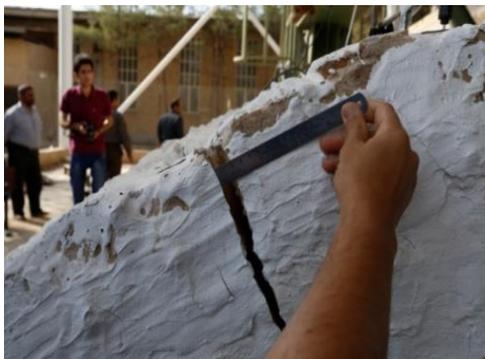
(a) Cracks at the closest point to the spring

(b) Cracks at the closest point to the spring

(c) Increase the width of the cracks in the right vault to 2 cm

(d) Increase the width of the cracks in the left vault to 2 cm

Fig. 13 Cracks in the structure in the ultimate capacity

Fig. 13(a) and (b), show the crushed materials at the closest point to the spring. At this load level, the width of the cracks in the vault will be increased (Fig. 13(c) and (d)) and some cracks can be seen at the closest point to the spring. The unreinforced arch showed a brittle failure, due to the four hinges mechanism as predicted in Foraboschi (2004) and Borri *et al.* (2009). As it is clear in Figs. 13(a) and (b), cracks near the springer have been created but the sliding between brick and mortar is not created, based on Borri *et al.* (2009) and ASTM C 1314-03b (2003) the sliding occurs between brick and mortar in the first joint closest to the springer.

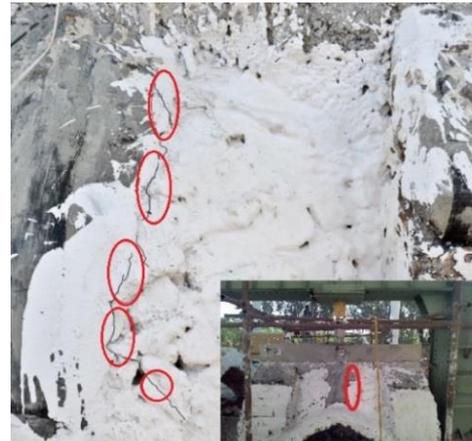
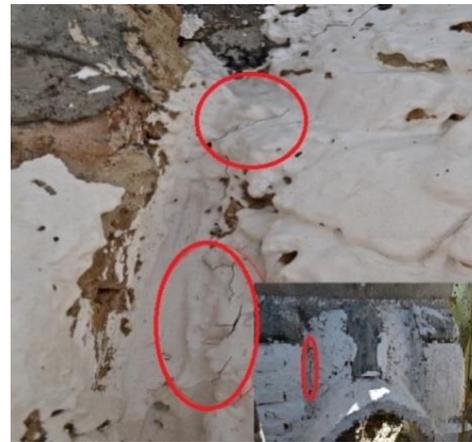
(a) Crack around the reinforced area with FRP under the load of 215 kN

(b) Cracks at the junction of rib cover to the vault under the load of 235 kN

Fig. 14 Cracks in the rib cover as a result of the loading

be helpful. Fig. 14 shows the cracks in the rib cover as a result of the applied load for the reinforced structure. The first crack around the reinforced area in the rib cover was created under a load of 215 kN (Fig. 14(a)). With the load

increasing up to 235 kN, cracks were created at the junction of the rib cover and vault (Fig. 14(b)). As a result of load increase to 245 kN, there was a clearance of 10cm between the created crack and the reinforced area.

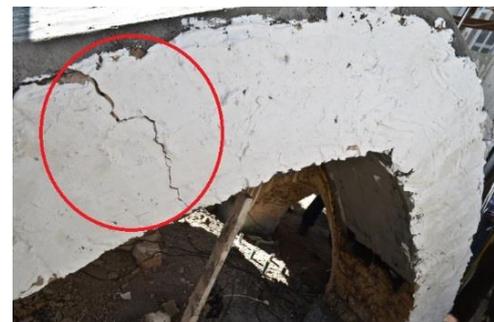
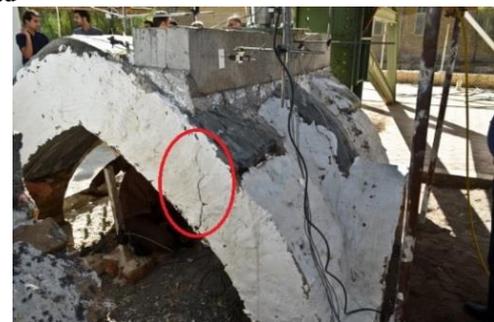
(a) Cracks in an intermediate point on the opposite side of the load

(b) Cracks in the vault under the load of 245 kN

Fig. 15 Cracks in the vault under the loading

Fig. 15 shows the cracks in the vault under the loading. According to this figure, the pattern of cracks in the structure is uniform that reveals the uniform load distribution on the structure (Fig. 15(a) and (b)). With increasing load up to 251 kN, Fig. 16 shows the cracks were created at the junction of FRP to vaults created. In Milani *et al.* (2014), the sample had been reinforced locally inside and outside the arc. In Milani *et al.* (2014), the plastic hinge was reported under the load, on springer and in an intermediate point on the opposite side of the load. In this experiment, the detachment of FRP under the vault was not observed. In experiments such as Valluzzi *et al.* (2001), the sample was only reinforced in the intrados, the failure occurred because of the detachment of the fibers from the masonry close to the point of application of the load. Also, unlike the results observation, Foraboschi (2004) and Borri

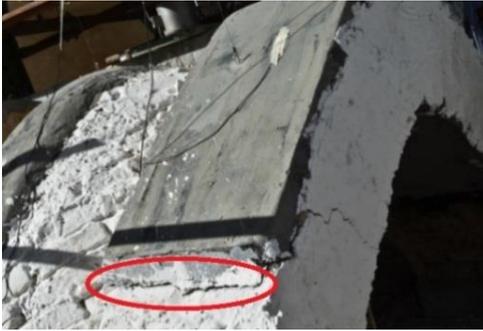
Fig. 16 Cracks at the junction of FRP to vaults under the load of 251 kN

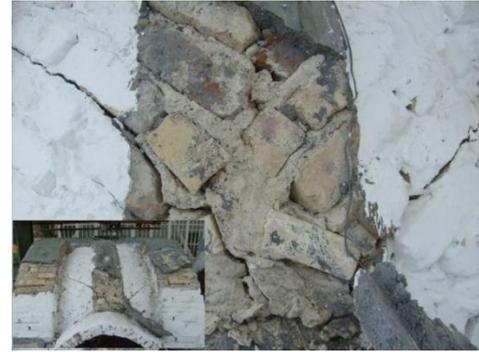
Fig. 18 Crack in the rib cover of reinforced structure after loading

Moreover, the cracks in the unreinforced rib are created on the top of rib cover, but for the reinforced rib, the cracks moved towards the bottom of the reinforced area and led to the vaults. Fig. 18 shows the crack in the rib cover of reinforced structure after loading. Cracks in the vault of the unreinforced structure were created under the load of 152 kN.

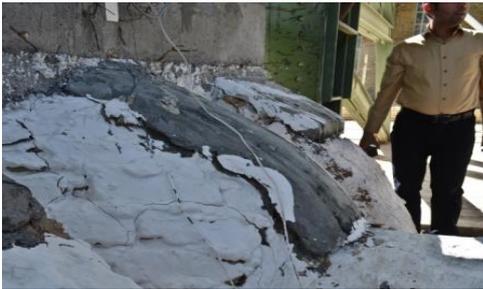
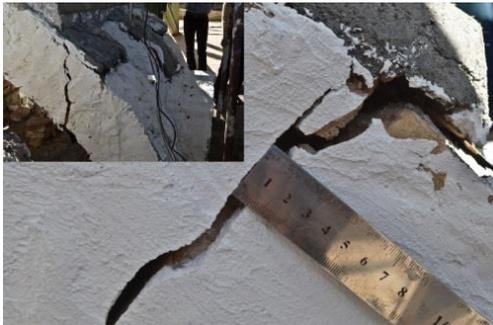
(a) FRP cement sand mortar separated from the rib cover

(b) The width of the cracks in the vault

Fig. 17 Cracks in the reinforced structures in ultimate capacity

At this stage, the structure up to ultimate capacity and as a result, the width of the cracks increased and FRP connectivity boundaries to rib cover broken up. The width of the cracks in the vault increased up to 1 cm. Cracks in the rib cover was created in the form of zonal and meridional. Also, smaller vaults that transfer part of the load to the reinforced concrete foundations were damaged and cracks were transferred to the reinforced concrete foundations. Fig. 17 shows the cracks in the reinforced structures in ultimate capacity.

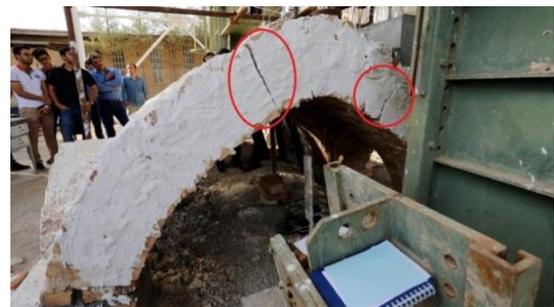
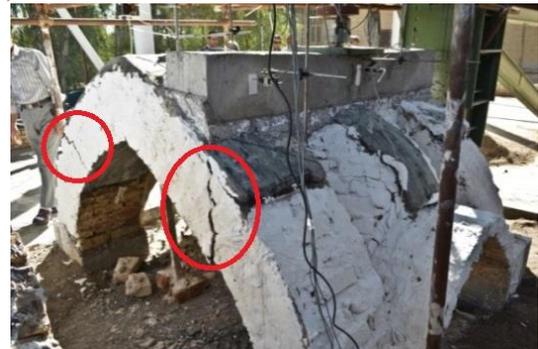
(a) Place of cracks in the vault, unreinforced structure

(b) Place of cracks in the vault, reinforced structure

Fig. 19 Crack in the vault of (a): unreinforced structure and (b): reinforced structure

However, the cracks were created in the vault of reinforced structures under the load of 245 kN. With increase in the length of the FRP strips up to the size of the vault, the capacity of tested structure will be enhanced and the cracks will moved toward the reinforced concrete foundation. Fig. 19 shows the cracks displacement as a consequence of the reinforcement.

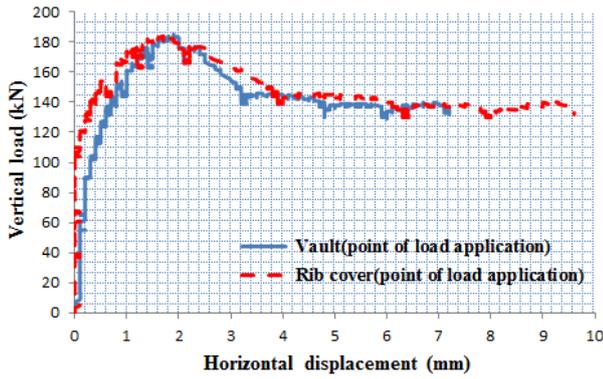
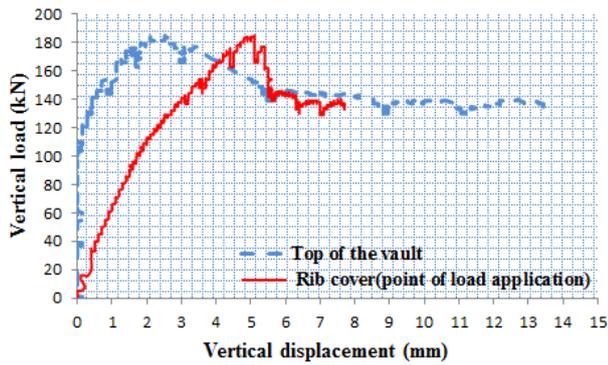
Fig. 20 Load-displacement curve of the unreinforced structure, (a): horizontal, (b): vertical

Fig. 20 shows the load-displacement curves of the unreinforced structure. According to Fig. 20, in the vertical direction, the stiffness of the top of the vault is more than to the rib cover but in the horizontal direction, there is no significant change. The strain gage is located in the compression zone at the lower part of the vault.

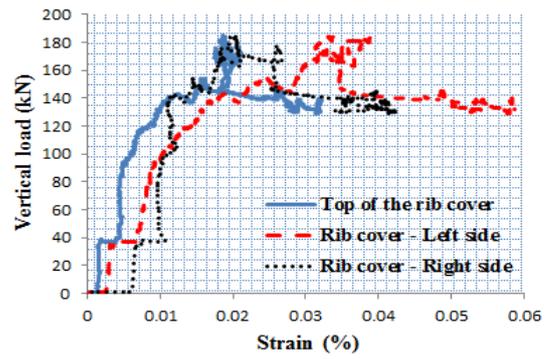
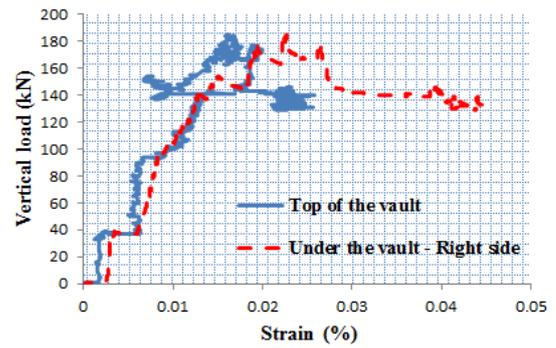
Fig. 21 Load-strain curve of unreinforced structure for (a): rib cover, (b): vault

The maximum range of this recorded strain is 0.000411 and the equivalent stress is 1.69 Mpa. This implies that the

Strain gauges have been installed at the left of rib cover with a maximum recorded strain is equal to 0.000587 represents the non-linear behavior.

Fig. 21 shows the load-strain curves in different parts of the structure.

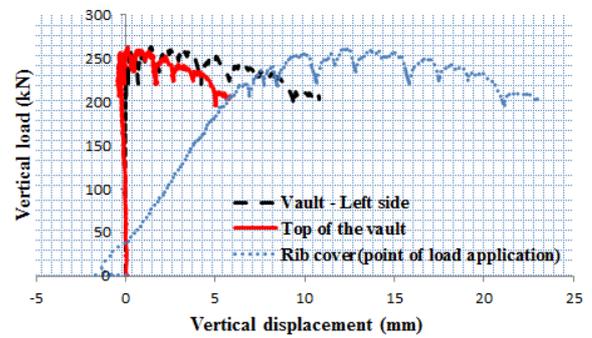
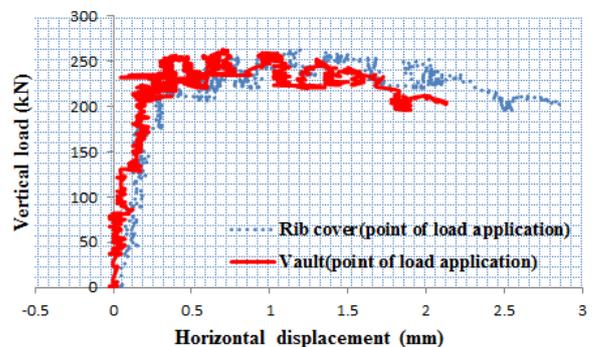
Fig. 22 Load-displacement curve of reinforced structure, (a): vertical (b): horizontal

Fig. 22 represents the load-displacement curve for the reinforced structure. According to this figure, the displacements for the vaults are less than the same parameter for the rib cover. This means that the vaults are much stronger than rib covers. The movement in the middle and at a quarter of the span is almost identical, but failure and crack do not happen in the middle of the span. According to the Fig. 22(a), the stiffness of rib cover is less than the vault that means the rib cover requires more strengthening.

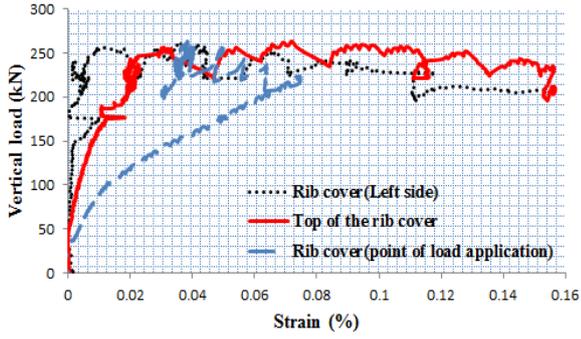
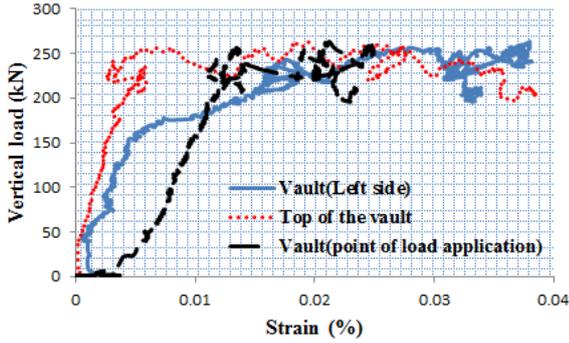
Fig. 23 Load-strain curve of reinforced structure for (a): rib cover, (b): vault

Fig. 23 shows the load-strain curve of reinforced structure. According to Fig. 23, a maximum strain recorded by the strain gauge is 0.0015 that means a stress of 360 Mpa in the FRP. It was much smaller than the tensile strength (4950 Mpa) and it shows that the FRP is still in a linear phase. But the bricks and the masonry materials are in the non-linear phase.

According to Fig. 23(a), the maximum strain is created in the spring. According to Fig. 23(b), the strain in the vault (right side) is negligible which causes less damages in the right side of the vault. Fig. 24 shows the comparison of the load-vertical displacement curve between the reinforced and the unreinforced structures.

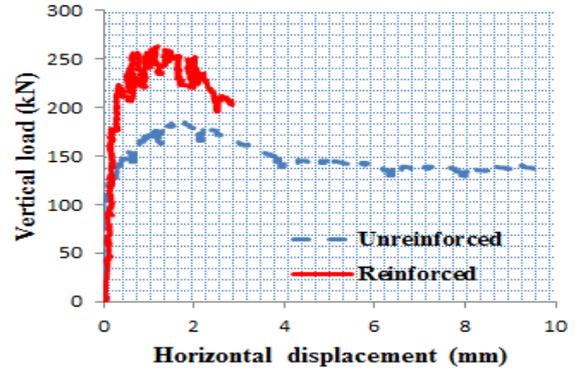
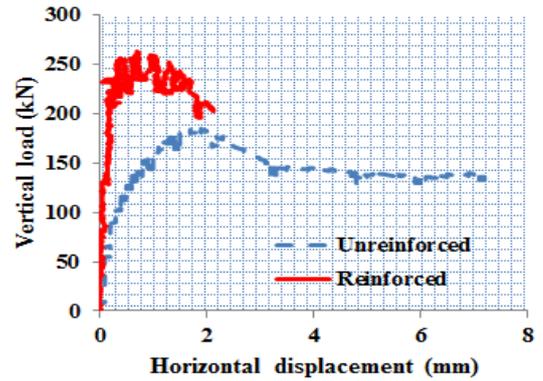
Fig. 25 Load-horizontal displacement curve of (a): rib cover, point of load application (b): vault, point of load application

Fig. 25 shows comparison the load-horizontal displacement curve for the reinforced and the unreinforced structures. According to this figure, it can be concluded that the stiffness and the strength of the reinforced structure, in comparison with the unreinforced structure, increased and the displacement decreased.

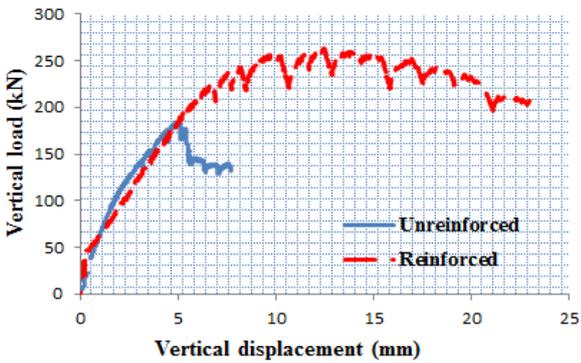
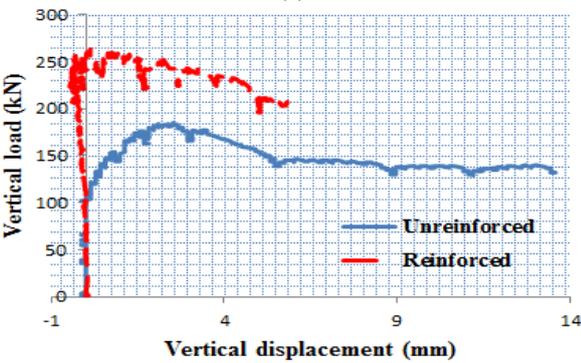
Fig. 24 Load-vertical displacement curve (a): rib cover, point of load application (b): top of vault

Once the structure has been reinforced, the displacement decreased almost 70 percent that indicates an increase in the bearing capacity of the structure.

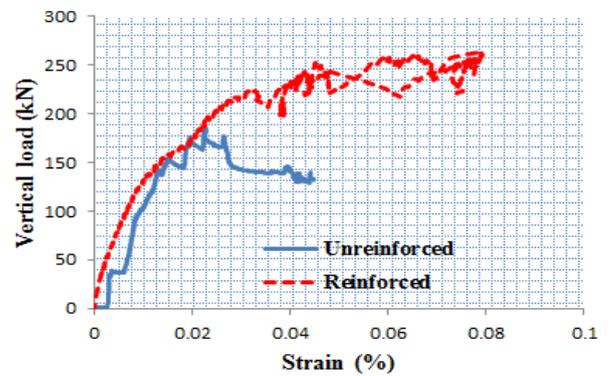
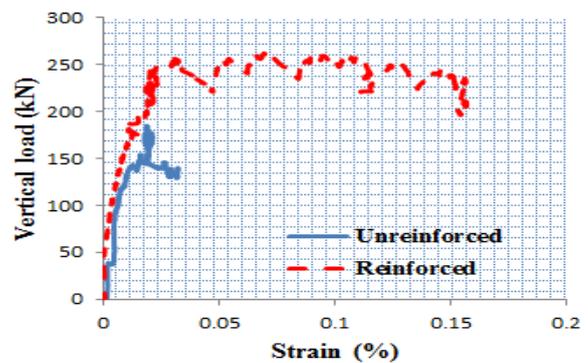
Fig. 26 Load-strain curve of (a): under the vault, right side, (b): top of the rib cover

Fig. 26 compares comparison the load-strain curve between the reinforced and the unreinforced structures. According to this figure, respectively, the ductility of the reinforced vault is more than the same value for the vault without reinforcement and the ductility of reinforced rib cover is larger that of the rib cover without reinforcement.
