# Monitoring in-service performance of fibre-reinforced foamed urethane sleepers/bearers in railway urban turnout systems

# Sakdirat Kaewunruen\*

## RailCorp - Track Engineering Level 13, 477 Pitt St., Sydney NSW 2000 Australia

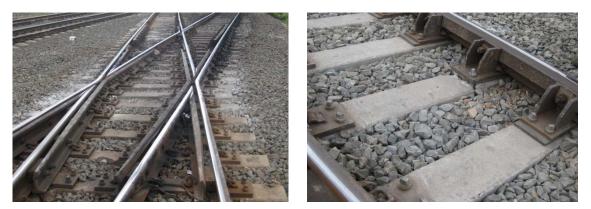
(a) pulverised ballast and broken concrete sleeper due to poor energy dissipation of material

From the dynamic behaviour results, the stiffness interface between FFU bearers and concrete sleepers needs a special attention (Remennikov *et al.* 2012, Kaewunruen and Remennikov 2013). Fig. 18 shows the actual dynamic effects on turnout systems, which previously were observed in the rail network. With the dynamic rigid body motion, the track superstructure will move/vibrate

upward and downward against the substructure (ballast and formation). If stiffness transition is not established, rapid deterioration of substructure could incur, e.g., white ballast, large settlement, poor top, or pumping track etc. RailCorp standard ESC 230 (RailCorp 2012d) has suggested a treatment method of stiffness transition by replacing hard HDPE pads with softer SA-47 pads for 20 approaching concrete sleepers.
