Vibration measurement and vulnerability analysis of a power plant cooling system

Keywords: vibration; finite element method; cooling structure; accelerometers; vulnerability analysis

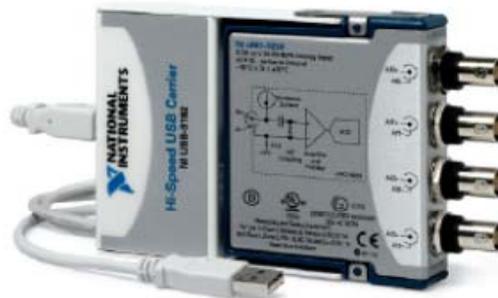
Fig. 2 Measurement devices

The accelerometer, cable and data logger used in measurements are shown in Fig. 2. Also, several examples from the photographs taken during field measurements are presented in Fig. 3. Acceleration measurements were taken at the locations on the cooling structure shown in Figure 1 in both directions for 500 sec. The duration of the measurements was determined by several trial measurements taken prior to the actual measurements, and this duration was kept long enough to ensure that the vibration profile of the cooling structure is accurately determined. A total of 15

(a) ICP Model 353B02 accelerometer

(b) 003A20 model cable

(b) NI 9233-USB-9162 data logger

ICP type accelerometers with model number 353B02, manufactured by PCB Group were utilized for acceleration measurements of the cooling structure. A 003A20 model special cable, manufactured by PCB Group, was used for transmission of measurements acquired from the

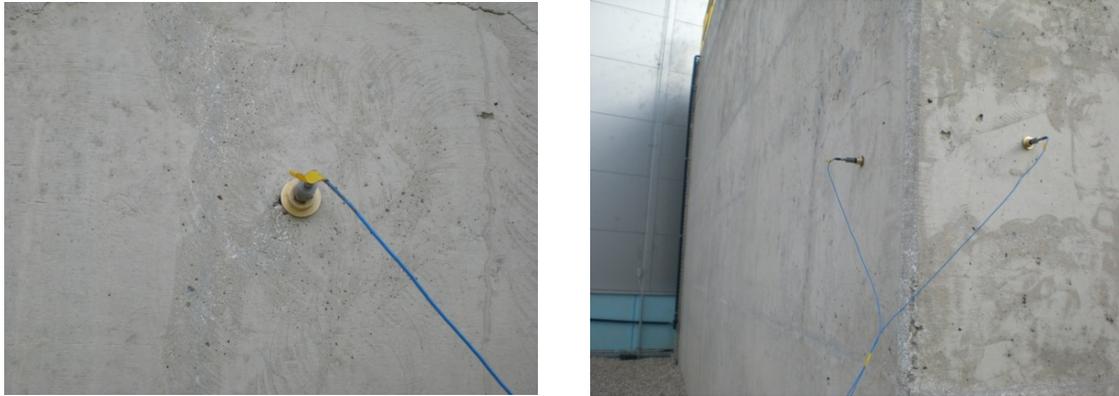
Fig. 3 A photo of field acceleration measurements
