Efflorescence assessment using hyperspectral imaging for concrete structures

Byunghyun Kim^a and Soojin Cho^{*}

Department of Civil Engineering, University of Seoul,
163 Seoulsiripdae-ro, Dondaemun-gu, Seoul 02504, Republic of Korea

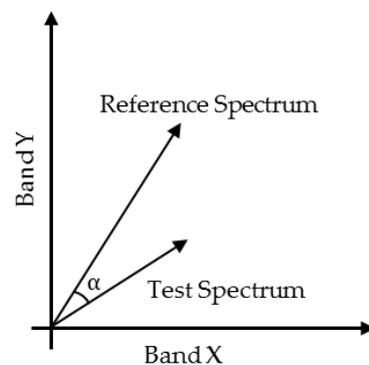
Fig. 1 Simplified SAM example with two bands (Redrawn from Kruse *et al.* (1993))

SAM is a spectral classification tool that permits rapid mapping of the similarity of two spectra as a form of an “angle” (Kruse *et al.* 1993). SAM treats spectra as vectors in a space with dimensionality equal to the number of bands (nb). SAM assumes that a single pixel or certain group of pixels in HSI represents one certain material, and the same material can be found by comparing the similarity between spectra. The angle (α) between a test spectrum and reference spectrum can be derived from the arc-cosine of the dot product of two spectra defined as a geometric vector as

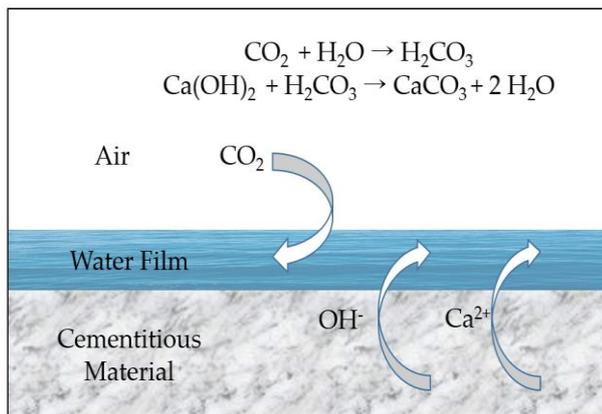
Fig. 2 CaCO_3 formation on cementitious material

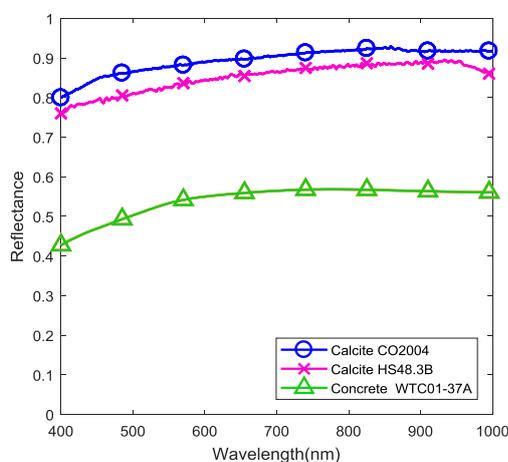
Fig. 3 Spectra of calcite and concrete in the USGS spectral library in the 200–1000 nm range

Fig. 3 shows the spectra of two calcites and a concrete in the 400–1000 nm range. The spectra of pure calcites shown in Fig. 3 have a high reflectance rate of approximately 80–90% and show a gentle slope in the visible and near-infrared (VNIR) spectrum range. At the same time, the spectrum of concrete shown in Fig. 3 has a relatively low reflectance rate of approximately 50% and shows a relatively steep spectrum difference near 550–600 nm. This infers that the efflorescence and concrete can be distinguished by the shape of their spectra.

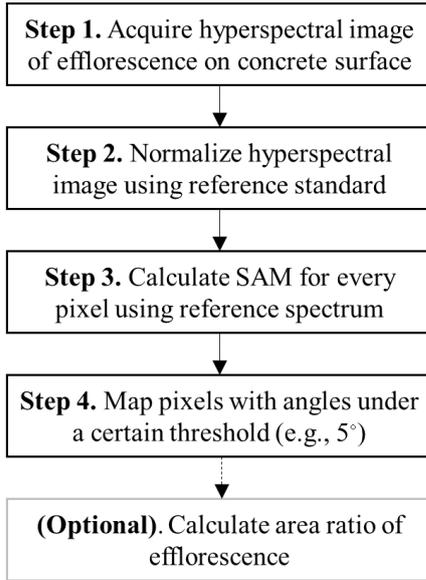
Fig. 4 Flowchart of efflorescence assessment using HSI

Because the shape of the efflorescence spectrum differs from that of the concrete spectrum, a SAM that quantifies the spectrum similarity is proposed for assessing efflorescence against concrete in an objective manner. Fig. 4 depicts a flowchart of the proposed approach to assess efflorescence using HSI. In the first step, the HSI device acquires the hyperspectral image of efflorescence on the surface of the concrete structure to be assessed. In the second step, the hyperspectral image is normalized using a barium sulfate reflector as a reflectance standard to remove the effect of lighting conditions. In this step, noisy bands due to inappropriate lighting conditions may be eliminated. In the third step, the spectral similarity of every pixel in the image is calculated using SAM by taking a reference spectrum of efflorescence. The reference spectrum of efflorescence is taken from the USGS spectral library in this study, but experimental spectrum may be used instead. In the fourth step, pixels with angles under a certain threshold are labeled as efflorescence, and they are mapped to visualize the shape of efflorescence. The threshold is determined as 5° for efflorescence in this study after a series of experiments, but the threshold may vary according to the chemical material to be assessed.

As an option, the area ratio of efflorescence can be obtained with pixels labeled as efflorescence. In Korea, the area ratio of efflorescence is requested for rating concrete structures by the guideline for safety inspection (MOLIT 2016). The area ratio is defined as the ratio of the efflorescence occurrence area to the unit inspection area. The efflorescence occurrence area is the area of a rectangle tightly bounding the efflorescence, and the unit inspection area is generally the structural element to be assessed, such as a span of a bridge girder or slab. According to the area ratio and the other inspection factors (e.g., cracking, leakage, and spalling), the inspected structure is graded from A to E, and its further maintenance is determined by the grade. Because real efflorescence generally has an unclear boundary, as discussed in the next section, the area ratio obviously depends on the subjective determination of efflorescence in the conventional visual inspection. Thus, the proposed approach based on HSI can provide objective assessment based on measurement results, not on the expertise of inspectors.

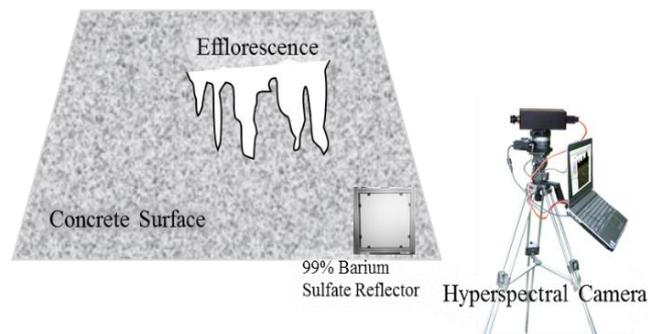
Fig. 5 Experimental setup

The experimental setup shown in Fig. 5 was shared for both field experiments. A hyperspectral camera along with a focusing lens (PS-VNIR, Specim, Spectral Imaging Ltd., Finland) was used in this study. The camera works as a push-broom type line-scan camera, and collects 2D images with the help of a rotary stage installed underneath. Its spectral range is 400–1000 nm in the visible and near infrared (VNIR) range, and it has 1392 (spatial) \times 1040 (spectral) active pixels in full frame. The camera has a fore objective lens with focal length 23 mm. The camera is connected to a computer using a Firewire interface, and samples at 11 frames per second (fps) for full frame, and up to 62 fps when binning eight spectral bands together. The computer controls the camera using data acquisition software made by the manufacturer, and analyzes the acquired hyperspectral images using commercial software ENVI (Harris Corporation, FL, USA). For all experiments, the camera was located approximately 1.5 m distant from the test structure, and a 99% barium sulfate reflector was placed near the efflorescence for normalization. The reflector was installed near the test structure so as to share similar light conditions with the efflorescence.

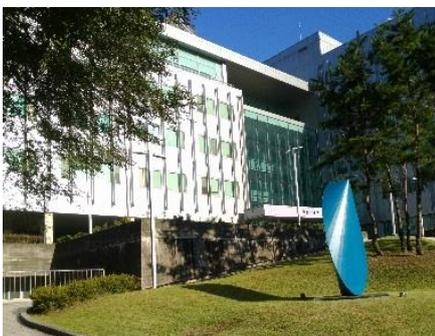
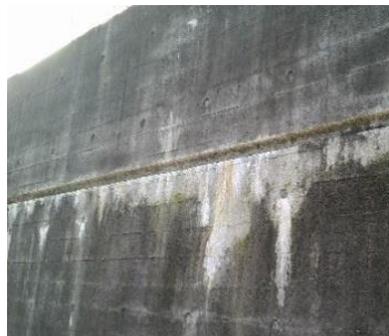
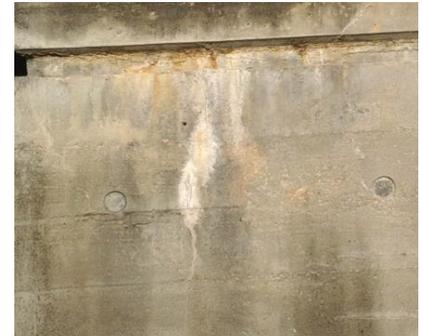
Fig. 6 Field experiment on a building

(a) Test Building

(b) Efflorescence on the north side of the concrete wall (W1-N)

(c) Efflorescence on the west side of the concrete wall (W2-N)

The first field experiments (W1-N and W2-N) were conducted on a concrete wall of a building at the University of Seoul shown in Fig. 6(a). Efflorescence occurred at the north and west sides of the wall at the first floor of the building. The north side of the wall is approximately 10.5 m

wide and 3.85 m tall, and the west side is approximately 18 m wide and 3.65 m tall. Severe efflorescence was found at the joints on the wall as shown in Figs. 6(b) and 6(c), and two hyperspectral images were obtained around the efflorescence on both sides of the wall using the HSI setup in Fig. 5 during the daytime. Then, the proposed approach was applied to the obtained hyperspectral images. To calculate SAM, two reference spectra of calcite (Calcite CO2004 and Calcite HS48.3B) are taken from USGS spectral library version 7 (USGS Spectral Library 2017), and data from 420 nm to 850 nm, where the camera of this experiment can obtain data with a low spectral noise level, were used in the experiments.

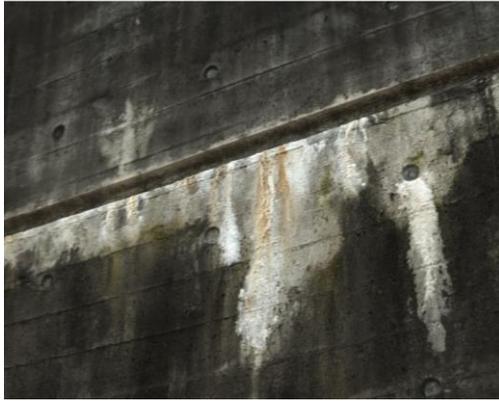
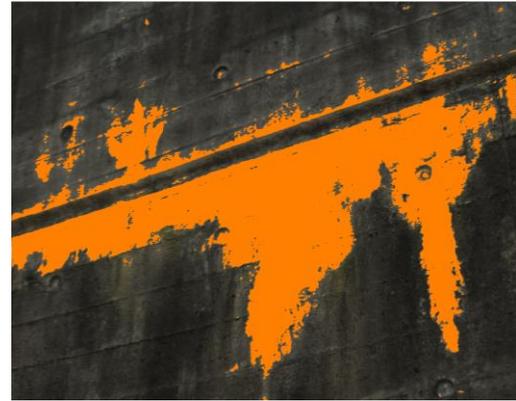
Fig. 7 Efflorescence assessment using an RGB image in case W1-N

(a) RGB image rebuilt from the hyperspectral image

(b) Efflorescence assessment using intensity mimicking visual inspection

Fig. 7 shows the result of efflorescence assessment using the RGB image from W1-N. The image of W1-N has 758 × 692 pixels, corresponding to 1.3 m wide and 0.8 m high around the efflorescence. For the RGB image shown in Fig. 7(a), 90 was selected as an intensity threshold to find

the efflorescence as shown in Fig. 7(b). As explained herein, the intensity threshold changes for every RGB image, because each RGB image has different intensity values of efflorescence and concrete, though they are rebuilt from the normalized hyperspectral image.

The single intensity threshold used for an image may miss thin efflorescence. In W1-N, very thin efflorescence at the upper part of the image was missed, as shown in Fig. 7. In P1-N, the start of flow near the micro crack, which is the source of efflorescence, was missed, as shown in Fig. 12. The increase of threshold can assess the missed part with exaggerated efflorescence shape. In Fig. 12, the end of flow was exaggerated even with the missing start of flow. This obscure ambiguity of “true” efflorescence influenced the evaluation of the proposed approach using performance measures.

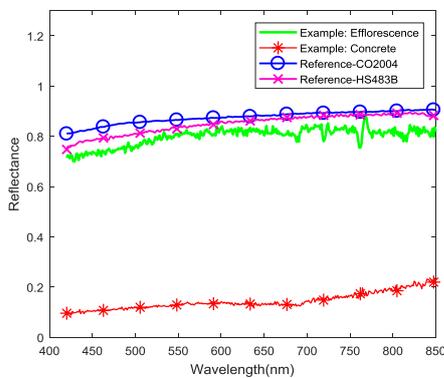
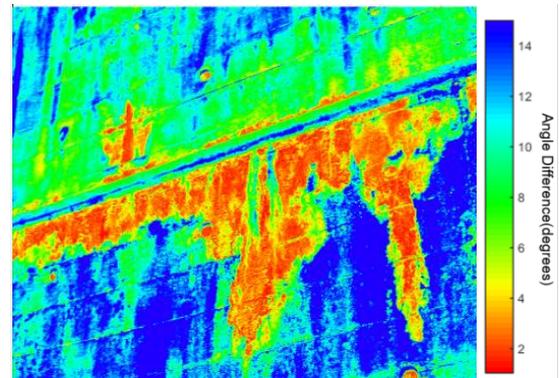
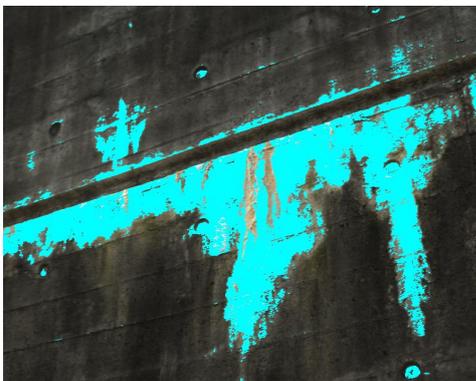
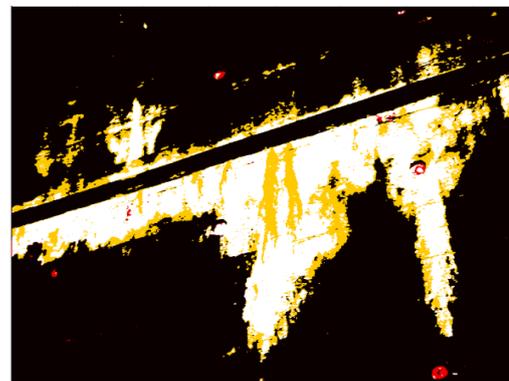
Fig. 8 Efflorescence assessment by proposed approach for case W1-N

(a) Example spectra of efflorescence and concrete plotted with reference spectra

(b) Spectral angle (Reference: Calcite CO2004)

(c) Efflorescence assessment by the proposed approach using a 5° threshold

Legend: True positive (white), False positive (red), False Negative (yellow), True Negative (black)

(d) Distributions of TP, TN, FP, and FN referring to the assessment using the RGB image

Fig. 8 shows the results of efflorescence assessment of W1-N by the proposed approach. Fig. 8(a) shows an example of spectra for efflorescence and concrete pixels picked up from the hyperspectral image of W1-N, compared to two reference spectra taken from the USGS library. In the range of 420–850 nm, the two reference spectra and the example spectrum of efflorescence are quite similar, whereas the example spectrum of concrete shows a clear disparity in the shape. Fig. 8(b) shows the spectral angle of the hyperspectral image obtained using SAM by taking the reference spectrum of Calcite CO2004. The pixels with angles of 2° – 4° were colored with shades of red, those of 5° – 10° were colored with shades of light green, and pixels with angles more than 11° were colored with shades of blue. Comparing Fig. 8(b) with Fig. 7(a) shows that the thick efflorescence corresponds to a small angle under 5° , whereas thin efflorescence has an angle between 6° and 8° . From the spectral angles, the pixels with angles smaller than 5° to the reference spectrum are overlapped on the RGB image in Fig. 8(c), which shows an overall shape of efflorescence similar to the result using the RGB image in Fig. 7(b). Then, the distributions of *TP*, *TN*, *FP*, and *FN* were visualized as shown in Fig. 8(d) by referring to the assessment using the RGB image. In Fig. 8(d), white and black pixels, respectively representing *TP* (i.e., correct labeling of efflorescence) and *TN* (i.e., correct labeling of concrete), are distributed along the overall shape of the efflorescence and concrete. Yellow pixels, representing *FN* (i.e., missing labeling of efflorescence), are distributed along the very thin efflorescence that is mostly on the boundary. Red pixels, representing *FP* (i.e., false labeling of efflorescence), are rarely detected. This result indicates the good performance of the proposed approach, although the very thin efflorescence and boundary are missing, as colored yellow.

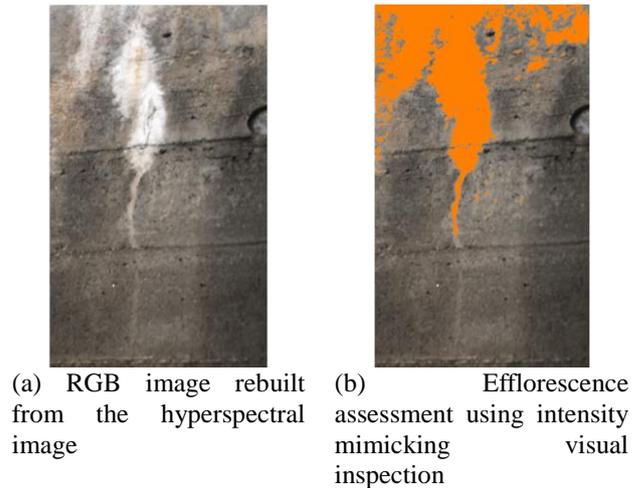
Fig. 9 Efflorescence assessment using RGB image in W2-N

The hyperspectral image from W2-N was processed similarly to that described in Section 3.3.1. The image of W2-N has 647×325 pixels, corresponding to 0.4 m wide and 0.25 m high around the efflorescence. The result of efflorescence assessment using RGB image from W2-N was shown in Fig. 9. For the RGB image shown in Fig. 9(a), 140 was selected as an intensity threshold to find the efflorescence as shown in Fig. 9(b), which differs from 90 of W1-N. Fig. 10 shows the result of the efflorescence assessment of W2-N by the proposed approach. Similar to the result of W1-N, the thick efflorescence was detected appropriately using a 5° threshold, whereas thin efflorescence has an angle between 6° and 8° as shown in Fig. 10(a). The assessment result by the proposed method is shown in Fig. 10(b), which shows an overall good assessment. Fig. 10(c) shows the distributions of *TP*, *TN*, *FP*, and *FN* by referring to assessment using the RGB image in Fig. 9(b). Unlike the result of W1-N, W2-N has more pixels of *FN* and *FP*, and the reason is discussed in Section 4.

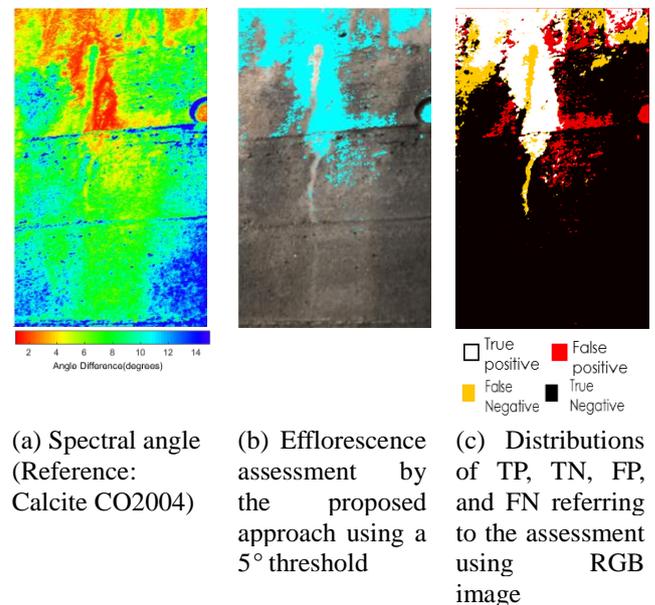
Fig. 10 Efflorescence assessment by proposed approach for W2-N

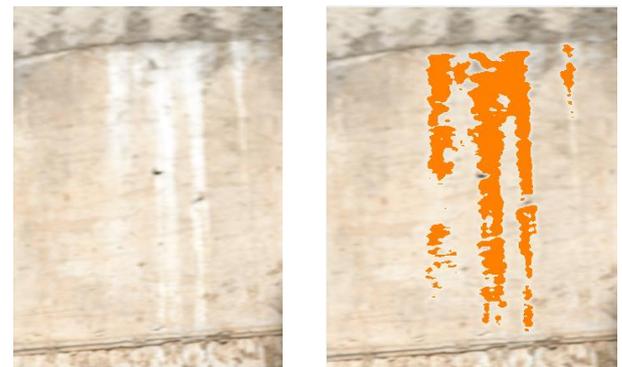
Fig. 12 Efflorescence assessment using RGB image in P1-N

(a) RGB image rebuilt from the hyperspectral image (b) Efflorescence assessment using intensity mimicking visual inspection

Fig. 12 shows the result of efflorescence assessment using the RGB image from P1-N. The image of P1-N has 303×401 pixels, corresponding to 0.5 m wide and 0.8 m high around the efflorescence. For the RGB image shown in Fig. 12(a), a high intensity threshold of 237 was selected because of the bright concrete color, and the efflorescence was obtained as Fig. 12(b). In this case, a considerable change in the obtained efflorescence was made by a small change in the intensity threshold, and Fig. 12(b) was obtained by many trial-and-error cycles to keep the shape of the efflorescence shown in Fig. 12(a). However, the obtained efflorescence has an unexpected irregular and discrete shape, which clearly shows a limitation of the intensity-based efflorescence assessment.

Unlike in the previous experiment, the 5° threshold provides good estimation with a smooth and regular shape compared to the result in Fig. 12(b). The distributions of TP , TN , FP , and FN in Fig. 13(d) shows many yellow and red pixels related to FN and FP , respectively. The yellow pixels are observed at the end of flows that are difficult to judge, and the red pixels are at the start of flow near the micro crack that is the source of the efflorescence. Considering the shape and the occurrence process of the efflorescence, it can be concluded that the proposed approach assessed the thin efflorescence better than the conventional method.

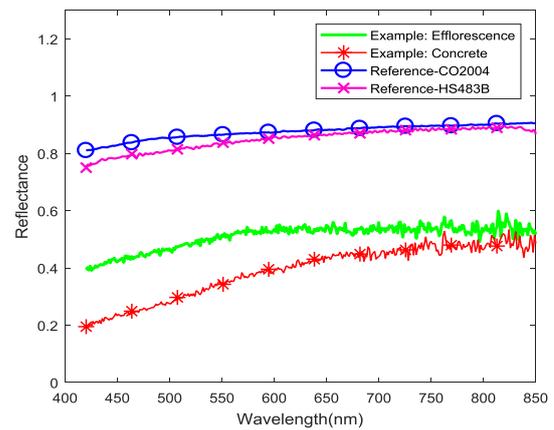
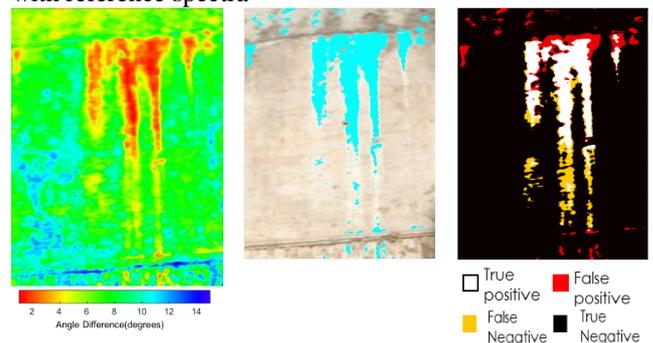
Fig. 13 Efflorescence assessment by proposed approach for P1-N

(a) Example spectra of efflorescence and concrete plotted with reference spectra

(b) Spectral angle (Reference: Calcite CO2004) (c) Efflorescence assessment by the proposed approach using a 5° threshold (d) Distributions of TP, TN, FP, and FN referring to assessment using RGB image

The proposed approach was applied to the hyperspectral image from P1-N as in Fig. 13. An example of spectra for efflorescence and concrete pixels is shown in Fig. 13(a), and the shapes of the spectra are different from those from the building in Fig. 8(a). The concrete has a spectrum with higher reflectance due to its bright color, and the efflorescence has a spectrum between the reference spectra and concrete spectrum because of its thinness. Fig. 13(b) is the mapped spectral angle, and Fig. 13(c) shows the assessed efflorescence using a 5° threshold.

the building in Fig. 8(a). The concrete has a spectrum with higher reflectance due to its bright color, and the efflorescence has a spectrum between the reference spectra and concrete spectrum because of its thinness. Fig. 13(b) is the mapped spectral angle, and Fig. 13(c) shows the assessed efflorescence using a 5° threshold.

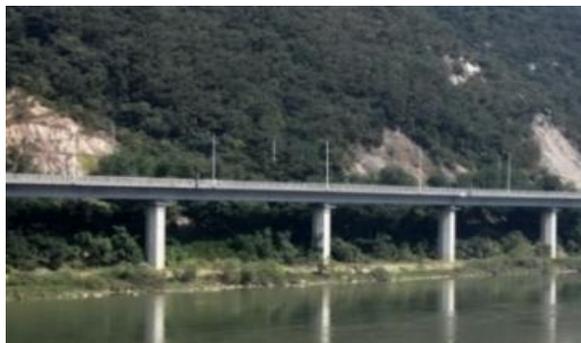
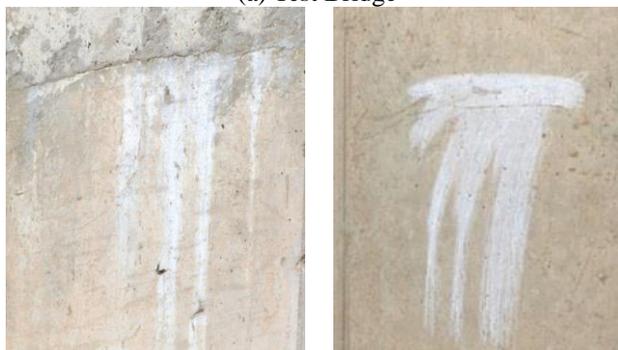
Fig. 11 Field experiment on a bridge

(a) Test Bridge

(b) Natural efflorescence on P19 (P1-N) (c) Artificial efflorescence on P19 (P2-A)

Other field experiments (P1-N and P1-A) were conducted on a pier of a concrete bridge. The test bridge is a 20-span bridge with high concrete piers approximately 4 m wide and 20 m tall as shown in Fig. 11(a). Unlike the test building at the University of Seoul, the concrete of the bridge is light brown colored. Experiments on this brown color of the pier surface determined if the proposed approach using SAM is affected by the color of the concrete surface. On pier P19 of the bridge, a thin natural efflorescence was observed as flowing down along a micro crack of the concrete column as shown in Fig. 11(b). To increase the experimental case, an artificial efflorescence was drawn next to the natural efflorescence using a slate pencil made of a limestone. The artificial efflorescence was

drawn imitating the shape of the natural efflorescence as shown in Fig. 11(c). The hyperspectral camera was placed approximately 1.5 m distant from each target efflorescence, and the 99% barium sulfate reflector was located near the efflorescence.

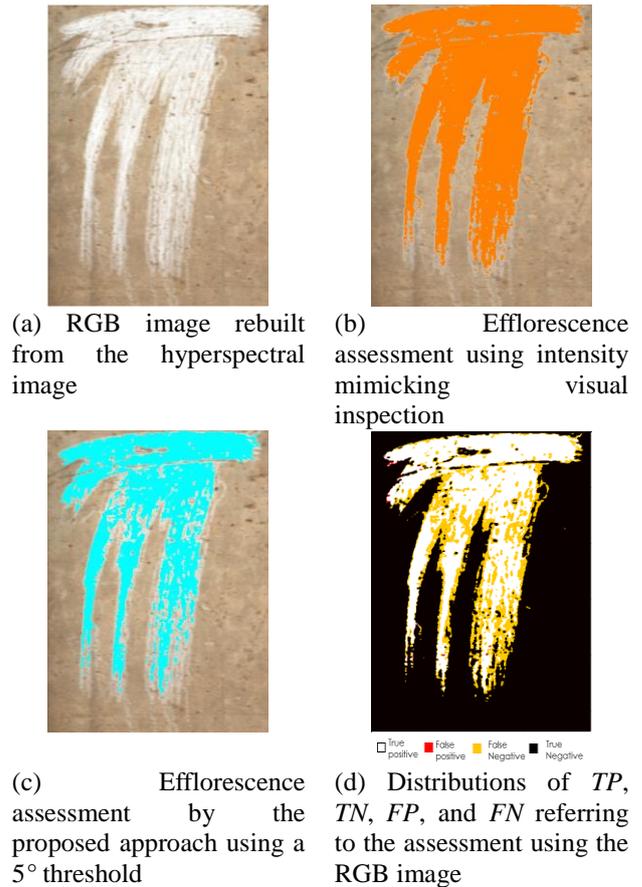
Fig. 14 Efflorescence assessment using the RGB image and by the proposed approach for P2-A

For the artificial efflorescence made with a slate pencil, the results by the conventional RGB-based and proposed approaches are briefly shown in Fig. 14. The image of P2-A has 393×534 pixels, corresponding to 0.35 m wide and 0.65 m high around the efflorescence. For the RGB image shown in Fig. 14(a), 190 was selected as the intensity threshold, and the efflorescence was reasonably obtained as Fig. 14(b). Fig. 14(c) shows the assessed efflorescence by the proposed approach using a 5° threshold. The distributions of TP , TN , FP , and FN in Fig. 14(d) show few red pixels, but many yellow pixels in the middle and boundary of the efflorescence where the slate pencil did not apply a thick layer. In this artificial efflorescence case, the assessment was highly successful due to the purity of the calcite in the slate pencil.

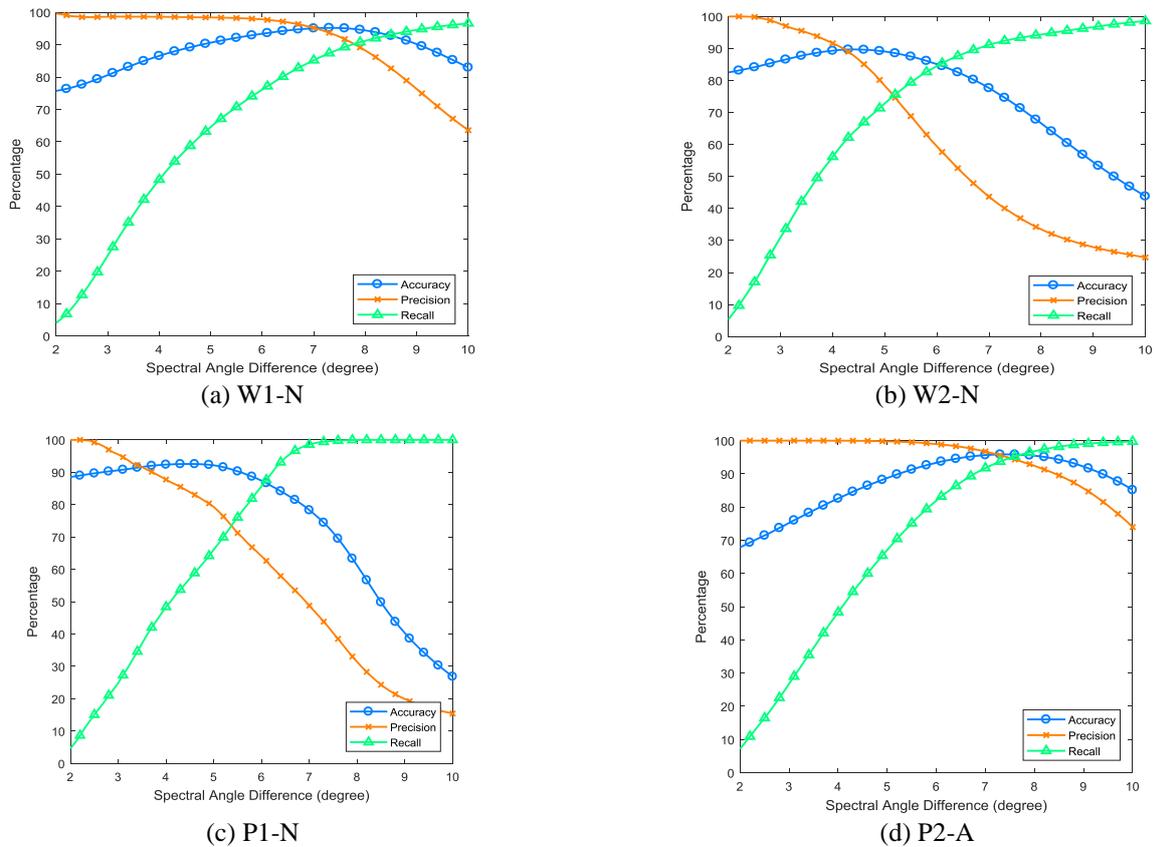
Fig. 15 Performance measures with varying threshold

Because a specified value of angle threshold is not recommended for certain chemical materials, it is a critical issue to find the best threshold for the proposed approach. To propose the best threshold, performance measures by changing the angle threshold from 2° to 10° are plotted in Fig. 15 for all test cases. The reference spectrum used here

is Calcite CO2004. The best accuracy is obtained at 7.5° for W1-N and P2-A, and at 5.0° for W2-N and P1-N.

This difference in best angle threshold originates from the thickness of the efflorescence; W1-N and P2-A have relatively large area of thick efflorescence, whereas W2-N and P1-N have mostly thin efflorescence. With regard to precision, high precision is observed with an angle threshold smaller than 8° in W1-N and P2-A, whereas the precision drops quickly by increasing the angle threshold in W2-N and P1-N. This implies that the proposed method accurately assesses thick efflorescence. With regard to recall related to detection of actual efflorescence, recall increases when the angle threshold increases. Recall over

85% is achieved at the 7.5° threshold for all cases. Because the result of the conventional assessment is based on a conservatively determined intensity threshold, a larger angle threshold assesses the thin efflorescence, especially near the boundary of thick efflorescence as presented in Figs. 8(b), 10(a), and 13(b). If the threshold increases, the recall is improved at the cost of sacrificing accuracy and precision.

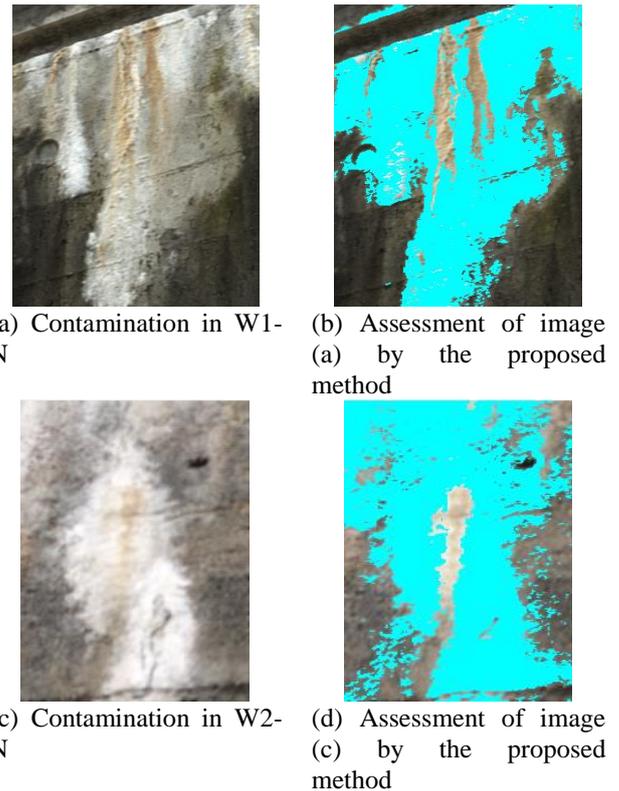
Fig. 16 Omitted efflorescence due to contamination

In W1-N and W2-N, brown-colored contaminants were observed on the surface of efflorescence as shown in Figs. 16(a) and 16(c). The source of the contaminants is presumed to be corrosion of rebar migrated out of the surface. The basis for this speculation is that the shape of the contaminants also forms along with the direction of water flow on the concrete surface. Obviously, the pixels corresponding to the contaminants were not labeled as efflorescence as shown in Figs. 16(b) and 16(d). With further image processing, the omitted efflorescence by the contaminants may be filled to form a solid efflorescence shape.
