# Performance of structures and infrastructure facilities during an EF4 Tornado in Yancheng

**Abstract.** Heavy damages to properties with attendant losses were frequently caused by tornadoes in recent years. This natural hazard is one of the most destructive wind events that must be fully studied and well understood in order to keep the safety of structures and infrastructure facilities. On June 23, 2016, a severe tornado, which is an Enhanced Fujita (EF) 4 storm, occurred in the rim of a coastal city named as Yancheng in China. Numerous low-rise buildings as well as facilities (e.g., transmission towers) were destroyed or damaged. In this paper, damages to structures and infrastructure facilities by the severe tornado are reviewed. The collapses of residential buildings, industrial structures and other infrastructure facilities are described. With an overview of the damages, various possible mechanisms of the collapse are then discussed and utilized to reveal the initiation of the damage to various facilities. It is hoped that this paper can provide a concise but comprehensive reference for the researchers and engineers to help understand the tornado effects on structures and ex

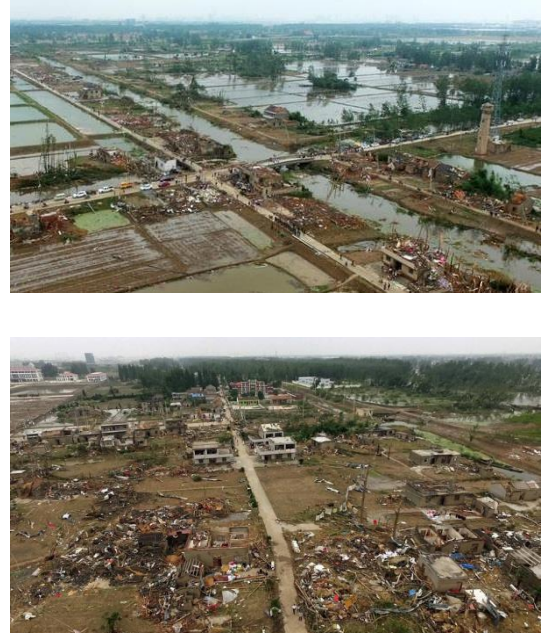
Fig. 4 Overview of the tornado-induced damages in Yancheng

On the afternoon of June 23th, 2016, a tornado accompanied with frequent lightning and heavy hail occurred in the countryside of Yancheng in Jiangsu Province. According to the damages to constructed facilities, it was rated as an EF4 tornado that caused 99 fatalities and 846 people injured. More than 1962 residential buildings and 8 industrial structures were ruined, and over 3200 hectares of crops were destroyed. A general view of tornado-induced damages is shown in Fig. 4.

severe heartrending disaster. Large numbers of well-constructed residential buildings were completely leveled, and cars as well as other large objects like debris were rolled up and thrown towards other facilities, which further generated missiles threatening the safety of other structures. The injuries and fatalities were caused by the tornado mainly in three ways: i) picking people up and hurling them towards the ground; ii) crushing people under debris; iii) impaling people with objects flying in the air with incredible force. Hence, the common practice of sheltering from the tornado is staying in an interior room under the ground of a residential building. This also raises a consideration to construct a reinforced basement or subterranean shelter for each residential building to provide safety against wind actions or debris attacks in tornado-prone areas.

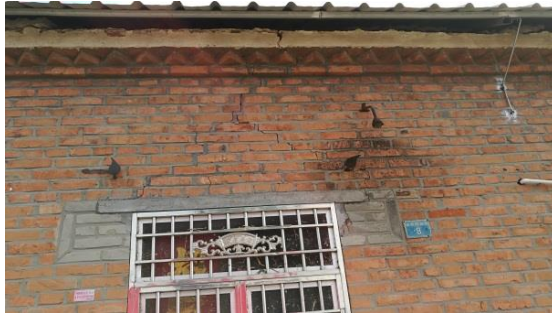
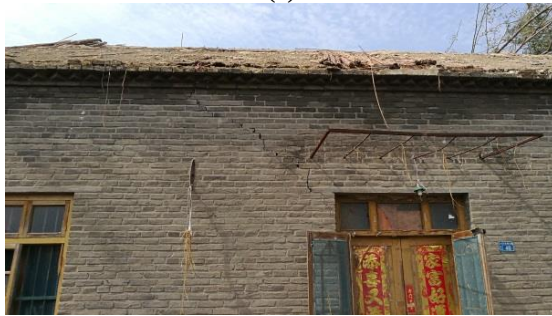
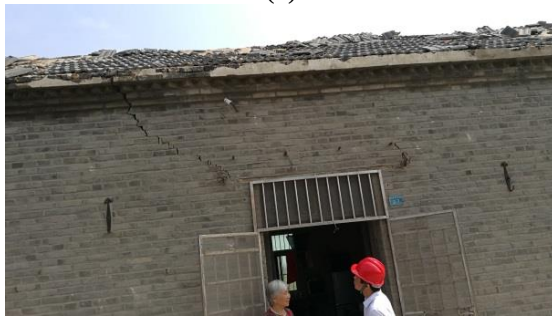
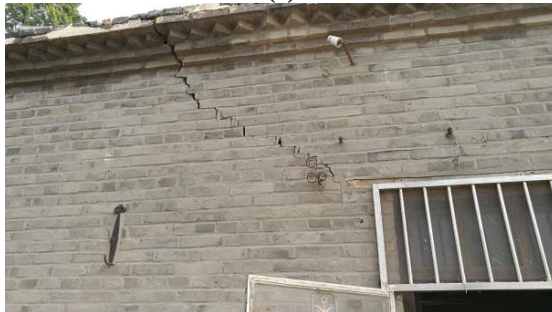
Fig. 5 Inclined cracks occurred near the top corner of the door

There are two kinds of cracks observed in the tornado-induced damages to structures. One is the inclined crack, and the other is the vertical crack. The typical inclined and vertical cracks observed in residential buildings are shown in Figs. 5 and 6, respectively.

Actually, these cracks occurred in the masonry walls are characterized by the failure of mortar, while no penetrating cracks are observed in bricks. The masonry structure is a typical composite structure with the cooperation between bricks and mortar. The observation above is the most likely failure mode of masonry structures, as the tensile strength of mortar is far smaller than that of bricks. As a result, these mortar cracks are always what triggers the further collapse of structures. Improving the tensile strength of the mortar and the adhesive property between the mortar and bricks are therefore a direct measure that can mitigate cracks.

As shown in Fig. 5, two categories of inclined cracks are observed near the top corner of the door. One is the case that the inclined crack stretches towards the outside of the door, as illustrated in Figs. 5(b)-5(d). The other case shown in Fig. 5(a) is that the inclined crack is generated over the door and then bifurcated into two cracks towards the two corners of the door. In the view of the crack width, they both originate at the junction of the roof and the wall, and extend to the top corner of the door. This is because the largest peak pressures occur at the corners of the roof under tornado winds (Haan *et al.* 2010) and a significant stress concentration always exists at the blunt corner of the door where the geometric is discontinuous. In Fig. 5(a), the lintel is employed to alleviate the stress concentration. However, it cannot avoid the tornado-induced crack stemming from the corner of the roof. To alleviate this kind of inclined cracks, the cast-in-place concrete roof is thus suggested be utilized with the lintel employed over the door.

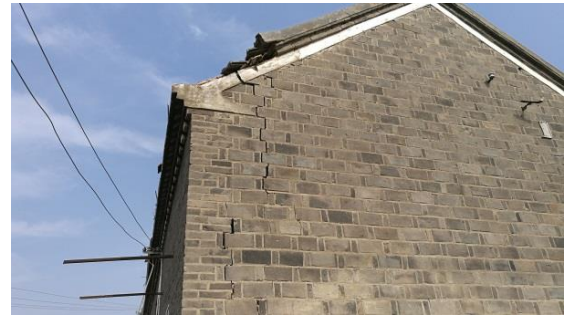
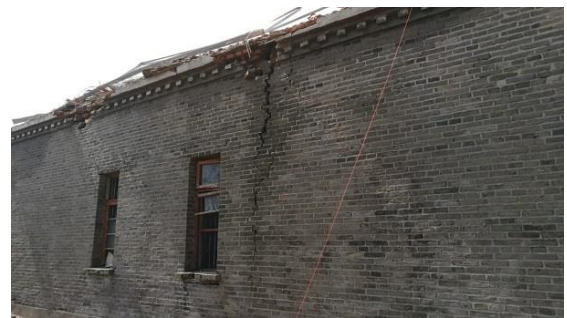
Fig. 6 Vertical cracks occurred in masonry walls

It can be seen from Fig. 6 that the vertical crack in the masonry walls also originates from the corner of the roof. Compared to inclined cracks observed at the door, this kind of crack is more serious as it may directly lead to the collapse of the structure. Several studies have shown that tornadoes produce greater pressure on structures than straight-line winds for the same reference wind velocity

(Sabareesh 2012, Masoomi and van de Lindt 2016). In respect to the gable-roof building, the general lateral force by tornado winds can be 50% greater than the standard provisions and the vertical uplift force is two to three times the value of provisions (Haan *et al.* 2010). This improves the possibility for masonry walls to suffer from cracks since the wind load is not a significant consideration in the design of these low-rise residential buildings. In such a case, the wind pressure coefficients in standards are suggested be defined in two categories according to buildings whether located in tornado-prone areas or not.

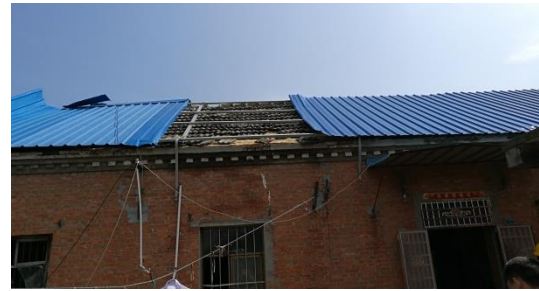
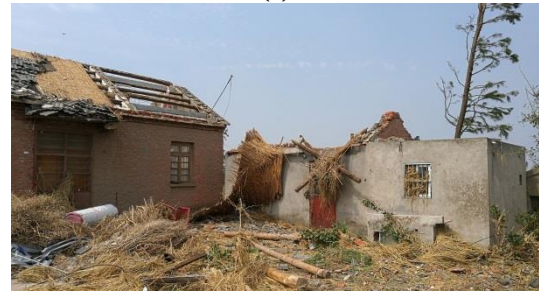
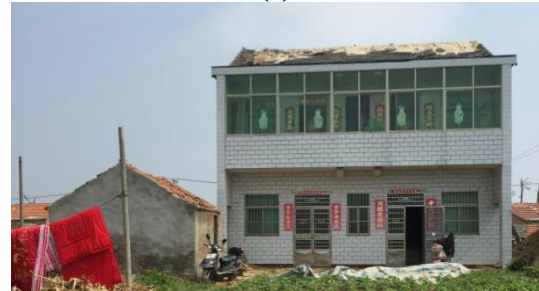
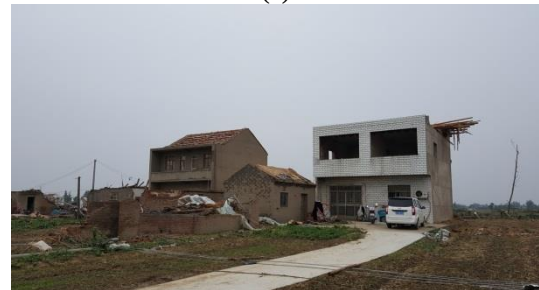
Fig. 7 Damages to the roofs of residential buildings

As one might expect, the houses experienced the EF4 tornado also sustained roof damages, which typically exhibited missing or partially damaged roofs and imposed the trusses above the buildings as shown in Fig. 7. The roof of a building in this area is always fabricated with clay tiles distributed over wooden beams. There is usually no connection between two adjacent tiles, which thus resist the wind-induced uplift forces only with gravity. In some houses, an enhancement is often employed over the clay tiles with large pieces of steel tiles connected by rivets. The damage pattern in Fig. 7(a) indicates the feasibility of the enhancement in protecting the inner roof from being further damaged by the tornado although the steel tiles are partially torn apart. For the roofs shown in Figs. 7(b)-7(d) with only tiles as cladding covers, the tiles are easily rolled up and swept away due to the strong uplift force caused by the low static pressure zone inside the vortex core of the tornado (Haan *et al.* 2010, Huang *et al.* 2015, van de Lindt *et al.* 2007, Yang *et al.* 2018). The damage of roof panels can be evaluated with the data-based probabilistic damage estimation method (He *et al.* 2015, Huang *et al.* 2016, Ji *et al.* 2018). In addition, it is very dangerous that the tiles may be rolled into the tornado as debris and then hit other infrastructure facilities like physical missiles. Hence, improving the wind-resistant performance of the roof against the strong uplift forces is an urgent problem in the tornado-prone areas. The concrete roof may obviously alleviate this problem, as it works with a higher strength and integrity.

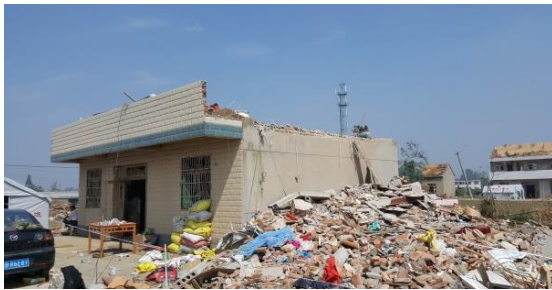
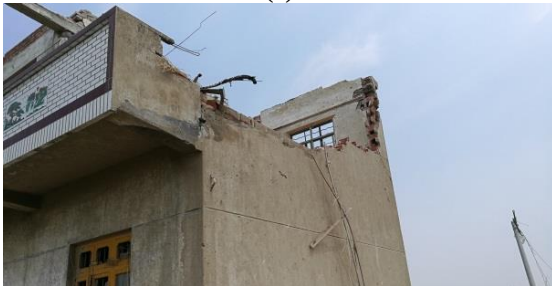
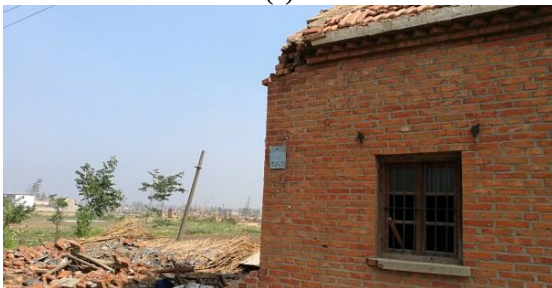
Fig. 9 Tornado-induced collapses of residential buildings

The most severe damage induced by the tornado is the collapse of structures. The residential buildings in this area are either single-storey or double-storey structures. As shown in Fig. 9, the prominent collapse failure of the single-storey structure is being totally toppled down with the walls broken into separate bricks. However, only the second storey of the double-storey structure is pushed over by the tornado and the main structure of the first floor is almost undamaged. It can be predicted that the collapse of the masonry structure originated from the roof damages which were easily caused by the aforementioned strong uplift forces. After the wooden beams were swept away from the roof, the walls lacked sufficient out-of-plane stiffness and were easily toppled down by the

pressure. Meanwhile, the largest pressure occurred in the corner of the roof (Haan *et al.* 2010), which enhanced the bending moment imposed on each wall. In addition, the gust-front wind shown in Fig. 3(b) intensifies the wind pressure on buildings. These may explain what caused the collapse of residential buildings.

For the double-storey structure, the aerodynamic shape was changed to a cube after the second storey was pushed over. Meanwhile, the tornado effect was transient due to the small-scale climate. The tornado might have moved to a place far from the double-storey building after the collapse of the second storey. With these considerations, the aerodynamic forces acting on the first storey of the double-storey structure are alleviated compared to the single-storey building. The difference in aerodynamic actions may account for the different failure modes in the two categories of structures.

In fact, the tornado loads are seldom considered in current design codes for buildings and other structures except nuclear facilities since a low occurrence rate is historically summarized (Masoomi and van de Lindt 2016). However, the tornado-induced damages to residential buildings are really severe and different from our knowledge to those caused by strong boundary winds. The tornado effects are generally more violent due to its physical structure and working mechanism that produce large wind velocities, gust-front winds, strong uplift forces, etc. Hence in standards, it is suggested to divide the areas into two categories, the tornado-prone area and ordinary area, in light of the historical statistics of tornadoes and local topographic features. The latter point on landform considers the potential places where tornadoes are more likely to happen.

It is widely reported that concrete structures sustain little visible damages to the main elements, and only windows and glass curtain walls are easily destroyed. Besides, for steel structures, the envelope system and roof frequently sustain significant damages (LaFave *et al.* 2016). In such a case, concrete structures, with a reinforced concrete room as a shelter, are suggested for residential buildings in tornado-prone areas.

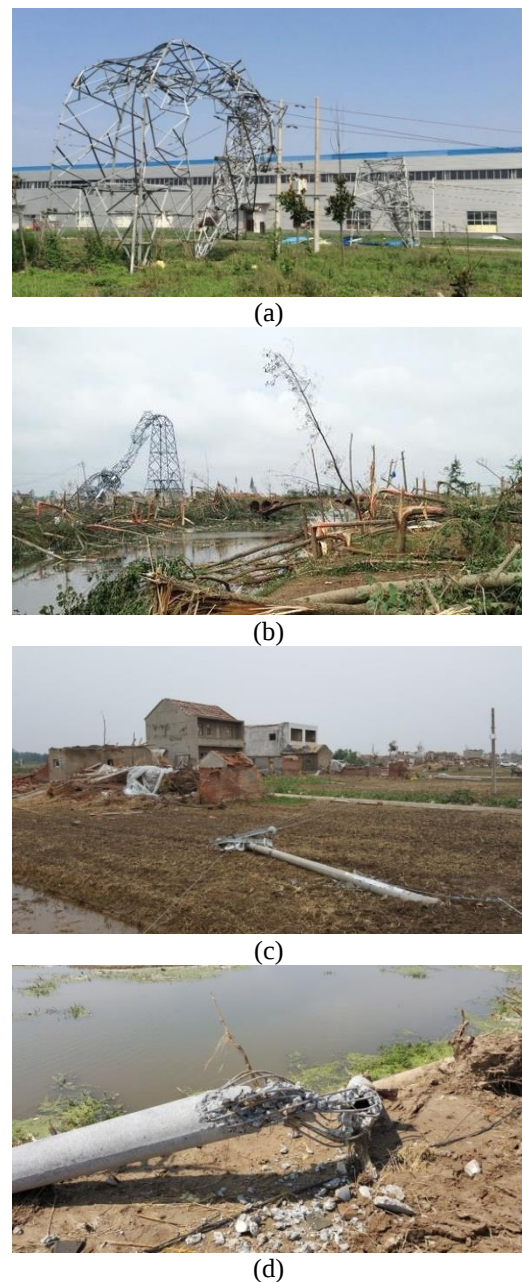
Fig. 11 Tornado-induced damages to transmission lines

The EF4 tornado also caused severe damages to infrastructure facilities in Yancheng, such as the collapse of transmission lines, advertising boards, street lamps, trees and cars. Fig. 11 shows the typical damage patterns of transmission lines. The transmission tower for long-distance power transport and the utility pole for short-distance case are included in Figs. 11(a) and (b) and Figs. 11(c) and 11(d), respectively.

The failure mode of the transmission tower is the collapse due to buckling. The large tangent wind velocity and gust-front wind of the tornado account for this kind of destruction. However, there is a lack of procedures in the codes to guide the estimation of tornado effects on transmission line systems (El Dammatty and Hamada 2016). This calls for more studies focusing on the tornado forces on transmission line systems and the measures to mitigate the failures of transmission towers. In respect to the utility pole, it is often pushed over due

to the shallow burial depth that cannot resist the tornado-induced moment. Hence, increasing the burial depth is a good solution to alleviate this problem.

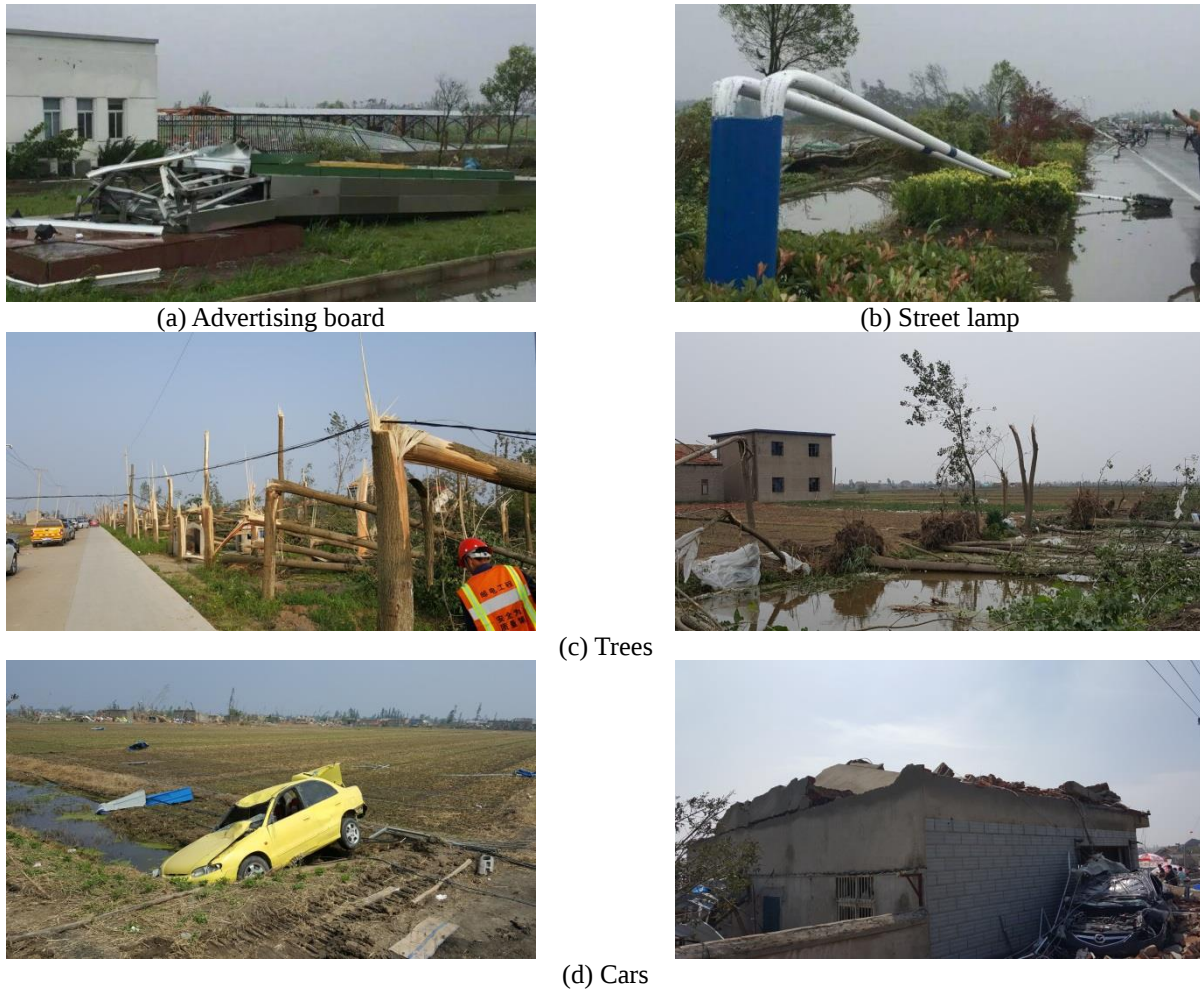
Fig. 12 Tornado-induced damages to other infrastructure facilities

Other tornado-induced damages to infrastructure facilities are presented in Fig. 12. For the advertising board being pushed over, there is a lack of resistance at the base against moment induced by the wind pressure, which highly depends on the wind velocity. Because of buckling, the failure pattern of the street lamp is similar to that of the transmission tower. Some of the trees are broken off at the same height, which is initiated by the gust-front wind velocity. Meanwhile, some other trees are directly pushed over, as the roots are too shallow. The damages to cars are caused in two manners. One is being directly rolled up by the tornado and thrown towards ground with a crash. The other is generated by the debris missiles smashing up cars or resulting in severe deformations.
