## Structural Health Monitoring of short to medium span bridges in the United Kingdom

**Keywords:** bridge structural health monitoring

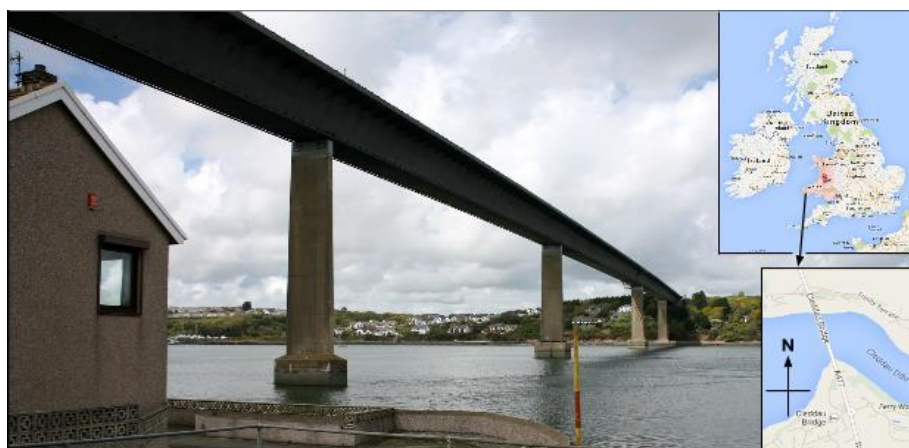
Fig. 1 The Cleddau bridge (looking from east of Pembroke dock) (left) and its geographical location (right). (Courtesy: Pembrokeshire County Council)

The Cleddau Bridge (Fig. 1) located in South-West Wales was opened to the public in 1975. Being 819.4 m long, the seven-span steel box-girder bridge spans North to South between Pembroke Dock (at its North end) and Nyland (South end) across the estuary of the River Cleddau.

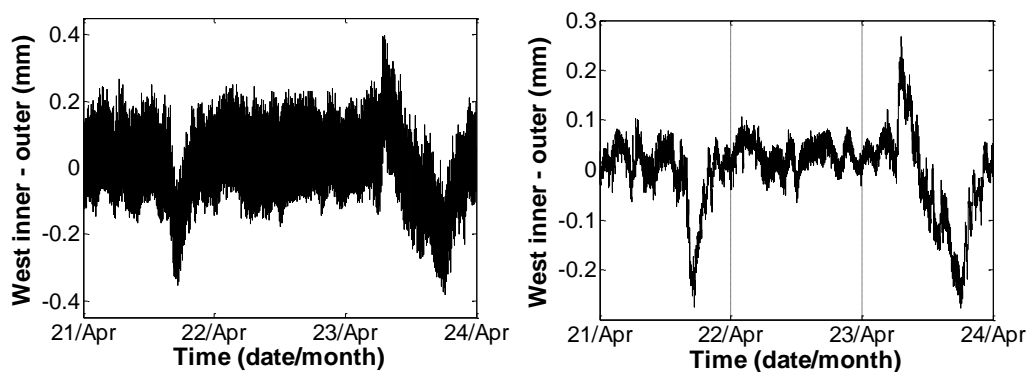
Fig. 5 Raw (left) and smoothed (right) time-histories of differences between the movements measured at the outer and inner ends of the west bearing

Variations of temperature across the width of the box-girder similar to that on April 23 can produce plan bending of the bridge, which then leads to plan twists at bearings. The magnitude of the twists is the difference between the displacement measurements at the inner and outer ends of the bearings. Fig. 5 (left) shows the time-history of the differences between raw measurements taken at the inner and outer ends of the west bearing. The figure plots results from measurements taken at a frequency of 1 Hz. The data are extremely noisy, making visualizing of trends difficult so Fig. 5 (right) plots the same data as in Fig. 5 (left) but after smoothing. While smoothing reduces the magnitudes of the peaks, the resulting plot is sharper and also more useful for illustrating comparisons with predictions from numerical models. If there is no plan twist, the differences should be zero. However, the difference between measured movements of the inner and outer ends varies from around  $-0.23$  mm to  $+0.23$  mm in the smoothed data-set.

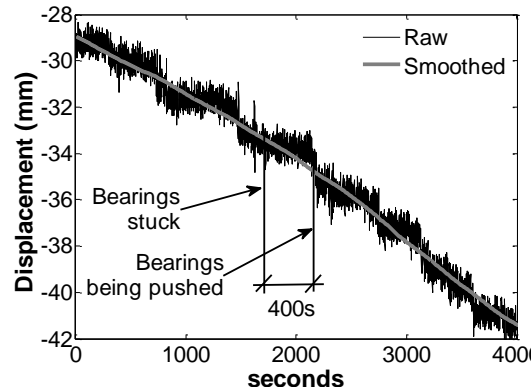
Fig. 6 Measurements over a one-hour period showing bearing locking and release (right)

The sample rate for bearing displacements is sufficiently high to reveal that bearing movements are seldom smooth (Fig. 6). Movements happen incrementally and friction plays a significant role. Bearings are seen to lock briefly and then to release especially during periods when temperatures change rapidly. A certain slip force is required to initiate the release. This phenomenon has also been observed in previous research (Emerson 1976). In Fig. 6, the abrupt drops in east-gap displacement that take place every 300 to 600 seconds are representative of this phenomenon.

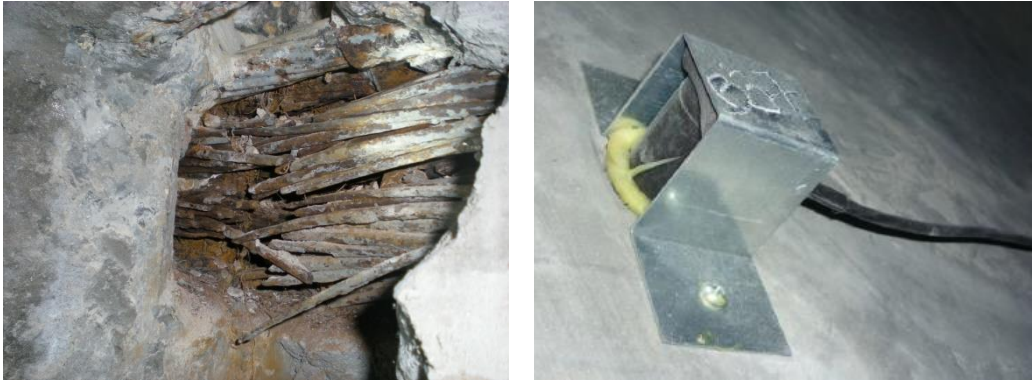
Fig. 8 Failed wire strands (left) and acoustic emission sensor (right)

The AE monitoring used seven systems with 600 sensors to detect wire breaks (Fig. 8) and to drive a deterioration model for predictions on remaining life before loss of reserve capacity.

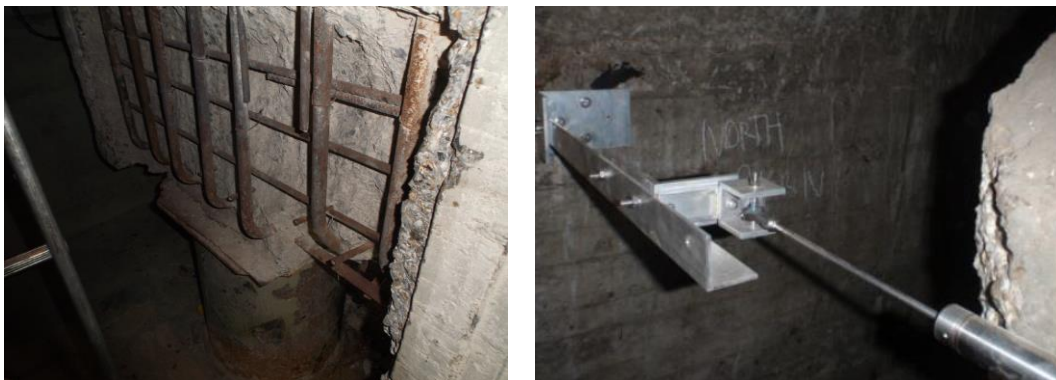
Fig. 10 Base of pier and extensometer for bearing movements

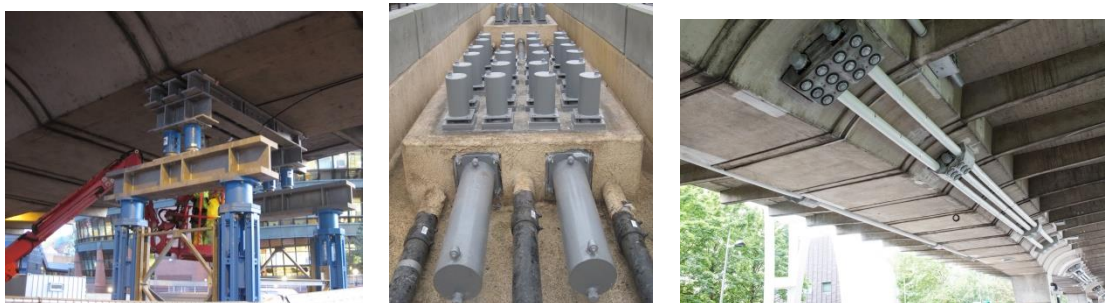
Fig. 11 Temporary propping during investigations (left), new external post-tensioning across critical spans (middle) and additional strengthening (right)

As an interim measure the critical span was propped in 2011 Fig. 11 (left), and following further intrusive investigations a decision was taken to close the flyover to all traffic on 23<sup>rd</sup> December 2011, resulting in severe traffic disruption. During the closure, more intrusive investigations were carried out to determine with greater accuracy and resolution the condition of the post-tensioning system. Subsequent refinement of the condition factors allowed the bridge to reopen with one lane in each direction to light vehicles (7.5 tonne limit) only while emergency strengthening works were undertaken.

The emergency strengthening works involved the construction and installation of an external post-tension system across the top of five critical piers Fig. 11 (middle) to restore compression and full load carrying capacity to those areas of the structure. All lanes were reopened to all traffic on 30<sup>th</sup> May 2012 in time for the London 2012 Games, while a second project was initiated to complete strengthening of the remainder of the structure (Fig. 11). Structural health monitoring, including AE, continued in the interim and provided data to the deterioration model. The deterioration model continued to predict the date at which zero reserve capacity would be available, and thus provided a deadline for the completion of the strengthening works.

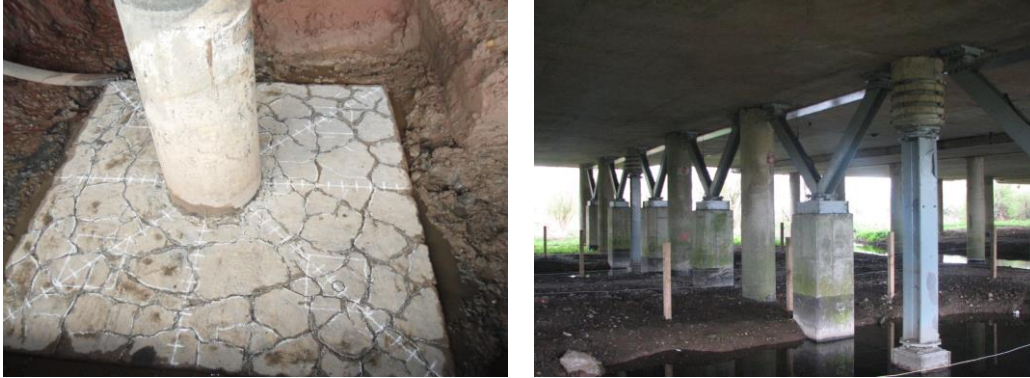
Fig. 13 Alkali-silica reaction on a footing of a pier of Floodplain #2 (left) and piers subjected to full scale tests on the grid-line S (right). (Courtesy: Highways England)

The cement and the aggregate used in the construction was prone to alkali-silica reaction (ASR) as was later found out through testing; Fig. 13 (left) shows ASR on the surface of the footing of a pier. The Highways Agency conducted a series of full-scale load tests on certain footings suffering from ASR (Fig. 13 (right)). Loading tests demonstrated that footings can carry much higher loads than they were designed for, however, in order to detect any change in the bearing capacity of the piers due to ASR, a monitoring system was installed on the bridge in 2004.

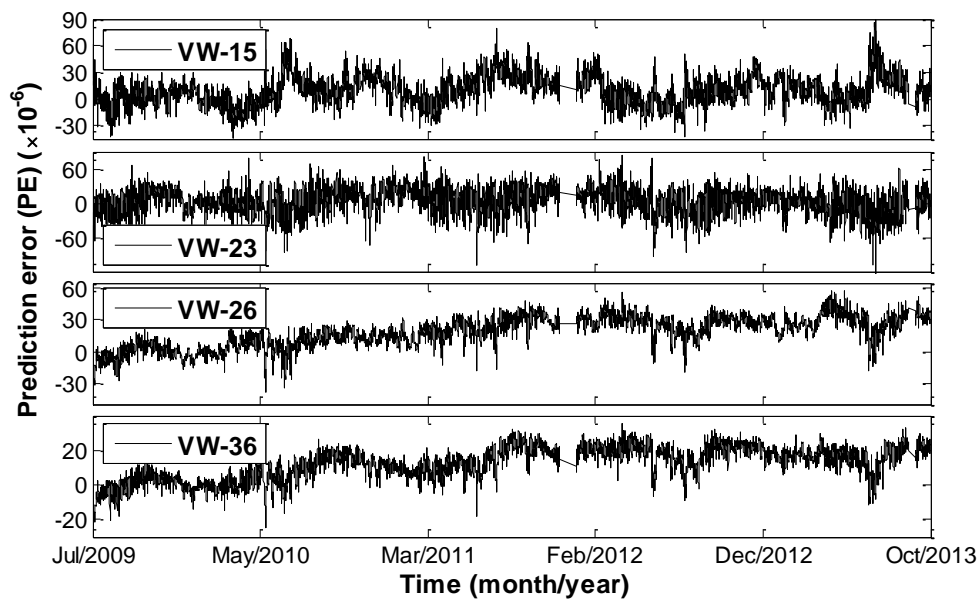
Fig. 16 Prediction error signals for sensors VW-15, VW-23, VW-26 and VW-36

For illustrative purposes PE VW 15, PE VW-23, PE VW-26 and PE VW-36 are shown in Fig. 16. PE VW-15 and PE VW-23 remain stationary and no obvious shifts or drifts in their signals are observed during the monitoring period. However, PE VW-26 and PE VW-36 drift albeit gradually indicating drifting sensors. This is confirmed when PE VW-26 and PE VW-36 are analysed using anomaly detection techniques. In fact analysis of all measurement clusters that include sensors VW-26 and VW-36 indicate presence of anomaly events (Kromanis 2015).
