Monitoring of bridge overlay using shrinkage-modified high performance concrete based on strain and moisture evolution

Abstract. High performance concrete (HPC) has been extensively used in thin overlay for repair purpose due to its excellent strength and durability. This paper presents an experiment, where the sensor-instrumented HPC overlays have been followed by dynamic strain and moisture content monitoring for 1 year, under normal traffic. The vibrating wire and soil moisture sensors were embedded in overlay before construction. Four given HPC mixes (2 original mixes and their shrinkage-modified mixes) were used for overlays to contrast the strain and moisture results. A calibration method to accurately measure the moisture content for a given concrete mixture using soil moisture sensor was established. The monitoring results indicated that the modified mixes performed much better than the original mixes in shrinkage cracking control. Weather condition and concrete maturity at early age greatly affected the strain in concrete. The strain in HPC overlay was primarily in longitudinal direction, leading to transverse cracks. Additionally, the most moisture loss in concrete occur

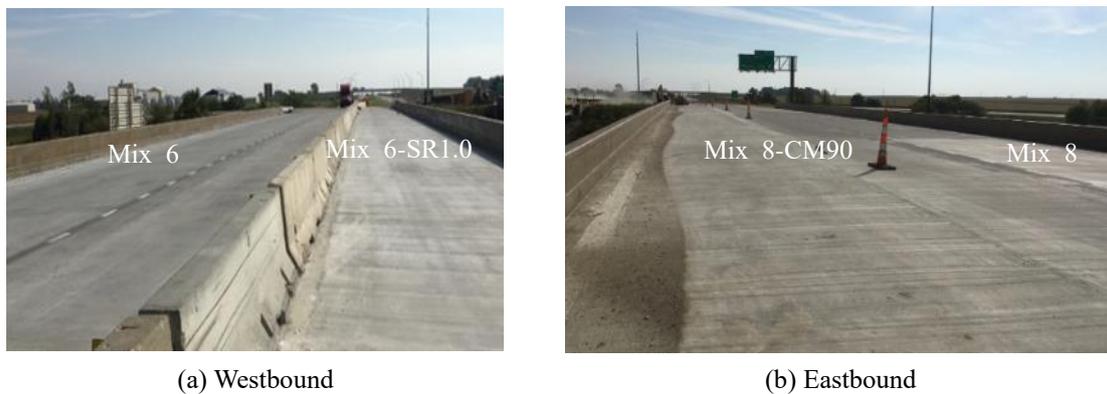
Fig. 1 The US 20 over I 35 dual bridge location

As shown in Fig. 1, field site was selected on the US 20 over I 35 dual bridge in Iowa, where four HPC mixes, namely Mix 6 and Mix 6-SR1.0 as well as Mix 8 and Mix 8-CM90 were placed side-by-side for the bridge overlays. The bridge is in the east-west direction. Because these new overlays were in similar geometries, restraints, environmental exposure, and traffic loads, their performance could be monitored and compared more accurately.

As shown in Fig. 1, each of the dual bridge was 79 m long and 15 m wide. It has two stages for construction: Stage 1 is outside (slower traffic) the bridge and Stage 2 is inside (faster traffic) the bridge. Mix 6 (original and modified) and Mix 8 (original and modified) were placed on the westbound and eastbound bridge deck, respectively. Mix 6 and Mix 8 were paved in Stage 1, while Mix 6-SR1.0 and Mix 8-CM90 were paved in Stage 2. The thicknesses of the new concrete overlays were all 5 cm. Table 2 shows the construction timeline related to the present field study.

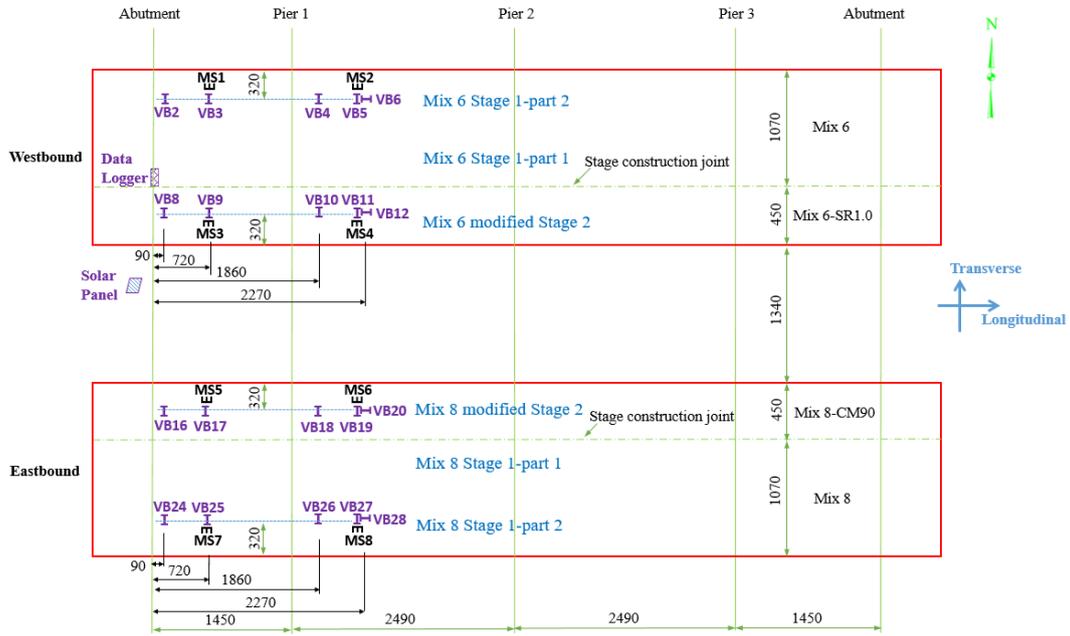
Fig. 4 Sensors location on the bridge deck (unit in cm)

20 strain gauges and 8 MSs were embedded at the depth of 2.5 cm in the new overlays from the edges of the abutment to the middle point between pier 1 and pier 2. The locations, orientation, and layouts of the sensors are shown in Fig. 4. On the stage 1-part 2 and stage 2 of each bridge, 4 strain gauges were installed transversely at 0.9 m, 7.2 m, 18.6 m and 22.7 m respectively, and one was installed longitudinally at 22.7 m from the abutment. 2 MSs were installed at 7.2 m and 22.7 m from the abutment, respectively.

In Fig. 4, for each mix, four strain gauges were installed transversely (perpendicular to the traffic direction) in the overlay with a distance of 90 cm to 2270 cm from the abutment. One strain gauge was installed longitudinally (parallel to the traffic direction) with a distance of 2270 cm from the abutment. Figs. 17 and 18 show the strains of all overlay mixes (positive: tension and negative: compression).

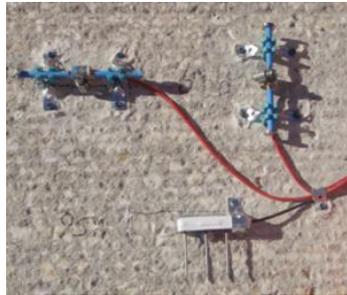
Fig. 5 Installation of Geokon4200 and GS3 on deck

The installation of sensors was completed prior to concrete paving. As shown in Fig. 5, each strain gauge was fixed at 2.5cm high on the substrate by 2 screwed plastic seats. The MS was supported also at 2.5 cm in height using glue and screws.

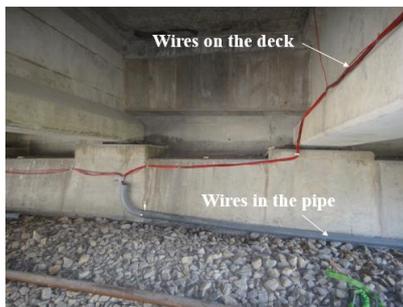
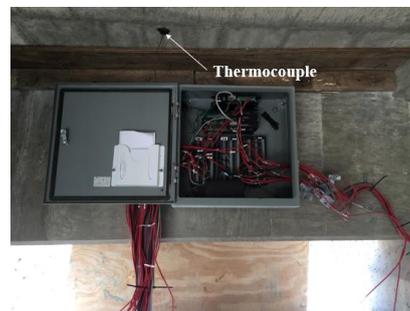
Fig. 6 Wires layout

It should be noted that, during the installation of the sensors, the sensors and wires needed extra attention because there would be very difficult to repair them once they were cast inside concrete. In this research, all wires were went through the deck, and placed in a polyvinyl chloride (PVC) pipe under bridge as seen in Fig. 6(a), to connect with data acquisition system (DAS) stored in an alloy shield box. To avoid wire mess, zip ties were used to mount extra wires to PVC pipe. A thermal couple was attached under the concrete deck above the DAS to record ambient temperature as shown in Fig. 6(b).

(a) Wires in PVC pipe

(b) Wires to DAS

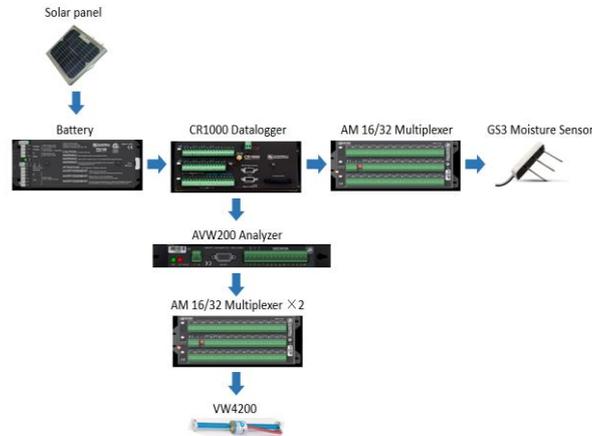
Fig. 7 Data acquisition system

As shown in Fig. 7, DAS includes one Campbell CR1000 data logger, three AM16/32B-ST-SW multiplexers, one vibrating wire analyser module (AVW200), one solar panel, and one battery used for data collection. DAS was fixed on girder above the ground to reduce environmental

disturbances. The solar panel in an open area between the east and west bound bridges, continuously supplied power of DAS through a 12 V battery source. The data logger was connected with a multiplexer for MSs, and an AVW200 which was extended for two AM16/32 multiplexers for stain gauges as shown in Fig. 8. In this study, the sensor readings were recorded every 5 minutes, and the total monitoring time was about one year.

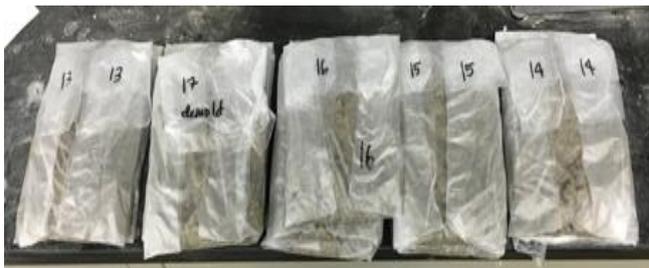
Fig. 8 Concrete samples used for MS calibration

(a) Concrete in sealed bags

(b) Concrete cylinder with MS

For each mix, after mixing, 17 bags of concrete with the same volume of 400 cm^3 and a $10 \times 20 \text{ cm}$ cylinder were cast. They were completely sealed with plastic sheet to simulate the field concrete curing under burlap. After designated time interval, the water content of the concrete in each bag was determined by the weight loss of concrete in each bag using microwave drying after different curing time, as seen in Fig. 8(a). Meanwhile, ϵ of concrete was recorded by a MS inserted to the concrete cylinder, as shown in Fig. 8(b). Generally, the time interval was 1-2 hours within the first day, but larger 3-4 hours afterwards as the rate of moisture loss decreased.

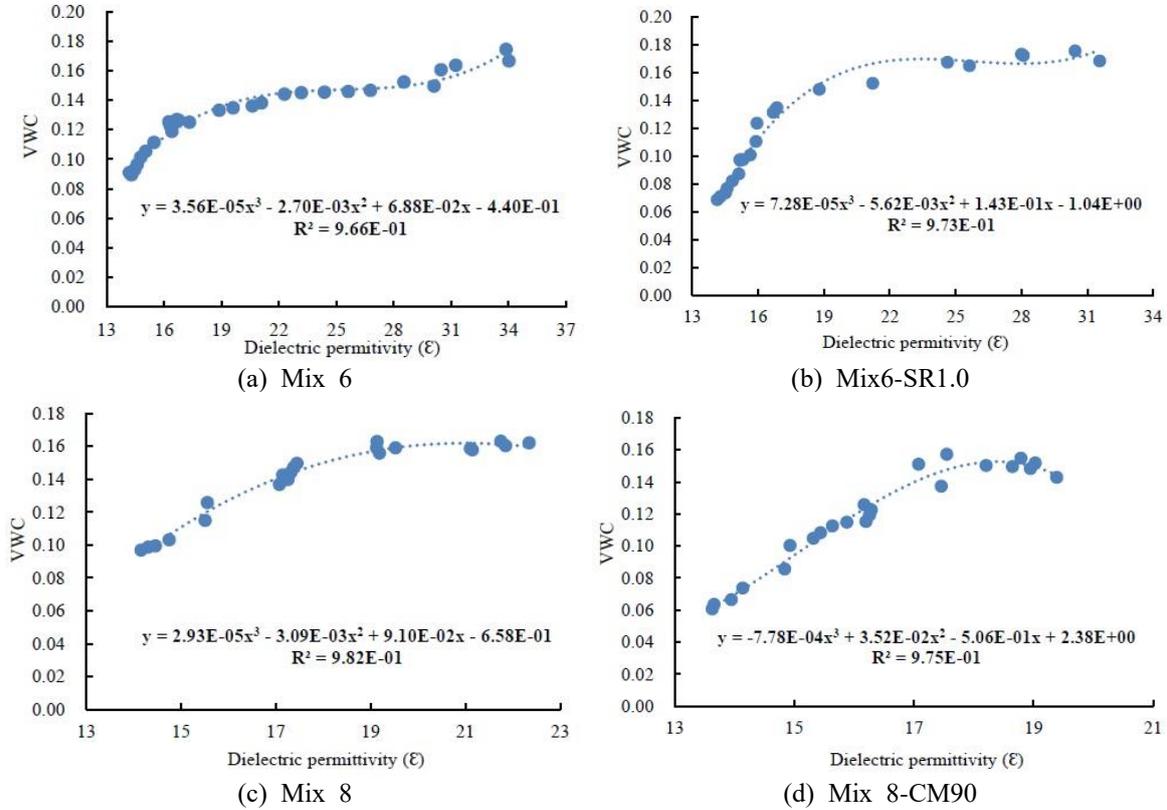
Fig. 9 Calibrated VWC equations for four mixes

Thus, it had to be calibrated for each concrete mix. The basic principle of calibration for concrete was to measure VMC and ϵ over time in concrete under similar condition to the field. Then, a polynomial trend line of VMC- ϵ was regressed similar to the above default equation, for the concrete mix.

After the burlap was removed from the field concrete, the concrete cylinder was demolded to determine VWC by measuring the weight loss of the cylinder daily until the age of 36 days (the calibration stopped at 36th day for each mix due to negligible weight loss). According to the test results, polynomial VWC vs. ϵ curves were fitted for all concrete mix to obtain their relationships, as shown in Figs. 9(a)-9(d). Using these equations, VWC of concrete overlays were calculated based on ϵ from the embedded sensor.

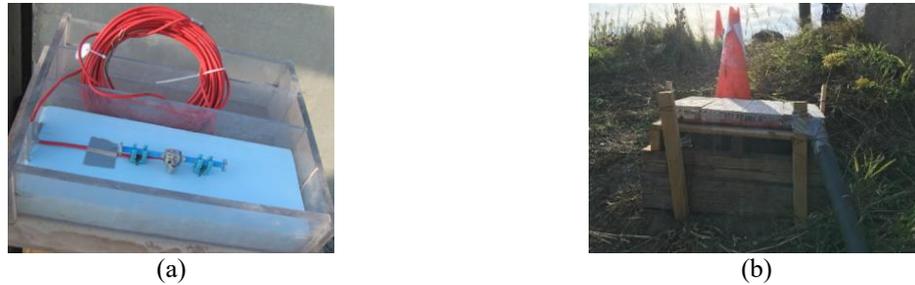
Fig. 10 (a) Mini slab mold and strain gauge location and (b) Mini slabs on the field site

To make a mini slab, a strain gauge was preinstalled in the middle of the slab formwork (also in the middle of the height), as shown in Fig. 10(a), before concrete casting. After casting, the mini concrete slab was cured under a wet towel and placed under the bridge. The strain gauge was connected to DAS. After 24 hours, the slab was demolded and sealed on the bottom and side surfaces, leaving only the top surface open to the environment. The slab was then moved to an open area near its corresponding concrete overlay to ensure the same weather conditions.

Fig. 10(b) presents the layout of mini slabs with a wooden protection. The mini slabs of four field concrete mixes were placed together on the wooden plates that were supported by wooden bars and reinforced by a steel wire for their positions. It can be seen in Fig. 10(b) that the wires from strain gauges of the mini slabs were tied together by a tape, passed through a PVC pipe, and then connected to the data logger.

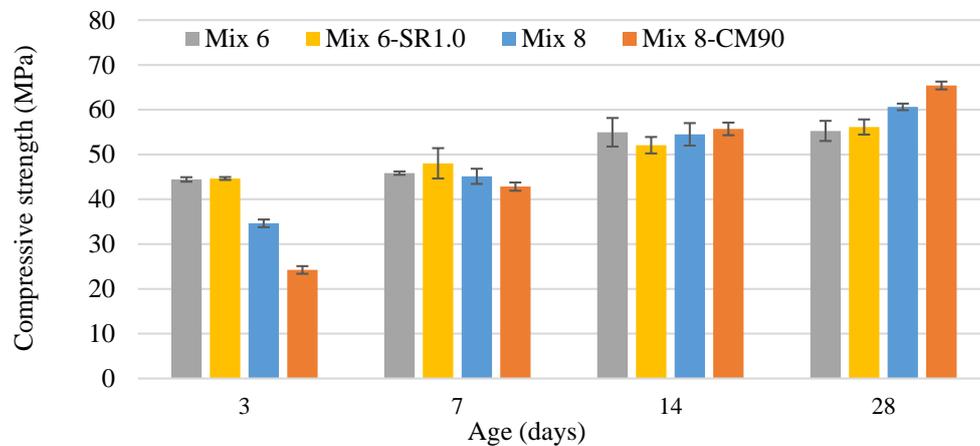
Fig. 11 Compressive strength of mixes.

Compressive strengths of the 4 field concrete mixes (cast in field) were tested, and the results were shown in Fig. 11. It can be seen from Mix 6 that 1.0 gallon/cy (4.95 L/m³) of SR addition did

not affect the concrete compressive strength. ASTM C494 (2019) requires that mixes with special admixtures should not have less than 90% of the strength of the reference mix at the same age. Addition of 1.0 gallon/cy (4.95 L/m³) of SR in mix 6 met this criterion. For Mix 8, the 10% cementitious reduction only reduced the early age strength of field concrete; and interestingly, the 28-day strength of Mix 8-CM90 was even a little higher than that of Mix 8. This might be due to the field hot environmental temperature, which possibly accelerated both hydration and pozzolanic reaction of slag and fly ash.

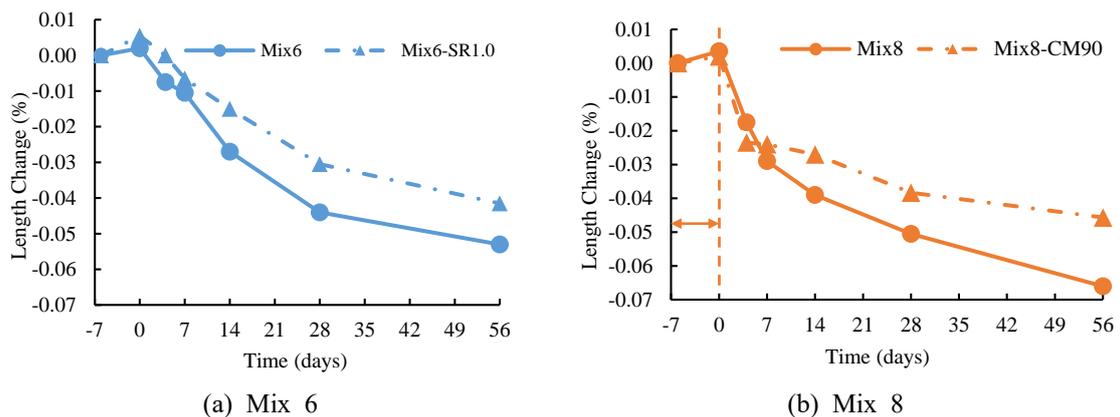
Fig. 12 Free drying shrinkage of field concrete mixes

The free drying shrinkage of field concrete samples are shown in Fig. 12. It illustrates that 4.95 L/m³ SR addition reduced the free drying shrinkage of Mix 6 by 20%, and 10% cementitious reduction decreased the free drying shrinkage of mix 8 by approximately 30%.

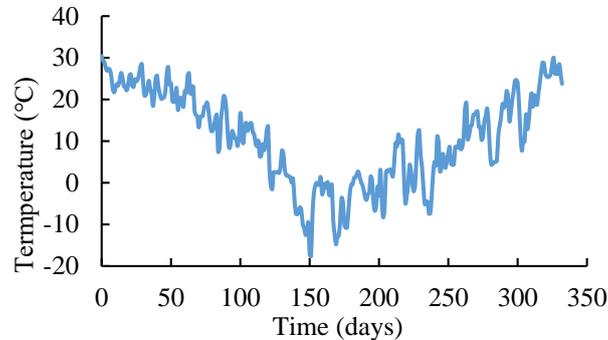
Fig. 13 Ambient temperature of the field sited (where Day 0 was on June 22, 2018, the day of the first overlay construction).

The daily average ambient temperatures are shown in Fig. 13. It can be seen that the maximum (30.4°C) and minimum (-17.6°C) temperatures were observed at Day 0 (June 22, 2016) and Day 150 (November 20, 2016) respectively. The maximum difference of ambient temperature was 48.0°C in the monitoring period.

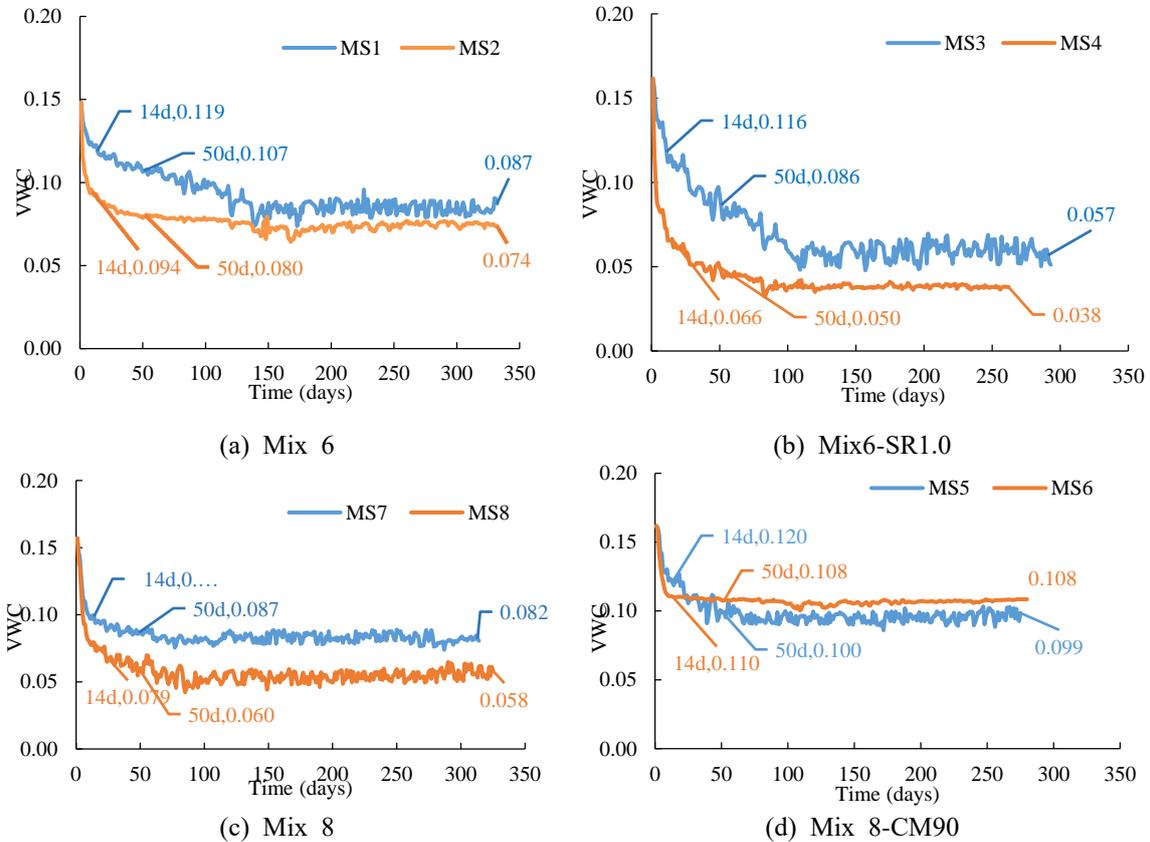
All MSs functioned appropriately during the entire monitoring period. VWC profiles captured by the MSs were illustrated in Fig. 14. It provides a comparison of MS readings at 0, 14, 50, and >300 days after starting of the sensor monitoring. Several observations can be made from these figures:

(1) The initial VWC was about 0.15 for Mix 6 and 0.16 for the rest mixes, which was consistent with that calculated from their mix proportions. The calibrated equations are perfectly matched to their corresponding mixes.

Fig. 14 VWC measurements from Mix 8 series (MS1 and 3 were 720 cm and MS 2 and 4 were 2270 cm from the abutment, MS5 and 7 were 720 cm and MS 6 and 8 were 2270 cm from the abutment)

(2) The VWC readings of MS1, 3, 5, and 7 (in blue) at the locations 720 cm from the joint (near the abutment) were generally higher than those of the MS2, 4, 6, and 8 (in orange) at the locations 2270 cm from the joint, except for Mix 8-CM90.

(3) For Mix 6 series, the VWC readings of the MS1 and 3 (in blue) close to the joint near the abutment dropped slowly to a stable VWC; while the VWC readings of MS2 and 4 (in orange) further away from the joint dropped rapidly to a stable VWC. This indicates that the joint probably allowed moisture ingress.

(4) Mix 6 reached a stable VWC at approximately the coldest day (150 days after construction), and the stable VWC values of Mix 6 were 0.087 and 0.074 for MS1 and MS2, respectively. Mix 6-SR1.0 reached a stable VWC at approximately 100 days after its overlay construction, and the stable VWC values of Mix 6-SR1.0 were 0.057 and 0.038 for MS3 and MS4, respectively. The difference in VWC between Mix 6 and Mix 6-SR1.0 might be partially attributed to the different overlay construction time (Mix 6 on 7/22/2016 and Mix 6-SR1.0 on 8/29/2016), since the early age exposure condition could have a significant impact on moisture condition in the concrete.

(5) As shown in Figs. 14(c) and 14(d), Mix 8 reached a stable VWC before 100 days after its

overlay construction, and the stable VWC values of Mix 8 were 0.082 and 0.058 for MS7 and MS8, respectively. Comparing with Mix 8, Mix 8-CM90 had a quite different moisture behavior, especially in the location away from the joint/abutment (MS6). MS6 readings (Fig. 14(d)) show that the concrete had a very rapid moisture drop before 14 days, and reached a relatively high stable VWC value (0.108) shortly thereafter. Such a behavior might be attributed to the pore structure of the concrete, which needs further study. The reduced free drying shrinkage might also be responsible for the relatively high VWC value.

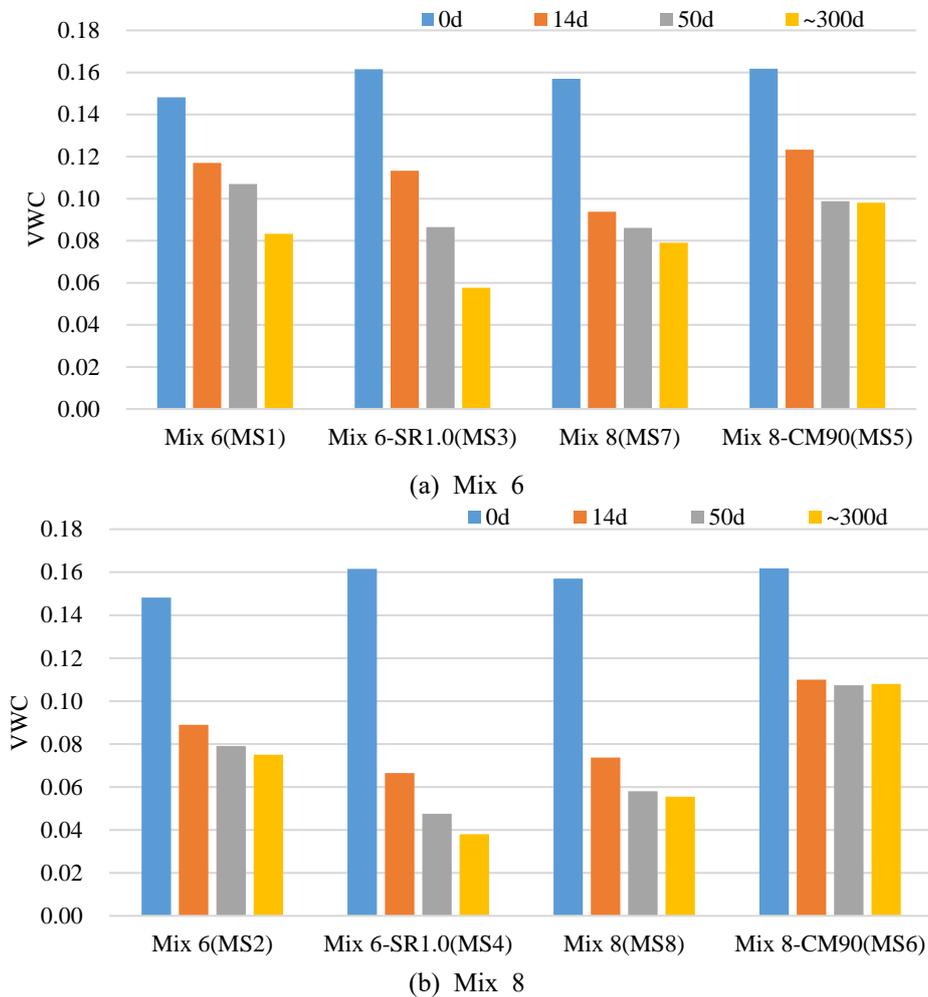
Fig. 15 Comparison of MS readings at 0, 14, 50, and ~300 days of field monitoring

Fig. 15 illustrates that concrete at the location away from the abutment had a sharp moisture decrease in the first 14 days, which might be largely contributed by cement hydration. All VWC curves exhibited a daily fluctuant trend throughout the entire sensor monitoring period. This fluctuation was probably due to environmental moisture change during day and night as well as weather changes.

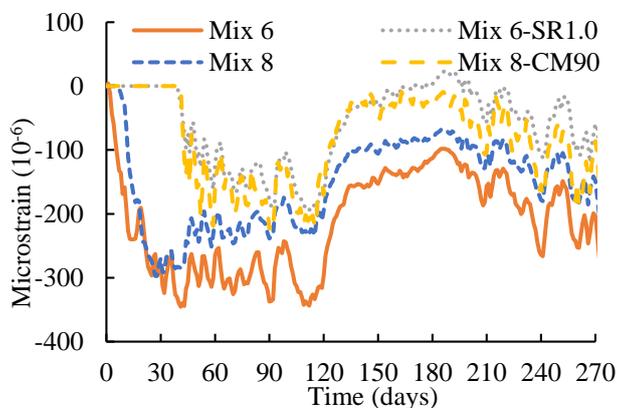
Fig. 16 Microstrain at mini slabs for different mixes

To further understand the field concrete shrinkage behaviour under unrestraint condition, the strains in mini slab samples were studied. As seen in Fig. 11, the strain gauges in the mini slabs were in the longitudinal direction. Fig. 16 illustrates the microstrain monitored by the strain gauges in the mini slabs. It indicates that mini slabs were mainly subjected to compressive strains due to concrete shrinkage under an unrestrained condition. As the slabs were under the bridge deck, their thermal expansion at the summer time in the early age was much less than concrete overlays, and therefore, free drying shrinkage was the dominate deformation. During the winter time, the mini slabs expanded against freezing temperature, which offset the shrinkage and reduce the compressive strain. With temperature rising, such expansion reduced, and compressive strain increased until the second summer. Fig. 17 also reveals that the mini slabs of modified mixes had the much less compressive strains caused by free shrinkage than their original mixes. This is consistent with the laboratory shrinkage test results presented in Fig. 13.

On October 9, 2017, cracks on the surface of overlays that had one year traffic service were surveyed using wet test method. Water was sprayed on concrete surface followed by vacuuming to expose cracks clearly as seen in Fig. 19. Fig. 20 shows the locations and patterns of the cracks. As seen from the figure, five cracks on Mix 6 overlay and two cracks on Mix 8 overlay were observed. The width of cracks was from 0.3 mm to 1mm. They were mostly transverse and located close to piers, possibly due to negative bending moments at the supports. No visible cracks were found on either of the modified mixes (Mix 6-SR1.0 and Mix 8-CM90). These observations supported the strain results of mini slabs as shown in Fig. 16.

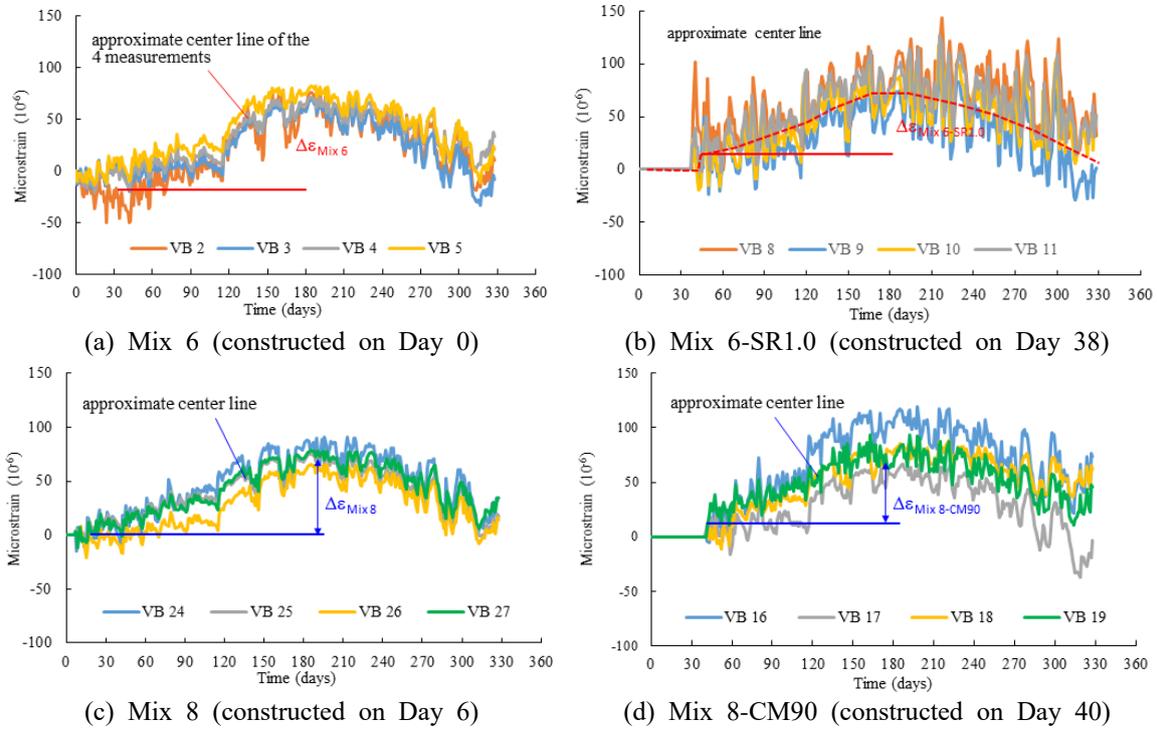
Fig. 17 Strain gauge readings at various locations of overlays in the transverse direction

It should be noted that the strains measured in the field concrete decks resulted from the combined effects of hydration (autogenous shrinkage), drying-wetting cycles, and thermal expansion/contraction, traffic loads, and creep behavior. The concrete of the bridge decks was under a strained condition. From Fig. 17 and Fig. 18, the following observations can be made:

(1) The strain ranged within -50 to +150 microstrain for all strain gauges embedded in overlays, which was in typical range from -150 to +150 microstrain in response to environmental loads, similar to those found in studies (Wells 2005, Asbahan 2009, Qin 2011, Nassiri 2011).

(2) The shapes of all the strain curves were similar, but opposite to that of the ambient temperature curve in Fig. 13. For all mixes, the highest tensile strains (shrinkage) encountered in the wintertime (around Day 180). Some compressive strains (expansion) were observed in the summertime (around Day 0 and Day 330). This indicates that the thermal strain was dominant in the concrete. The overlay of Mix 6 displayed more compressive strains, due to the highest cement content, highest heat of hydration, and the hottest day on construction.

(4) For a given concrete mix, the strain readings from the sensors in the transverse direction of the bridge were close and independent with their locations. This is because in the view of the transverse cross section, the concrete deck was all supported by the same girders, regardless its distance from the abutment. However, the strain readings of VB2-VB5 were different as seen in Fig. 17. The transverse strain readings in the overlays made with original mixes (Figs. 17(a) and 17(c), Mixes 6 and 8), were very similar, regardless of location. These two overlays were constructed at relatively high ambient temperature ($>25^{\circ}\text{C}$ during the first 7 days). The transverse strain readings from the overlays made with modified mixes (Figs. 17(b) and 17(d), Mixes 6-SR1.0 and 8-CM90) at the different locations displayed quite different. These two overlays were paved at the lower ambient temperature (mostly $<25^{\circ}\text{C}$ during the first 7 days). This may imply that weather condition and concrete maturity at early age might have significant impact the strain behavior of the concrete.

(5) To filter the effect the variations from the strain readings of the transverse strain gauges in different locations for a given mix, an approximate centerline was drawn for each mix (Fig. 17).

Comparing the centerline curves, it is found that although mini slab study shows Mix 6 had the highest shrinkage among all mixes, the maximum tensile strain from the average of 4 transverse strain gauges (Fig. 17(a)) appeared lower than that of Mix 6-SR1.0. It is because Mix 6 had a compressive (negative) strain, due to the concrete expansion caused by heat of hydration and hot weather at early age, and the tensile strain from the drying and frosting shrinkage compensated the compressive strain. As a result, the absolute strain difference ($\Delta\varepsilon$) was the highest for Mix 6 among all mixes studied. Mix 8 had the second highest $\Delta\varepsilon$. Mix 8-CM90 and Mix 6-SR1.0 had similar $\Delta\varepsilon$ values. This trend is consistent with the order of strains of minislabs.

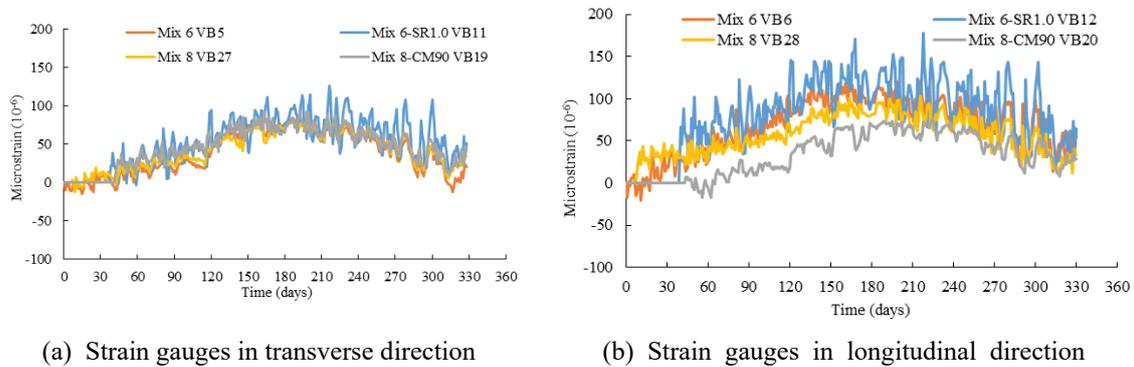
Fig. 18 Comparison of strains in different concrete mixes

Fig. 19 compares the strains in different concrete mixes at the locations of 2270 cm from the abutment in both transverse and longitudinal directions. It illustrates that the concrete strain behaviors were generally similar in the transverse direction, although the strain in Mix 6-SR1.0 concrete was a little high. However, for the strains in the longitudinal direction (Fig. 18(b)), the concrete strains in Mixes 6 and 6-SR1.0 were clearly higher than those in Mixes 8 and 8-CM90.

The strains in the longitudinal direction were noticeably larger than the strains in the transverse direction. These indicate that Mixes 6 or 6-SR1.0 might have high potential of cracking in the transversal direction. However, as mentioned previously, cracking potential is related not only to the strain values but also many other parameters, e.g., the concrete tensile strength and creep behavior, and more stress analyses should be conducted to verified the overlay cracking potential. It would be desirable if more strain gauges were installed in the longitudinal direction of each concrete mix.

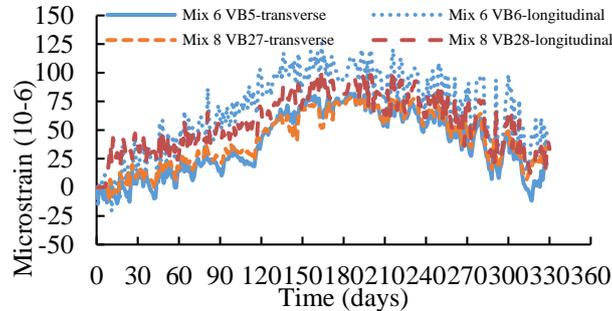
Fig. 21 Strain in different direction at same location

drawn out to compare the strain magnitude at different directions as shown in Fig. 21. It can be seen that the sensors in longitudinal direction have more strain than those in transverse direction which means that the longitudinal strain is greater than transverse strain. This phenomenon can perfectly explain that the most cracks found on overlays are in transverse.
