Assessment of damages on a RC building after a big fire

Mehmet Ada, Barış Sevim*, Nabi Yüzer and Yusuf Ayvaz

Abstract. This paper presents a case study about the damages on the structural elements of a cast in place reinforced concrete (RC) building after a big fire which was able to be controlled after six hours. The fire broke off at the 2nd basement floor of the building, which has five basements, one ground, and two normal floors. As a result of intensely stocked ignitable materials, it spread out to the all of the upstairs. In visual inspection, most of the typical fire damages were observed (such as spalling, net-like cracks, crumbled plasters, bared or visible reinforcement). Also, failures of the 2nd basement columns were encountered. It has been concluded that the severity failures of the columns at the 2nd basement caused utterly deformation of the building, which is responsible for the massive damages on the beam-column connections. All of the observed damages were categorized related to the types and presented separated regarding the floors. Besides to the visual inspection, the numerical analysis was run to verify the observed damaged on the building for columns, bea

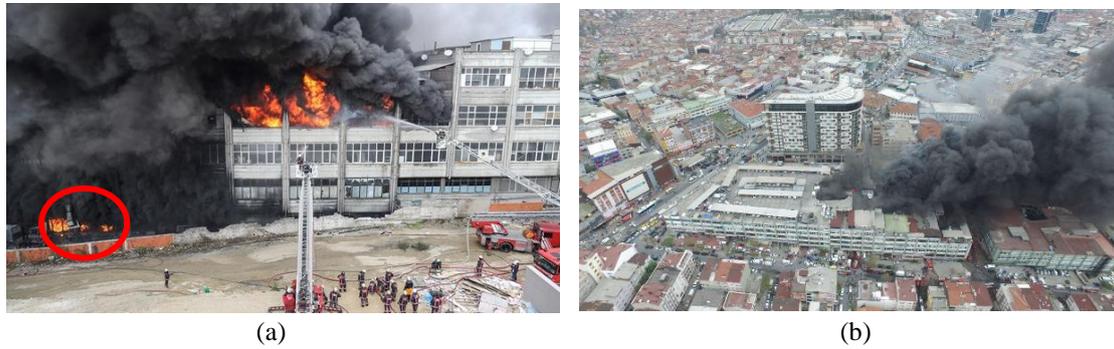
Fig. 6 The photographs of the building during the fire (NTV 2017, DNA 2017)

after, through the vertical openings between storeys, the fire spread to the upper floors. Meanwhile, damaged windows on the elongated sides with already open-air sides of the clearances made the transmission of the fire quickly. The fire was able to be taken under control after 6 hours of operation. As a result of the fire, 30 offices were burned out completely, 97 office damaged partially and 52 vehicles wholly buried or damaged partially (IMM 2016). The ventilation chimney marked within the circle can be seen at the left of Fig. 6(a) and the fume caused by the fire can be seen in Fig. 6(b).

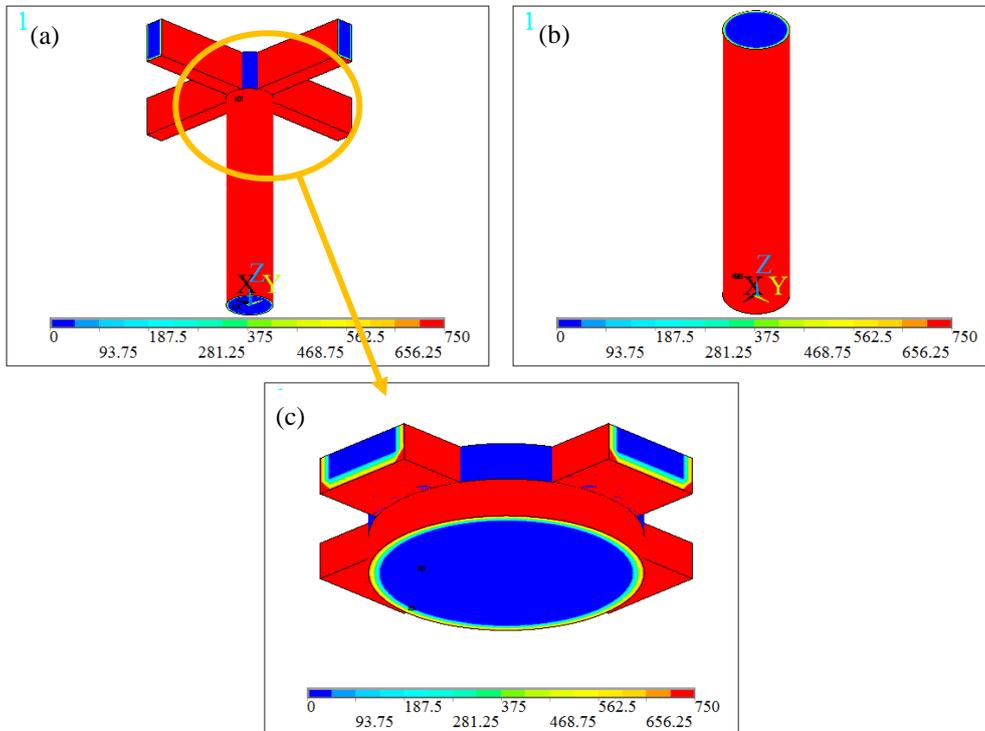
Fig. 25 The body temperatures (in °C) of the model (a), column (b) and the joint section (c)

In the performed thermal analysis with finite element method provided damages similarly with the observed damages on the column, beam, and connections in the fire-damaged building. The variation of the body temperatures in the components and the connection are given in Fig. 25. The results show that the effects of the fire are diminished about 4 cm depth from the surface, however, because of the spalling of concrete cover and cracks that develop on the surface of the elements may cause the reaching of the thermal effects more in-depth than this value.

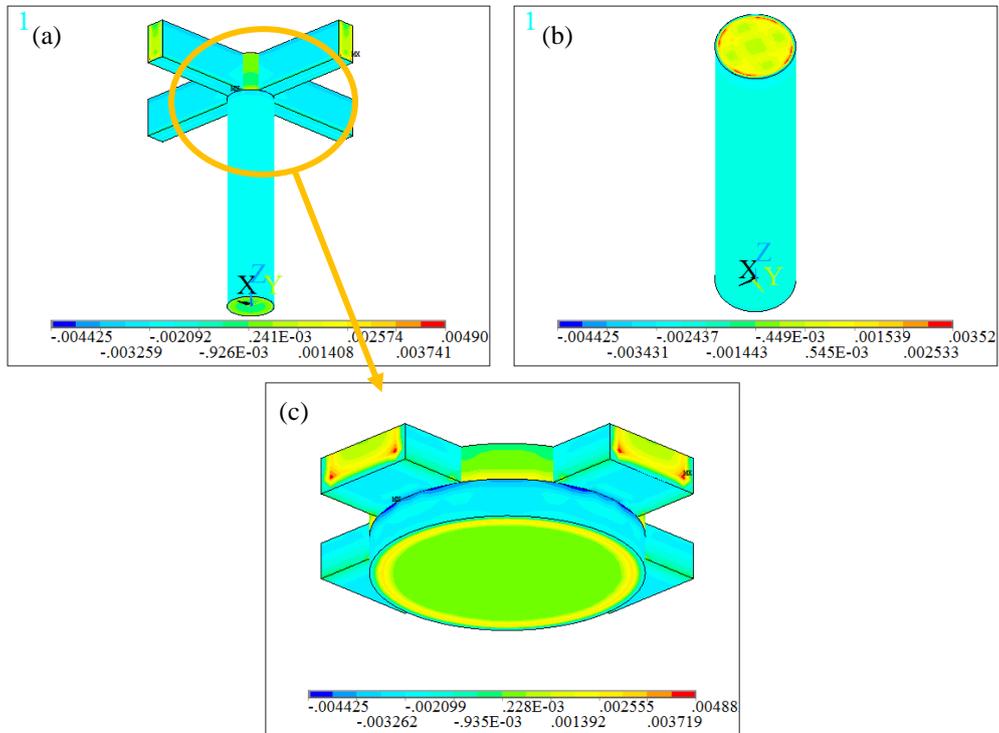
The strain is one of the parameters that can be used to determine the location of the damages. Therefore, in this study, the strains caused by the thermal loading were considered to evaluate the validity of the numerical model by comparing the results with the investigated building. It is accepted that the failure strain of the concrete is about 0.0035 for normal strength concrete (Reynolds *et al.* 2008). In this regard, the thermal strains exceed the limit value for failure in most of the model (Fig. 26(a)). Especially on the surfaces, the level of strains is about 0.0035 range which will cause the spalling of the concrete cover and plaster. Besides, in some specific locations, such as the connection, the level of strains are more than 0.0045 which declare the mechanical failure will take place in this region (Fig. 26(b)). All of the obtained results from this numerical model is coherent with the observed damages on the columns, beams and connection region of

Fig. 26 The principal strains of the model (a), column (b) and the joint section (c)

the edge of the beams, the strains are more than 0.0045 which is already much more than the failure limit of the concrete (Fig. 26(c)). In consequence of this strain concentration, spalling may be one of the most expected damages in the beams (see Fig. 27).

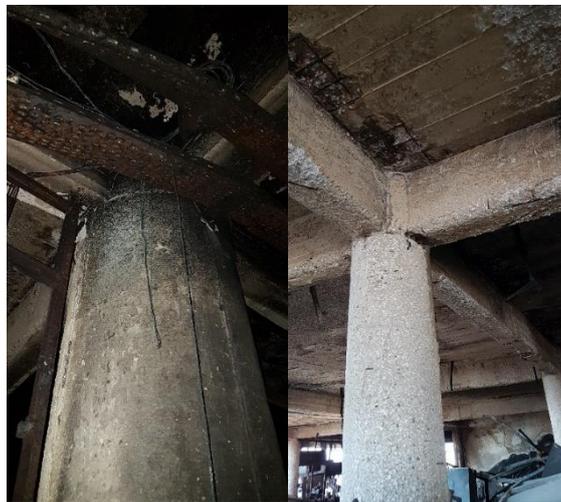
Fig. 27 The principal strains of all the model, column and the joint section

them. In Fig. 27, the most commonly observed damages which are the spalling of the concrete cover, cracks on the connection zone and spalling on the edges of the beams. The locations of the cracks on the columns and the connection region in Fig. 27 are similar to the locations of the strains obtained from the numerical analysis that is over the failure limit of the concrete. Also, near
