# Construction failures of masonry and adobe buildings during the 2011 Van earthquakes in Turkey

# Erkut Sayın<sup>\*</sup>, Burak Yön, Yusuf Calayır and Mesut Gör

Civil Engineering Department, Fırat University, 23119, Elazığ, Turkey

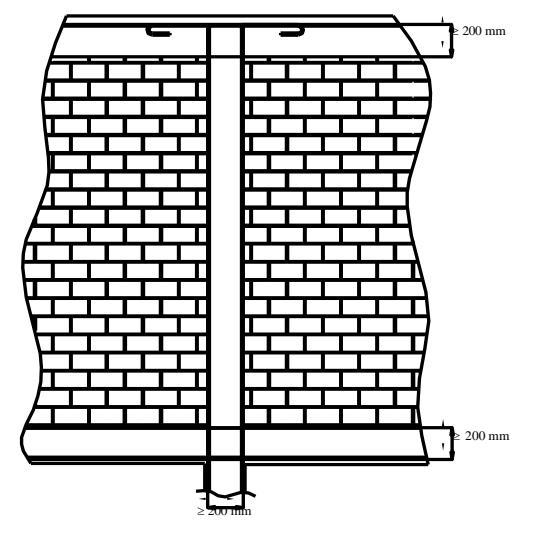
Fig. 8 Vertical bond beams at load-bearing walls

This type of mechanism generally occurs at wall to wall and wall to roof connections when subjected to out-of-plane displacements. The stress concentrations at the intersection of the walls increase during an earthquake. To decrease these effects, the TSC requires reinforced concrete vertical bond beams, which increase the seismic performance of masonry buildings. Fig. 8 shows vertical bond beams at load-bearing walls. In these beams, the compressive strength of concrete should be at least 16 Mpa and  $\emptyset$  8 stirrups, and a maximum spacing of 200 mm should be used together with longitudinal reinforcement.

These bond beams should be used for the entire height on the corners of buildings, along the intersections of the load-bearing walls, and on both sides of the openings. The cross section of these beams should be equal to the thicknesses of the walls that intersect at the corners of the buildings. Furthermore, the other cross-sectional dimension should not be less than 200 mm. Corner damages were common in the adobe and masonry buildings in the earthquake region. Poor connections between adjacent walls and the absence of bond beams caused serious damages. In addition, there were no appropriate connections at the corner of the walls in damaged buildings. This type of damage for adobe and masonry buildings is shown in Figs. 9 and 10, respectively.

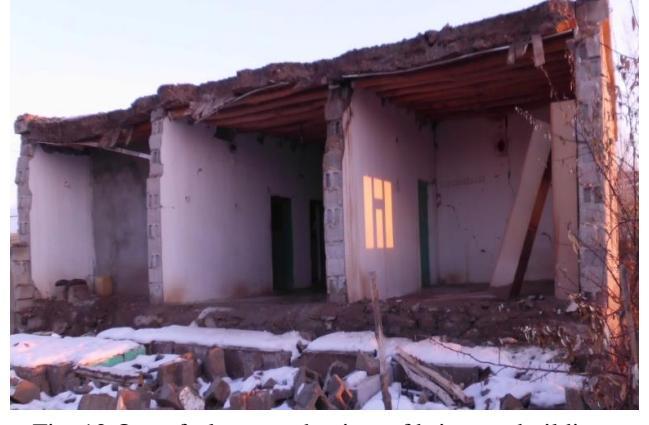
wall lengths cause the separation of walls and cause damage to occur via the of out-of-plane mechanism. Thus, the whole of the wall or a significant part of it falls down during the earthquake. Wooden logs that bear the weight of the floor of the building are placed on load bearing walls in only one direction. Thus, earthquake loads are transferred to perpendicular walls to wooden logs. The walls that are not supported by the wooden logs may easily overturn out-of-plane. This failure mechanism was commonly observed in the earthquake region. Figs. 11 and 12 illustrate the out-of-plane mechanism of the adobe and briquette masonry buildings, respectively.

To prevent this type of damage to adobe buildings, the TSC requires using timber bond beams. These timber beams should be two elements of square sections of  $100 \times 100$  mm and should be placed with the outer faces coinciding with the exterior and interior wall surfaces. These pieces should be tied to each other every 500 mm with nail jointed timber elements with a cross section of  $50 \times 100$  mm. However, there were no bond beams in the damaged adobe buildings. Fig. 12 illustrates that the exterior load bearing walls that are parallel to the wooden logs were overturned out-of-plane because of the lack of bond beams, poor connections, and unsupported wall lengths.

Fig. 12 Out-of-plane mechanism of briquette buildings

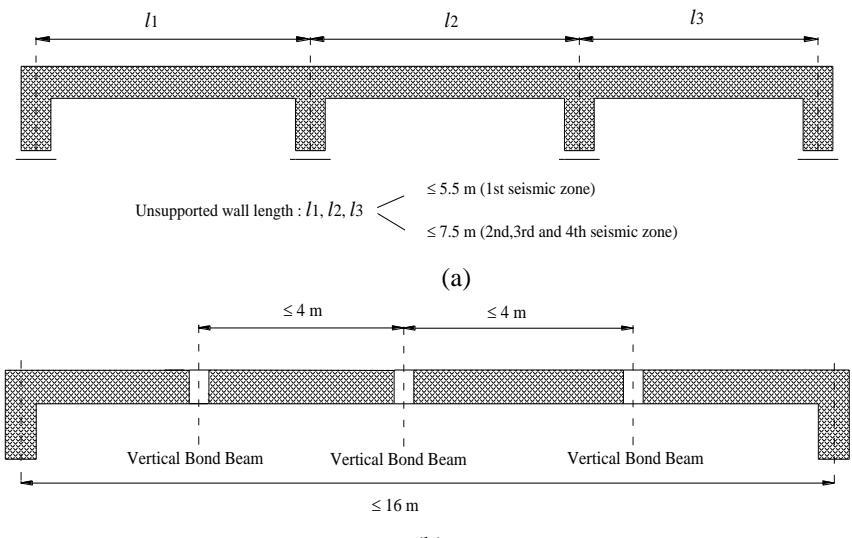
Fig. 13 Maximum unsupported wall length and span between vertical bond beams

Furthermore, to prevent these damages in masonry buildings, the TSC requires that the maximum unsupported length of a wall should not exceed 5.5 m in the first seismic zone and 7.5 m in the second, third and fourth seismic zones in the plan. However, this unsupported length should not exceed 4.5 m in adobe buildings in all seismic zones (Fig. 13(a)). In addition, if these requirements are not provided, reinforced concrete vertical bond beams should be constructed along the full storey height at the corners. Furthermore, these beams should be used every four meters along the wall in plan and the unsupported wall length should not exceed 16 m (Fig. 13(b)).

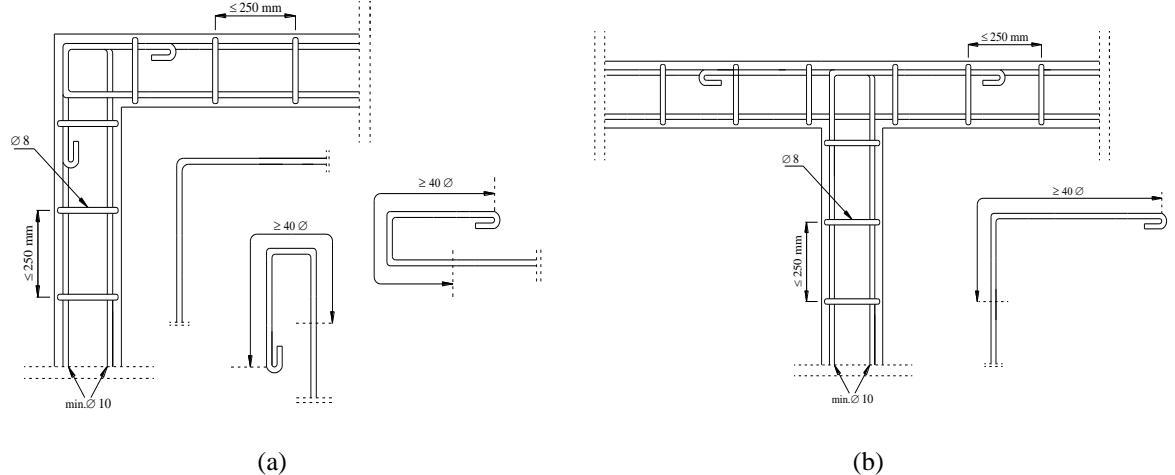
Fig. 14 Details of the horizontal bond beams

longitudinal reinforcement. Figs. 14(a) and (b) present the horizontal bond beams at the corner and intersection of the walls, respectively.

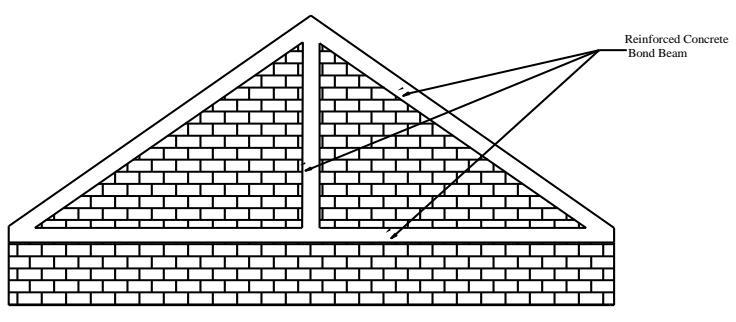
Fig. 16 Recommended details for gable walls

To prevent damage to the gable wall, the TSC requires that the height of the gable wall resting on the horizontal bond beam at the top storey exceed 2.0 m. Furthermore, vertical and inclined reinforced bond beams should be constructed in these walls. Fig. 16 shows the construction details of the gable wall.

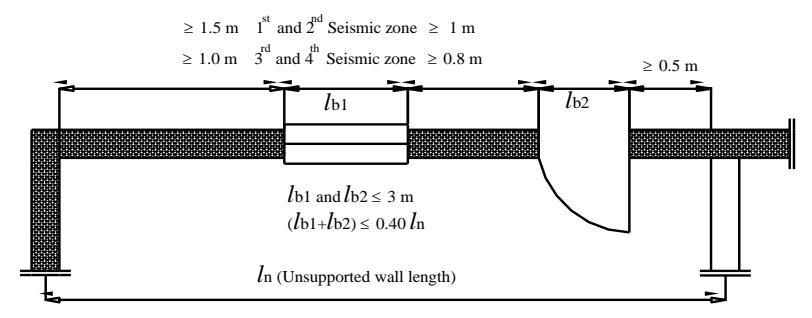
Fig. 19 Maximum openings in load-bearing walls according to the TSC

Our observations in the earthquake region indicated that most masonry buildings did not have sufficient and proper bond beams to enhance the lateral strength of the walls. Furthermore, large openings that decrease the stiffness of the walls increased the shear effects. To limit this type of failure, the TSC requires that the reinforced concrete bond beams should be used (Figs. 8 and 14). The requirements of the openings of load-bearing walls are illustrated in Fig. 19.
