Structural repairing of damaged reinforced concrete beam-column assemblies with CFRPs

Özgür Yurdakul^{*1} and Özgür Avşar^{2a}

Keywords: CFRP; beam-column joint; reinforced concrete; structural repair

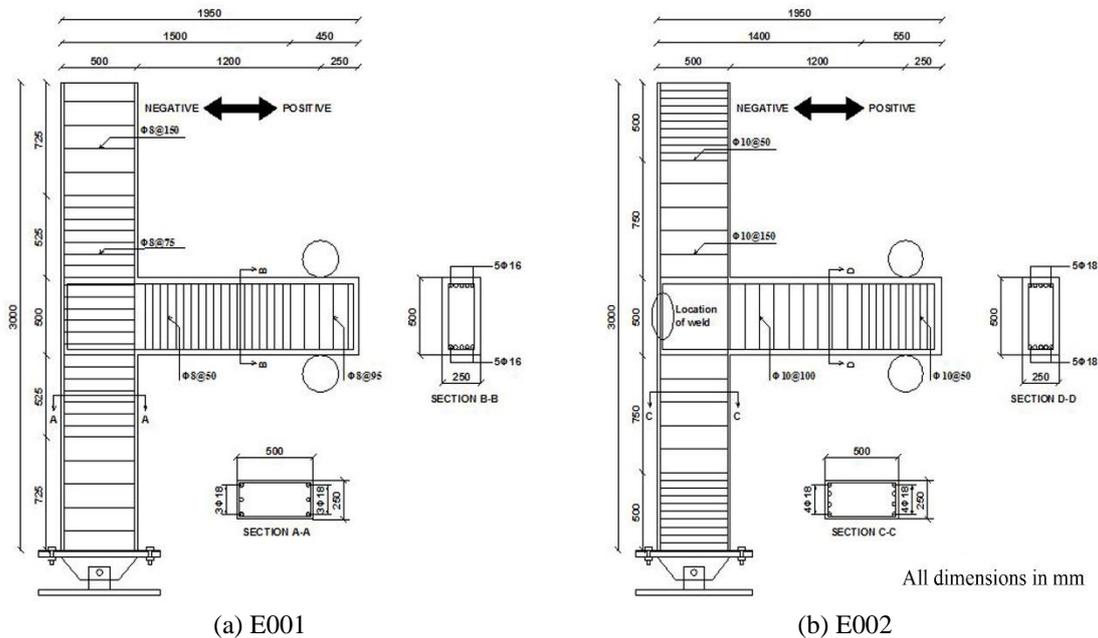
Fig. 3 Dimensions and reinforcement detailing

The first beam-column assembly test specimen (E001) was designed according to current Turkish Earthquake Code (TEC 2007). The first test specimen had column dimensions of 250×500×3000 mm, the column was connected to half-length beam with dimensions of 250×500×1500 mm at mid-span (see Fig. 3(a)). The longitudinal reinforcement ratio of column and beam were 1.22% and 1.61% respectively. 16 mm and 18 mm diameter deformed bars were used in the column and beam. 8 mm diameter deformed bar with 135-degree hooks was used as transverse reinforcement in the beam and column. They are placed with a spacing of 75 mm and 50 mm at the confinement regions of column and beam, respectively. But for the unconfined regions, the transverse reinforcement spacing was selected as 150 mm and 95 mm for the column and beam, respectively. Since the first specimen was designed according to the earthquake code in action, transverse reinforcements are placed in the beam-column joint. According to TEC (2007), minimum concrete compressive strength is 20 MPa and it was selected as a target compressive strength for the first test specimen, E001.

The second test specimen (E002) represents the deficient beam-column assembly, which is very common in most of the existing buildings that were constructed before 1999 in Turkey. The second specimen was non-conforming to the current and former earthquake design code principles. The same geometric dimensions with the first specimen were also selected for E002. The longitudinal reinforcement ratio of column and beam were 1.63% and 2.04 % respectively. 18 mm diameter plain round bars were used in the column and beam. 10 mm diameter undeformed bar with 90-degree hooks were used as a transverse reinforcement (see Fig. 3(b)). In the second specimen, there was no transverse reinforcement in the beam-column joint region and the concrete compressive strength was expected around 8-10 MPa. The maximum aggregate dimensions are selected to be between 5 mm to 12 mm for the concrete mixture design of low concrete strength. In order to investigate the seismic behavior of RC beam-column assembly for the reference and repaired test specimens, the minimum required axial load for columns according to TEC (2007), which is $0.1A_c f_c^*$, was used for both specimens. Because the axial load increase the joint shear strength, the axial load applied to the columns was selected to be the minimum to consider the most critical case. Mechanical properties of materials and applied axial load for each reference specimens (E001 and E002) as well as the repaired test specimens (E001-R and E002-R) were summarized in Table 1.

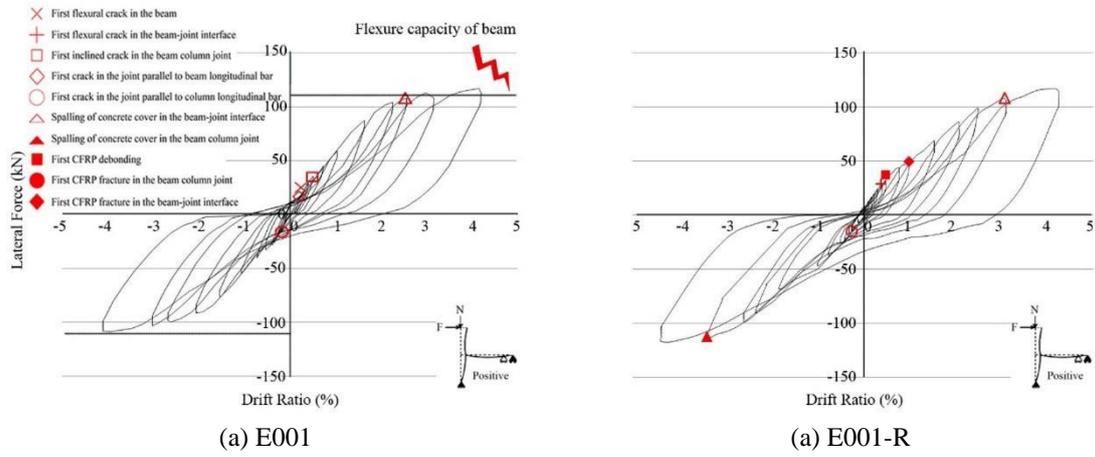
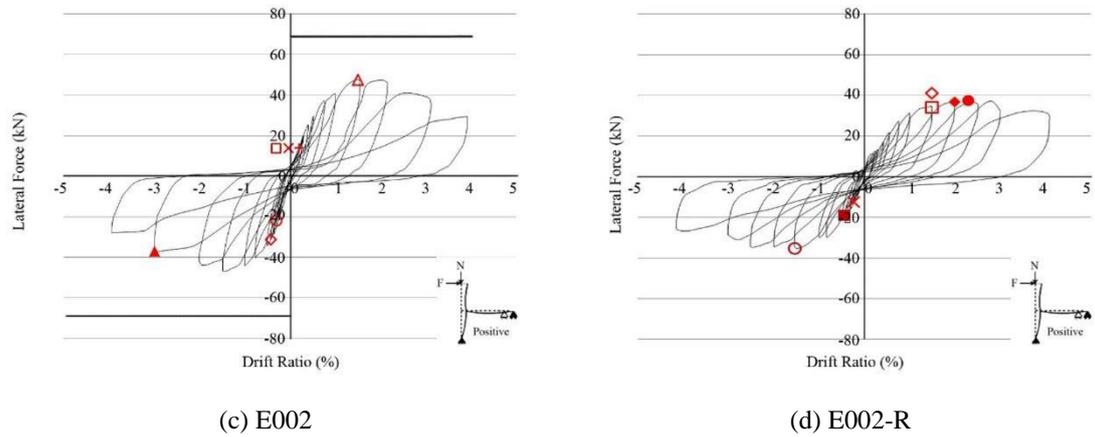
Fig. 10 Maximum lateral load vs. drift ratio graphs for specimen

The horizontal responses of both specimens were examined and the overall performance of reference specimens was compared with the corresponding repaired specimens. The damaged photographs of specimens at 4% drift ratio are illustrated in Figs. 9(a)-(b). The column lateral tip load versus drift ratio and envelopes of hysteretic loops for all specimens are plotted in Figs. 10-11, respectively. Also, the significant steps in the experiments such as cracking, debonding and fracture of CFRPs, concrete spalling are also indicated in the graphs shown Fig. 10. Observed

The observed failure mode of E002-R was shear failure at joint as also observed for the reference specimen, E002. The performance of repaired specimen was quite satisfactory until debonding of the diagonal CFRP sheets on the joint surface. The first CFRP debonding was observed at 0.40% drift ratio which corresponds to 50% of maximum lateral load. However, the flexural crack was observed in the beam at 0.20% drift ratio which is before the occurrence of CFRP debonding. This implies that the application of diagonal CFRPs at the beam-column joint has changed the behavior of the beam-column assembly and flexural deformations in the beam dominated the overall response before the fracture of CFRPs. After several cycles of the first debonding, fracture of the CFRPs was initiated as shown in Fig. 9(d).

The reason of failure in the E002-R specimen was the fracture of diagonal CFRPs (see Fig. 9(d)) and as a consequence the spalling of repair mortar at joint core was occurred. The first CFRP fracture at joint occurred at 2% drift ratio. After this point, the capacity of the repaired specimen was diminished by the shear failure of the beam column joint leading to a brittle type of failure. In the design of CFRP sheets for repairing the damaged E002 specimen, two layers of CFRP sheets with 200 mm width was selected to be applied diagonally at the beam-column joint. In the design stage, the full CFRP sheet area was considered to be in tension. However, one side of the CFRP sheet was exposed to larger stress due to the eccentricity and hence total CFRP section did not work as it was designed. This led to tearing of the CFRP sheet from one side that had higher axial stress. Therefore, it is inferred that more layers of diagonal CFRP sheets should have been used for the applied repairing technique to be more effective for the higher drift ratios. Even the application of two layers of CFRP sheets with 200 mm width result in more flexural deformations in the beam leading to a more ductile behavior compared to the reference specimen. Propagation of flexural cracks was in the uncracked beam sections as well as widening of crack width in the existing cracks observed in the repaired specimen before the fracture of diagonal CFRPs.

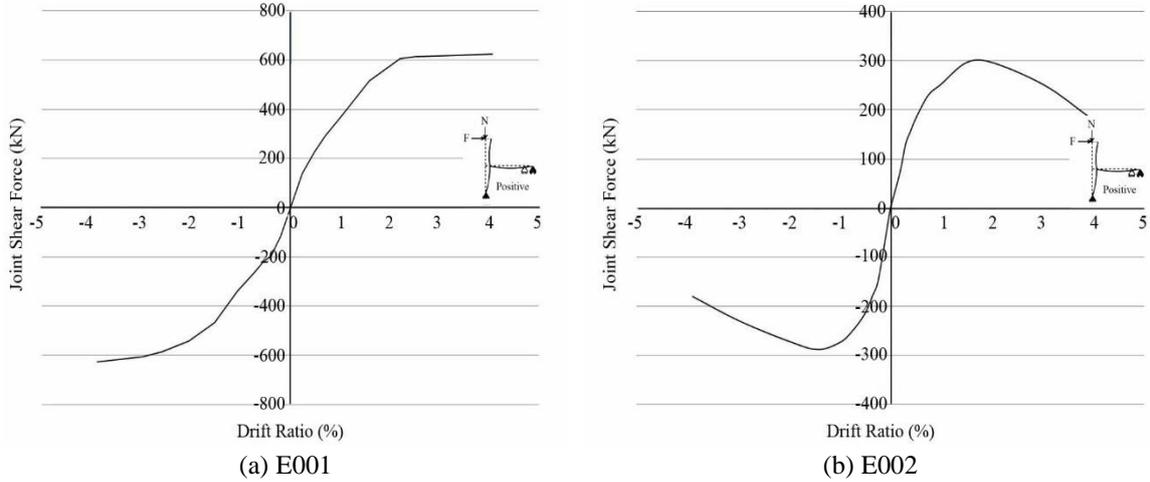
Fig. 12 Joint shear force vs. drift ratio responses

gauges are not functional anymore due to rupture or separation from the reinforcement surfaces to which they were attached. Therefore, no data could be collected from strain gauges after testing the reference specimens. The joint shear force versus drift ratio is plotted in Figs. 12(a)-(b). These curves are in good agreement with the corresponding backbone curves presented in Figs. 11(a)-(b). The joint shear capacity of the first specimen, which was designed in accordance with TEC (2007), is twice more than the second specimen without exhibiting any deterioration.

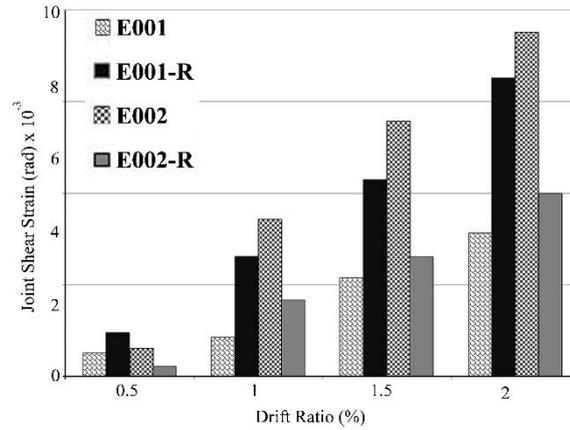
Fig. 13 Joint shear strain vs. drift ratio

Where L_v , L_h , L_d are obtained by summing the original length and measured displacement of vertical, horizontal and diagonal LVDTs respectively. The joint shear strain versus positive drift ratio graph was plotted in Fig. 13. The obtained result shows the effect of repairing on the joint response. The joint shear strains of E001-R are larger than its reference sample (E001). In the repaired specimen (E001-R), the beam and column capacities are improved with the addition of CFRPs while nothing was changed with the joint. In the reference specimen damage was concentrated in the beam. After repairing, damage was transferred to the beam-column joint, which resulted in an increase in the joint shear strains. For the second specimen, repairing by CFRPs at the deficient beam-column joint led to less joint shear strain for E002-R compared to reference sample, E002. This proves the effectiveness of diagonal CFRPs as a repairing technique for the damaged beam-column joints up to the fracture of CFRP sheets, which correspond to 2% drift ratio in this study.

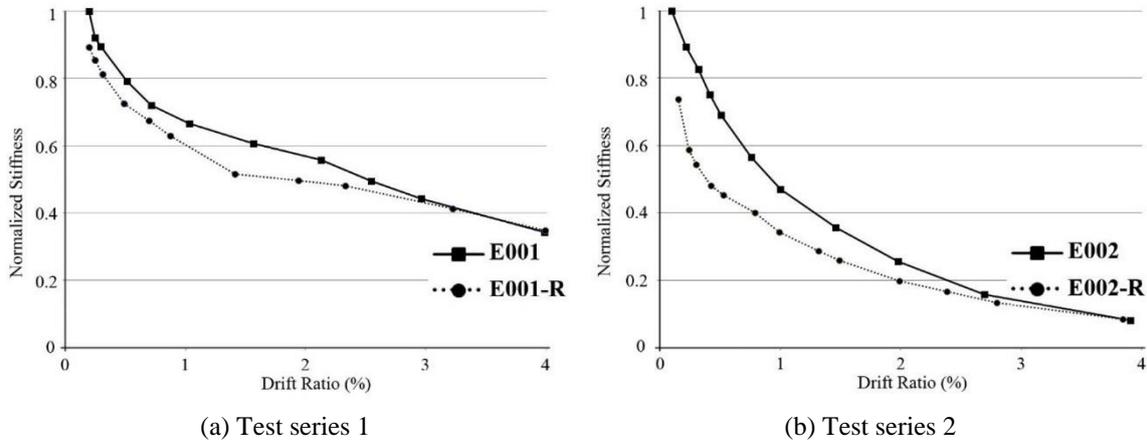
Fig. 14 Stiffness degradation curves

The peak to peak stiffness, K^p , is defined as the slope of line that connects the ultimate load points in positive and negative direction of hysteresis loop in each loading cycle. The normalized peak to peak stiffness with respect to reference specimens versus drift ratio curves is presented in Figs. 14(a)-(b). The peak to peak stiffness at each loading level decreased when the applied load devolved into inelastic range along with the increased level of damage. The sustained stiffness in each loading cycle of the reference specimens was higher than the repaired specimens due to existence of pre-formed cracks in the reference specimens. However, for drift ratios greater than 3%, the reference specimens could sustain the same level of peak to peak stiffness with the repaired specimens due to reduction in the contribution of CFRPs as a result of fracture.

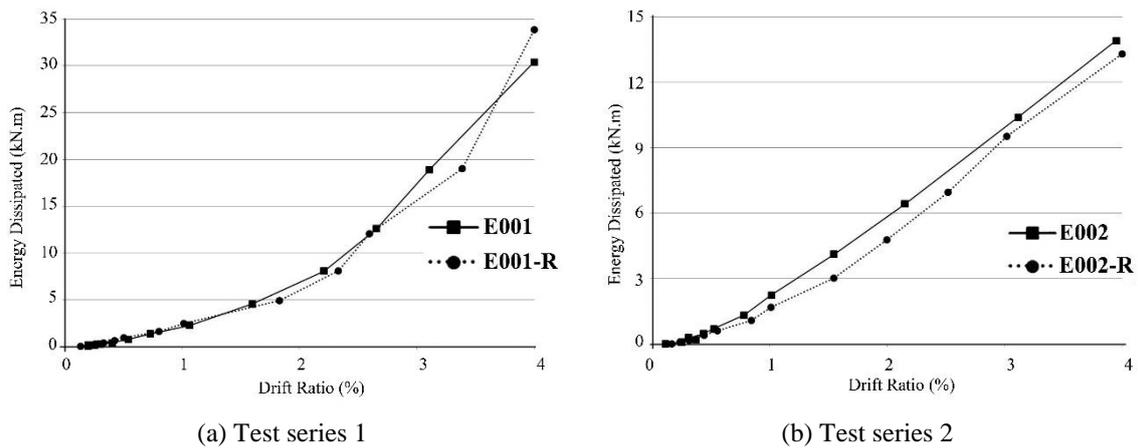
Fig. 15 Cumulative dissipated energy curves

The energy dissipation capacity during each loading cycle is computed to be the area enclosed within load-displacement curves. Then, the cumulative energy dissipated by specimens is obtained by summing the areas calculated for each loading cycle. The resulting cumulative energy versus drift ratio is shown in Figs. 15(a)-(b). The difference between the energy dissipation of E001 and E001-R is not more than 10% for each cycle. Therefore, repairing technique applied for E001 is considered to be effective in terms of energy dissipation. For the second specimen, energy

dissipation capacity of the repaired specimen is always less than the reference specimen. As mentioned before, fracture of diagonal CFRP sheets result in less lateral force capacity and hence less energy dissipation capacity. If the fracture of CFRPs had been prevented by employing more layers of CFRPs, energy dissipation capacity of the repaired specimen expected to be higher than the reference specimen. At lower drift ratios, the energy dissipation capacity of E002 is larger than the repaired counterpart (E002-R) before the fracture of the CFRPs. This can be explained by the imposed structural damage in the repaired assembly occurred during the tests of the reference assembly.
