Damage of scarf-repaired composite laminates subjected to low-velocity impacts

Abstract. The damage characters of scarf repaired composite laminates subjected to low-velocity impact with various energy levels at different locations are studied experimentally. The results are compared with those of the original laminates which have no initial damage and don't need repair. The impact load-time history of the specimens, the velocity-time curves of the impactor, the post impact compressive strength of the specimens and the C-scan photographs of the damaged regions are obtained. The delamination threshold load and damage character of the specimen section at impact point are also studied. The results have shown that the impact response of a repaired composite laminate is sensitive to the location of the impact. The impact load and the delamination threshold load have shown different characters for specimens with different impact locations. The debonding characters of the adhesive and compressive strength after impact of the specimens are also influenced by impact locations.

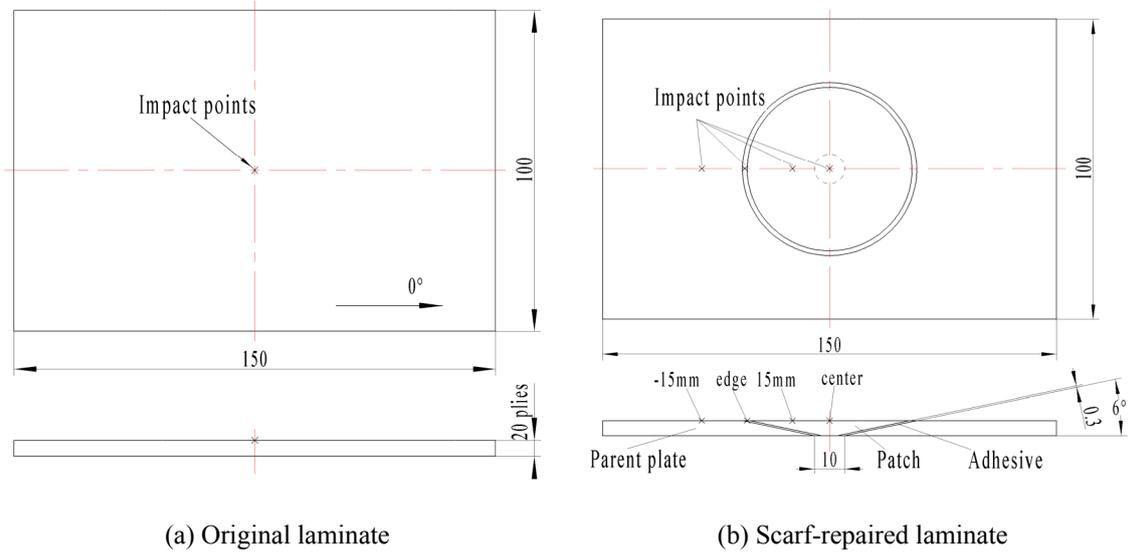
Fig. 1 Low-velocity impacted specimen configurations

There are two kinds of specimens in this study, including the original laminated specimens and the scarf-repaired laminated specimens. Both of them are of the same size which is 150 mm in length and 100 mm in width. The 0° direction is parallel to the long sides. Bottom diameter of scarf-repair region is 10 mm, and the scarf angle is 6° . Schematic diagrams of the specimens can be found in Fig. 1.

Low-velocity impacts in different energy levels are proposed in geometric center (location P1) of original plates and in four locations of scarf-repaired plates separately. The impact points are all aligned on the width center line for both kinds of specimens. For repaired specimens, the specific locations of impact points are at the patch center (location P2), the middle of adhesive area (location P3), the edge of the patch (location P4) and outside the patch (location P5), as is shown in Fig. 1(b). Table 1 gives the contents of experimental work contained here.

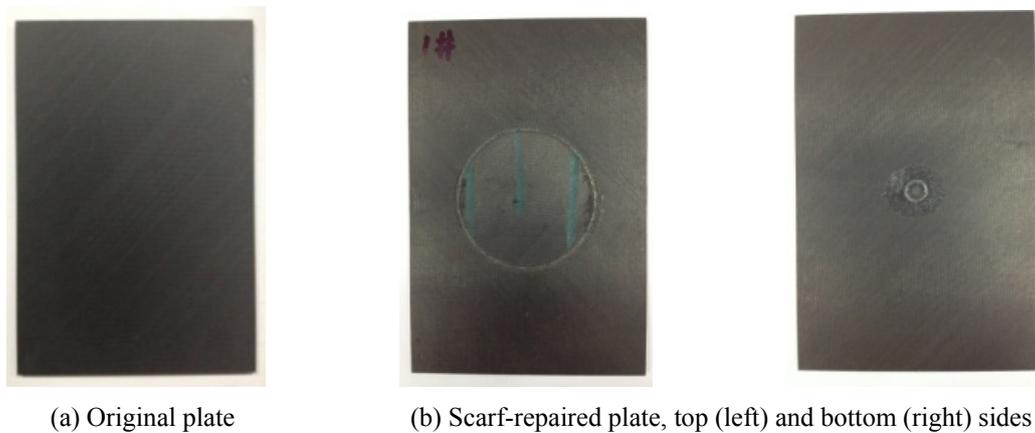
Fig. 2 Photographs of specimens

machine as the parent plate of the repaired specimen. The patch, the parent plate and the adhesive film are then fixed together and placed in an environmental chamber for secondary curing. Photographs of original and repaired laminate specimens are shown in Fig. 2.

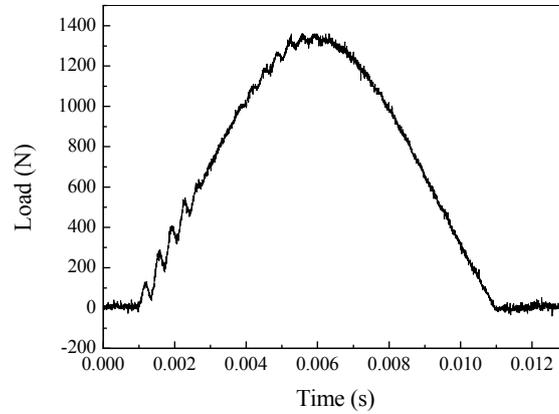
Fig. 3 Contact load history of original plate subjected to 1.55 J impact

The contact load-time history of original laminate specimens subjected to a 1.55 J impact is shown in Fig. 3. The load curve contains some minor oscillations due to vibration and elastic wave responses of the specimen. This phenomenon is repeatable, as described in a previous study (Cheng *et al.* 1998). There is no visible indent on the impacted surface, and no visible cracks or other signs of damage on the back surface either.

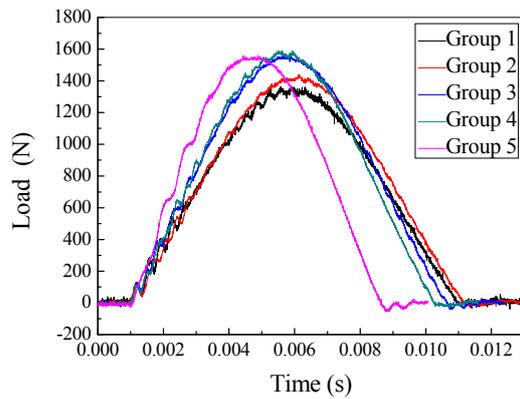
Fig. 4 Contact load history of five group specimens subjected to 1.55 J impact

Fig. 4 shows the load histories of all the five group specimens subjected to 1.55 J impact. The curves show that the wavelength and amplitude of Group 1 and Group 2 are close to each other. The wavelength of Group 3 and Group 4 is less than that of Group 1. The wavelength of Group 5 has significantly decreased comparing to the other groups, while the amplitude is similar to those of Group 3 and Group 4.

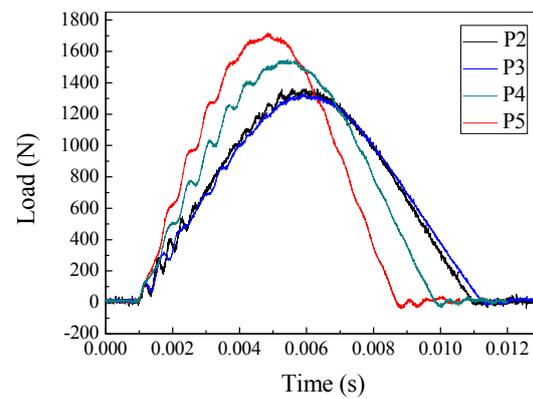
Fig. 5 Contact load history of original plates subjected to 1.55 J impact at 4 different locations

In order to find out whether the variety of the equivalent stiffness is induced by relative position between the patch and the impact location, or by the varying distances between the punch and the impact fixture support edges, a set of comparative tests are performed. In these tests, a 1.55 J impact is imposed on original laminates at four different locations corresponding to P2, P3, P4 and P5 of the repaired laminates. The load-time curves are shown in Fig. 5.

In Fig. 5, the curves which represent for specimens impacted at the location of P2 and P3 almost coincidence with each other. The other two curves have evident differences in wavelength and amplitude, which can be derived from the variety of equivalent stiffness with reference to Eq. (1). Since the influence of the relative position between the impact point and the patch has been eliminated, the variety of equivalent stiffness must be triggered by the varying distances between the punch and the impact fixture.

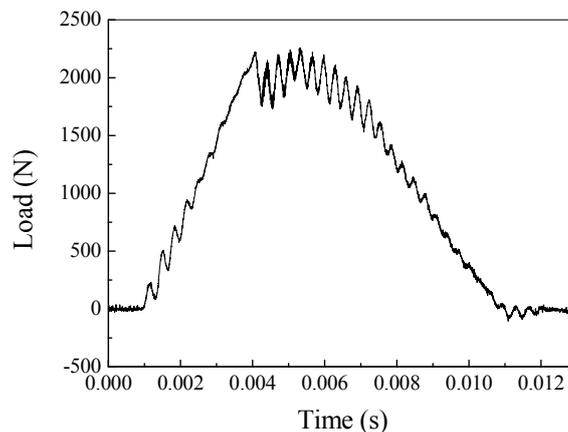
Fig. 6 Contact Load histories of original laminate specimen to 4.61 J impact

The load-time history for original laminate specimen subjected to a 4.61 J impact is shown in Fig. 6. It can be seen that the loads drop suddenly and sharply after reaching a certain value, and oscillations exist in the entire contact process for all groups of specimens. The sudden load drop is the result of the instable expansion of interlaminar damage. This is an obvious difference from the result of 1.55 J impact. There is no such load drop in the latter ones.

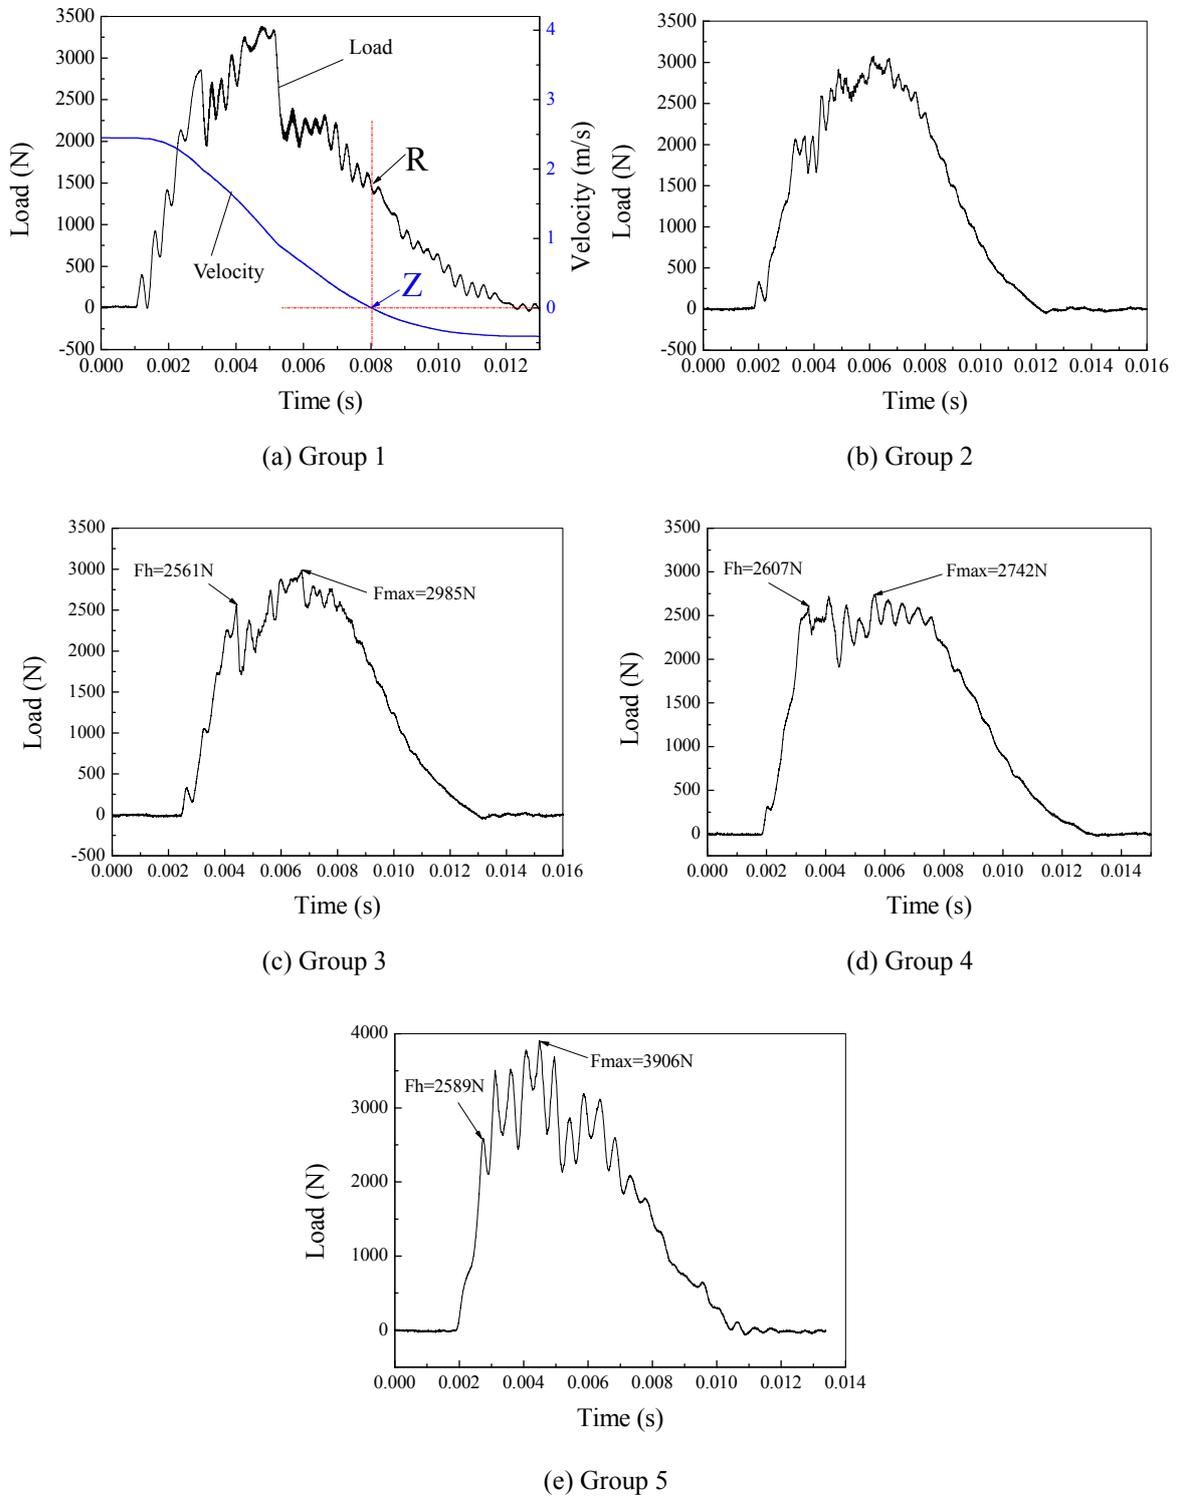
Fig. 7 Load history curves of five group specimens subjected to 6.67 J/mm impact

Fig. 7(a) shows the load and velocity history curves for a specimen in Group 1 subjected to 6.67 J/mm impact. In the beginning portion of the curve, load fluctuates across several small peaks, then rises to relatively large oscillations. After the maximum impact load, the load plunges into severe oscillating region. Afterwards, the load gradually reduces to 0. According to the velocity history curve, during the velocity decrease, the punch has reached the maximum displacement before it starts to rebound. The 'Z point' in the figure represents for the rebound point where the punch velocity is zero. It is corresponding to the 'R point' in the load history curve, which indicates that the load curve following the 'R point' reflects an unloading process.

The load-time curve of a specimen in Group 2 subjected to 6.67 J/mm impact is shown in Fig. 7(b).

The load-time curve of a specimen in Group 3 subjected to 6.67J/mm impact is shown in Fig. 7(c).

The load-time curve of a specimen in Group 4 subjected to 6.67 J/mm impact is shown in Fig. 7(d).

The load-time curve of a specimen in Group 5 subjected to 6.67 J/mm impact is shown in Fig. 7(e).

The impact response load increases from zero to DTL smoothly with little oscillations, then starts to oscillate violently with increasing amplitudes. The load begins to decrease after maximum load point. There seems to be a second oscillation region during the decrease. There is no sudden load drop after reaching the maximum response load, compared with the original plates subjected to the same loading condition.

Comparing load-time curves of specimens subjected to 4.45 J/mm (see Fig. 8) with 6.67 J/mm (see Fig. 7) impact, it can be found that the damage propagation of scarf repaired composite laminates differs from original laminates. For scarf repaired laminates, the impact position also exists specific influence on the damage propagation.

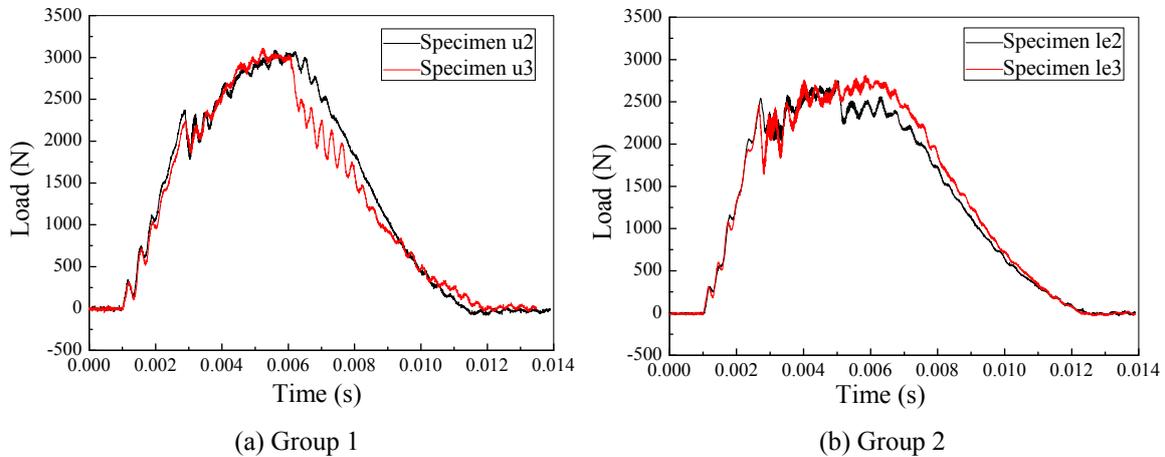
Fig. 8 Load histories of specimens subjected to 4.45 J/mm impact

The load-time curves of the Group 1 and Group 4 specimens subjected to 4.45 J/mm impact are shown in Fig. 8 respectively.

The impact response load of the original plates drops sharply after reaching DTL, then increases to the maximum load and drops sharply again. Afterwards, the load shows trend of second oscillation and decreases to zero subsequently.

For the scarf repaired plates, impact at P2 and P3 have triggered similar trends of the curves. In these both cases, the load drops slightly at DTL, then increases and forms a raised platform similar to a quadric function on the load-time curve before it decreases to zero. The oscillations are more violent when impact at P3, while the curves are smoother when impact at P2. For the specimens impacted at P4, their load-time curves almost degenerate into platforms with intensive oscillations

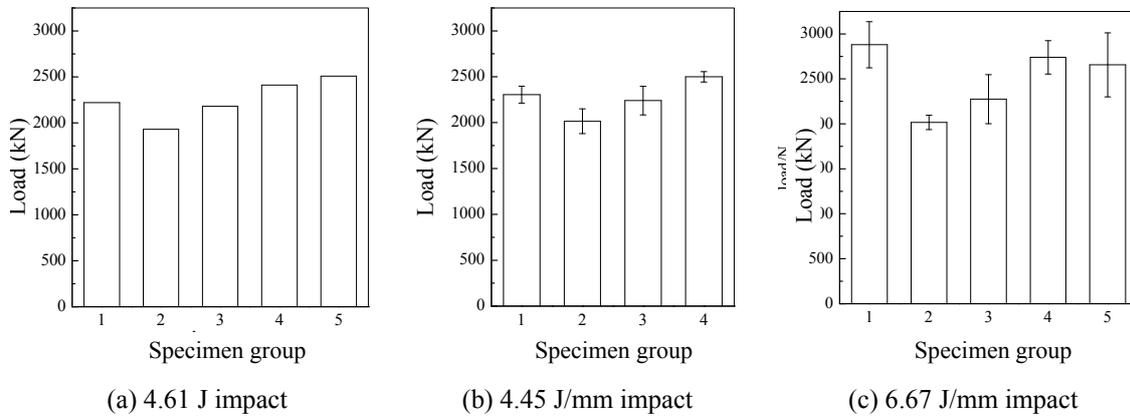
Fig. 9 DTLs of each group specimens under three different impact energy level

For low-velocity impact with the energy of 4.61 J, 4.45 J/mm and 6.67 J/mm, DTL can be determined directly from the load-time curves. The results are shown in Fig. 9.

The DTL of 4.61J impact is shown in Fig. 9(a). There is no scatter marked in this figure since there is only one specimen for each impact location. Fig. 9(b) regards to the DTL of 4.45 J/mm impact. There are two specimens for each impact location. Fig. 9(c) regards to the DTL of 6.67 J/mm impact. There are 3 or 4 specimens for each impact location. The figures have shown that DTL of original laminates impacted at P1 and repaired laminates impacted at P2 are close to each other. For repaired laminates subjected to impact of the same energy level, DTL increases slightly when the impact position moves outwards from the center (from P2 to P5).

When subjected to a higher energy impact (6.67 J/mm), a higher scatter of DTL is gained. Nevertheless, the result still implicates that a lower DTL can be gained when the repaired laminate is impacted at P2.

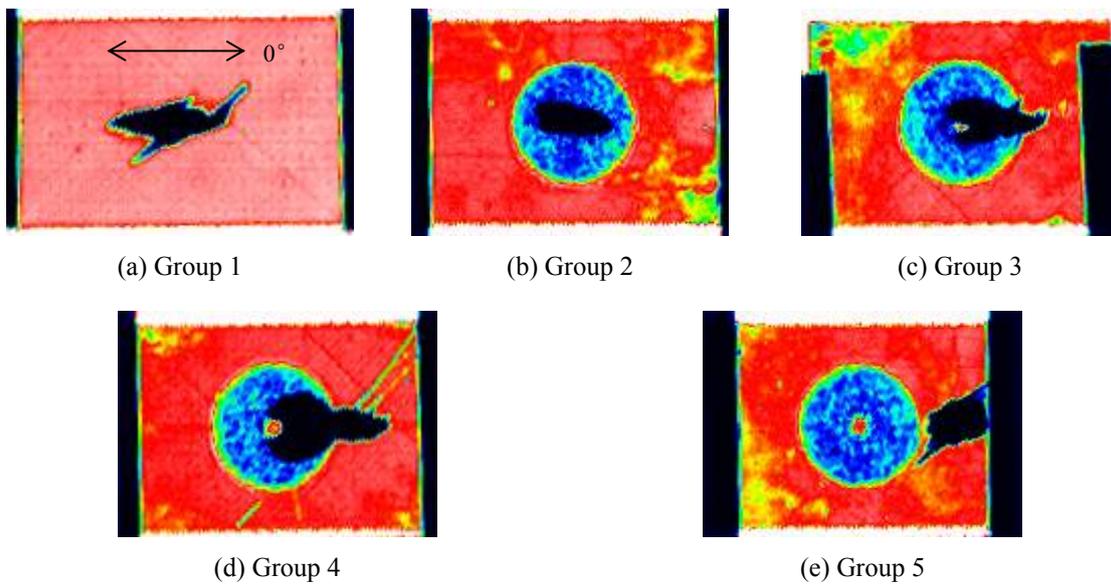
Fig. 10 Ultra C-scan images of five group specimens after 6.67 J/mm impact

Figs. 10(a)-(e) show the typical ultra C-scan images of impact damage of five group specimens.

Fig. 10(a) shows the damage of an original laminate after impact, the projection of damage seems to be long and thin, and its longitudinal direction parallels to the fiber direction of the first ply. Figs. 10(b)-(e) are the ultra C-scan images of repaired laminates after impact at P2, P3, P4 and P5 respectively. It can be found that the damage area is much larger when the repaired laminate is impacted at P3, the bond line of the top surface. While the damage zone is restricted to the patch when impacted at the center of the patch and to the parent laminated when impacted at 15 mm away from the bond line.

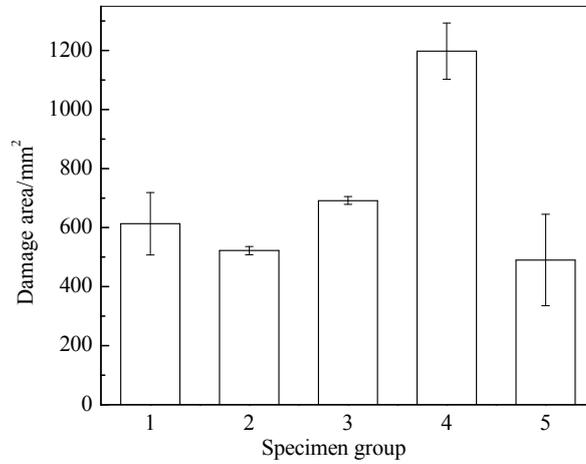
Fig. 11 Projection damage areas of five group specimens after 6.67 J/mm impact

The projection damage areas of the five group specimens are shown in Fig. 11.

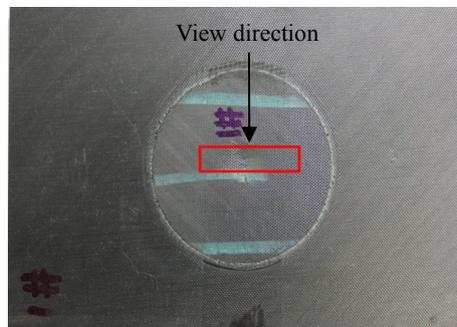
Fig. 12 The location of the sample taken from the repaired specimen for microscopic examination and its view direction

Samples for the micrographic analysis for the repaired composite laminates subjected to 6.67 J/mm impact are cut from the repaired specimens with impact damage, and the region is located at the impact point, as is shown in Fig. 12 in which the view direction is represented by the arrow.

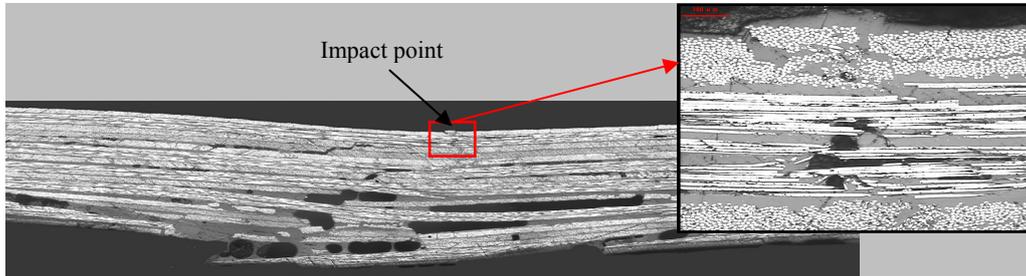
Fig. 13 Micrograph of the repaired laminate subjected to impact at P1

As is shown in Fig. 13, there are numerous matrix crack, fiber breakage and delamination in the patch when the impact position is located at P1, the center of the patch top surface. While there is

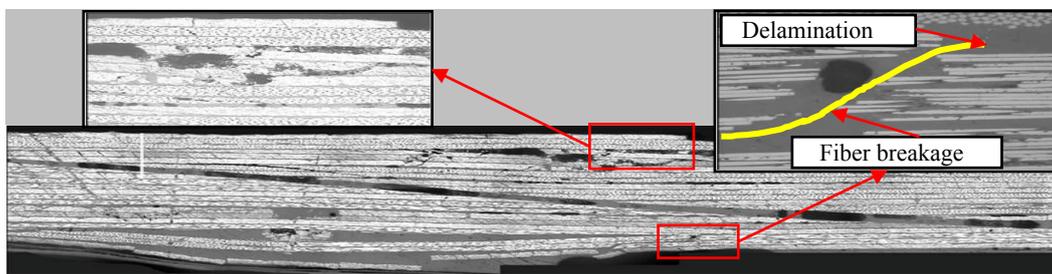
Fig. 14 Micrograph of the repaired laminate subjected to impact at P2

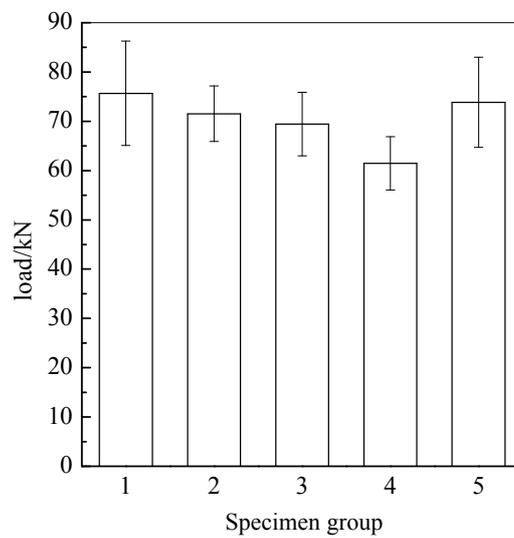
Fig. 15 CAI strength of the five group specimens subjected to 6.67 J/mm impact

The CAI strength of the five group specimens subjected to 4.45 J/mm impact and their scatters are shown in Fig. 15.
