Experimental study on repair of corroded steel beam using CFRP

Meiling Chen and Sreekanta Das*

Department of Civil and Environmental Engineering, University of Windsor, Windsor, Ontario N9B 3P4, Canada

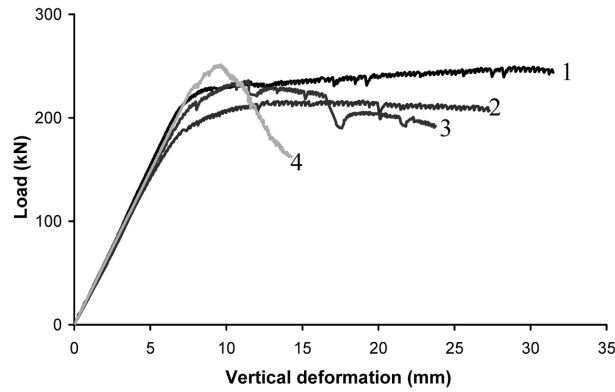
Fig. 5 Load-deformation of group 1 specimens

Fig. 5 shows the load-deformation behavior for specimens in group1. The numbers beside the curves

indicate the specimen numbers as shown in Table 1 and thus, 1 is for the first specimen (CV-G1) and 4 is for the fourth specimen, RC-W133-T2.4-G1. The first specimen (CV-G1) yielded at 202 kN load and 7 mm vertical deformation at mid-span. The ultimate load was recorded as 249 kN when the vertical deformation was 29 mm. This beam specimen exhibited good ductility since it was able to show large elastic-plastic deformation. The test was discontinued at 243 kN and the vertical deformation at 31.5 mm (Table 3). This specimen did not fail either due to lateral torsion buckling or due to web buckling. However, the top flange under the load buckled slightly at this stage. The specimen at that time was considered as failed and the test was discontinued primarily due to large deformation.

The second specimen (CC-G1) in Table 1, the other control specimen with corrosion and shown by 2 in Fig. 5, was also able to show good elastic-plastic deformation. This specimen however, yielded at a lower load of 165 kN load and at that time vertical deformation at mid-span of the beam was recorded as 5.7 mm. The drop in yield load with respect to the virgin specimen (specimen 1) was 18.3% as shown in Table 2. The ultimate load was recorded as 215 kN (Table 2) which was 13.6% lower as compare to specimen 1 (CV-G1) and at that time, the mid-span vertical deformation was recorded as 13.4 mm. In this table, P_y is the yield load, P_{ult} is the ultimate or maximum load. The changes in yield and ultimate loads were calculated with respect to the respective values obtained from specimen 1 or virgin specimen (CV-G1). The specimen first yielded at the corrosion location and it was confirmed since significant necking at that location was observed. Then, the flange and a small portion of the web under the load buckled plastically. The specimen was considered as failed and the test was discontinued when the vertical deformation at mid-span of the beam reached 27.3 mm since the buckling at the web-flange intersection at mid-span became large.

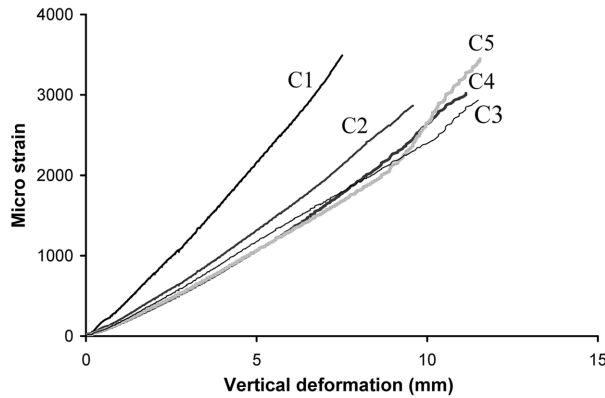
Fig. 11 Deformation-CFRP strain for specimen 8

Fig. 11 shows mid-span vertical deformation vs. strain behavior of all CFRP strain gauges and Fig. 12 shows similar behavior for all steel strain gauges used in specimen 8. The strain gauge numbers and their locations are shown in Fig. 4. The strain gauge numbers are also indicated in Figs. 11 and 12. The strains at gauges C1 and S1 showed highest rate of strain since these two gauges were located at the mid-span of beam and thus, at the mid-length of the corrosion. The strains on gauges 5 (C5 and S5)

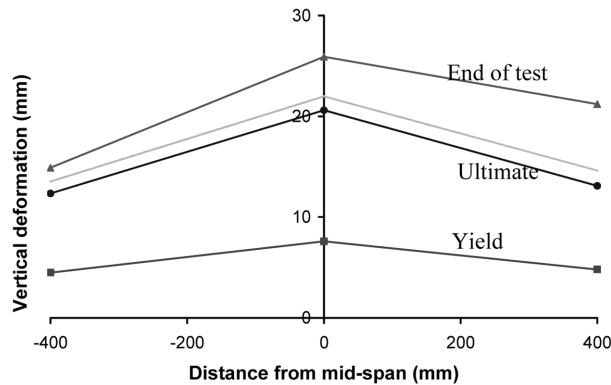
Fig. 13 Distribution of vertical deformation for specimen 8

Fig. 13 shows vertical deformation distribution in direction-3 obtained from three LVDTs (Fig. 1) mounted at 400 mm spacing on the bottom flange of specimen 8. Four curves represent deformation

distributions when yield load (250 kN) was applied, when ultimate load (330 kN) was applied, when mid-span vertical deformation was 22 mm, and when specimen failed and test was discontinued (mid-span vertical deformation was 25.9 mm). This figure shows that the vertical deformations recorded from this specimen were almost symmetric about the beam's mid-span until when the mid-span vertical deformation was 22 mm. At that stage, the buckling in the web on the roller end initiated and thus, the vertical deformation distribution became un-symmetric and this un-symmetry increased as mid-span deformation was increased. Thus, the deformation test data confirms that this beam specimen behaved in a very stable manner until about 22 mm mid-span vertical deformation. The load capacity dropped at a faster rate then after because the web buckling on the roller end initiated and grew with application of further deformation.
