Seismic rehabilitation of RC frame using epoxy injection technique tested on shaking table

Abstract. A 1/4-scale two-bay eight-storey reinforced concrete frame was tested on shaking table. Initial shaking table tests were carried out through a set of real seismic excitations to investigate the seismic behavior of the RC frame. Subsequently, the damaged frame was repaired using epoxy injection technique, and then subjected to the tests with the same records. The purpose of this study was to investigate experimentally the dynamic characteristics, cracking pattern and lateral inter-story stiffness of RC frames using epoxy injection technique. The test results indicate that epoxy-injection technique appears to be a satisfactory method for repairing earthquake-damaged structure.

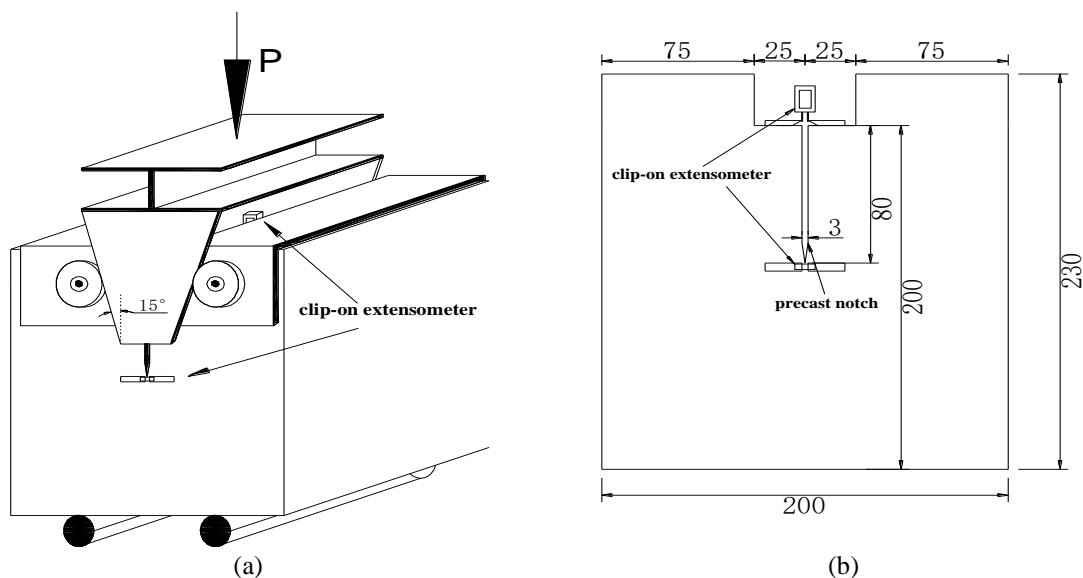
Fig. 1 Configuration of WST: (a) loading arrangement, (b) specimen shape

To study the feasibility of restoring concrete with epoxy injection, six prisms, namely SW-1~SW-6, were simultaneously cast with the RC frame model. The dimensions of prism are depicted in Fig. 1. A closed-loop servo controlled hydraulic jack with a maximum capacity of 1,000 kN was employed to conduct a so called “wedge splitting test (WST)” (DL/T 5332-2005 2005, Xu 1999). Two clip-on extensometers were installed at the mouth and the tip of the precast notch to measure the crack mouth opening displacement (CMOD) and the crack tip opening displacement (CTOD). To obtain the complete load-deflection curve (P-CMOD), the test rate was fixed at 0.2 mm/min, and it took approximately 30 min to complete a single test of specimen. The initial curves of P-CMOD were obtained by the first splitting, and then the split specimens were repaired with epoxy. RSW-1~ RSW-6 designates the repaired prisms.

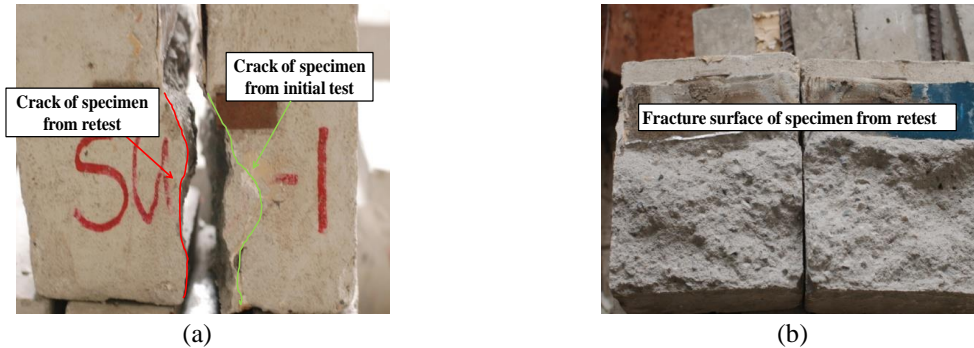
Fig. 2 Fracture locations of specimens in initial test and re-testing: (a) cracks location of specimen, (b) fractural surface of specimen

After curing for 7 days, the repaired prisms were split again. Fig. 2 shows the fracture locations of specimens in initial and re-splitting tests. In the re-testing, cracks of all 6 prisms initiated and propagated in new ways. No repaired crack was opened again. Fig. 3 shows the variation of P-CMOD curves. Comparison of P-CMOD curves shows that the peak loads and embraced area of repaired specimens are both higher than that of initial ones, which indicates the improvement in load bearing capacity and fracture energy of the repaired specimens.

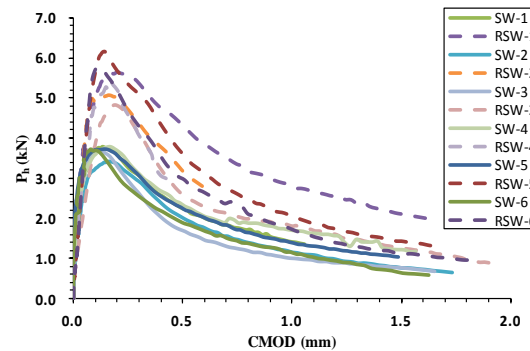
Fig. 3 P-CMOD curves of specimens from initial test and re-testing

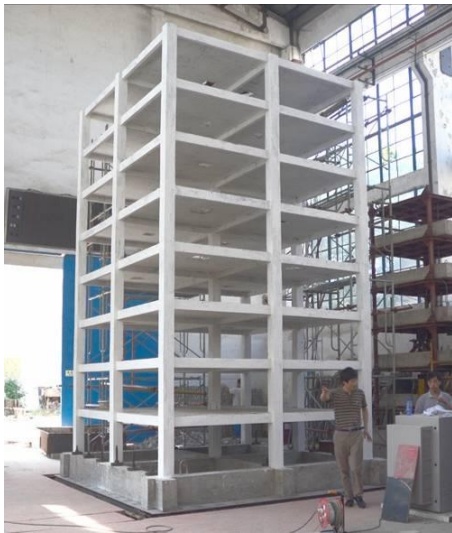
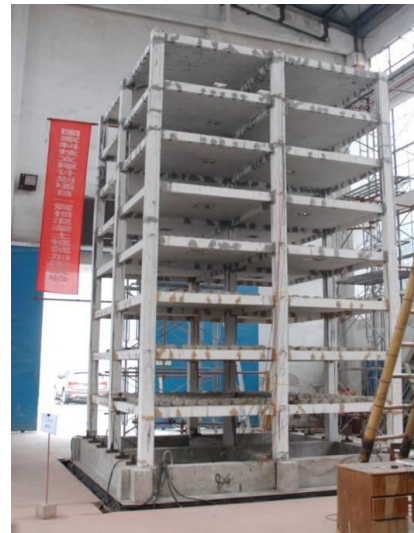
Fig. 4 Facade view of initial model frame and repaired model frame: a) the initial model frame, b) the repaired model frame

A 1/4-scale two-bay eight-story RC frame was constructed for shaking table test. Table 3 lists the similarity coefficient of model. The frame was 3.4 m×3.4 m in plan and had a constant storey height of 0.75 m. The cross sections of column and beam were uniformly 150 mm×150 mm and 125 mm×50 mm, respectively. The specifications of rebar engaged in construction were #10, #12, #14, #16 and #20, of which the diameters were 3.50 mm, 2.77 mm, 2.11 mm, 1.60 mm and 0.90 mm respectively. The thickness of slabs was 30 mm. A general view of the frame along with details of the general geometry, element sections and corresponding reinforcement are shown in Fig. 4 and Fig. 5. Model concrete, with a ratio of 0.76:1:4.58:1.69 was made of recycled aggregate

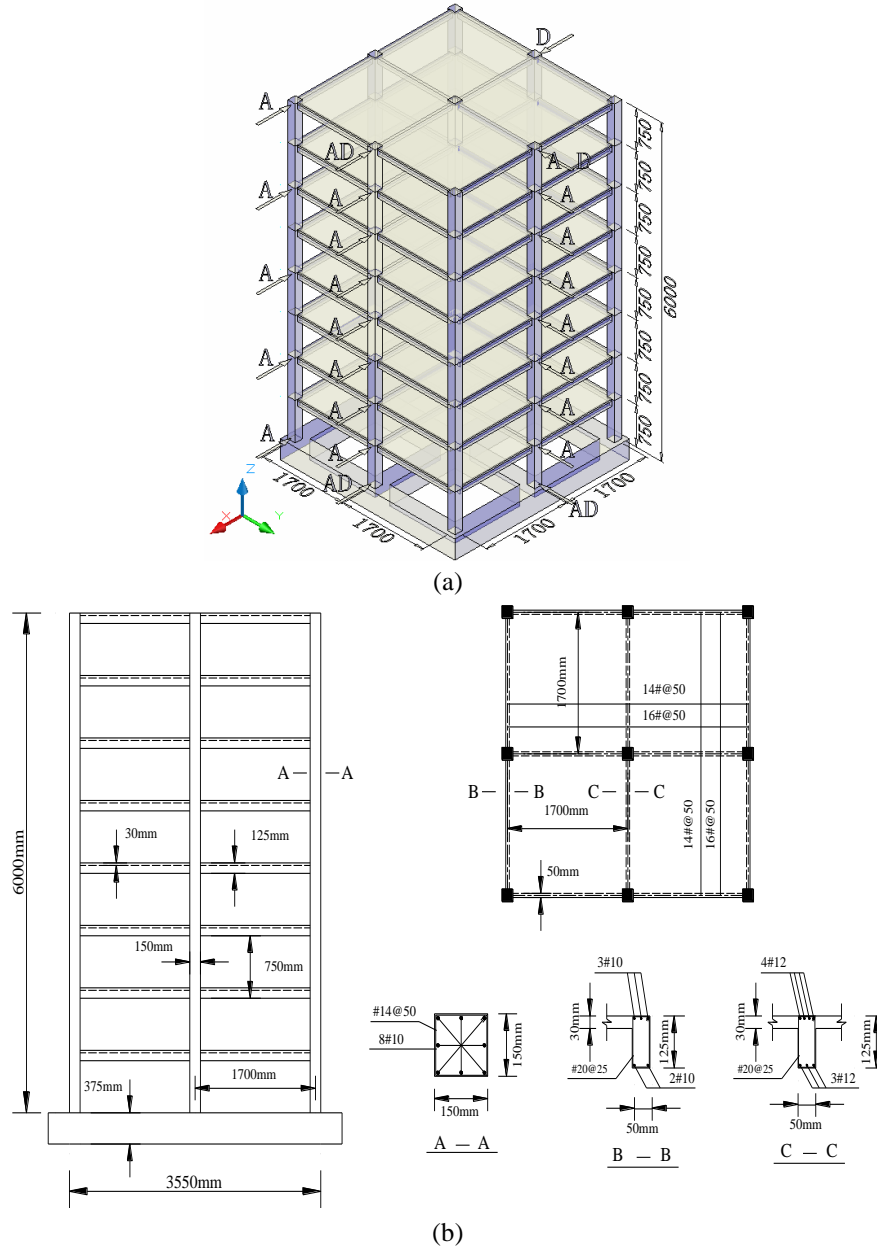
Fig. 5 The layout of displacement & acceleration transducers and framework model: (a) sensors distribution, (b) element sections and corresponding reinforcement

The shaking table test was conducted in the State Key Laboratory for Disaster Reduction in Civil Engineering at Tongji University. Totally 12 displacement transducers (designated by capital letter *D*) and 28 accelerometers (designated by capital letter *A*) were installed to measure the lateral displacement and acceleration, as shown in Fig. 5. Accelerometers were set on the external-middle joints in both *X* and *Y* directions at each floor, as well as in both *X* (on the corner columns) and *Z* directions at every two floor, i.e., the ground floor, 2nd floor, 4th floor, 6th floor and 8th floor. Displacement transducers were set at the ground floor and roof floor in both *X* and *Y* directions to measure the absolute displacement. 8 displacement transducers were placed at beam ends at the 2nd floor to measure the angular rotations near joints.

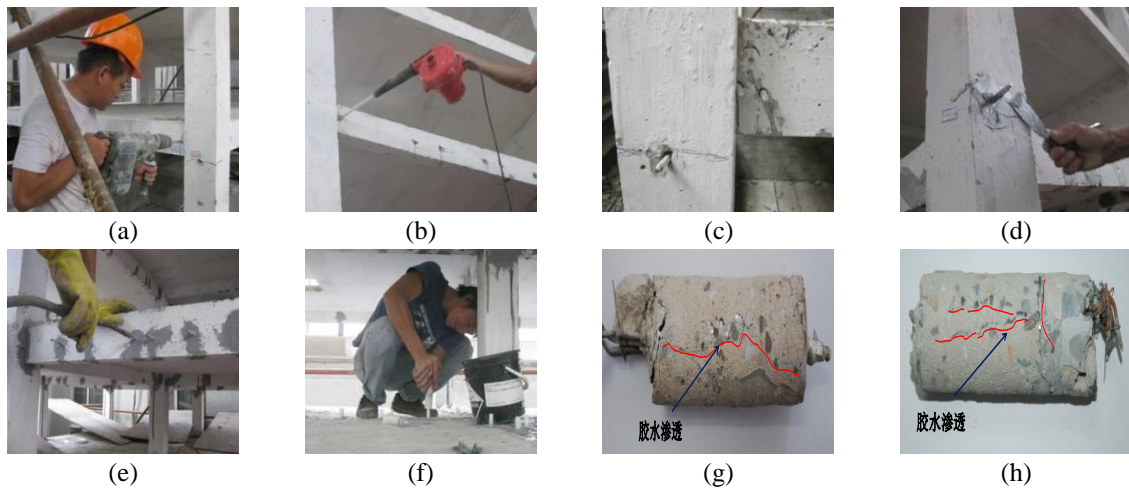
Fig. 6 Process of epoxy-injection technique and concrete samples: (a) hole drilling, (b) hole cleaning, (c) pipe installation, (d) crack surface sealing, (e) pressure injecting, (f) slab crack injecting, (g)~(h) core drilled from the repaired concrete

According to the guidelines of Chinese Code (GB50367-2006 2006), a crack whose width is smaller than 0.2 mm is recommended to be sealed from the outside rather than injection. In actual practice of China, crack injection is generally implemented with syringe pistons forced by elongated rubber bands, which can only provide low pressure when injecting. To guarantee the repairing effect, we decided to repair all the visual cracks with high pressure. A special injection machine was adopted to ensure quality. Fig. 6 presents the main procedures of injection, a) drill small holes perpendicular into the cracking concrete; b) clean dusts and particles from holes with a blower; c) plant steel pipes into drilled holes as inlets of epoxy; d) seal the surface of crack with XH111 Normal A/B, except for steel pipe inlet and outlet for air to escape from inner voids; e) pump epoxy through steel pipe under a specified pressure of 2.4 N/mm^2 . This value was designed to make sure a sound filling and at the same time avoid a undesired concrete fracture induced by overpressure. Fig. 6(g)~(h) shows the cores (diameter=60 mm) drilled from repaired concrete. Red lines in Fig. 6(g)~(h) highlighting the filling tracks of epoxy exhibit the desirable effect of such injection technique. Due to the limited thickness of slab (only 40 mm), the conventional method, syringe piston attached with elongated rubber bands is chosen for injection, as shown in Fig. 6(f).

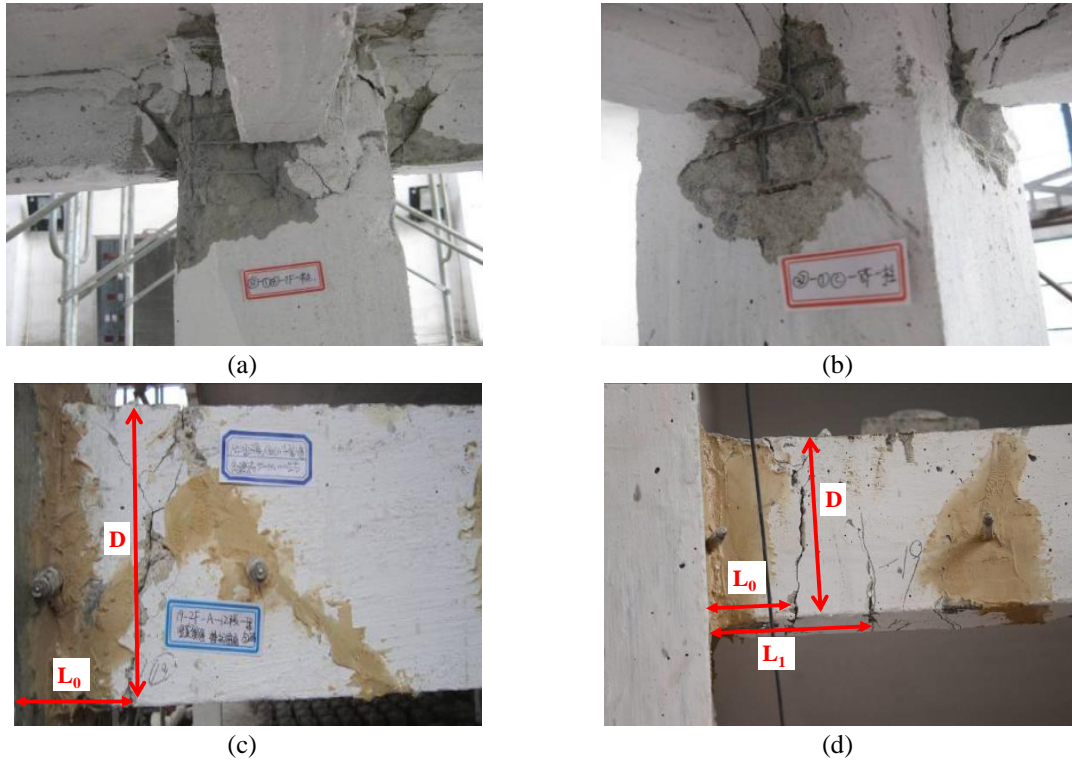
Fig. 7 Comparison of the failure of models in the initial test and re-testing: (a)~(b) Joints damage of the model in initial test, (c)~(d) Joints damage of the model in re-testing (D denotes the height of beam; L_0 and L_1 denote the distance between the new cracks and the column respectively)

Repaired model exhibited the following difference from the original one in failure pattern: 1) all cracks occurred in new regions (without exception), No repaired crack was opened again in re-testing; 2) failure mode was changed from joint failure to beam end failure and the distance between new crack and juncture of beam and column was at the range of 0.5 to 1 times of beam height, shown in Fig. 7; 3) compared with that in the initial test, the beams of repaired frame damaged more severely in lower floors, but possessed much less amount of cracks at upper floors. The damage level of columns in repaired frame was similar to the initial in lower floors. In upper stories, few cracks were found on the surface of column.

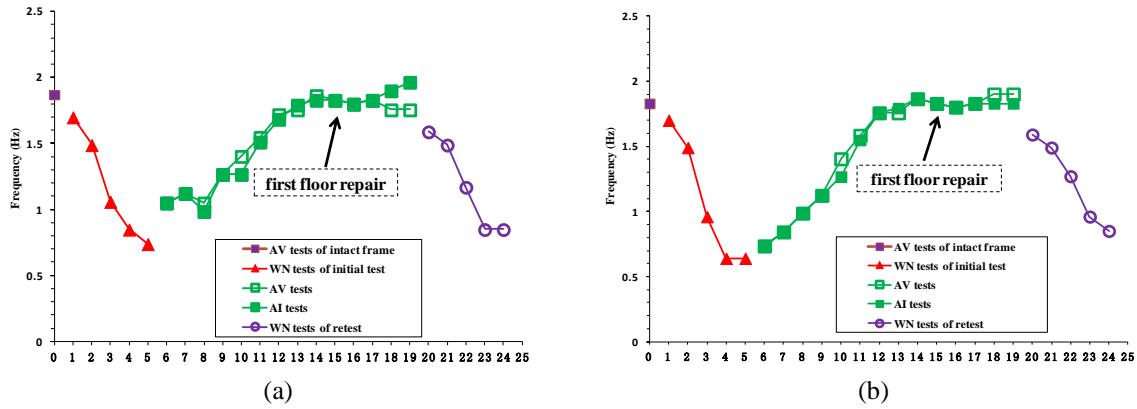
Fig. 8 Variation of the natural frequency: (a) X-direction, (b) Y-direction

It is very evident in Fig. 8 that there are progressive frequency reductions in double shaking table tests and progressive restoration in repairing process. Fig. 9 demonstrates the opposite variation of damping ratio. Frequency increased gradually and damping ratio decreased gradually when cracks were repaired floor by floor; frequency and damping ratio kept almost constant when slabs were repaired. In general, the cracks repairing cause a increase in frequency of the model in X direction and Y direction respectively up to 77.14% and 151.35%, namely from 1.05 Hz and

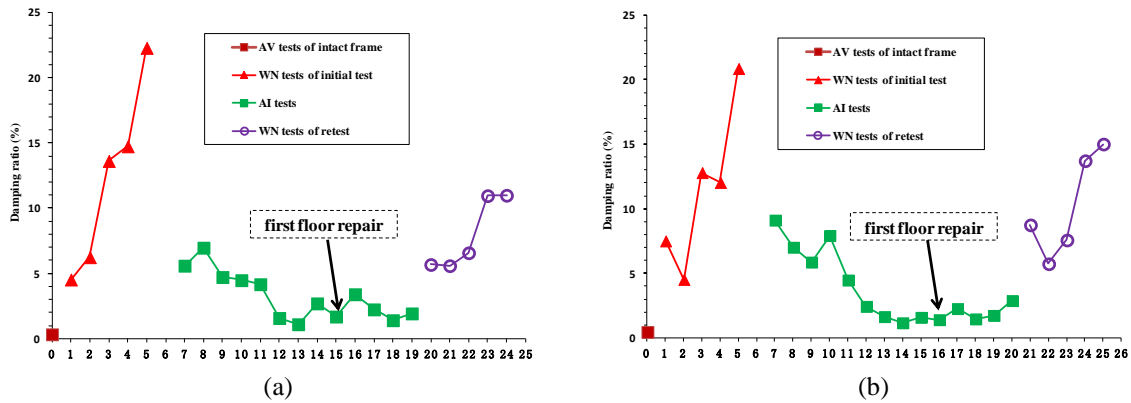
Fig. 9 Variation of damping ratio: (a) X-direction, (b) Y-direction

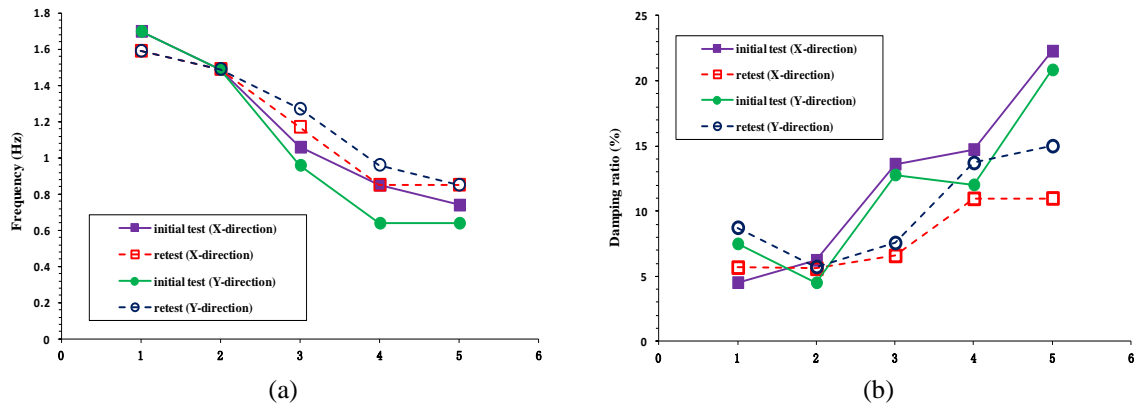
Fig. 10 Comparison of natural frequency and damping ratio from initial test and re-test: (a) frequency comparison, (b) damping ratio comparison

As shown in Fig. 10(a), the natural frequency consistently dropped with the increase of the ground peak acceleration (PGA). Through the whole damage process, the natural frequencies of the initial model in *X* direction and *Y* direction reduced by 56.47% and 62.35%, respectively, while that of the repaired model 46.54% and 46.54%. According to the interdependence of stiffness and frequency, the lateral stiffness decreases as the square of frequency reduction. Thus, it is safe to say the frame was severely damaged after initial test and re-test.

What is worth noting is the varying rate of frequency (Fig. 10(a)) and damping ratio (Fig. 10(b)) in the period of initial test and re-testing. Through repairing, frame recovered its natural frequency. But after the excitation of WN1 in re-testing, the frequency dropped to 1.59 Hz, a little lower than 1.70 Hz in initial test. After that, frequency of repaired frame decreases obviously slower. In the test of WN5 in re-testing, the natural frequency 0.85 Hz already exceed those in initial test, which were 0.74 Hz and 0.64 Hz, respectively. The damping ratio of the model increases with the peak value of acceleration inputs. The final damping ratio of initial frame in *X* direction and *Y* direction are respectively 22.29% and 20.85%, while that of the repaired is 10.99% and 15.00% after re-testing. The variation of damping ratio is similar to frequency.

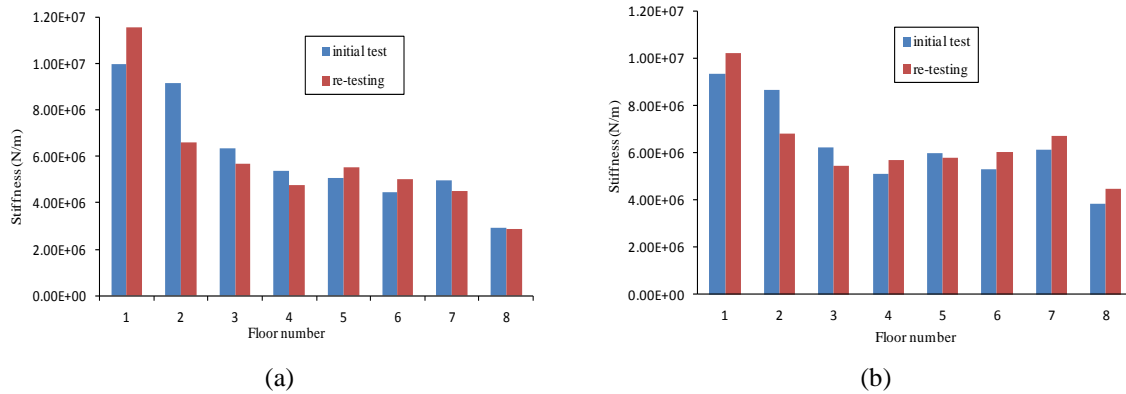
Fig. 11 The inter-story stiffness after loading case 8: (a) X direction, (b) Y direction

with the lower floor. In Fig. 11 and Fig. 12, we can see the decline of stiffness by floors.

Due to the limited space, the comparisons of the inter-storey stiffness with respect to only case 8 (Basic 8) and case 30 (Rare 8.5) are listed in Fig. 11 and Fig. 12. Referring to Table 5, loading case 8 represents a comparatively minor excitation, while case 30 represents much stronger motion inputting. From Fig. 11, at minor vibration stage (loading case 8), there was no apparent difference in inter-story stiffness between the initial test and re-testing. But after the last and also highest-amplitude motion (loading case 30) in Fig. 12, the stiffness of repaired model were obviously higher than that of original model at upper floors. In addition, the ground and second floor of repaired model experienced more serious damage comparing the stiffness with the original one. These variations were in fact consistent with the observed results listed Table 7. Frequency detected by WN tests shown the same trend.

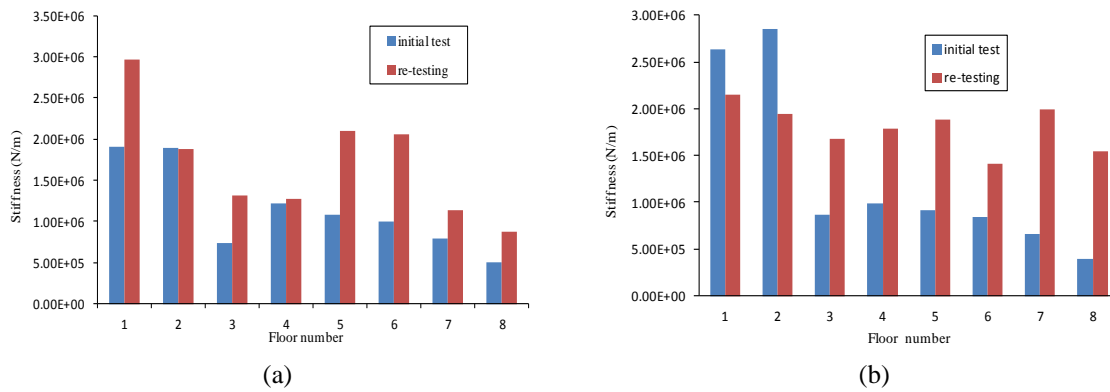
Fig. 12 The inter-story story stiffness after loading case 30: (a) X direction, (b) Y direction

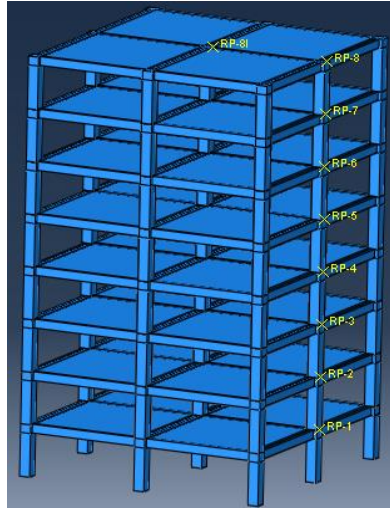
Fig. 13 ABAQUS model

The first step of simulation was to establish a benchmark FE model at undamaged state, which was used as a reference to quantify damage in the subsequent damage states. In this step, the element property of FE model was defined with data available from tested elastic moduli listed in Table 4. In this way, the frequency of intact frame was obtained by linear perturbation method in ABAQUS, and the initial inter-story stiffness of each floor was predicted.

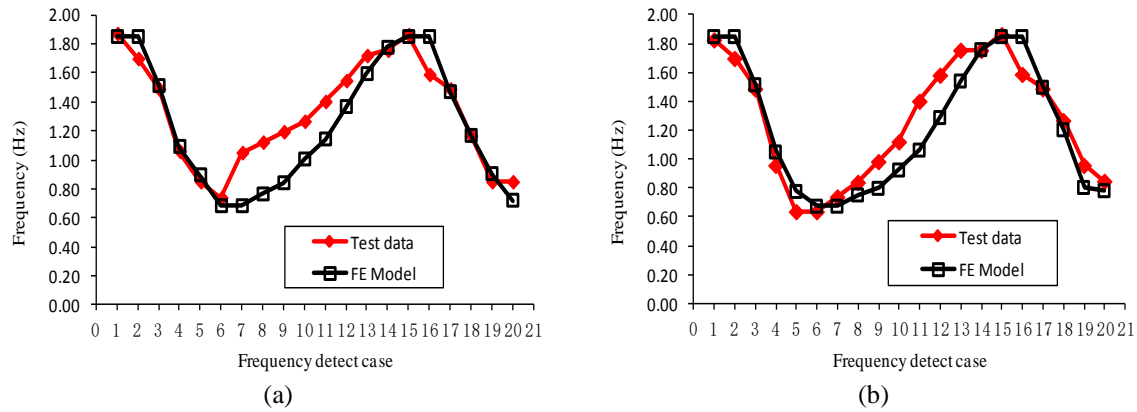
Fig. 14 Comparison of ABAQUS data and test results: (a) X direction, (b) Y direction

right before WN tests. Comparing the inter-story stiffness with the initial undamaged stiffness, stiffness deterioration at each floor was obtained. Using material elastic modulus reduction to reflect stiffness deterioration, we predicted the frequency variation in Phase 1 and Phase 3. In the period of repairing, namely Phase 2, the progressive restoration of inter-story stiffness was simulated by changing the elastic modulus from floor by floor. At the end of repairing, the elastic modulus of each floor was equal to that of benchmark model that meant full-recovery of damage. The progressive restoration of frequency was also listed in Fig. 14.

As shown in Fig. 14, the FE model performed well in simulating the variation of frequency obtained by WN tests, i.e., phase 1 and phase 3. The accurate prediction in frequency verified the reliability of data acquired in the tests, which can infer that the secant stiffness measured from the maximal inter-story drift ratio represents the actual damage state of the RC frame model and can be chosen to serve as lateral inter-story stiffness. However, it should not be ignored that the FE model consistently underestimated the natural frequencies in Phase 2. The gaps between test data and FE prediction can be attributed to the following points:
