# Seismic repair of captive-column damage with CFRPs in substandard RC frames

**Abstract.** The effectiveness of the repair scheme for the damaged captive-columns with CFRPs (Carbon Fiber Reinforced Polymer) was investigated in terms of response quantities such as strength, ductility, dissipated energy and stiffness degradation. Two 1/3 scale, one-story one-bay RC (Reinforced Concrete) frames were designed to represent the substandard RC buildings in Turkish building stock. The first one, which is the reference specimen, is the bare frame without infill wall. Partial infill wall with opening was constructed between the columns of the second frame and this caused captive column defect. Severe damage was observed with the concentration of shear cracks in the second specimen columns. Then, the damaged members were repaired by CFRP wrapping and retested. For the three test series, similar reversed cyclic lateral displacement under combined effect of axial load was applied to the top of the columns. Overall response of the bare frame was dominated by flexural cracks. Brittle type of shear failure in the column top ends was observed in the specimen with partial infill wall. It was obser

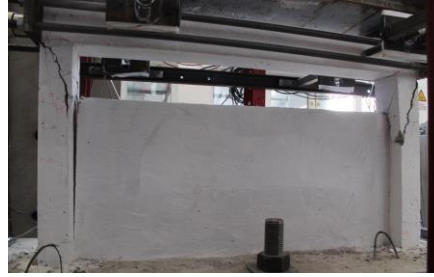
Fig. 2 Excessive shear cracks on the captive columns before repairing (CFRPE\_02)

Depending on several constraints such as cost, applicability, workmanship, etc., certain techniques can be applied for repairing the damaged structural members. Based on the previous studies, it was decided to wrap the damaged captive columns by CFRP sheets, which was proved to be one of the effective techniques for retrofitting and repairing. Fayyadh and Razak (2014) described the advantages of CFRP as high tensile strength, low weight, and low installation cost. Accordingly, CFRP sheets were used to upgrade the seismic performance of repaired specimen in terms of stiffness, strength and energy dissipating capacity. After the occurrence of severe damage due to the shear cracks in the captive columns under the reversed cyclic lateral displacement, repairing procedure was applied to the CFRPE\_02 specimen (Fig. 2).

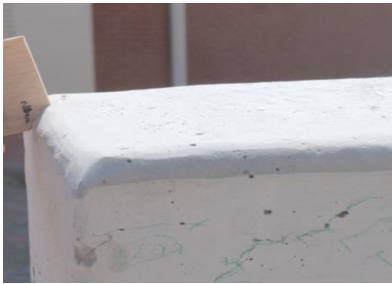
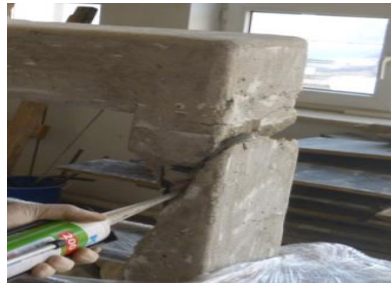
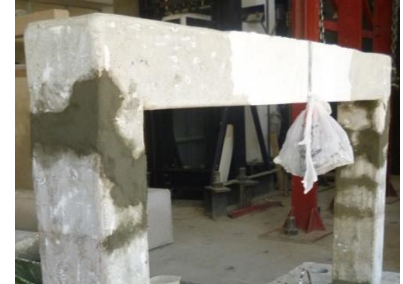
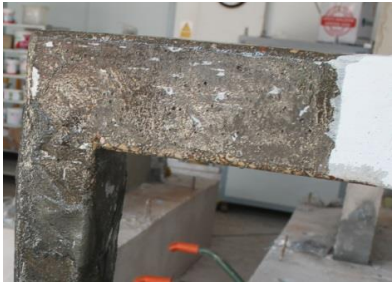
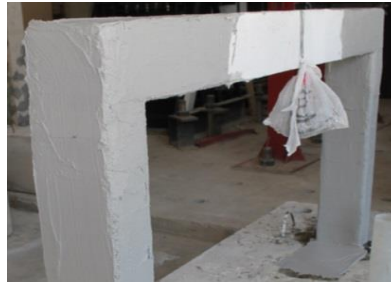
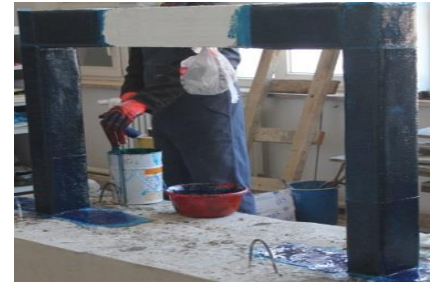
(a) Rounding corners

(b) Injecting chemical anchorage

(c) Applying repair mortar

(d) Applying primer epoxy coater

(e) Application of epoxy based repair and anchorage mortar

(f) Wrapping CFRP sheets with saturant material

Fig. 3 Repairing procedure for the damaged captive columns

Before the application of CFRP, the corners of the columns and beam members were rounded with a radius of 10 mm to get smooth corners for the RC sections (Fig. 3(a)). Otherwise, sharp corners of the RC sections can cause tearing of CFRP sheets, which can reduce the effectiveness of the repairing technique.

To fill the large shear cracks, observed at the top of the columns, an epoxy acrylate resin called chemical anchorage was injected into the cracks (Fig. 3(b)). The next step of the repairing procedure is the application of repair mortar in the place of spalled concrete (Fig. 3(c)). A primer epoxy coat at around 0.1 mm was used to provide an efficient adhesion between the concrete and epoxy based repair-anchorage mortar (Fig. 3(d)). The last step before the CFRP wrapping is both to cover the repairing parts with an epoxy based repair-anchorage mortar for repairing the wide cracks and to provide certain level of bonding between the repaired specimen and the CFRP sheets (Fig. 3(e)). Finally, the beam and the columns were wrapped by CFRP sheets with an epoxy resin before hardening the repair-anchorage mortar. The resin is used for establishing connection between the

CFRP sheets and the repair-anchorage mortar. Proper application of CFRP increases the flexural and shear capacity of the applied members (Fig. 3(f)).

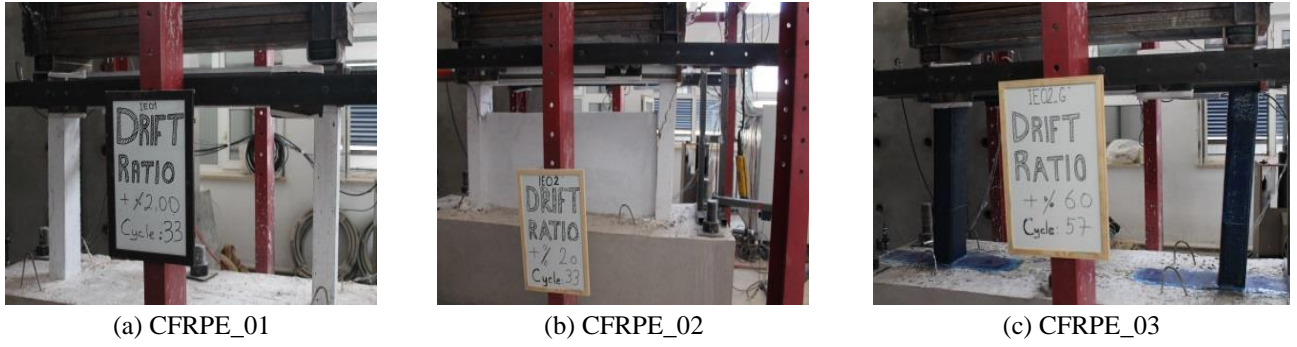
Fig. 7 Damage pattern of the test specimens at 2% drift ratio

The damage pattern of all the test specimens at 2% drift ratio are shown in Fig. 7. Nevertheless, only CFRPE\_01 and CFRPE\_03 specimens can displace up to 6% drift ratio. The views from both specimens are presented in Fig. 8 to demonstrate the damage pattern at the ultimate displacement.

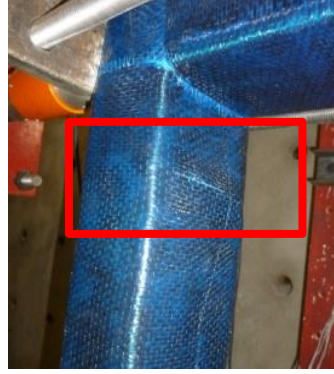
(a) CFRP delamination of column

(b) CFRP swelling

(c) Flexural crack in the beam

Fig. 9 Failure pattern of CFRP

specimen. The first delamination at the interface of the column and joint CFRP sheets in the column initiated at 1.5% drift ratio as seen in Fig. 9(a). In Fig. 9(b) the swelling of CFRP sheets was observed as the drift ratio increased. After the 5% drift ratio, flexural cracks were observed at the middle part of the beam, which was not wrapped with CFRP (Fig. 9(c)). In Fig. 10(c) two sudden decrement of load values were monitored when the target drift ratio was 4% in the negative direction. At that point, a sound similar to the fracture sound was heard. However, the fracture of the CFRP sheets could not be apparently observed from the outer CFRP layers of the repaired specimen.

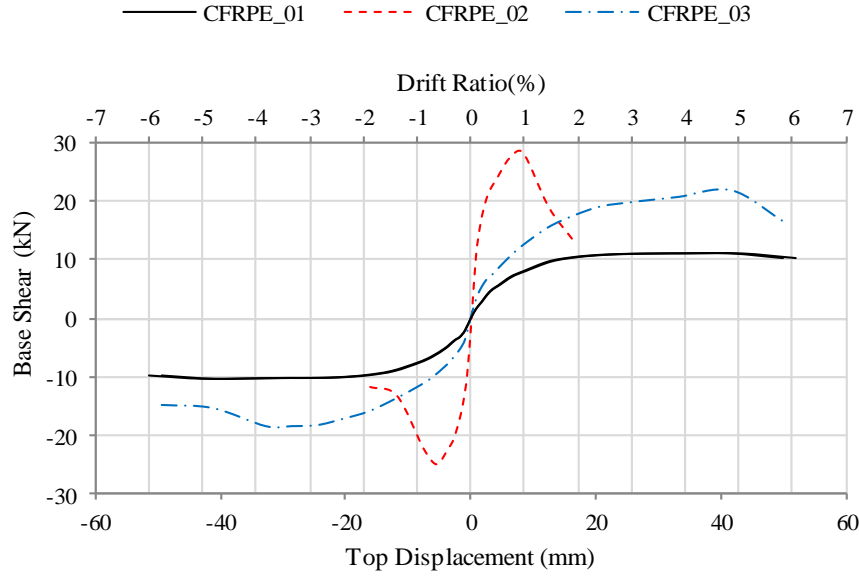
Fig. 11 Envelope curves for hysteretic loops

points at the first peak of each cycle, as seen in Fig. 11. It can be inferred that the strength of the repaired specimen (CFRPE\_03) is greater than the one for reference specimen (CFRPE\_01). However, if the results were compared with the second specimen (CFRPE\_02), the repaired specimen had a 23% lower strength value because of the contribution of partial infill wall in CFRPE\_02. For CFRPE\_01, CFRPE\_02 and CFRPE\_03 specimens, the ultimate strengths were observed at 4%, 1% and 5% drift ratio, respectively. Except for the CFRPE\_02 specimen, the other two specimens can be displaced up to the test displacement limits. Nevertheless, the second test had to be finalized at 2% drift ratio due to safety concerns.

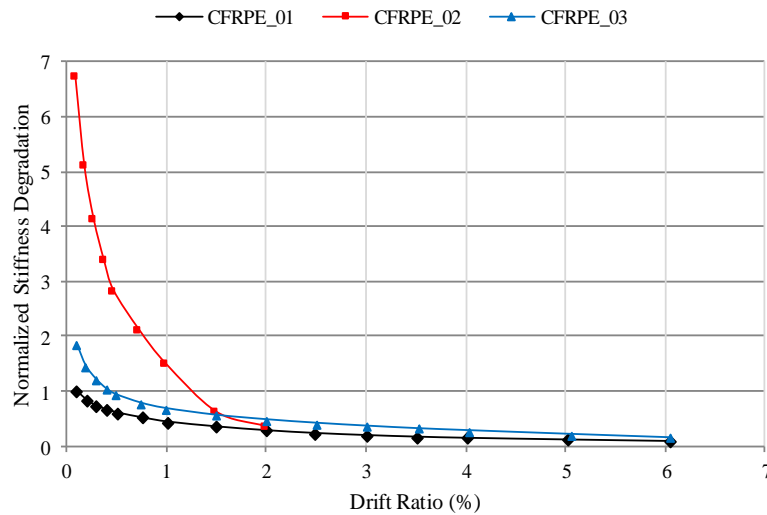
Fig. 12 Stiffness degradation

As the lateral displacement increased, lateral stiffness of the test specimens decreased very rapidly due to the formation of cracks and imposed plastic deformations (Fig. 12). The first step of specifying stiffness degradation was to determine the peak-to-peak stiffness for each displacement cycle. Peak-to-peak stiffness was defined as the slope of the line between peak lateral load values corresponding to the displacement value for positive and negative cycles. Then the peak-to-peak stiffness for each cycle was normalized with respect to the one for reference specimen for the first cycle. The normalized peak-to-peak stiffness versus drift ratio curves are shown in Fig. 12. As it can be observed from Fig. 12, CFRPE\_02 specimen has the highest initial stiffness value due to the lateral rigidity of the partial infill wall for the first cycle, and also a rapid reduction in stiffness is observed in this specimen. CFRPE\_03 specimen

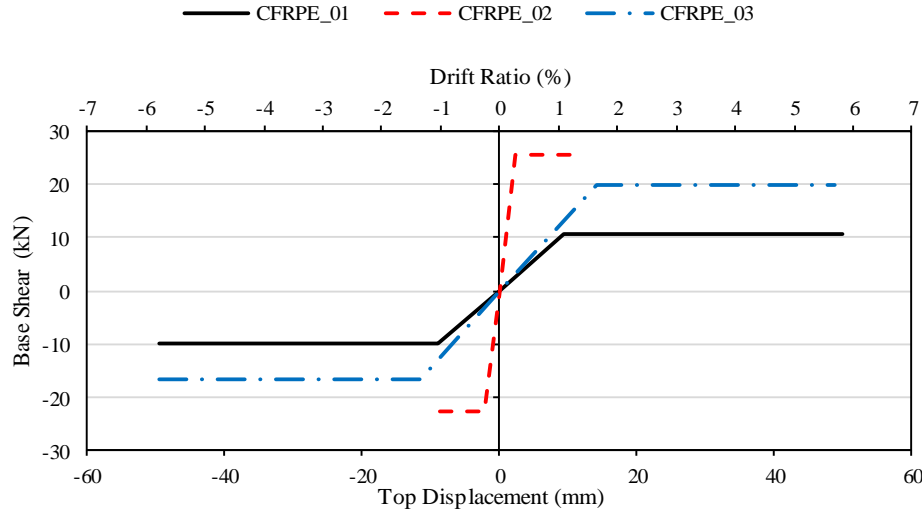
Fig. 13 Idealized bi-linear representation of the envelope curves

Park (1989) calculated the yield displacement and the ductility of a frame with an idealized elasto-plastic load-displacement relation. Fig. 13 represents the idealized bi-linear form of envelope curves for all test specimens. The inclined part of the graphs represents the equivalent initial stiffness of the RC frames. According to FEMA 356 (2000), equivalent initial stiffness is defined as the slope of a line connecting the origin and the point that corresponds to the 60% of the ultimate load on the increasing part of the envelope curve. The post-yield region of the graph was extended up to the displacement value at which the lateral load reduces to 80% of the ultimate load on the descending part of the envelope curve. In order to specify the yield point, an iterative procedure was employed such that the areas under the idealized bi-linear and envelope curve are equal to each other.

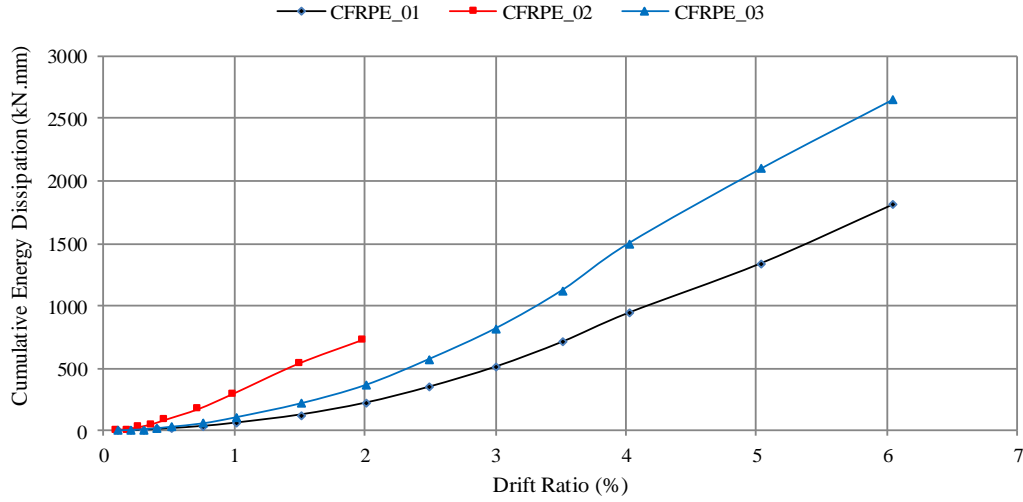
Fig. 14 Cumulative energy dissipation capacity of the tested specimens

loops. The cumulative energy dissipation was calculated by the summation of the areas of the hysteretic loops up to the corresponding drift ratios. Fig. 14 presents the relation between cumulative energy dissipation vs. drift ratio of the specimens. At 2% drift ratio, CFRPE\_02 specimen has the greatest dissipated energy capacity and the remaining specimens have almost similar capacities. When Fig. 14 is examined for 6% drift ratio, it can be concluded that the repaired specimen has more energy dissipation capacity than the reference specimen.
