## Effectiveness of seismic repairing stages with CFRPs on the seismic performance of damaged RC frames

**Abstract.** This study aims at evaluating the performance of repairing technique with CFRPs in recovering cyclic performance of damaged columns in flexure in terms of structural response parameters such as strength, dissipated energy, stiffness degradation. A 2/3 scaled substandard reinforced concrete frame was constructed to represent the substandard RC buildings especially in developing countries. These substandard buildings have several structural deficiencies such as strong beam-weak column phenomenon, improper reinforcement detailing and poor material properties. Flexural plastic hinges occurred at the columns ends after testing the substandard specimen under both constant axial load and reversed cyclic lateral loading. Afterwards, the damaged columns were externally wrapped with CFRP sheets both in transverse and longitudinal directions and then retested under the same loading protocol. In addition, ambient vibration measurements were taken from the undamaged, damaged and the repaired specimens at each structural repair steps to identify the effectiveness of each repairi

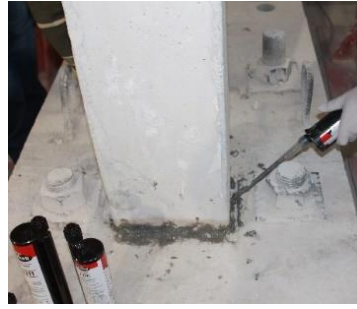
Fig. 4 Repairing procedure for the damaged columns

The entire repairing procedure took almost 11 days to conduct the experimental test and involved a total of six steps. In the first step, the column and beam surfaces smoothed and corners were rounded to prevent stress concentrations at sharp edges and to avoid a premature rupture of CFRP sheets. Then, the chemical anchorage was injected to several holes drilled at the plastic hinge zones to

fill the cracks. Then primer epoxy coat was applied on the concrete surface of columns to achieve an efficient adhesive between the concrete and epoxy-based repair and anchorage mortar. A total of seven days were waited for hardening process of epoxy coat according to the catalogue. Afterward, the epoxy-based repair and anchorage mortar was applied to the column surfaces with a thickness of 2-3 mm to repair cracks in addition to providing certain degree of bonding between the CFRP sheets and repaired specimens. Before hardening the epoxy-based mortar, firstly the longitudinal CFRP sheets were placed on the two faces of columns by extending over the foundation and beams to provide sufficient bonding. The transverse CFRP sheets were then placed at the top and bottom ends of columns for both confining the column ends and anchoring the longitudinal CFRPs. Before and after placing the CFRP sheets on the surface of the columns, epoxy resin was applied both on the concrete surface and CFRP sheets. Epoxy resin also increases the flexural and shear capacity of the applied members. All these repairing procedures are presented visually in Fig. 4.

(b) Injecting chemical anchorage

(e) Wrapping CFRP sheets with saturant material

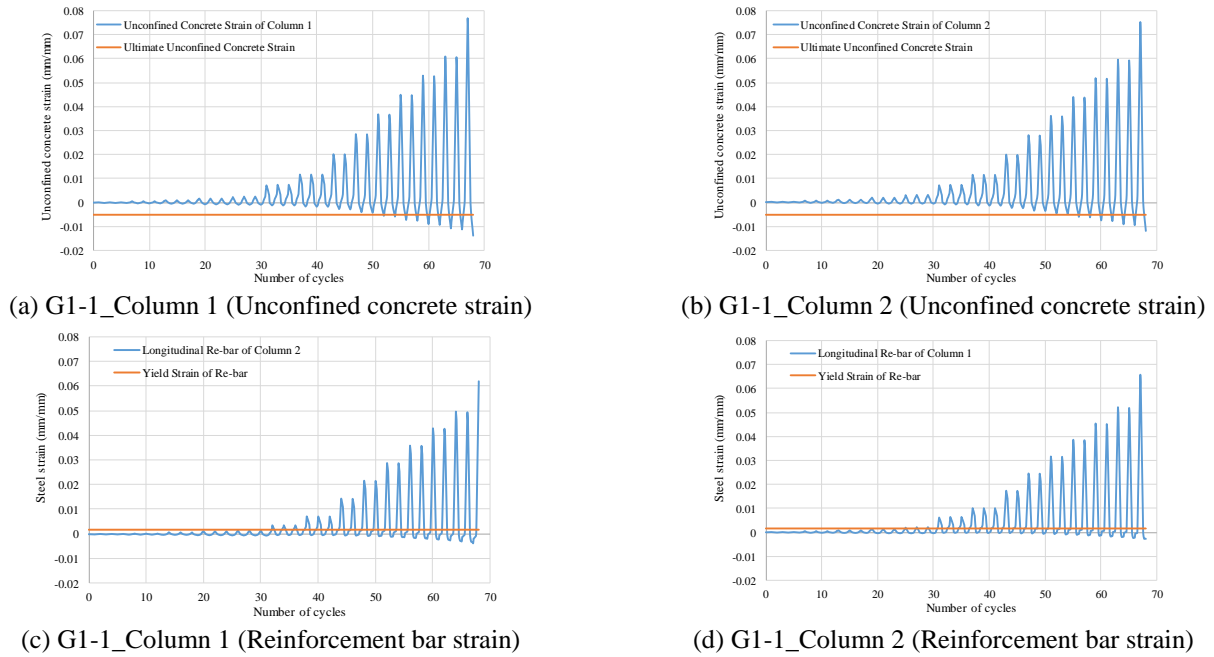
Fig. 13 Variation in material strains

The strain distribution of unconfined concrete and longitudinal reinforcements of columns at the bottom ends are given in Fig. 13. The ultimate strain of unconfined concrete was taken as -0.005 according to the TEC (2007), while the yield strain of the re-bars was determined to be 0.0016, which is the average yield strain obtained from the rebar tension tests shown in Fig. 2(b). Considering below Fig. 13, it is observed that the longitudinal reinforcements were yielded in the first cycles of the test. This observation is in accordance with the flexural cracks at the column ends occurred during the test (Figs. 3 and 17). Whereas, the unconfined concrete at the extreme fiber of the column section reached its ultimate strain value towards the end of

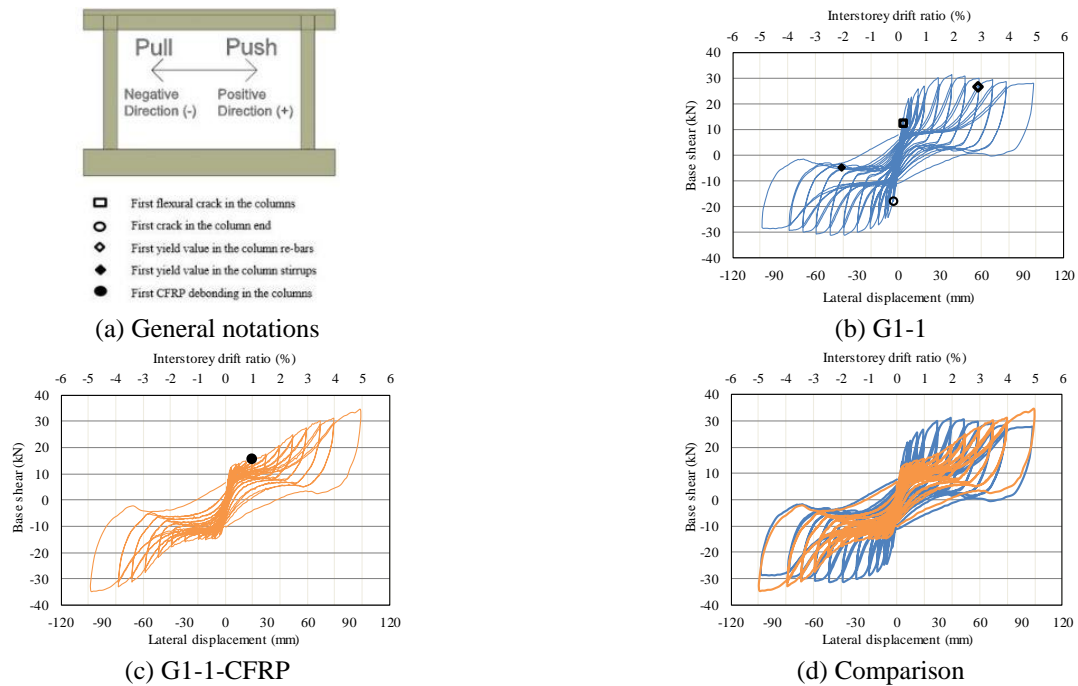
Fig. 14 Hysteretic loops of the specimens

The hysteretic responses of the tested specimens are shown in Fig. 14. It was observed during the test that there was no crack or any damage in the beam. Also, the strain values of reinforcements obtained from strain gauges indicate that any re-bar of the beam member didn't reach the yield value. On the contrary, the longitudinal re-bar and stirrup of column members yielded at +2.93% and -2% drift ratio, respectively. The first flexural crack in the column members formed at +0.2% drift ratio. For the second repaired frame, the CFRP debonding occurred at +1% drift ratio at the column bottom ends.

During the cyclic response, it was observed that after reaching higher drift ratios, the residual lateral load capacity of the damaged specimen was less than 10 kN when the specimen is at its un-deformed position due to the accumulation of damage. The yielding lateral load capacity of the repaired specimen reached to 13 kN, which is almost 50% higher than the residual load capacity of the damaged specimen. Moreover, as the drift ratio increases, both longitudinal and transverse CFRP sheets became effective and the lateral load capacity of the repaired specimen increased up to the value greater than the one for reference specimen. Due to the limitation in the stroke capacity of the hydraulic jack, the tests were ended at 5% drift ratio. However, the increasing trend even at 5% drift ratio in the hysteresis curve of G1-1-CFRP specimen in Fig. 14(c) can be accepted as an indicator for larger displacement capacity.

The hysteretic behavior of the RC frames and some critical failure types at the local level are indicated on the hysteretic curves for the two test specimens (Fig. 14). Envelope curves are obtained by connecting the ultimate lateral load values at the target lateral displacement points at the first peak of each cycle (Fig. 19). The ultimate loads of the reference and repaired specimens are 31.2 kN and 34.5 kN, respectively. After 2% drift ratio, lateral load capacity of G1-1 decreased smoothly to 28.5 kN. On the other hand, the repaired frame continuously increased its lateral load capacity after 0.5% drift ratio.

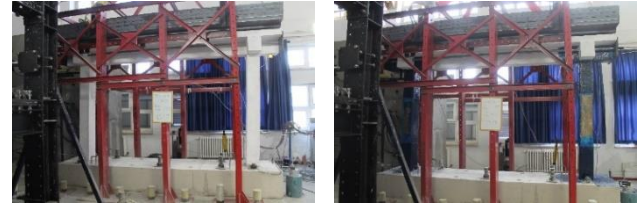
Fig. 15 Damage pattern of the tested specimens at +2% drift

Damage pattern of the tested specimens are shown in Figs. 15 and 16. Both reference and repaired frame was tested up to 5% inter-storey drift ratio and the views from the critical drift ratio limits are shown in the following figures.

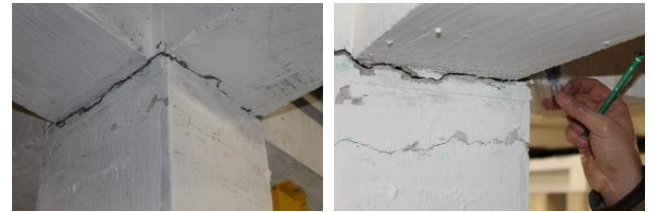
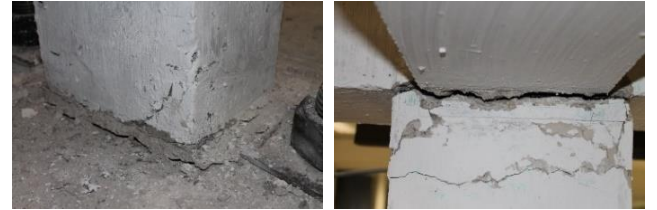
Fig. 17 Critical damage views of the G1-1

(a) Column end cracks at -2% drift ratio

(b) Increased crack width at -3% drift ratio

(c) Column bottom end at +3.5% drift ratio

(d) Plastic hinge at the column top end at 5% drift ratio

Based on the design principles of the RC frame, where the plastic moment capacity of T-sectioned beam is larger than the column members, beam member had no crack or visible damage in contrast to column members. As can be seen in Fig. 17, the column ends were exposed to severe damage and formation of plastic hinges was clearly observed as the lateral displacement progress.

The first frame has large cracks at the column ends due to bending moment. After observing first bending crack at +0.2% drift ratio, the width of the cracks increased and new cracks occurred almost 10 cm away from the column top ends that is almost equal to the plastic hinge length of the column. The substandard reinforced concrete frame reached its flexural moment capacity at 2% drift ratio and then the ultimate load decreased smoothly until the end of test. The second frame, which was repaired with CFRP sheets, had first CFRP rupture starting around at 1% drift ratio. Swellings on the CFRP sheets were observed together with CFRP rupture (Fig. 18). The repaired frame had significant separations at the joints when the experiment reached its maximum drift ratio limit. At the ends of column members, the transverse CFRP sheets also worked effectively and swelling in CFRP sheets was observed. It should be also underlined that the plastic hinging is not transferred to the beam due to the fact that the plastic moment capacity of T-shaped beam section is relatively higher than the column sections. Moreover, as shown in Fig. 5, longitudinal CFRP sheets were extended to the beam ends, which also improved the moment capacity of the beam end sections.

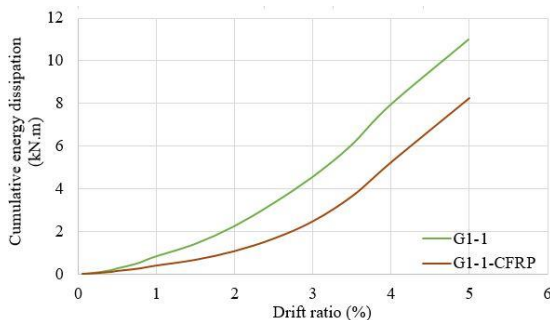
Fig. 21 Cumulative energy dissipation capacity of the tested specimens

The energy dissipation capacity of the tested specimens in each cycle are calculated by considering the area enclosed within the hysteretic loops of frames for the first cycles of displacement protocol (Fig. 21). The cumulative energy dissipation is then calculated by summing up the areas calculated for each loading cycle. The dissipated energy by the reference frame is 33% larger than the repaired frame in general. This difference is due to large crack widths and compression failure of concrete in the column ends occurred after the first testing.
