## Seismic and vibration tests for assessing the effectiveness of GFRP for retrofitting masonry structures

**Abstract.** Full-scale shake table seismic experiments and low-amplitude vibration tests on a masonry building are carried out to assess its seismic performance as well as study the effectiveness of a new multifunctional textile material for retrofitting masonry structures against earthquakes. The un-reinforced and the retrofitted with glass fiber reinforced polymer (GFRP) strips masonry building was subjected to a series of earthquake excitations of increasing magnitude in order to progressively induce various small, moderate and severe levels of damage to the masonry walls. The performance of the original and retrofitted building states is evaluated. Changes in the dynamic characteristics (lowest four modal frequencies and damping ratios) of the building are used to assess and quantify the damage states of the masonry walls. For this, the dynamic modal characteristics of the structure states after each earthquake event were estimated by performing low-amplitude impulse hammer and sine-sweep forced vibration tests. Comparisons between the modal results calculated using tra

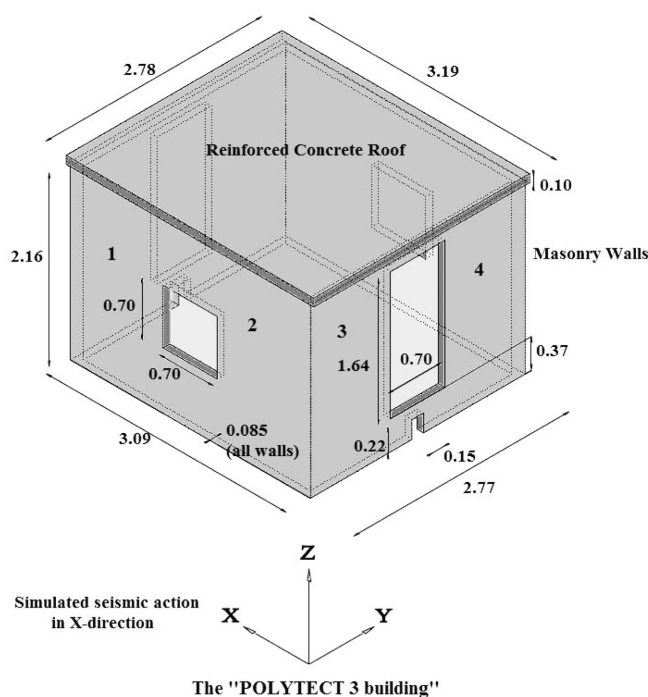
A full-scale single-story (one-room) brick-masonry building is designed and constructed in the laboratory. The un-reinforced single-room brick building is representative of a portion of the build inventory, particularly in the Greek countryside. The single-room building is used in this study since it simulates actual conditions at the sides of the masonry walls, wall continuity and large wall openings from doors and windows. The geometry of the masonry structure is shown in Fig. 1. The masonry structure consists of four single masonry brick walls with two opposite doors and windows, and a reinforced concrete roof. The four walls of the masonry building are anchored on the shake table using the mortar to assemble the bottom face of the clay bricks of each side wall with the shake table surface. This connection was used to simulate the actual anchoring conditions of common (old) masonry buildings to their foundation. The top view dimensions are 3.19 m parallel to the X-axis and 2.78 m parallel to the Y-axis. The structure height is 2.26 m (including 10 cm concrete roof thickness). The door's width and height is 0.70 m and 1.64 m, respectively and it is placed on the center of the two opposite wall's width. The window's width and height is 0.70 m and 0.70 m, respectively and it is placed on the center of the other two opposite wall's width. The layout of the door and window openings results in a symmetric building, avoiding eccentricities as much as possible. This symmetry was purposely introduced to reduce the number of dominant factors (material, mortar-brick, connections, large openings) that affect building behavior without compromising the value of this study since all other masonry building characteristics are maintained. All the surrounding walls are 8.5 cm thick, determined by the width dimension of the bricks.

Fig. 1 Geometric of masonry building

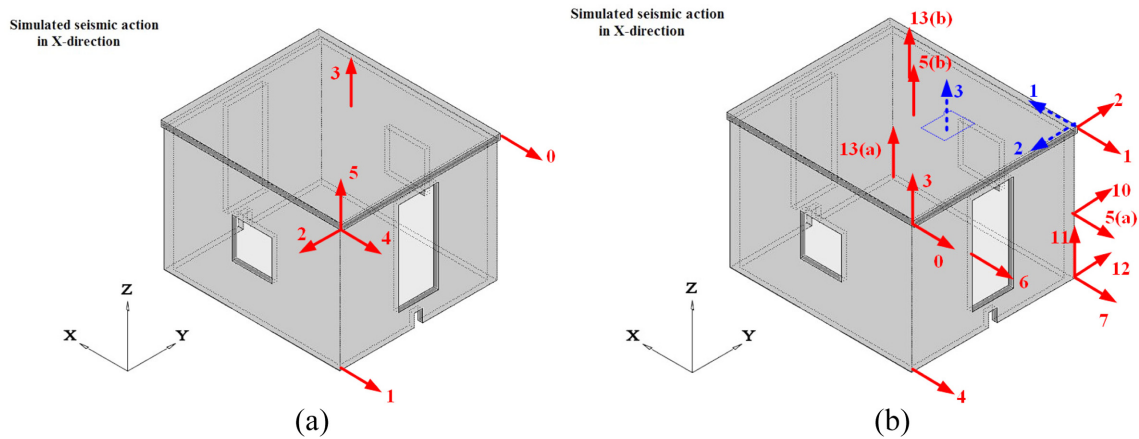
Fig. 2 Sensor configurations (solid arrows) and hammer impact points (blue-broken arrows) on the masonry structure, (a) un-reinforced building and (b) reinforced building

2(a) during the series of tests conducted for the un-reinforced masonry structure. Twelve (12) sensors were placed on the structure as shown in Fig. 2(b) during the series of tests conducted for the reinforced masonry structure. For the reinforced structure, three different sensor configurations were employed based on the series of tests conducted and the experience gained from previous tests on similar reinforced masonry structures.

As many as twelve (12) uni-axial accelerometers, six (6) piezo beam and six (6) K-beam capacitive accelerometers, were mounted on the shake table and the structure in order to record the severity of the seismic excitation and the vibration levels experienced by the structure along all three directions, as well as to identify the structural modal characteristics from low-amplitude vibration tests. The sensor locations along with the monitoring directions are shown in Fig. 2. The sensor configurations depend on the series of the two tests conducted on the un-reinforced and reinforced masonry building. Only six (6) sensors were placed on the structure as shown in Fig.

After each earthquake event, a total of 6 impulse hammer tests were conducted. The impact force was inflicted along the two horizontal directions and one vertical direction in order to excite all lower important modes of the structure. The impact points and directions are shown in Fig. 2(b) with blue (broken) arrows. Two independent tests per each excitation direction were performed. Each impulse hammer test lasted only a few seconds allowing to speed up considerably the whole procedure of acquiring data from the structure.

The un-reinforced building was instrumented with six (6) sensors shown in Fig. 2(a) for all low amplitude post-seismic vibration tests. During the first four (4) seismic tests (1<sup>st</sup>, 2<sup>nd</sup>, 3<sup>rd</sup>, and 4<sup>th</sup>), the reinforced building was instrumented with 10 accelerometer sensors (sensors 0, 1, 2, 3, 4, 5, 10, 11, 12 and 13 in Fig. 2(b)). During the 5<sup>th</sup>, 6<sup>th</sup> and 7<sup>th</sup> seismic tests the building was instrumented with 12 accelerometers. Acceleration sensors were added at positions 6 and 7 in Fig. 2(b) and the sensors 5(a) and 13(a) in the set up shown in Fig. 2(b) were re-positioned (at locations 5(b) and 13(b) in Fig. 2(b)) on the roof of the building as shown in Fig. 2(b). This sensor relocation was necessary in order to monitor the *z*-direction and take more accurate measurements of the out-of-plane mode of the concrete roof where strong motion was detected. During the final six (6) seismic

events (8<sup>th</sup> to 13<sup>th</sup> events) the building was again instrumented with 12 accelerometers. The location of sensor 13(b) in sensor configuration shown in Fig. 2(b) was changed to its original location 13(a). In addition, for all the 13 tests of the reinforced building, 8 FBG sensors were also installed in the GFRP, having the configuration shown in Fig. 3(a).

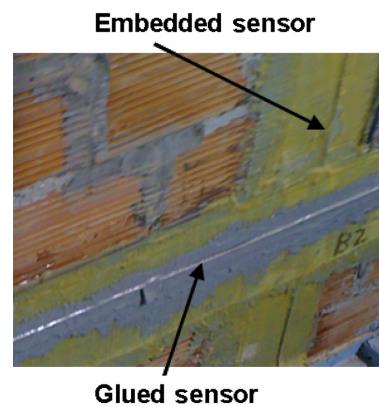
Fig. 4 Detail on FBG sensors glued and embedded on the reinforced building

from 1 to 1.5 m, according to the prediction of the strain-stress field distribution as calculated from FE models. The continuous lines in Fig. 3(a) represent sensors which were externally glued to the textile (due to the absence of cables embedded into the textile in the chosen location), while the dashed lines sensors represent sensors which were embedded into the FRP. A picture of the detail for glued and embedded strain sensors is shown in Fig. 4.

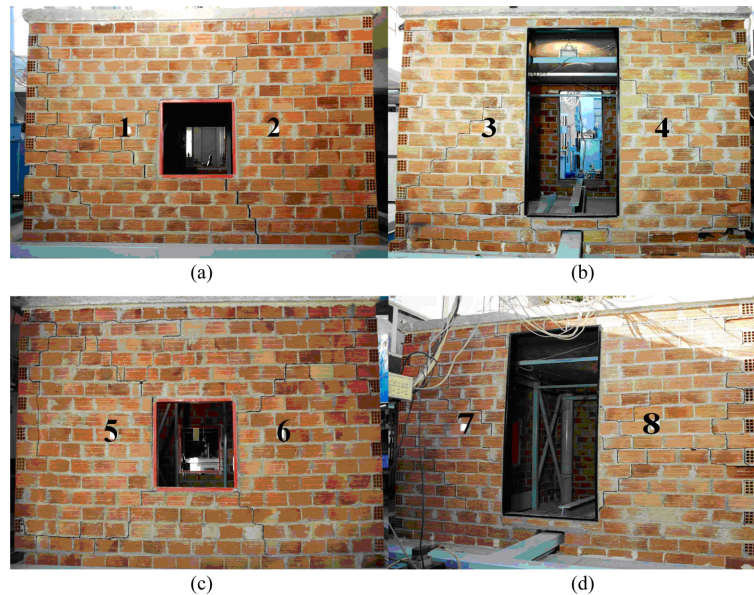
Fig. 6 The sides of the masonry building damaged after the application of the sixth seismic event

The un-reinforced masonry building sustained the first five seismic events without suffering any serious visible damage. The last seismic event, which was theoretically intensified almost 8 times the original seismic event, heavily damaged the building with large crack openings developed along the walls and propagated mainly through the mortar. The four sides of the masonry building after the application of the sixth seismic event are shown in Fig. 6. A schematic diagram of the patterns of the major crack developed on the two sides of the walls that were instrumented by FBG is shown in Fig. 3(b). Based on visual inspection, the sixth seismic event generated shear failure of many bricks and mortar, diagonal cracking on the walls, extensive flexural faults and measurable shear sliding in the walls 1, 2, 5 and 6. Larger crack openings were observed on the two sides of the wall with the window openings that extend along the direction of motion. The other two sides of the building walls, with the door openings that extend along the perpendicular direction of motion, also sustained serious damage. All the walls were damaged but it seems that the in-plane shearing (walls 1-2 and 5-6) produced more damage than the out of plane loading (walls 3-4 and 7-8). Overall, during the action of the sixth seismic event, the masonry building sustained serious visual damage, with the walls losing their structural integrity and posing increased threat to occupants due to high risk of collapse to future seismic excitations.

From the results in Figs. 9(a) and (c), one clearly observes that earthquake shaking damages internally the structure causing a stiffness degradation, manifested as a reduction in the values of the modal frequencies. As the intensity of the earthquake event increases the values of all four modal frequencies reduce. However, for the first five seismic events no visible cracking in the masonry walls was evident for the case of the un-reinforced masonry structure. The small reduction of the modal frequencies observed is an indication of internal damage caused by non-visible micro cracking in the mortar and the interface between the mortar and the bricks. A large reduction in the modal frequency is observed after the sixth earthquake event which is due to significant stiffness deterioration caused by the severe damage in the masonry walls. As mentioned before, under the action of the sixth seismic event all four masonry walls sustained large crack openings, shown in Fig. 6.

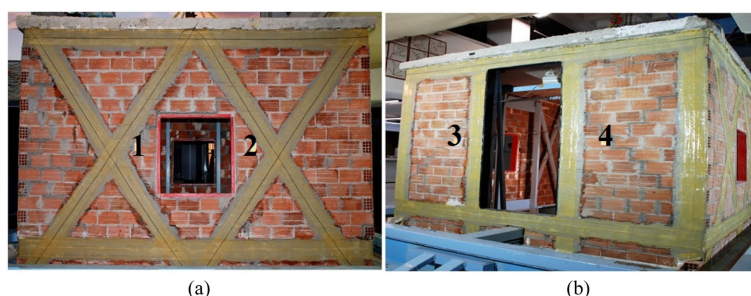
Fig. 7 A picture of the repaired masonry building with reinforced GFRP strips: (a) sides 1-2 and (b) sides 3-4

The repairing design consists also of external reinforcement by bonding peripherically, tensioned glass fibre thermoplastic strips, with spacing in agreement with the CNR-DT/2004 guidelines (CNR-DT 200/2004). Specifically, after the repair work was completed, the masonry walls were reinforced by GFRP strips against out-of-plane and in-plane loading, according to the CNR-DT/2004 guide. The results from FE analyses were also used as guidance for placing the GFRP strips. Fig. 7 show the GFRP strip reinforcement along the masonry building walls 1-2 and 3-4. Exactly the same reinforcement patterns were applied along the masonry building walls 5-6 and 7-8. The GFRP strips are 150 mm wide, 3 mm thick and have 4 kN tensile strength.

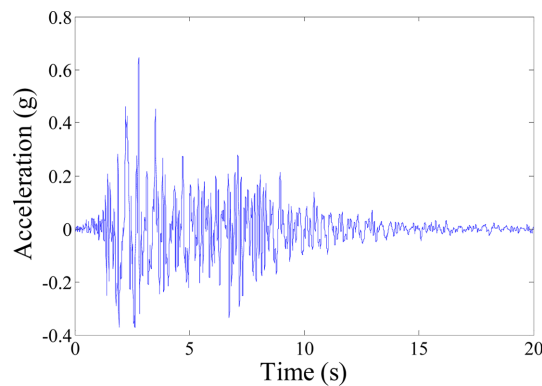
Fig. 8 2009 W-E component of L' Aquila earthquake shaking

A new series of earthquake excitation tests were conducted on the retrofitted building by scaling the intensity and time of the 2009 L' Aquila W-E earthquake accelerogram, shown in Fig. 8. This particular record from the destructive L' Aquila earthquake event was made available after the test campaign on the un-reinforced masonry building. It is more representative of the strong motion expected in parts of the Mediterranean region as opposed to the ground motions predicted by the artificial accelerogram shown in Fig. 5(a). For the purpose of our present study that concentrates on damage evaluation based on the dynamic characteristics of un-reinforced and reinforced masonry, the use of the L' Aquila record does not qualitatively influence the respective results and conclusions. Thirteen (13) seismic excitation events were included in the new series of tests. The thirteen excitations correspond to various intensity levels of the L' Aquila earthquake. As before, the different intensity levels were accomplished at the shake table by either changing the intensity of the command displacement in the table or scaling the time over which the earthquake was applied. Table 2 reports the information on the thirteen seismic excitation events, including the corresponding scale in intensity and time. It also gives the recorded and theoretical PGA values along the direction of motion.

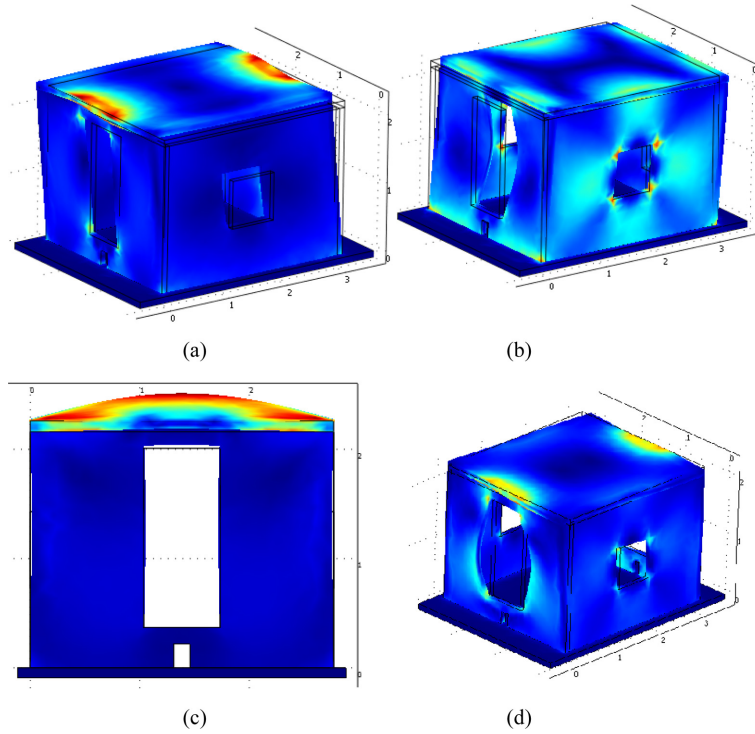
Fig. 12 Finite element model predicted mode shapes (a) first mode, (b) second mode, (c) third mode and (d) fourth mode

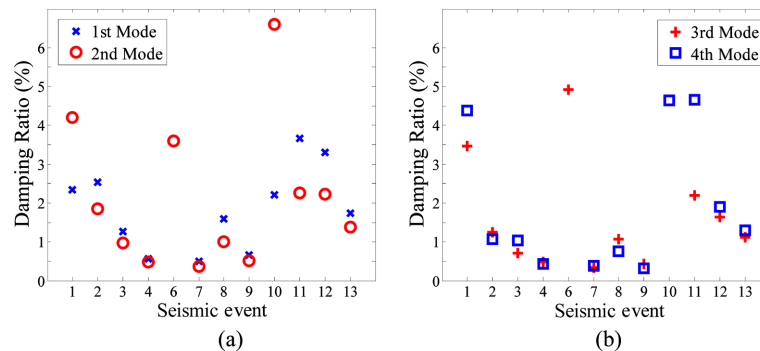
Fig. 14 Evolution of modal damping ratios as a function of the seismic events for the reinforced building using FBG sensors

In addition to the acceleration measurements, FBG sensors data were recorded during the seismic events and the subsequent low-amplitude vibration tests of the reinforced building, with the exception of test number 5. FBG sensors time histories were then used to identify the modal characteristic of the structure, to be compared with the results obtained by the accelerometers time histories. FBG data, recorded at 685 Hz, were re-sampled at 100 Hz. Then filtering was applied to remove low frequencies from 0 to 0.5 Hz which results in noise modes. This noise, confirmed from the experimental/laboratory tests on the FBG sensors installed on the building, is due to the stiffness on the connection masonry/FRP which induced the noise at very low frequencies. Finally the measurements were processed to identify the modal frequencies and the damping ratios. The Eigensystem Realization Algorithms (ERA) as proposed by (Juang and Pappa 1985) was adopted for the modal identification purpose. From FBG sensors results, the identified modal frequencies, as a function of the seismic event for the reinforced building, are reported in Fig. 13 with reference to the lowest four modes, while in Fig. 14 the identified modal damping ratios are reported.

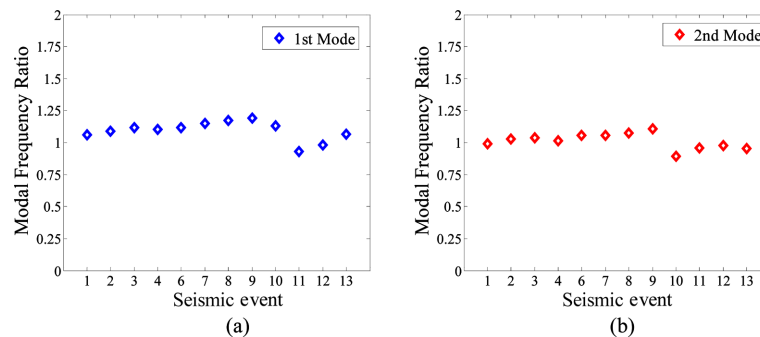
Fig. 15 Ratio of the modal frequencies values for the reinforced building among the FBG and accelerometers, (a) 1<sup>st</sup> mode and (b) 2<sup>nd</sup> mode

the most significant changes to the modal characteristic of the reinforced building. This can be assessed by looking at Fig. 15, which reports the ratio of the modal frequencies estimated from accelerations and FBG measurements.

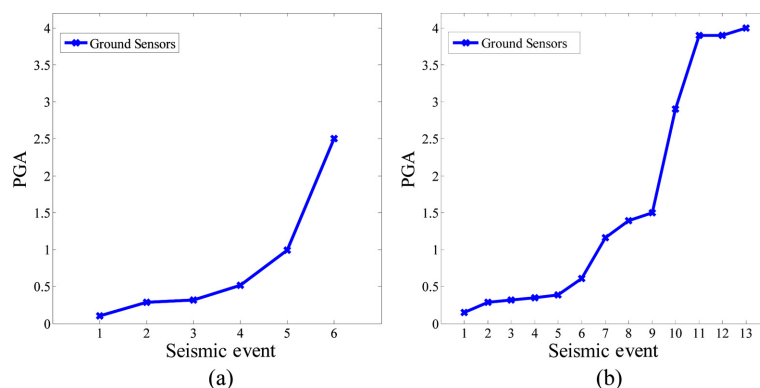
Fig. 16 Evolution of PGA as a function of the seismic events (a) un-reinforced building and (b) reinforced building

The change (reduction or increase) of the lowest four modal frequencies observed in Fig. 9 and in Fig. 13 is due to the change in stiffness of the masonry building caused by damage under the applications of the seismic events or by the retrofitting actions. The results in these figures confirm that the identified values of the modal frequencies are highly dependent on the intensity levels of the seismic events and the corresponding health state of the building. To further illustrate this the PGAs of the seismic events are shown as a functions of the seismic events in Figs. 16(a) and (b) for the un-reinforced and the reinforced building, respectively.

shown in Fig. 3(a), during the seismic tests for the reinforced building. The trend depicted in Fig. 17 is very close to that showed in Fig. 16(b). The evolution of the PGAs and of the standard deviation of FBG sensors strain measurements with the seismic tests is very close.

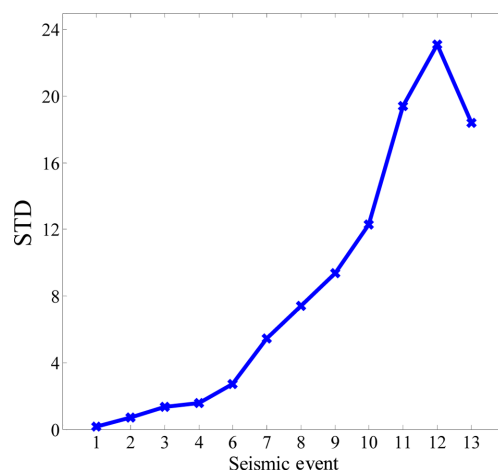
Fig. 17 Evolution of the standard deviation of strain recorded by the FBG sensors as a function of the seismic events for the reinforced building

With respect to the PGAs evolution with the seismic tests, the feasibility of the FBG sensors in detecting the changes of the dynamic characteristics and propagation of damage can also be assessed. This can be investigated by looking at Fig. 17 which shows the evolution of the standard deviation of the strain data recorded by the S8 horizontal FBG sensors located close to the base as
