Relationship between hardness and plastically deformed structural steel elements

Abstract. A field based non-destructive hardness method is being developed to determine plastic strain in steel elements subjected to seismic loading. The focus of this study is on the active links of eccentrically braced frames (EBFs). The 2010/2011 Christchurch earthquake series, especially the very intense February 22 shaking, which was the first earthquake worldwide to push complete EBF systems into their inelastic state, generating a moderate to high level of plastic strain in EBF active links for a range of buildings from 3 to 23 storeys in height. Plastic deformation was confined to the active links. This raised two important questions: what was the extent of plastic deformation and what effect does that have on post-earthquake steel properties? A non-destructive hardness test method is being used to determine a relationship between hardness and plastic strain in active link beams. Active links from the earthquake affected, 23-storey Pacific Tower building in Christchurch are being analysed in the field and laboratory. Test results to date show clear evidence that this method is able to give a

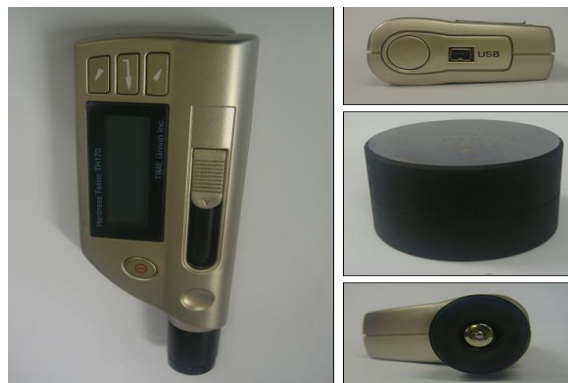
A portable Leeb hardness tester, series TH170, has been used in these experimental studies. This instrument measures the hardness of the material dynamically by impacting a spherically shaped indenter onto the test surface, so that the impacting and rebounding velocity of the test material is measured as a hardness of the test material. TH170 is being widely used because of its speed, light weight, portability, ease of use and because the Leeb Hardness measurement procedure is covered by an ASTM standard (2011). Fig.1 shows the portable hardness tester TH170.

Fig. 1 Integrated portable Leeb hardness tester Th170

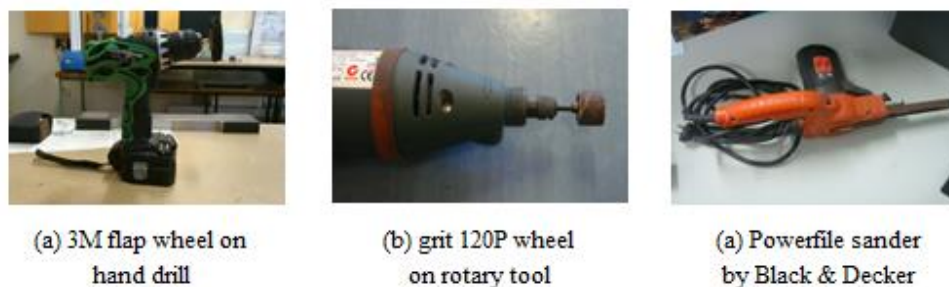
For an accurate hardness test result, surface roughness was identified as an important parameter during this study. Test specimens must be smooth, even and clean enough according to ASTM Standards (2011) for hardness determination of metallic materials by this rebound based portable machine. Oxide scale or mill scale and other foreign matter can lead to inaccurate readings. Any paint, including undercoat and surface coat, pits and scale must be removed. Testing on a range of surface roughness as described below established that surface roughness (R_a) needs to be less than 1.6 micro-meter (μm) when using TH170 testers for accurate hardness test results. Three surface preparation methods were used to carry out a surface test; 3M Flap Wheel on electric rotary tool followed by hand sanding, Two Dremel Wheels on electric rotary tool followed by hand sanding and an electric sander (variable speed Powerfile by Black and Decker) with different sanding belts followed by hand sanding. Different surface preparation instruments and prepared surfaces are shown in Fig. 3 and Fig. 4.

Fig. 3 Surface preparation tools

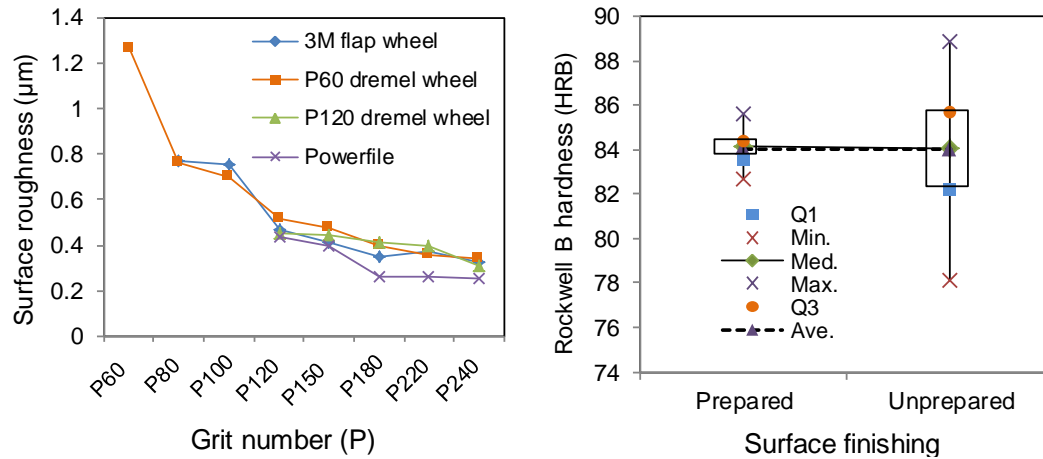
(a) Comparison of surface roughness

(b) Influence of surface finishing on hardness

Fig. 5 Surface roughness with different surface cleaning methods and the influence on hardness

explained in section 3.2, and presented in Fig. (a). The test results show the roughness on all prepared surfaces. As all of these are less than the 1.6 microns recommended for the TH170 operation, it can be considered that any roughness below P60 would be sufficient to carry out TH170 hardness measurements accurately as given in Section 3.1. Fig. 5(b) describes the influence of surface preparation on hardness values. Hardness readings from as-received specimens are scattered over a wide range compared to the prepared specimens. This indicates more accurate hardness could be achieved from a specimen properly prepared.

In Fig. 5(a), the grit number P60 gives the highest the surface roughness ($Ra=1.27 \mu\text{m}$) whereas P240 gave the finest surface achieved in this study. The test results were then compared to identify the best cleaning method out of the three discussed in previous section to achieve the most cost and time effective surface roughness for the portable hardness tester TH170. Challenges in adopting the best method involves access to the test site and location, geometry of the sections, availability of appropriate tools and materials and the safety of the building specially in earthquake effected zones and building structures. There is significantly greater variation in the Rockwell and Leeb readings for the unprepared surface and a slight difference in the average value. This highlights the need for surface preparation to achieve a roughness of $Ra < 1.6$ microns.

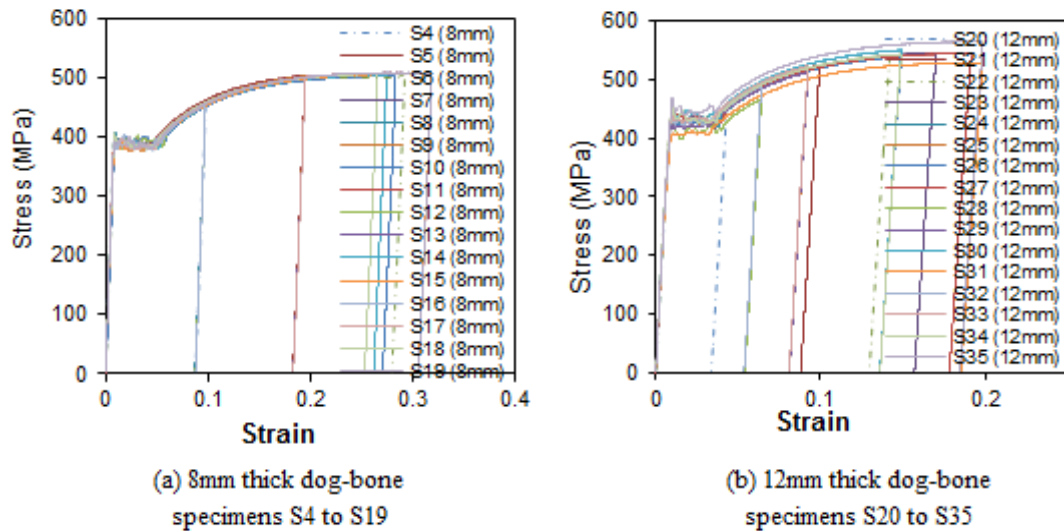
This section presents tensile test results for 8 mm and 12 mm thick dog-bone specimens. For different strain demands, load against the displacement graphs were plotted and the hardness was measured before and after the tensile testing. Load-displacement diagrams for 8 mm thick specimens S4-S19 are presented in Fig. 6(a). Specimen S1 was strained to failure in order to determine the overall force-displacement characteristics over the full plastic strain range.

Fig. 6 Load-Displacement diagrams for 8 mm and 12 mm thick dog-bone specimens

Specimens S2 and S3 were used as trial specimens. The target strains were set as 5%, 10%, 15%, and 20%, however, due to test setup flexibility, the strain achieved was slightly different. Other mechanical properties, i.e., yield strength, ultimate tensile strength, yielding and plastic deformation behaviour of all the specimens is same.

Fig. 6(b) represents load-displacement graphs for 12 mm thick specimens S20 - S35. Targeted strains set for these specimens were 2.5%, 5%, 10% and 15%; achieved strains were slightly different. The maximum yield load obtained from the 12 mm specimens was about 65 kN, which is 15 kN higher than the maximum yield load of 8 mm thick specimens. Unlike the 8 mm thick specimens, a small inconsistency was observed within a few 12 mm specimens. Hardness test results in Fig. 7 don't show any dramatic changes due to these minor inconsistencies in plastic behaviour.

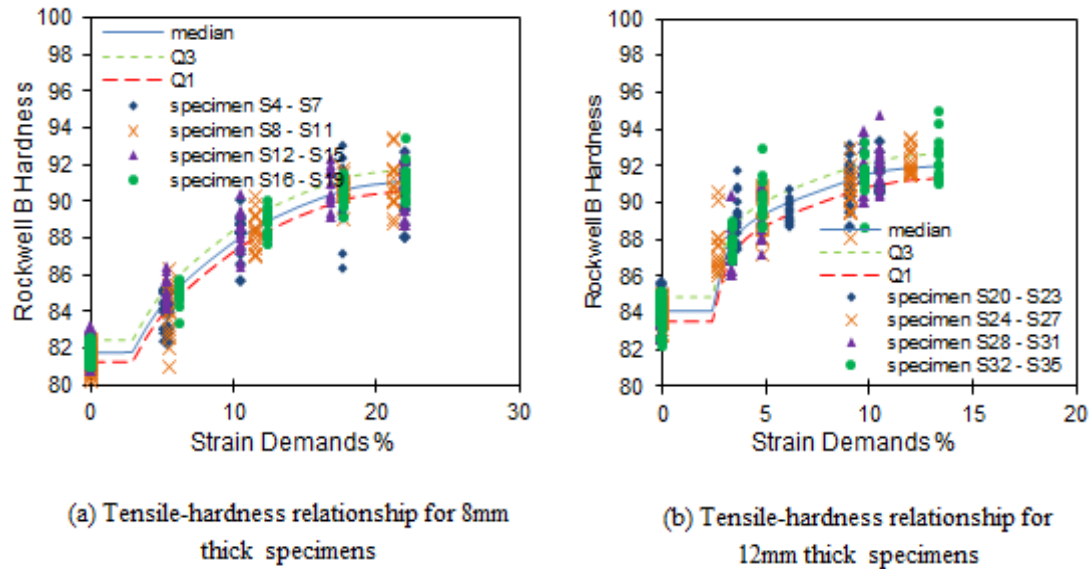
Measured hardness against plastic strain from the dog-bone specimens is presented in Fig. 7. Hardness measurements were undertaken with the Rockwell B bench top hardness tester, with the readings for different specimens being taken on different days. For the hardness tests, specimens were grouped from lowest to highest achieved strain levels as a set, and this was repeated for up to four sets. At zero strain, Rockwell hardness for 8mm thick specimens ranged from 79.6 to 83.2 and for 12 mm thick specimens ranged from 82.2 to 85.6. Hardness measurements up to the beginning of plastic strain were considered to be constant and it were plotted following the load-displacement diagram shape. At each strain level, 15 hardness readings were taken and recorded in four categories; average, minimum, maximum and median. Hardness gradually increased with increasing plastic strain in both the cases as shown in Fig. 7. It was observed, the majority of hardness values fall between the first and third quartile (Q1 and Q3), indicating that this relationship is within the acceptable limits. Based on monotonically strained specimen test results,

Fig. 7 Hardness - tensile relationship at various strain demands

Fig. 7 shows, curves meeting the zero strain hardness values at the plastic strain corresponding to the end of the yield plateau. This intersection point which is got from the force-displacement diagram in Fig. 6 are based on the fact that the material strength does not increase above yield in the yield plateau region, meaning that the hardness will not increase in that region either. For Grade 300 steel that extends out approximately 2.8% plastic strain.

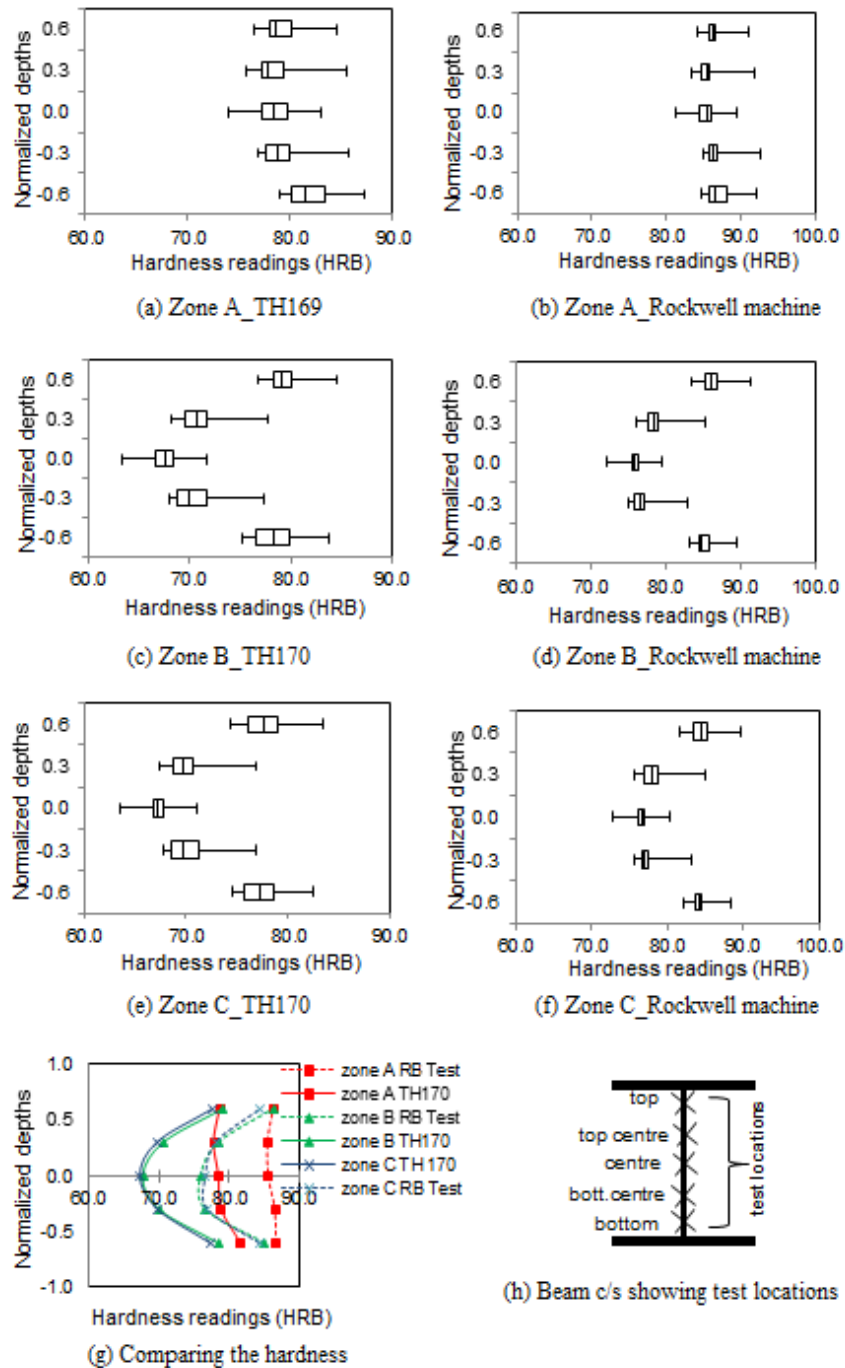
Rockwell B hardness for both testers, as a function of normalized link depth is presented in Fig. 9(a) to (f) and (g) represents a comparison of hardness over the three zones. Accuracy of the hardness method can be predicted by comparing the proximity of the box plots. It is noted that the hardness measurements in these tests were carried out before adopting the proper surface preparation technique discussed in Section 0 and 6.1. These normalized link depths clearly demonstrate the difference in hardness between the three test zones using the two test methods as shown in Fig. (g). Rockwell B machine values were between 10 to 8 points higher than the Leeb

Fig. 9 Normalized link depth versus hardness in three zones of the active link beam

TH170 tester hardness values. The difference in hardness between these two methods could be due to the geometry of the section and the mass effect of the test specimen. Both machines clearly

show that Zone-A achieved the highest hardness values for both the methods. Constant high hardness values through the depth of the web in Zone-A indicates that the web of the active link had undergone appreciable in-plane plastic deformation during the earthquake, while the panel and beam zones, B & C, had much lower levels of plastic strain at the midpoints of the webs.

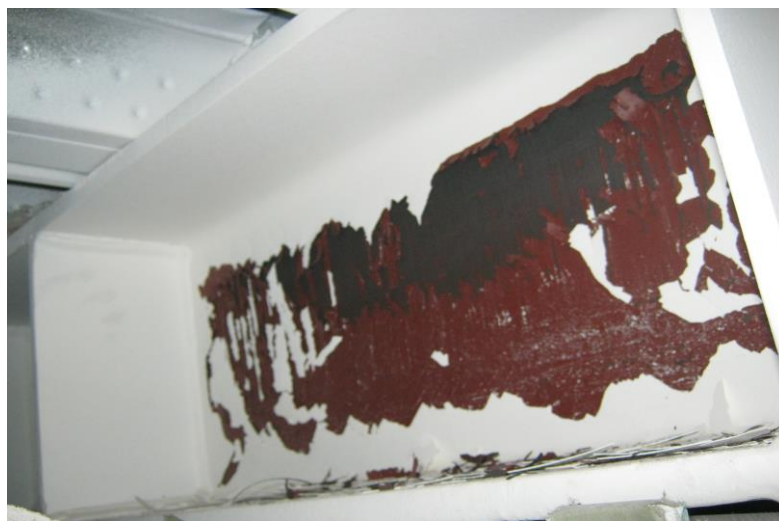
Fig. 10 Active link beam from Club Tower, Christchurch which has undergone plastic strain
