## A rapid assessment methodology for bridges damaged by truck strikes

**Abstract.** The present research aims to develop a methodology to rapidly assess bridges with damage to the superstructure, caused by overheight trucks or lower-than-average overhead clearance. Terrestrial laser scanning and image processing techniques are combined with the finite element method to arrive at an analytical model which is more accurate, with respect to the complex geometrical aspects of the bridge in its damaged configuration. “Virtual load testing” may subsequently be carried out on this analytical model to determine the reserve capacity of the structure in an objective manner.

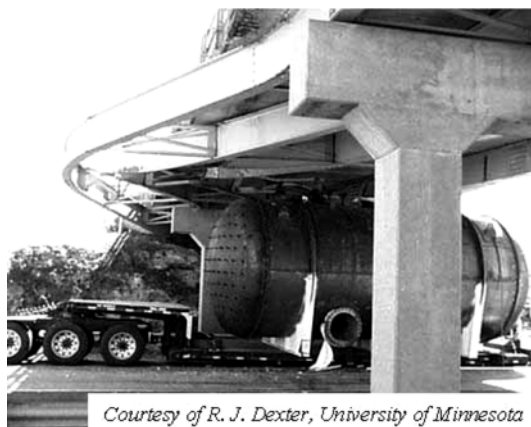
Fig. 1 Example of catastrophic bridge damage due to a vehicular impact

With respect to scenarios (1) and (2) above, the ensuing damage to the underside of the bridge may be catastrophic in nature (Fig. 1). However, it is more common that the bridge will sustain minor to moderate damage, while remaining intact. While such damage varies dramatically, depending upon the

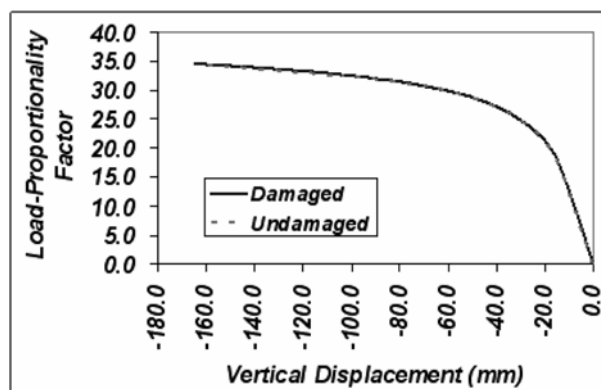
Fig. 11 Lambda-Displacement plot of midspan of Span 1 for end span load configuration

Figs. 11 and 12 provide “ $\lambda$ ”-displacement curves from two points on Girder 1: the midspan location of the loaded end span (Span 1) and the center span (Span 2), respectively. It is expected (and confirmed by Fig. 13) that Girder 1 will be the location for which the damage has the most significant effect; therefore, corresponding plots of the remaining five undamaged girders will not be necessary. Fig. 13 provides a contour plot of the difference in vertical displacements at the top-of-steel between the damaged and undamaged bridge, at the final load increment considered for the present research; this provides an indication of the system-wide impact the damage has on the structure. These values are based upon a linear interpolation between the deflections of the top flange-web junction of each girder.

Fig. 11 indicates that the damage to the fascia girder, located within Span 2, has a negligible impact on the midspan deflection of Span 1. When considering Span 2, Figs. 12 and 13 demonstrate some difference in behavior between the damaged and undamaged models.

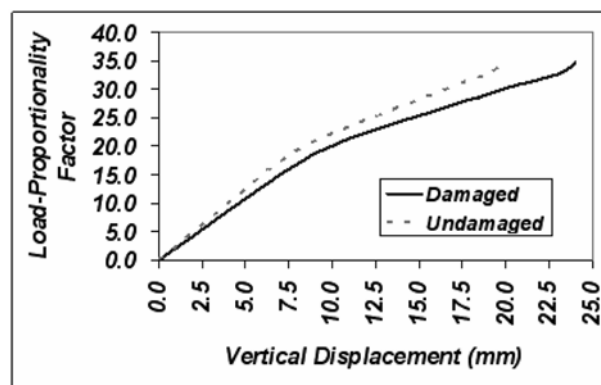
Fig. 12 Lambda-Displacement plot of midspan of Span 2 for end span load configuration
